**Subject:** ERA26LA009, FAA Wreckage Examination

N1998X Cessna 182H SN 18256098

Inspection for accident investigation ERA26LA009 conducted on 10/10/2025 at North Central, RI; Boston Skydive Center

Damage assessment:

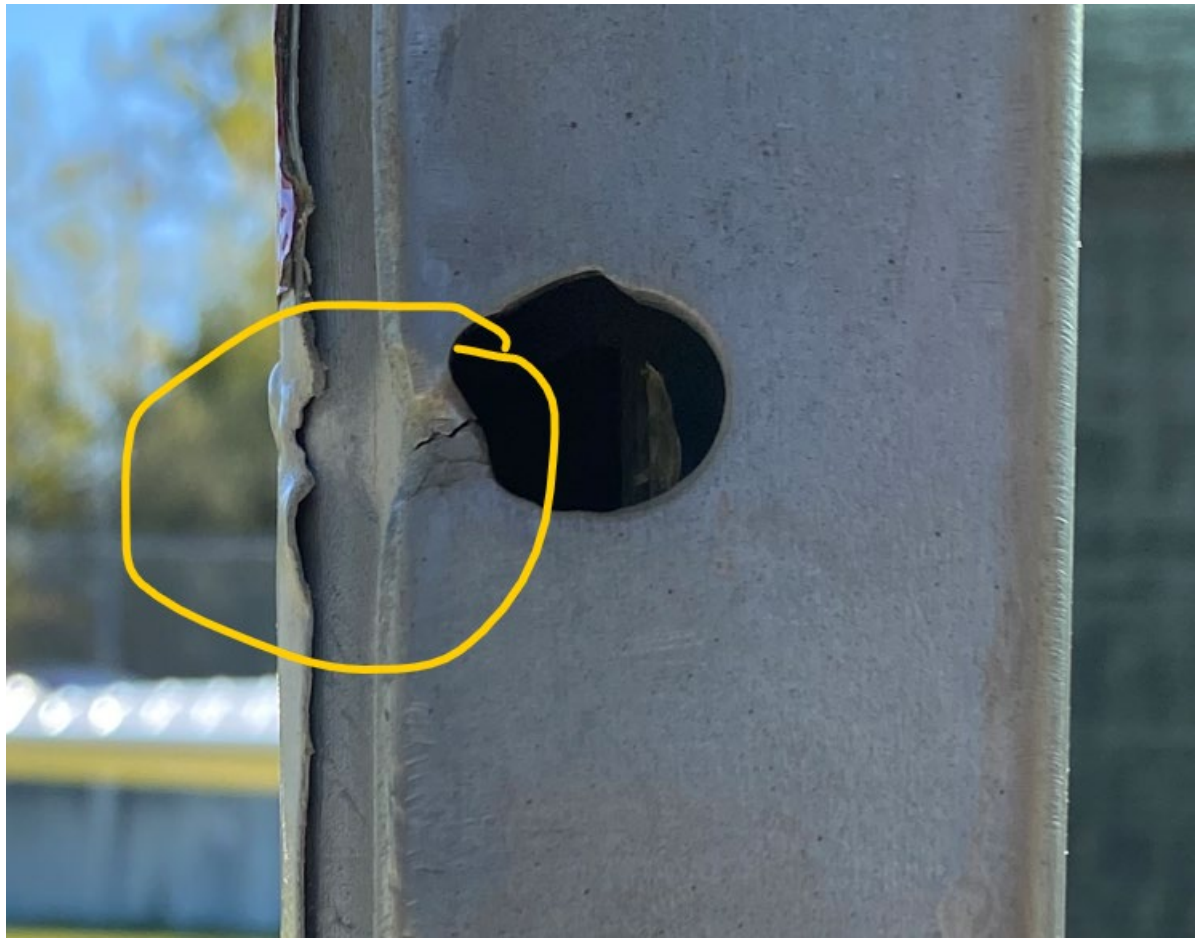
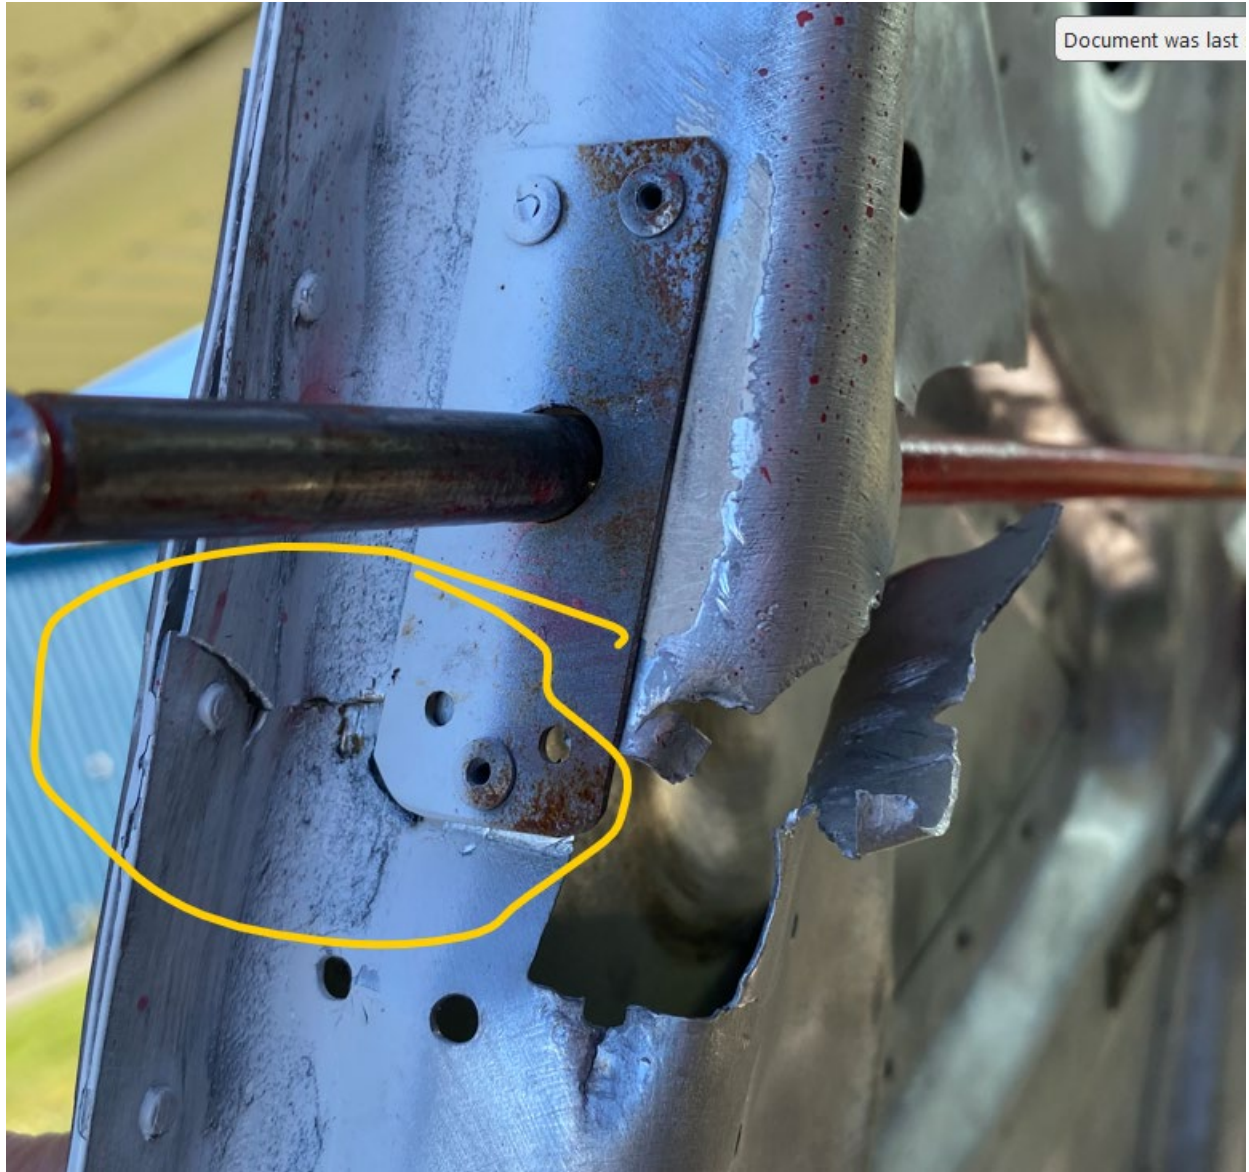
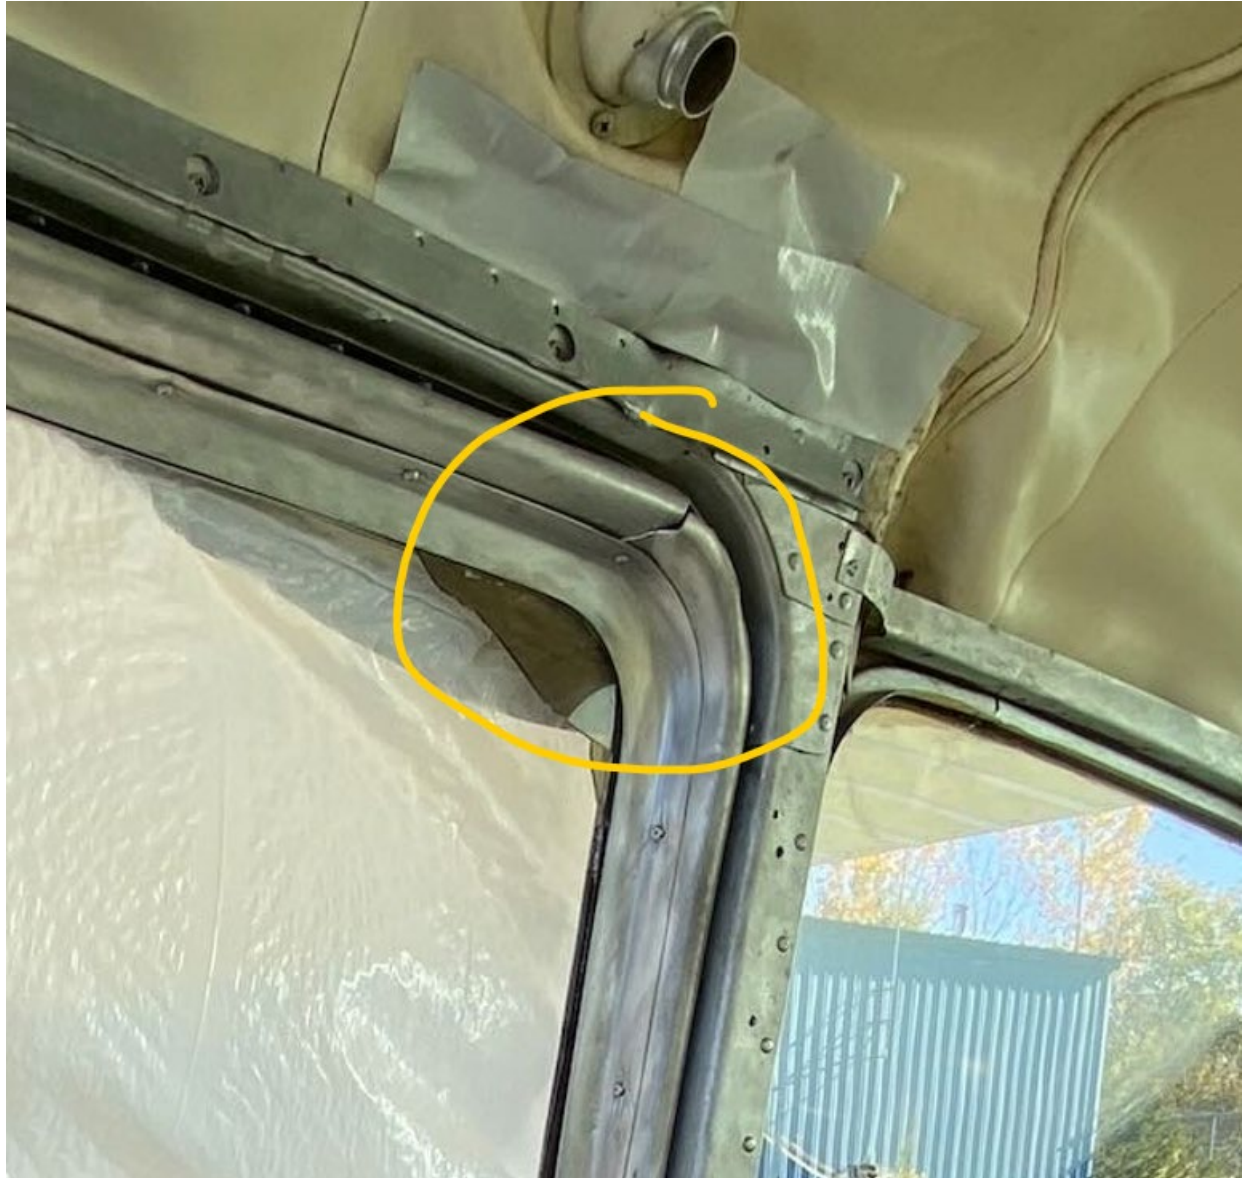
Door Assembly Frame Structure Cracks

1. The Jump door assembly was installed by FAA Form 337 Dated November 5, 1992 (page 23 of AW Registry Documents).
2. Cabin Jump door assembly and interior door frame locking mechanism has misalignment. Multiple cracks are present in the "formed aluminum" supporting door structure and in the area where the locking mechanism attaches. (there are minimum of 10 significant cracks with the airframe also cracked at a locking hole).

caused wear, distortion and cracks to the airframe skin, door frame, door supporting structure, locking rods and lock rod holes (located in the fuselage).

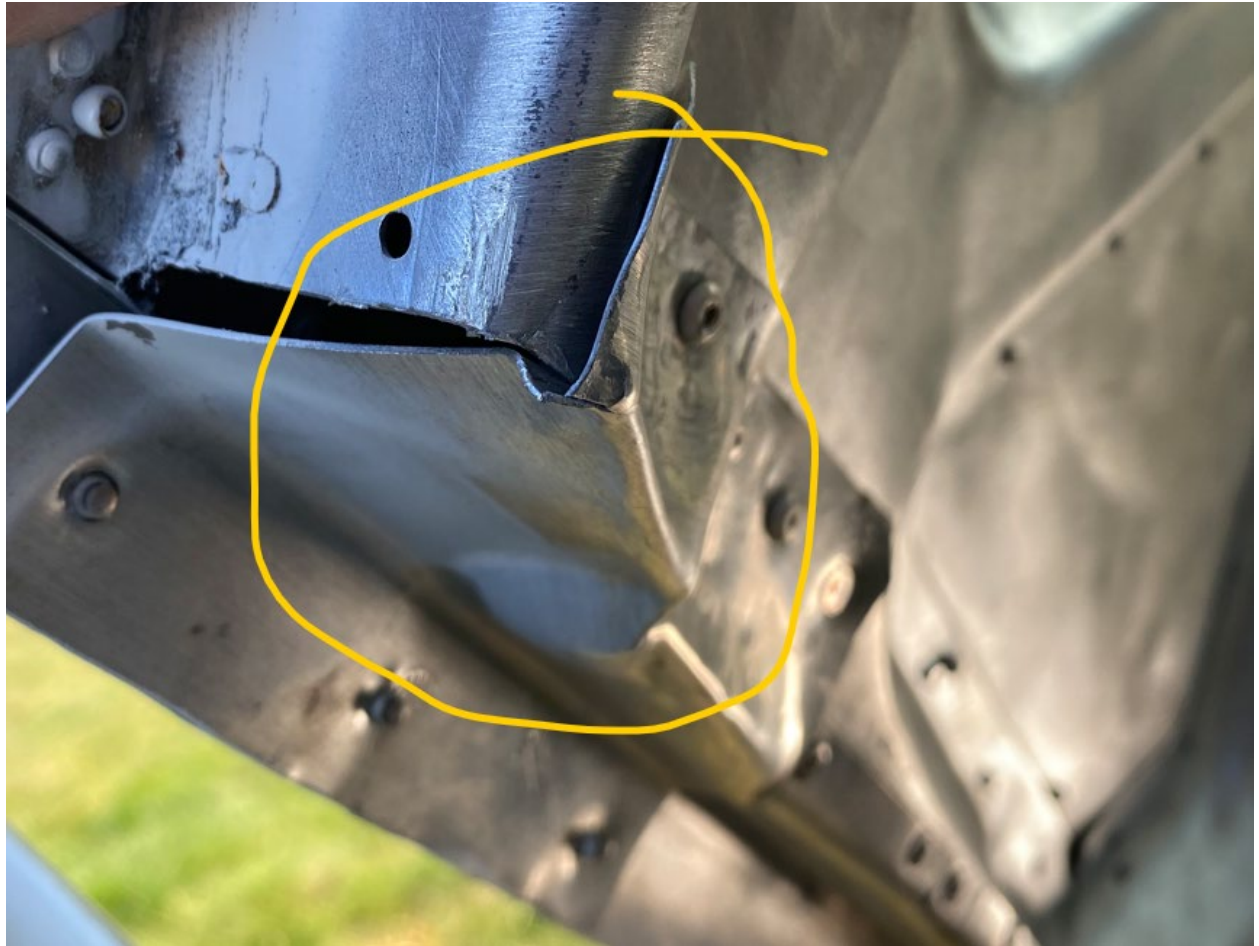
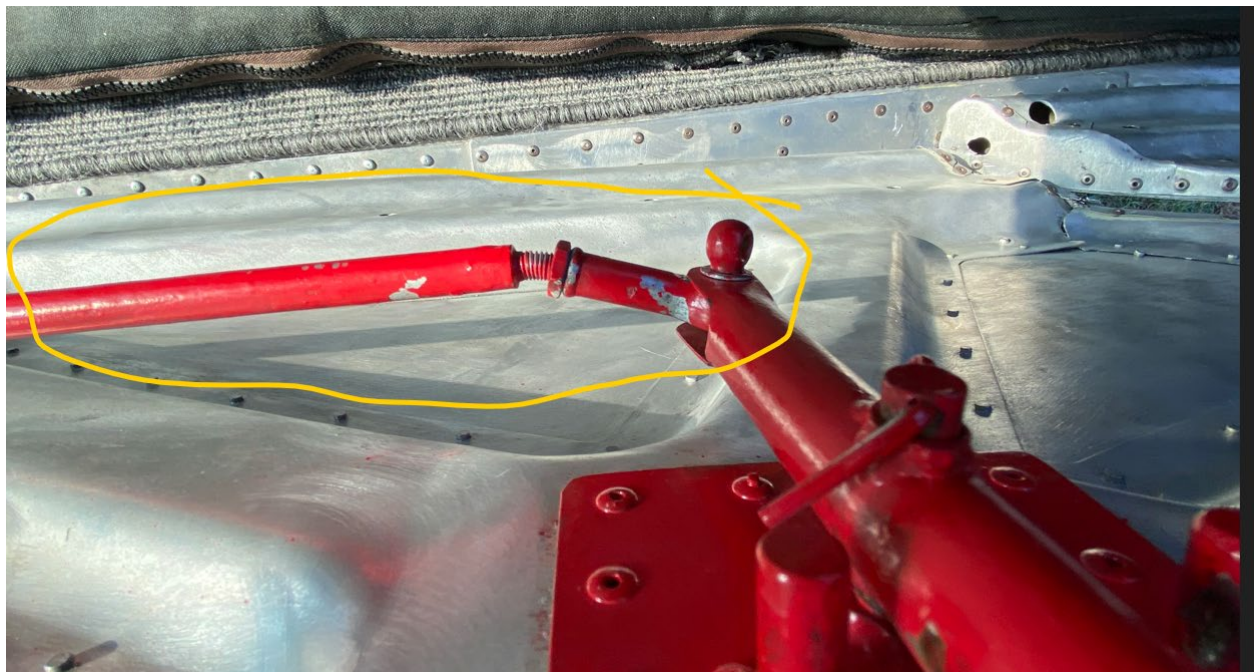
Aft Locking rod bent: Noted that this is the location required to be pulled, to close the door.

The locking rod is bowed as noted in these photographs.

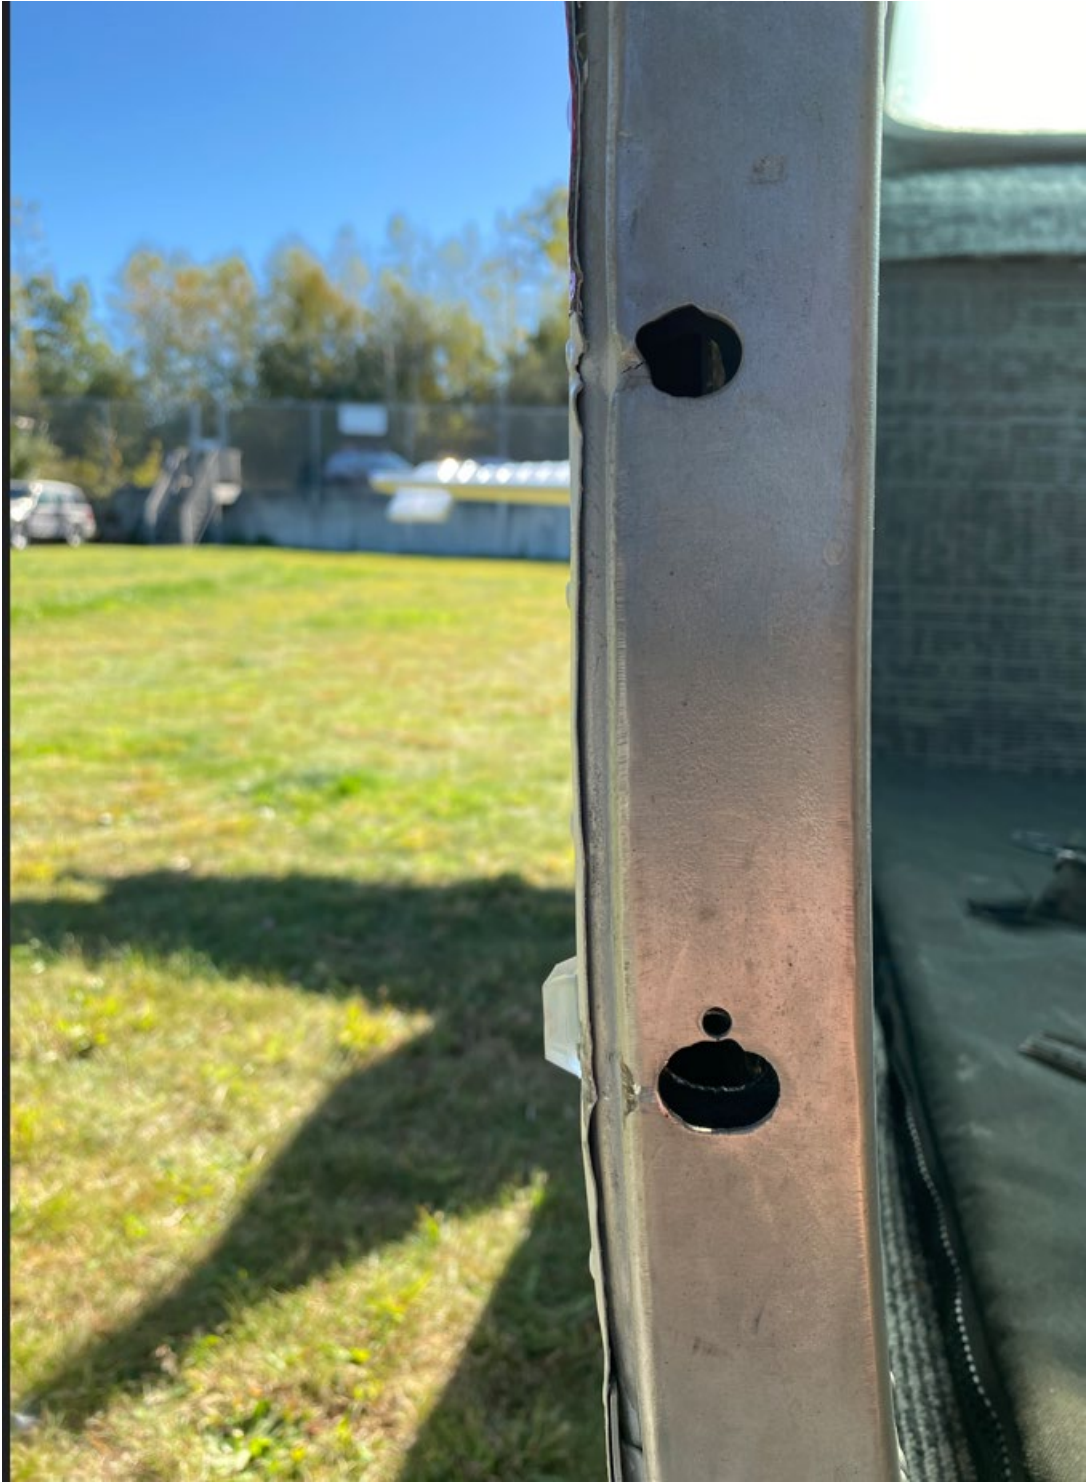
Trailing edge Alignment with the door pulled firmly closed, the locking rod does not align with airframe locking rod receptacle (hole) in the fuselage door frame. The locking rod is bowed inboard toward the pilot causing the locking rod extending beyond the edge of the door assembly, to bow outboard. Additionally, repeated striking of the locking rod against the fuselage door from attempting to close the door with the rod extended also contributes to the bending of the rod outboard. The damage on the outside of the fuselage door frame indicates occurrence of this action repeatedly. The door supporting structure can also be seen cracked in this location.

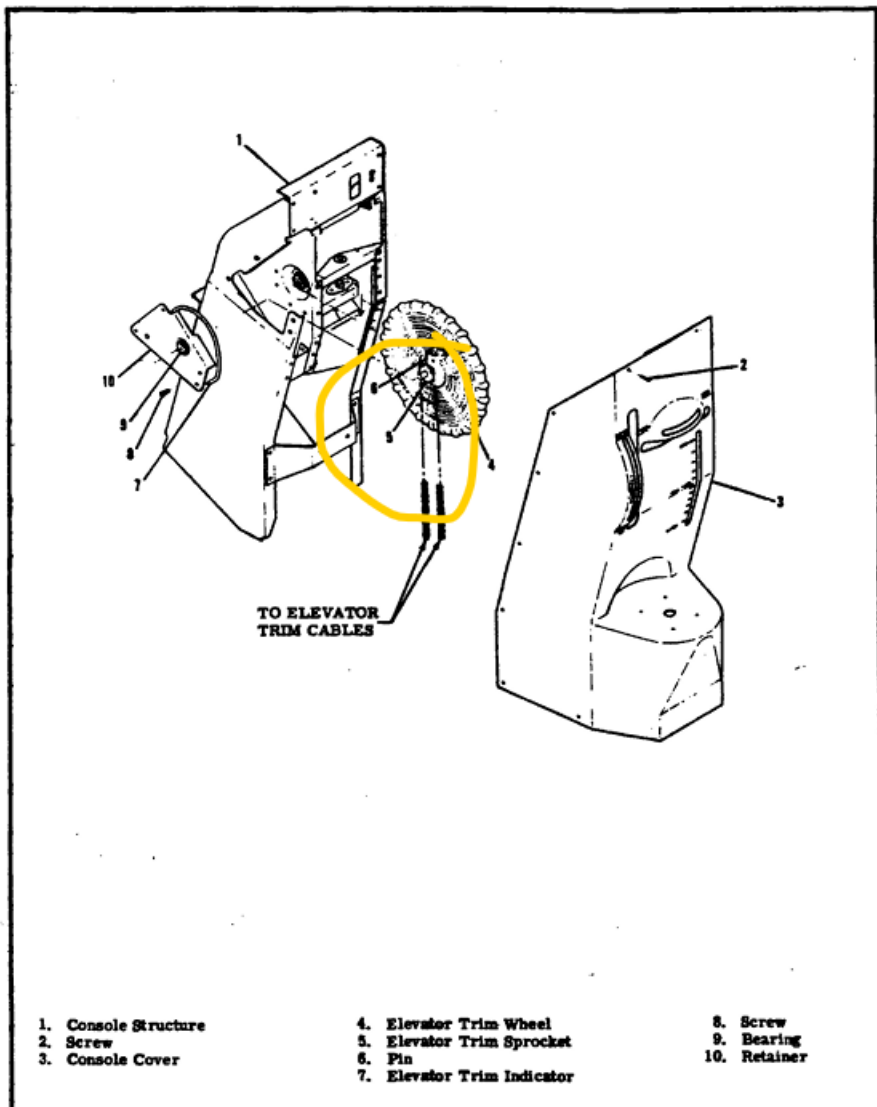
Figure 9-5 Model 182 Elevator Trim – Console Components

6. The Elevator trim system was found to have reversed function. Rotation of the elevator trim wheel, nose up (trim wheel rotated down) causes the trim tab to move up. Rotation of the elevator trim wheel, nose down (trim wheel rotated up), causes the trim tab to move down.

The elevator trim wheel pointer was also noted to go to full travel in the nose down position, moving only about 1/3 of the pointer window.

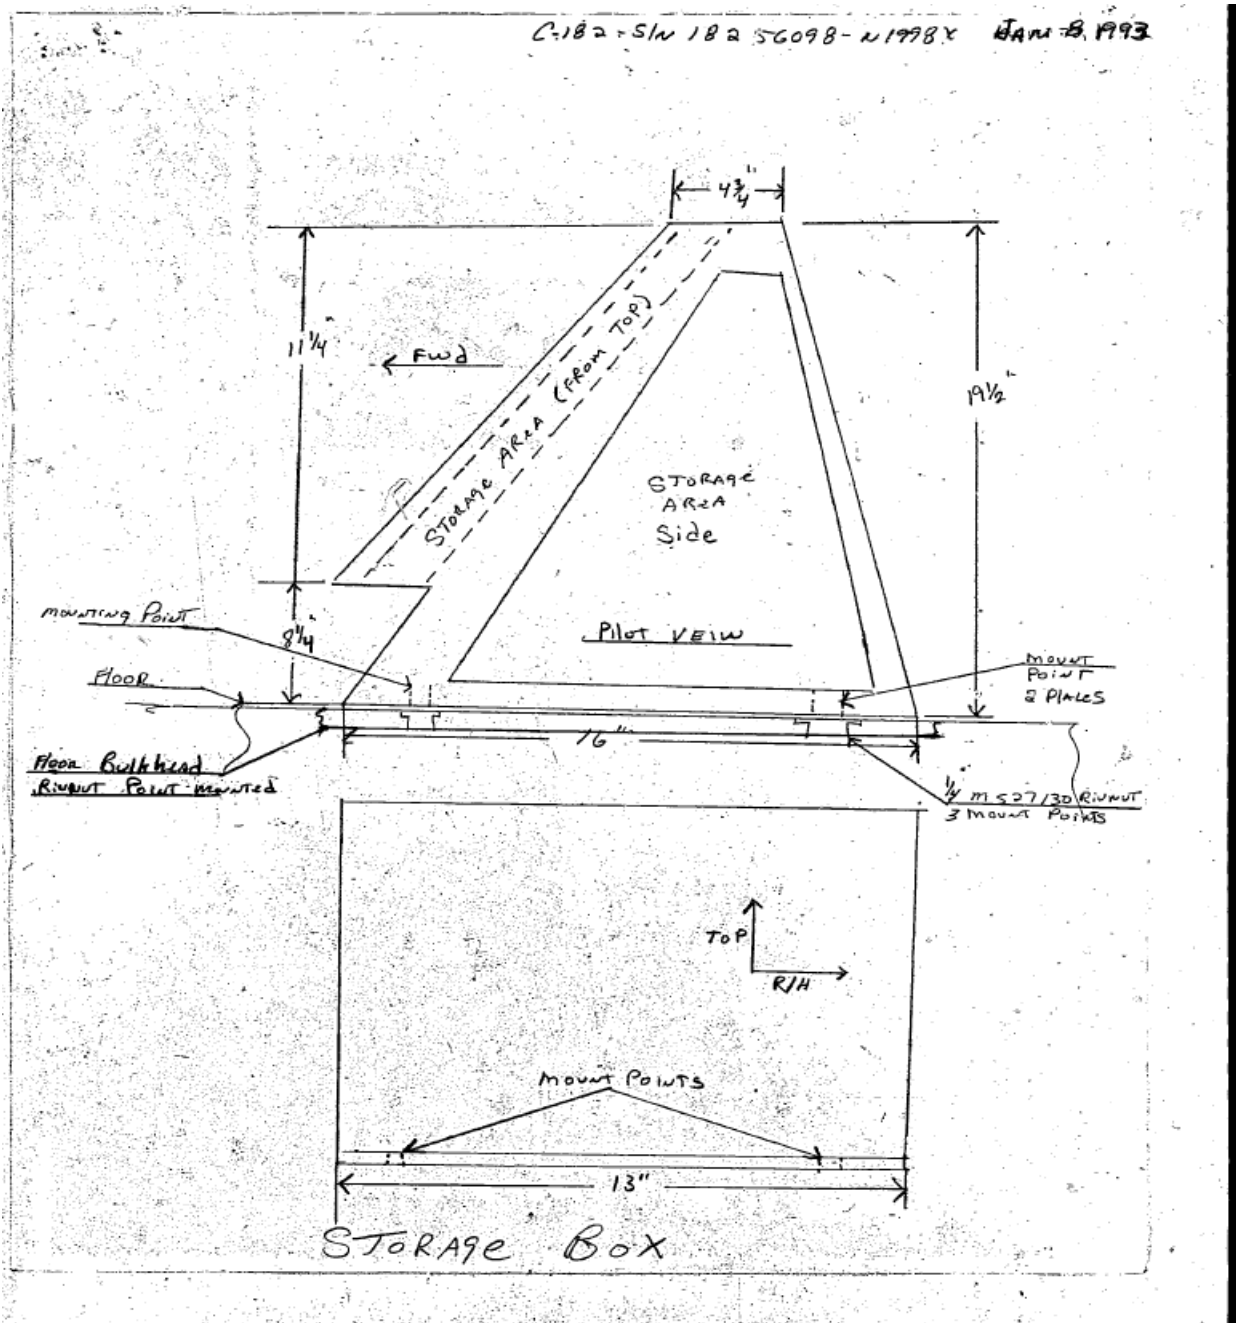
- Missing from the aircraft was the alteration for the control cover. This Alteration is part of the jump configuration and required to be installed to prevent personnel from being caught in the controls. Part of this alteration contains the RH gear leg step, which is installed. This Alteration can be noted on FAA Form 337 Dated 1/28/1993

- (E) Modified aircraft for jump configuration - manufactured and installed storage box and R/H gear leg step.
- (A) Manufactured and installed wooden box in front of copilot rudder pedal and control wheel at Station 22. The purpose of the box is installed for safety so the jumper will not accidentally move or hit the control wheel and rudder pedal, and for storage of jumper equipment.
- (B) The box is made of plywood. It is mounted to the floor at 3 locations with 1/4 inch MS27130 rivenut and AN4 bolt.
- (C) The box is installed only in jump configuration.
- (D) See attached sketch for detail.

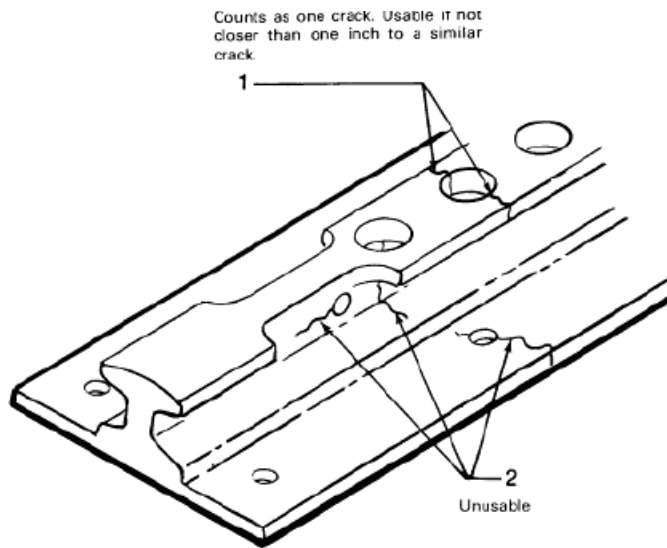
- A current 14 CFR 91.413 transponder certification entry could not be located.
- Seat track AD 11-10-09 was completed; however, should be reevaluated for cracks in the seat track after the hard landing. It appears that more than the maximum amount of cracks have developed in rail exceeding the total of 4.

**REPLACE SEAT RAIL WHEN:**

- (1) Any portion of web or lower flange is cracked (index 2).
- (2) Any crack in crown of rail is in any direction other than right angle to length of rail.
- (3) Number of cracks on any one rail exceeds four, or any two cracks (index 1) are closer than one inch.
