# Air Safety Investigation Examination Report

| Aircraft Incident/<br>Accident Information | Year: 1959 | Make: Cessna | Model: 180B |
| | Serial number: 50367 | | Registration: N5067E |
| Location: Waterloo, IA | | | Date: 06-06-15 |

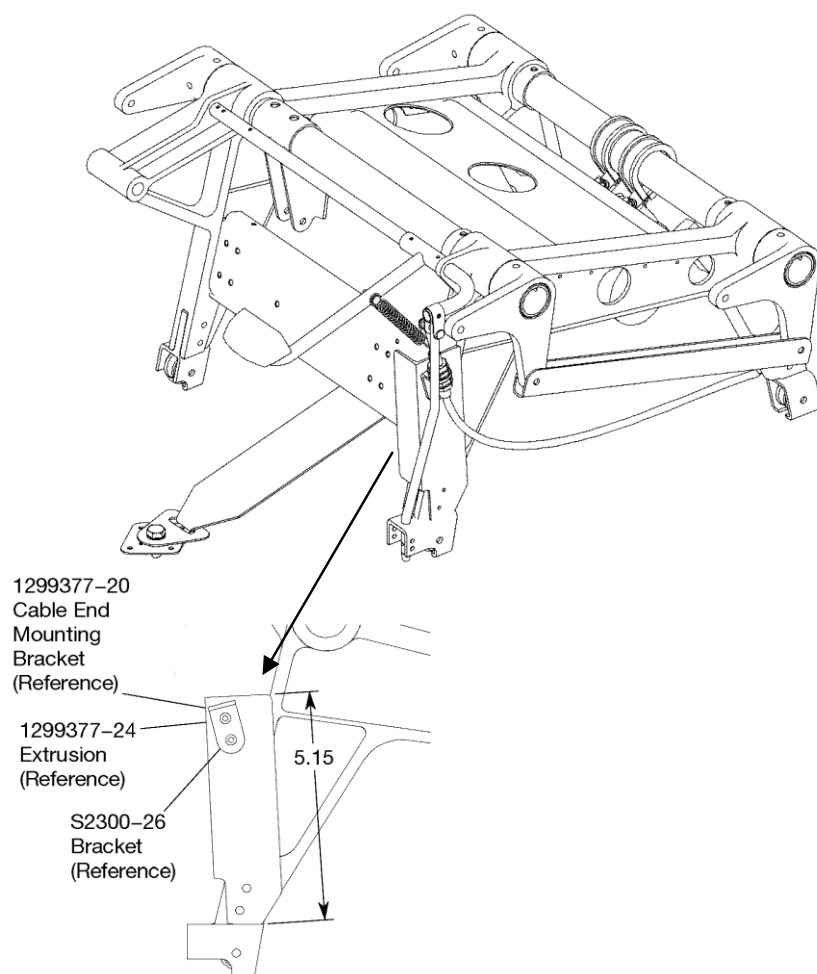
Images taken from SK210-174B

Included in the service kit is extrusion 1299377-24. The extrusion is a piece of aluminum bent 90° lengthwise. The installer is to trim the extrusion as required to meet the measurements shown in the service kit for the installation chosen. When the extrusion has been trimmed it becomes bracket 1299377-20. The installation instruction calls for 1299377-20 to be installed on the outboard side of the forward, outboard seat leg with the 90° portion pointing inboard. A second bracket, S2300-26 is attached to the outboard side of bracket 1299377-20. The threaded ferrule is then installed in S2300-26 and secured with nuts and lock washers. The terminal end of the cable is then attached to the pin adjustment mechanism by replacing the installed pin with a kit installed pin. The terminal end is secured on the pin using a cotter pin. Up to three washers can be installed on the pin.

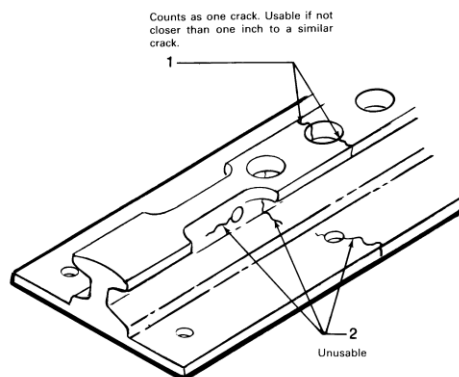
Cessna Service Information Letter (SIL) SE83-6, dated 03-11-83 provides inspection guidelines and seat rail replacement recommendations for seat rails that are found cracked. Item (g)(8) of AD 2011-10-09 requires a visual inspection of the seat rails for cracks and reiterates the guidance provided in SIL SE83-6. Item (g)(8)(i) of the AD states, "If there are seat rail cracks that exceed the crack criteria in figure 5, before further flight, replace the seat rail." The image below is labeled "Figure 5" in the AD.

#### REPLACE SEAT RAIL WHEN:

- (1) Any portion of web or lower flange is cracked (index 2).
- (2) Any crack in crown of rail is in any direction other than right angle to length of rail.
- (3) Number of cracks on any one rail exceeds four, or any two cracks (index 1) are closer than one inch.

Use of seat rail cargo tie-downs is not permissible on seat rails with cracks.
