**NATIONAL TRANSPORTATION SAFETY BOARD**  
**Office of Aviation Safety**  
**Washington, D.C. 20594**

**POWERPLANT GROUP CHAIRMAN'S FACTUAL REPORT**

**NTSB No: WPR13GA374**

Aircraft: MD Helicopter Inc. (MDHI) 369E Helicopter, Registration Number N62PJ

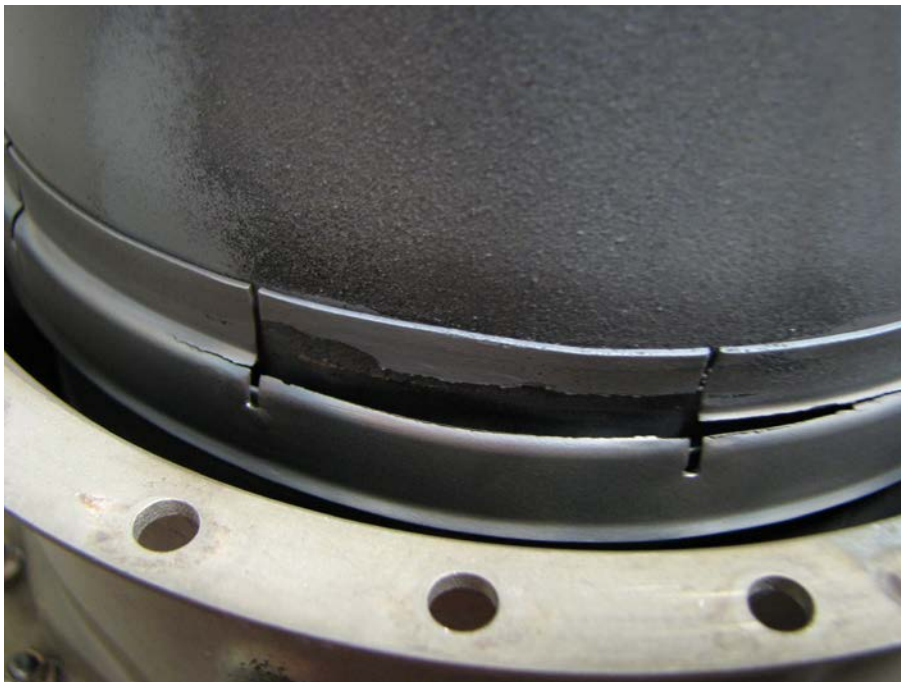
Figure 16 – Combustor Liner – Detail of Crack at Fishmouth Seal

The outer combustor case was intact and undamaged; however the combustor liner had a 2 inch long radial fracture of the fish-mouth seal at the 8 o’clock location (Figure 15 & Figure 16). The combustor liner was also heat distorted at the 8 o’clock location. The heat distortion started as a point at one of the aft most dilution holes and continued in an increasing pattern until meeting the fish-mouth. The 1<sup>st</sup> stage nozzle deflector shield heat shield was slightly distorted (Figure 17). The heat shield is a plate that is welded onto the deflector shield and has a wavy pattern corresponding to the mounting dimples on the deflector shield. The clearance between the edges of the heat shield and the deflector shield is approximately 1/8 inch, however at the 8 o’clock location; the edges were in direct contact with the deflector shield material.

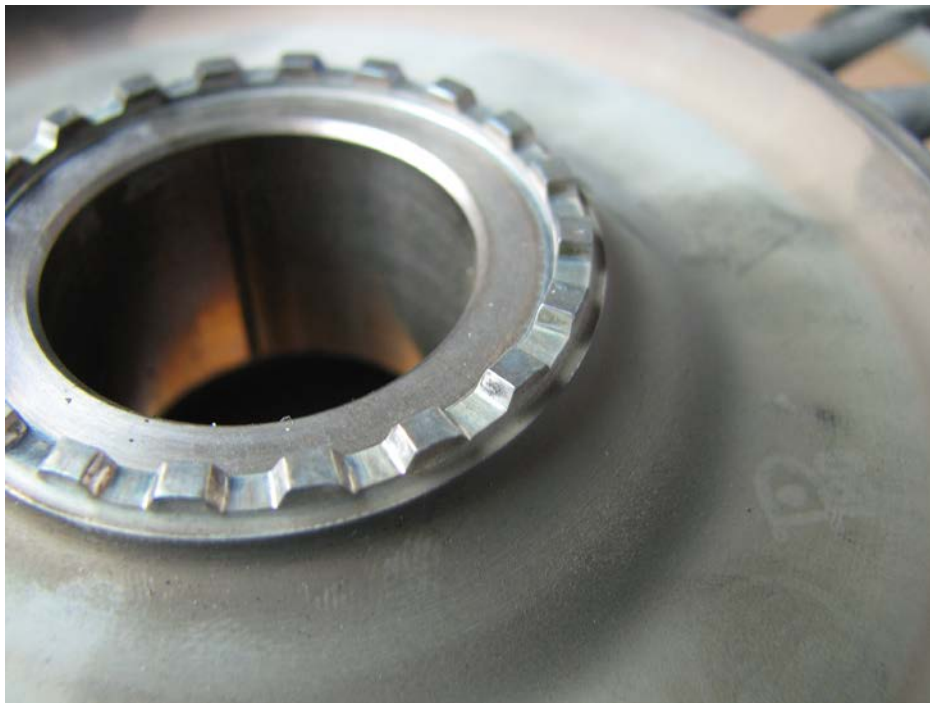
**Figure 24** – 4th Stage Turbine Wheel – Curvic Teeth

The 4<sup>th</sup> stage turbine wheel was missing one blade (Figure 20 & Figure 21). The missing blade was fractured near the inner rim (Figure 22). A 4-blade span of the shroud was also missing; it was located outboard of the liberated and three adjacent lagging blades. The three lagging adjacent blades were fractured near the tips, were missing the entire shroud segment and were twisted (Figure 23). The leading and lagging adjacent blades were still attached to the inner platform rim. All the other blades were present and intact however all were dented at the trailing edges approximately ½ inch inwards from the blade shroud. Nine of the curvic coupling teeth which mate to the 3<sup>rd</sup> stage turbine wheel were smeared on their contact faces; however, all were still intact (Figure 24).

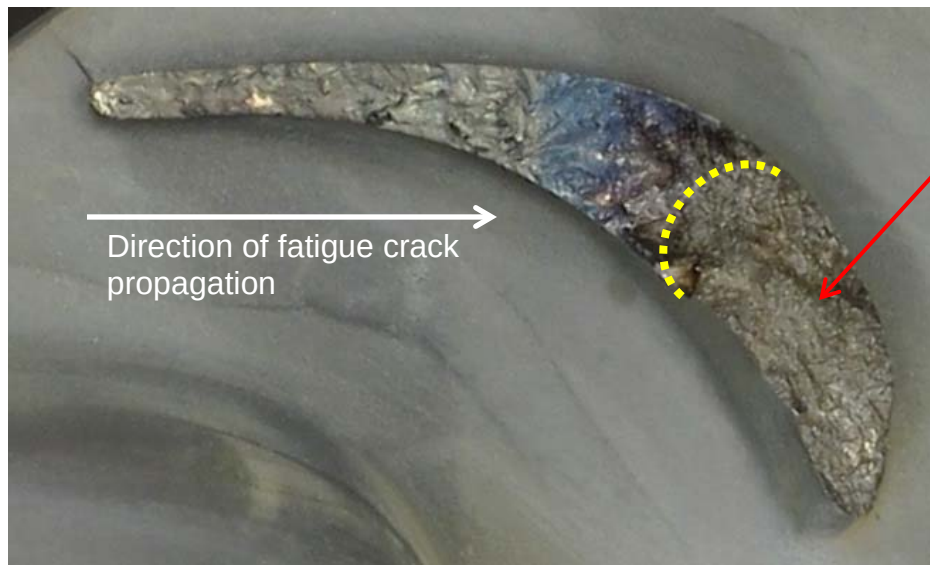
Figure 27 – Detail of Trailing Edge of Blade from

- 1) The 4<sup>th</sup> stage turbine wheel was P/N 23055944-F, S/N X586178.
- 2) One 4<sup>th</sup> stage turbine wheel airfoil fractured and separated due to fatigue. The fracture initiated as a low cycle fatigue (LCF) crack at the trailing edge of the airfoil at about 0.025 inch outboard of the hub rim (Figure 25) and propagated forward for 0.035 inch (Figure 26), at which point it transitioned

into a high cycle fatigue (HCF) crack, growing approximately 0.494 inches long before the airfoil separated in overload (Figure 27).
