**Class A Accident**  
**November 23, 2012**  
**Eurocopter AS-350B3 (2B1) Helicopter**  
**N3984A**  
**Newfield, Arizona**

**Accident Report**  
CBP Case Number 20121124ZC0001  
NTSB Case Number WPR13GA051

**U.S. Customs and  
Border Protection**

## **Aircraft Accident Report**

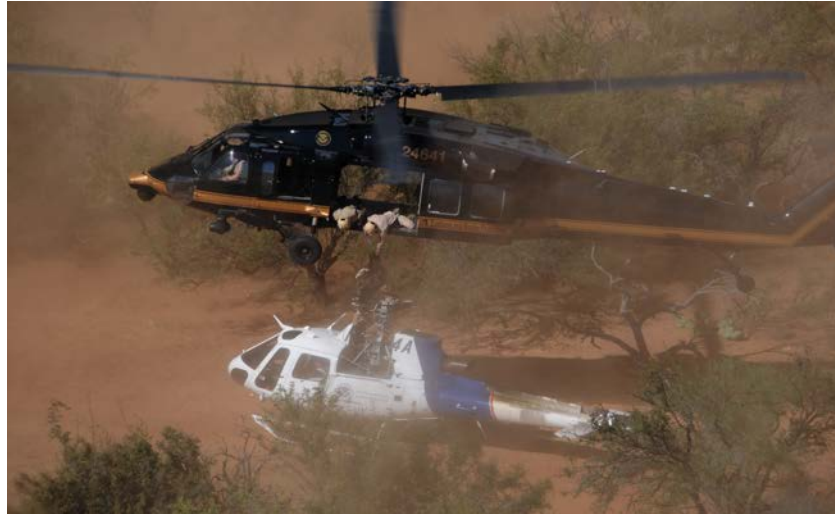
The accident aircraft was rigged in approximately two hours and certified by the ELO Master prior to the lift. The aircraft was then lifted/flown (Figure 6) approximately one half mile to a nearby road where it was lowered without incident to the awaiting flatbed trailer. The aircraft was then driven three hours back to the Tucson Air Branch where it was secured inside the North Hangar.

Figure 6. Aircraft Relocation for transport
