## **NATIONAL TRANSPORTATION SAFETY BOARD**

# **AIRFRAME AND ENGINE EXAMINATION**

**WPR14FA234**

Location: Paso Robles, CA  
Date: June 7, 2014  
Aircraft: Piper J3 C-65, Registration Number: N24918, Serial #: 3535  
NTSB IIC: Howard Plagens

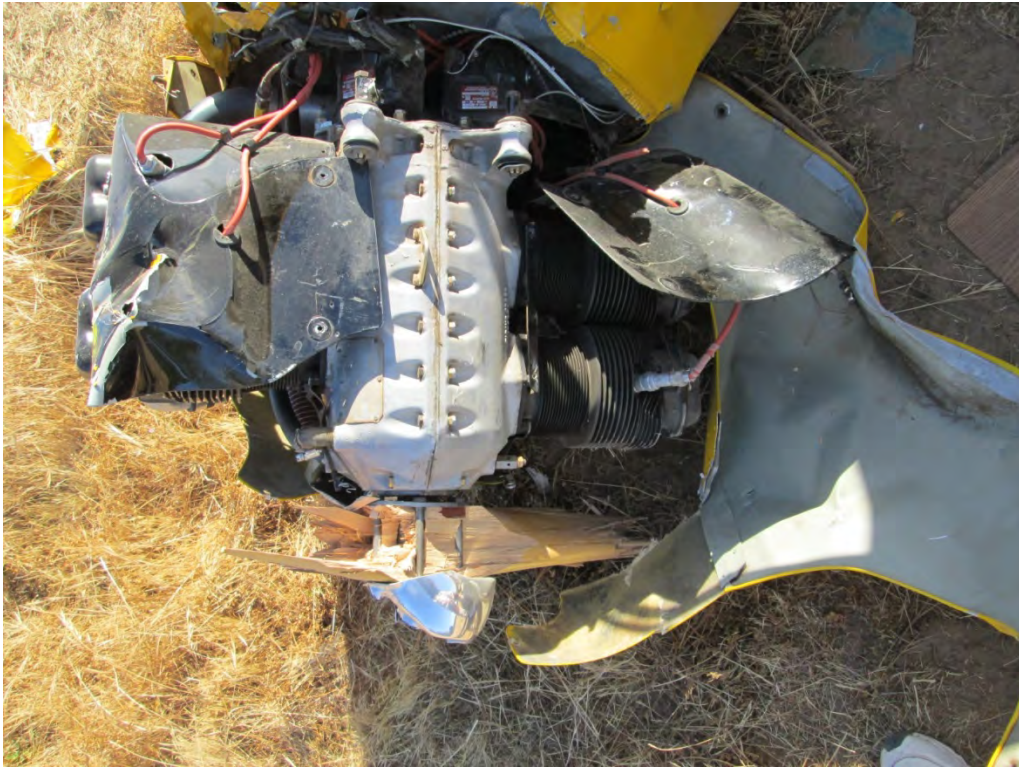
Photo 8 Top of Engine

Investigators left the engine in place. They removed the valve covers for cylinders one and three.
