# Continental Motors

## ENGINE FIELD INSPECTION REPORT

Addendum to Original Report dated 02/09/2015

| ENGINE MODEL | IO-520-BA12B Converted to IO-520-XXBB <sup>2</sup> |

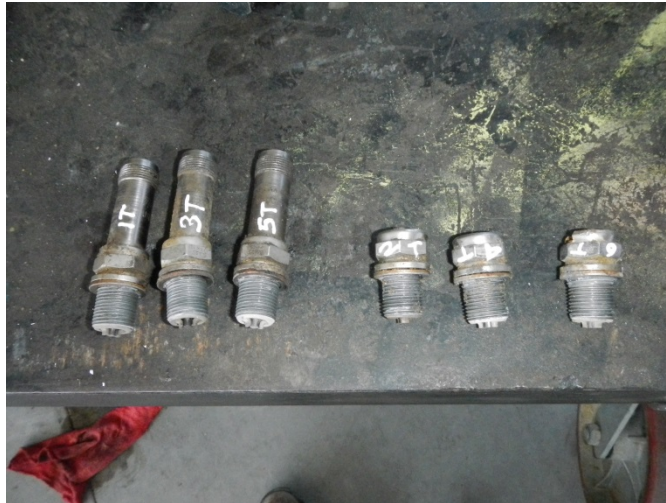
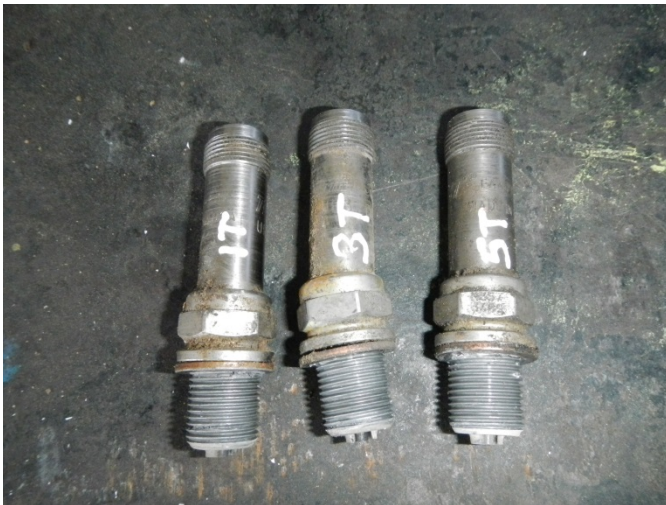
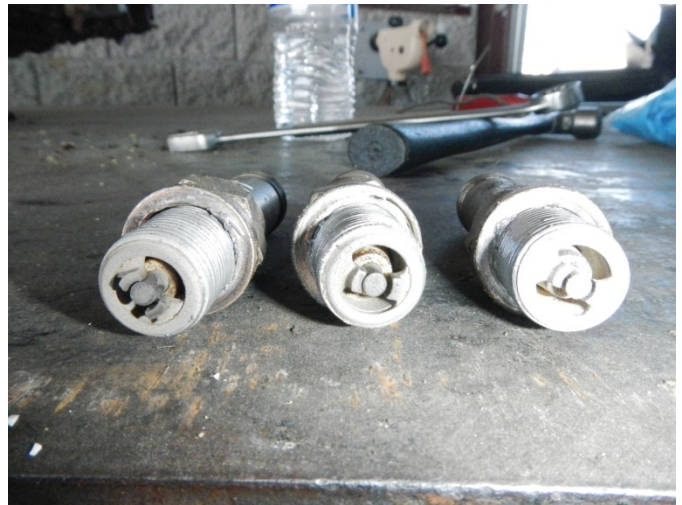
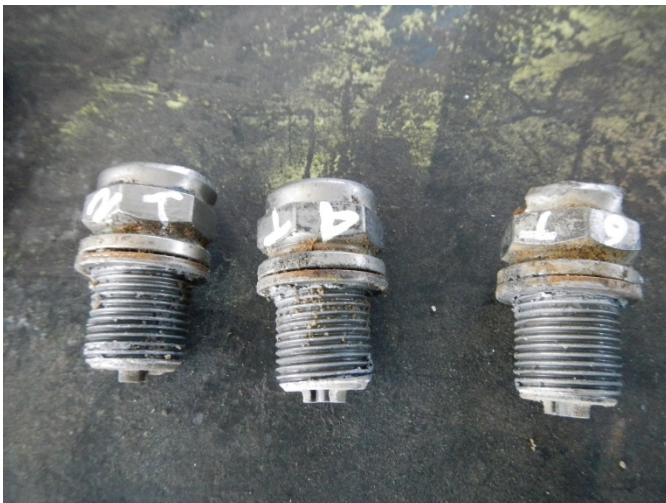
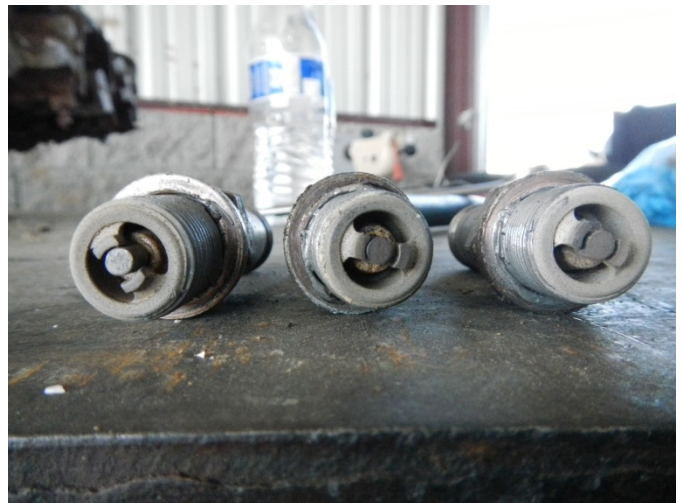
| Condition: | The #2, #4, and #6 top sparkplugs were fractured, but the electrode end remained inserted in their respective cylinders. The top sparkplugs were removed from the cylinders and examined. All of the sparkplugs displayed a new electrode condition along with combustion deposits that were consistent with lean engine operation. The #2, #4, and #6 top sparkplug center electrodes were displaced from the center position. | |

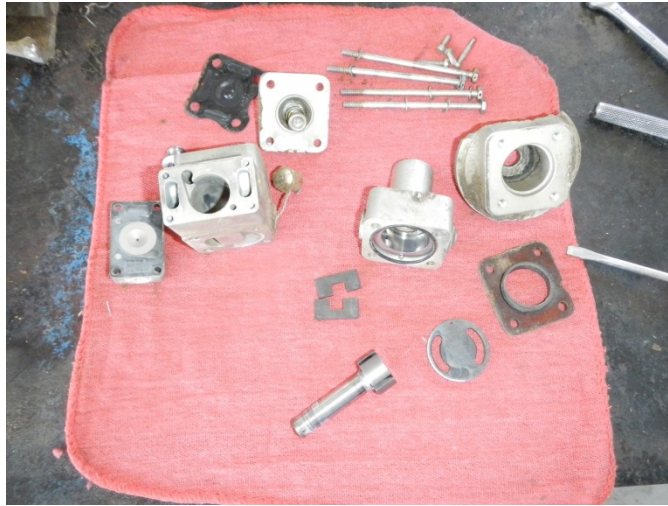
**Condition:** The fuel pump was separated from the engine and all of the fuel fittings were fractured as was the adjustable orifice fitting (though it remained safety-wired to the fuel pump housing). The mounting flange was fractured and mechanically deformed. The low pressure relief valve adjustable screw was fractured and its stop nut was displaced into the cap. The drive coupling was not identified. Inserting a screw driver into the base of the fuel pump drive shaft and manually rotating the screw driver resulted in a coinciding rotation of the drive shaft and revealed no binding. Disassembly of the fuel pump revealed no pre-accident anomalies with the internal components. Dirt consistent with that photographed at the accident site and noted on the engine's external surfaces was found within the fuel pump.

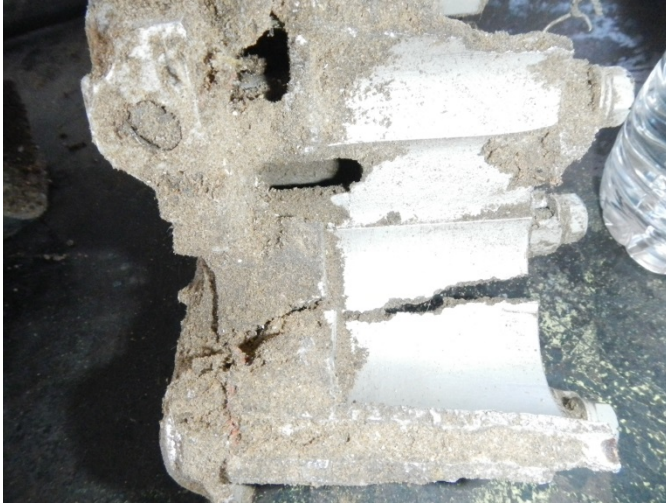
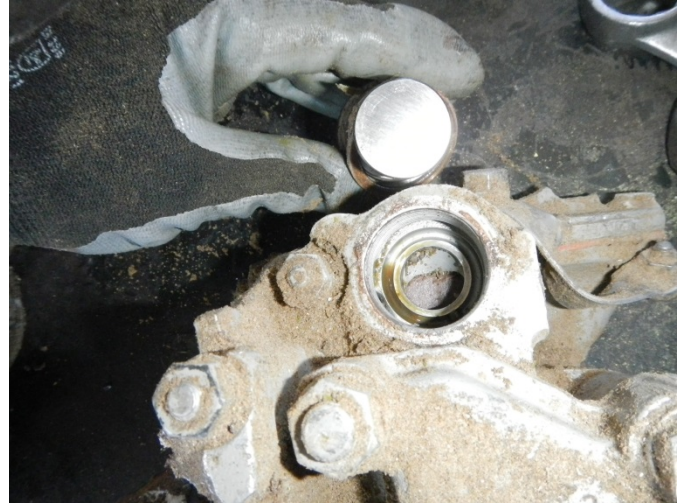
The oil filter was not observed and only a portion of its adapter was identified.
