## **NATIONAL TRANSPORTATION SAFETY BOARD**

### **AIRFRAME AND ENGINE EXAM REPORT**

WPR15FA200

Location: Corona, CA  
Date: June 28, 2015  
Aircraft: Great Lakes 2T1A-E, Registration Number: N7LM, Serial #: 1  
NTSB IIC: Howard Plagens

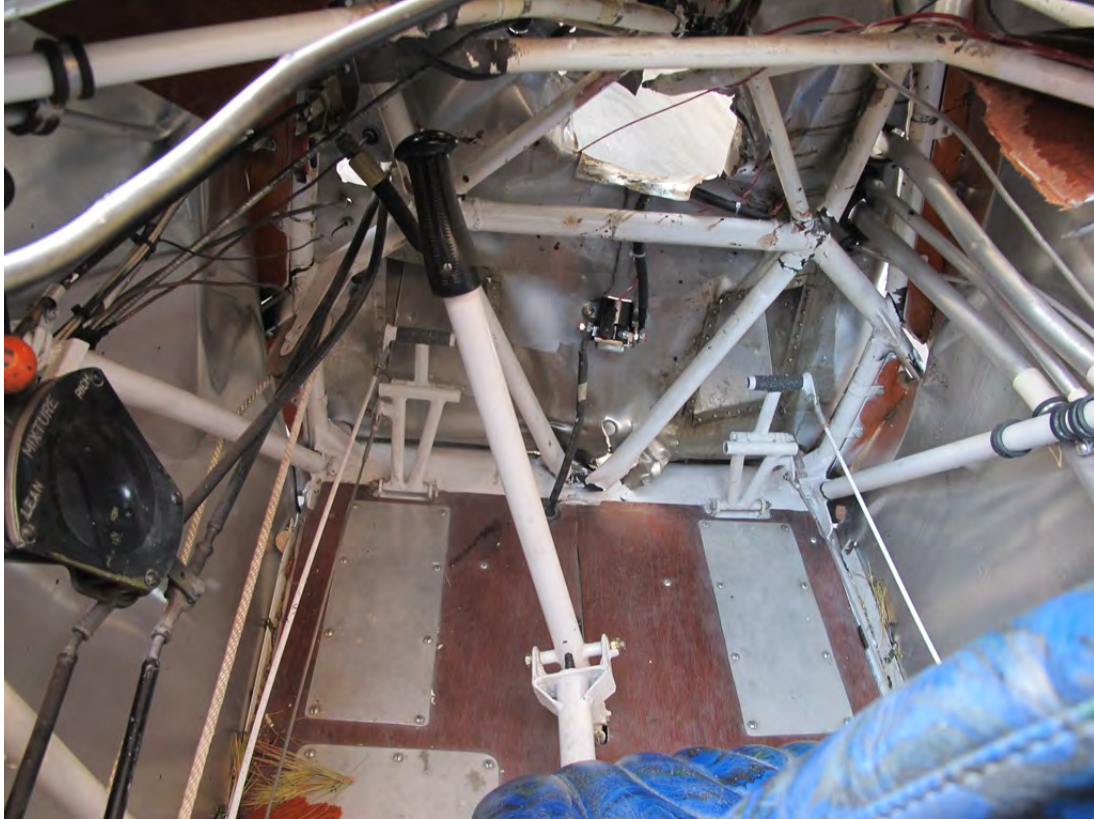
Photo 1 Rear Cockpit

The aileron and elevator flight control cables and push-pull tubes remained connected to the rear control yoke, which also had an interconnect to the front control yoke. There were multiple disconnects within the aileron control system. All identified fractures on push pull tubes were angular and jagged.

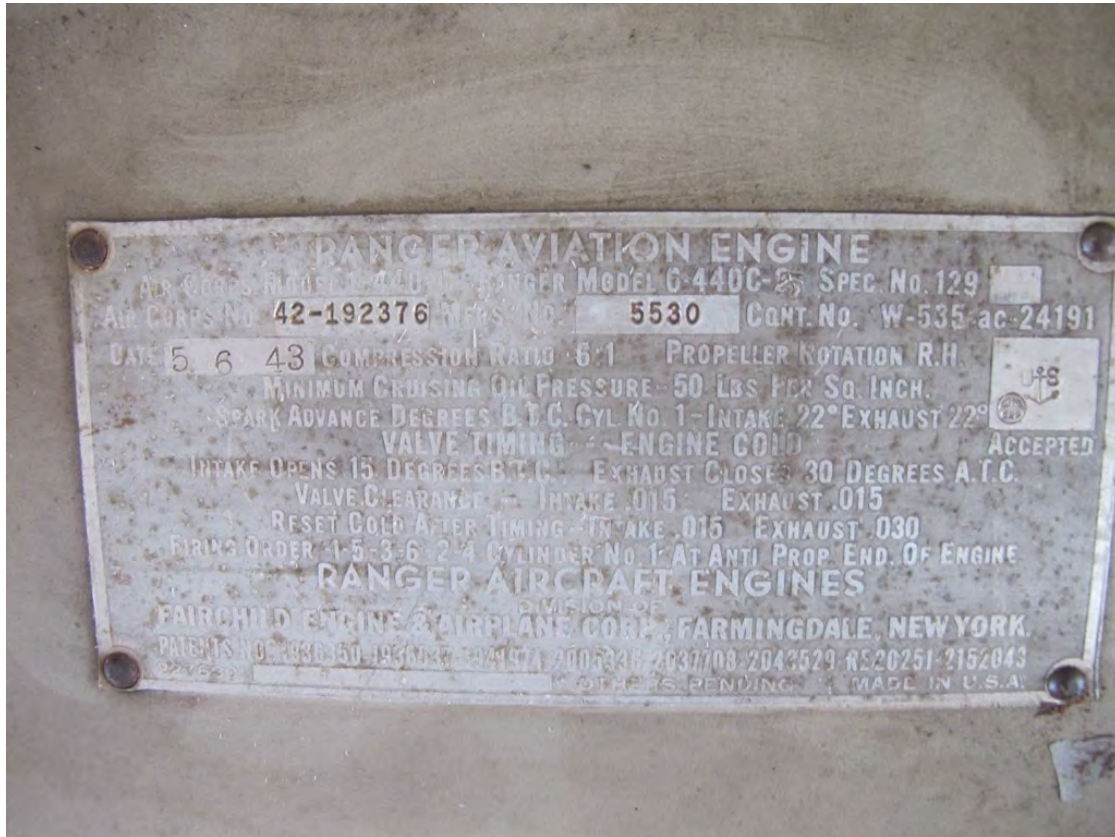
Photo 11 Engine Data Plate

The engine was a Fairchild Range 6-440-C5 inline six-cylinder engine, manufacturer's serial number 5530, Air Corps number 42-192376; the date of manufacture was May 6, 1943. It was rated at 200 horsepower. The firing order was 1, 5, 3, 6, 2, and 4.

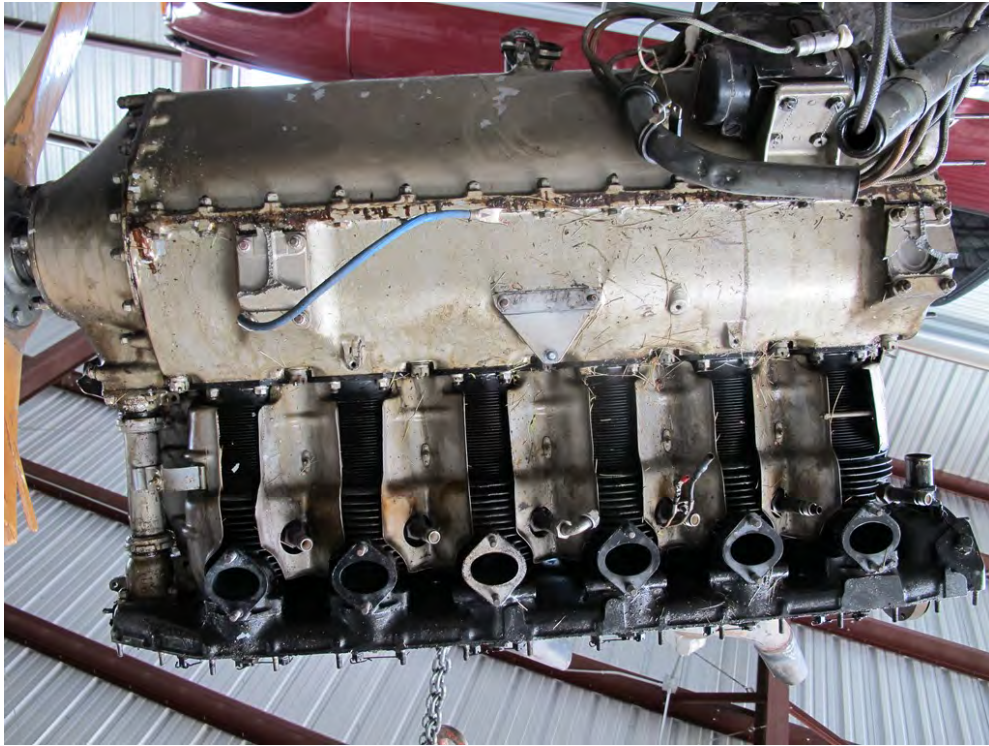
Photo 12 Top of Engine

The engine was separated during recovery, and it was slung inverted from a hoist.

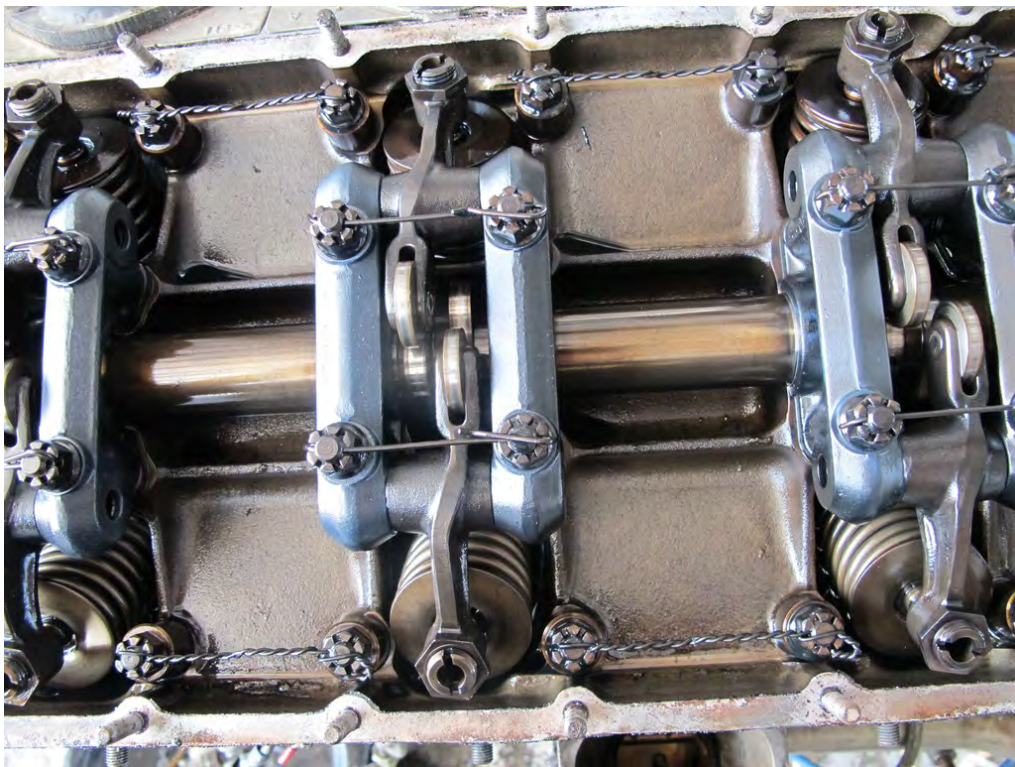
Photo 20 Exemplar Valve Rollers and Camshaft

The IIC manually rotated the crankshaft with the propeller. The crankshaft only rotated about 200 degrees. Removal of the alternator, starter, and accessory case did not create any additional travel. The valve cover was removed. Recovery personnel rotated the crankshaft, and the IIC observed movement of the exhaust valves on cylinders one, four, and five. The intake valves on cylinders two and six moved; neither valve moved on cylinder number three.

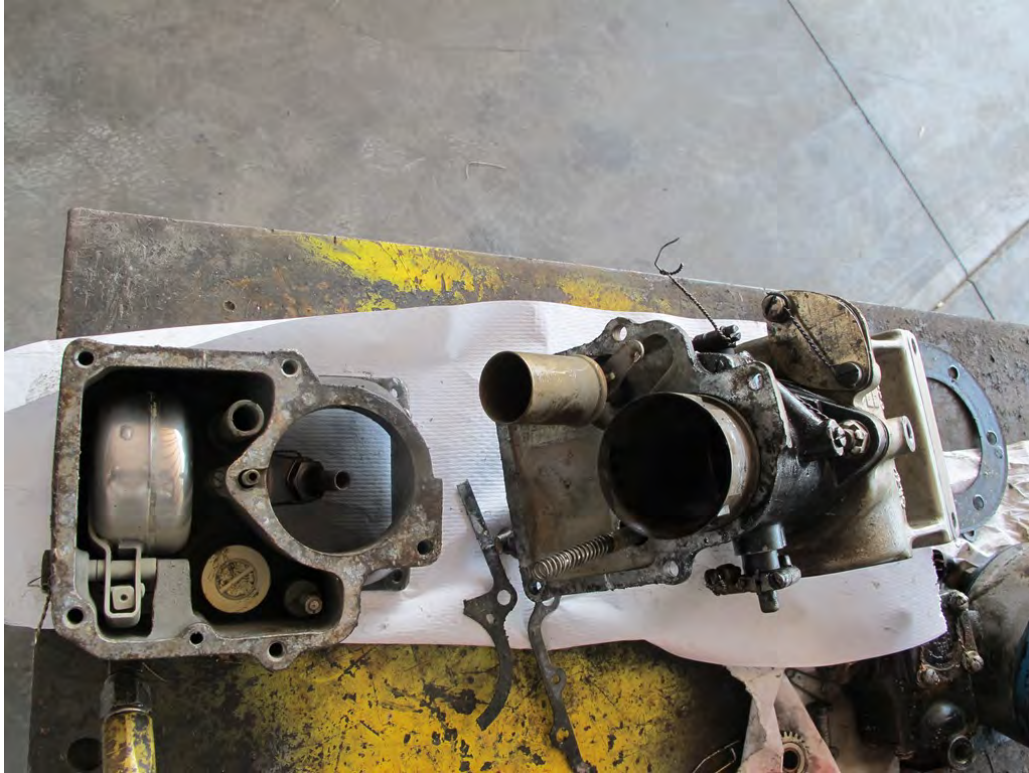
Photo 25 Disassembled Carburetor

The carburetor was a Bendix Stromberg number 5807804, model NA-R4B, part number 382012-8. The throttle and mixture valves moved freely from stop to stop. The carburetor heat valve was in the open position, and moved freely from stop to stop.
