## **NATIONAL TRANSPORTATION SAFETY BOARD**

### **AIRFRAME AND ENGINE EXAM REPORT**

WPR15FA206

Location: Carey, ID  
Date: July 2, 2015  
Aircraft: Piper PA22-135; Registration Number: N8195C, Serial #: 22-2300  
NTSB IIC: Howard Plagens

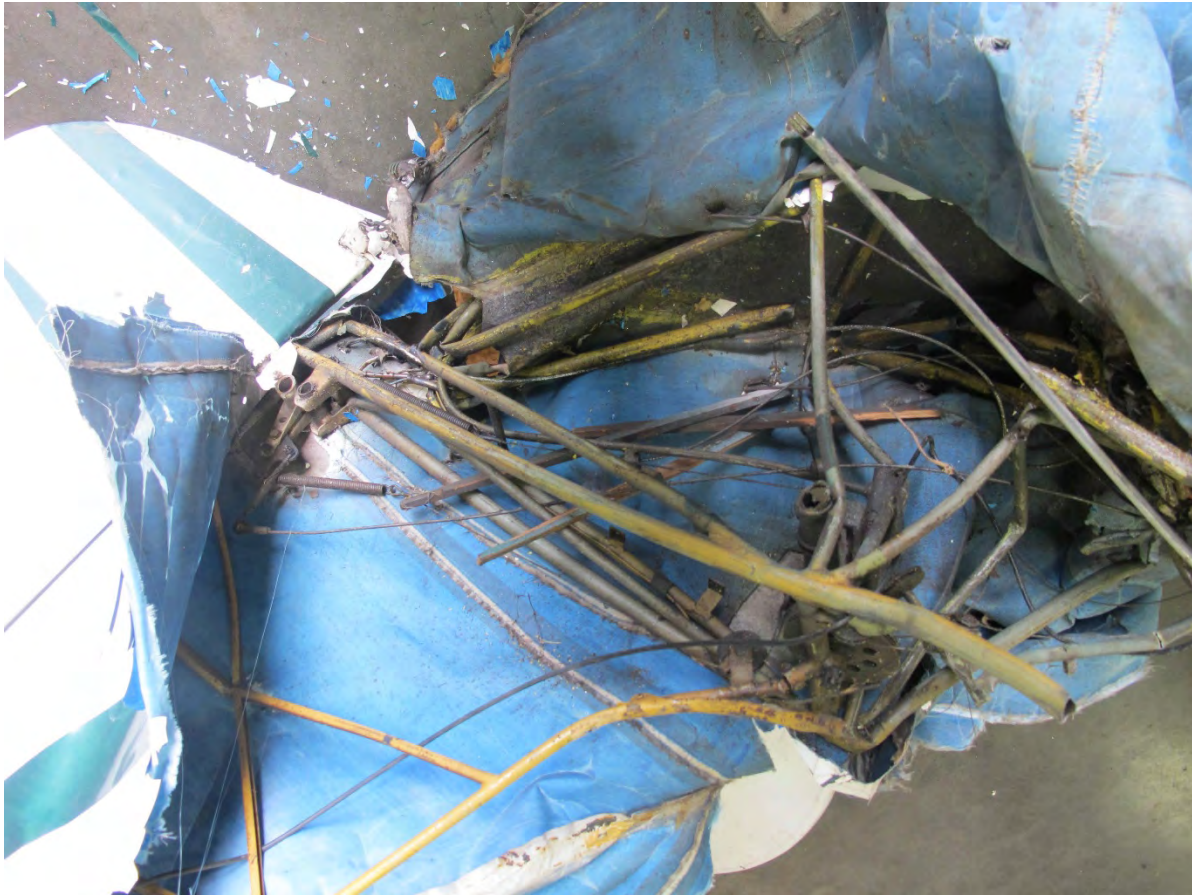
*Figure 7 Elevator Horns and Elevator Stabilizer Adjustment*

The elevator push-pull tube rod end remained attached to the T-bar, but fractured and separated at the last thread. The rod assembly was bent, and the fracture surface was angular. The push pull tube remained attached to the elevator bellcrank, and the elevator control cables were also attached to the bellcrank.
