# NATIONAL TRANSPORTATION SAFETY BOARD

MATERIALS LABORATORY FACTUAL REPORT

Report No. 16-054

Place : Prichard, Idaho  
Date : July 21, 2015  
Vehicle : Cessna 182Q, N759LV  
NTSB No. : WPR15LA220  
Investigator : Joshua Cawthra, AS-WPR

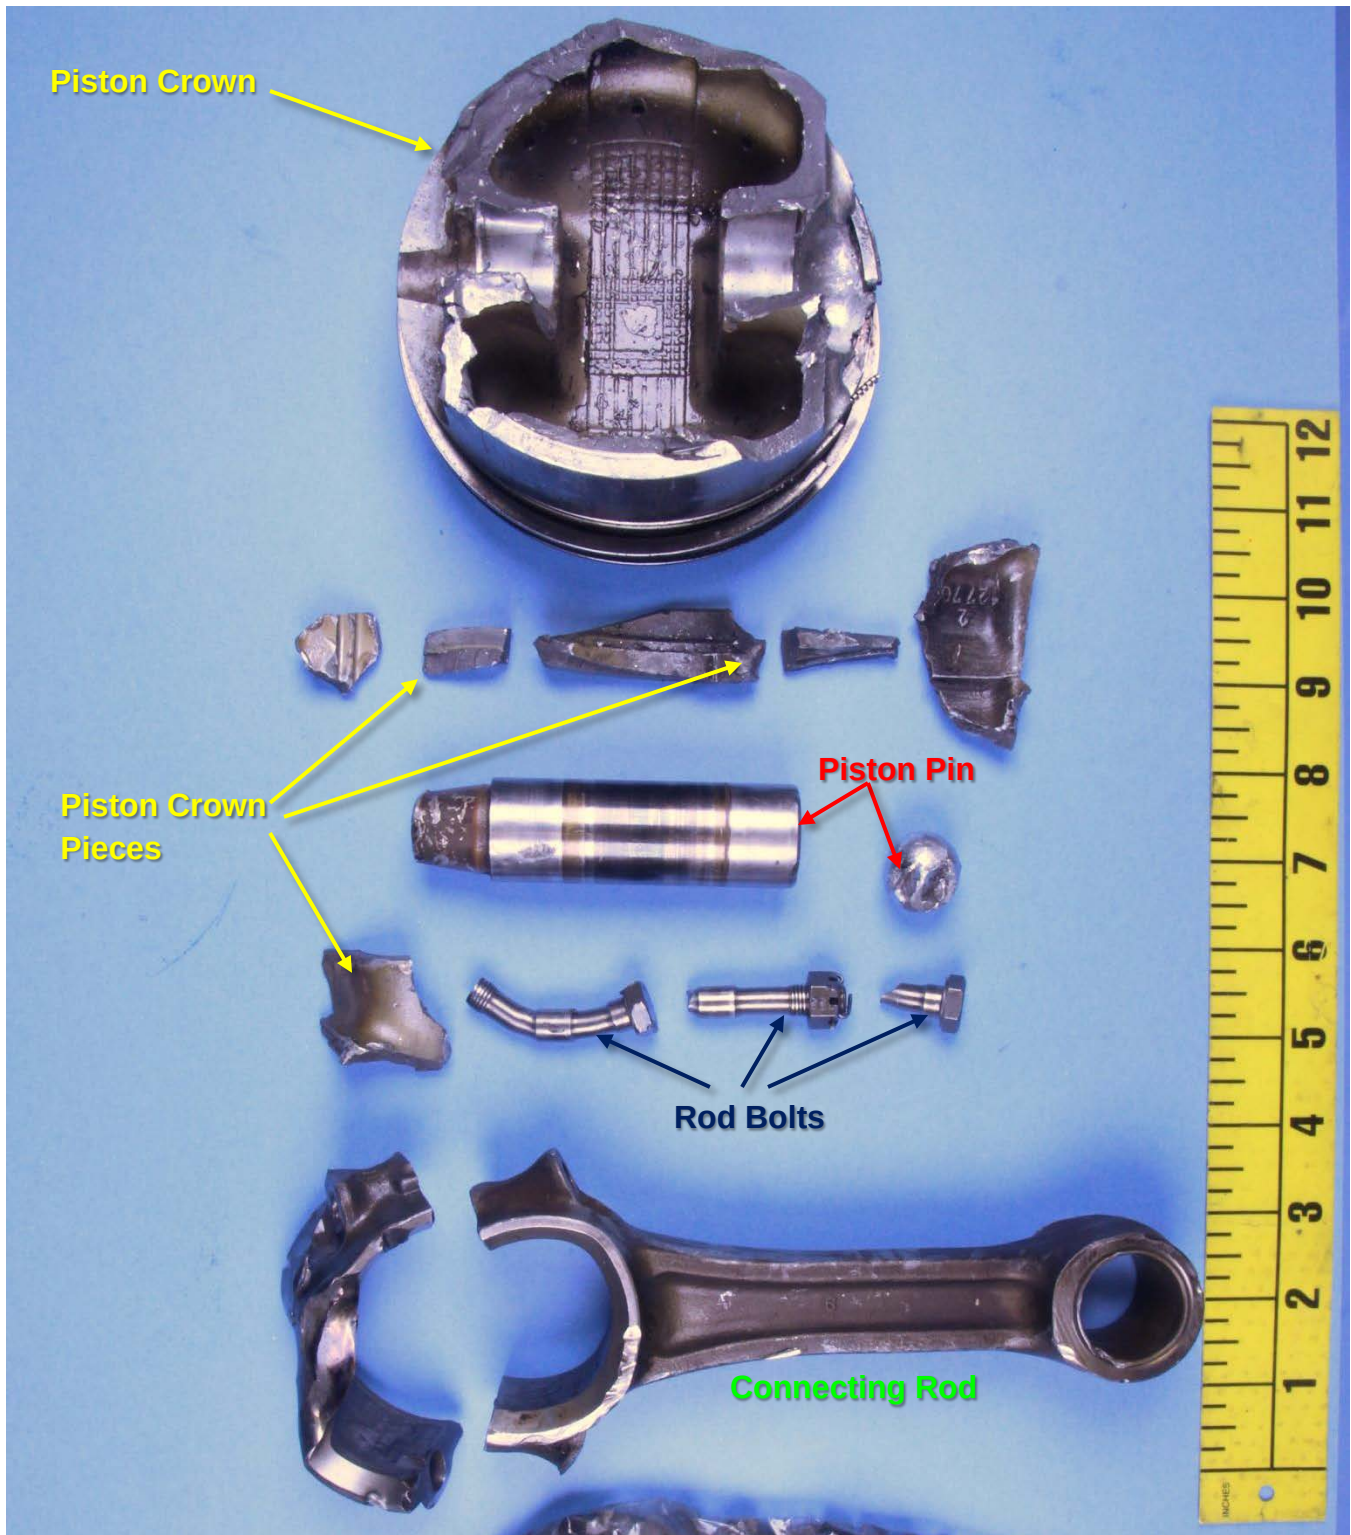
Figure 1 shows the parts submitted to the NTSB Materials Laboratory, as received. Figure 2 illustrates the underside of the piston crown, which had fractured into smaller pieces near the piston pin position. Figure 3 shows the piston crown from the side, illustrating the fracture surface in relation to the piston pin position. The fracture surface exhibited a rough, tortuous appearance along with a dull luster. The fracture surface of the piston crown exhibited river lines and chevron marks consistent with fracture originating at the pin position. The fracture features of the piston crown underside were consistent with overstress failure. No indications of pre-existing cracking or progressive failure were observed on the piston fracture surfaces.

Figure 1 – The items from the accident engine, as received (a bag of small broken miscellaneous parts is not shown).
