## **NATIONAL TRANSPORTATION SAFETY BOARD**

# **AIRFRAME EXAMINATION**

**WPR16FA041**

Location: Bakersfield, California  
Date: December 19, 2015  
Aircraft: Piper PA-32RT-300T, Registration Number: N36402  
NTSB IIC: Elliott Simpson

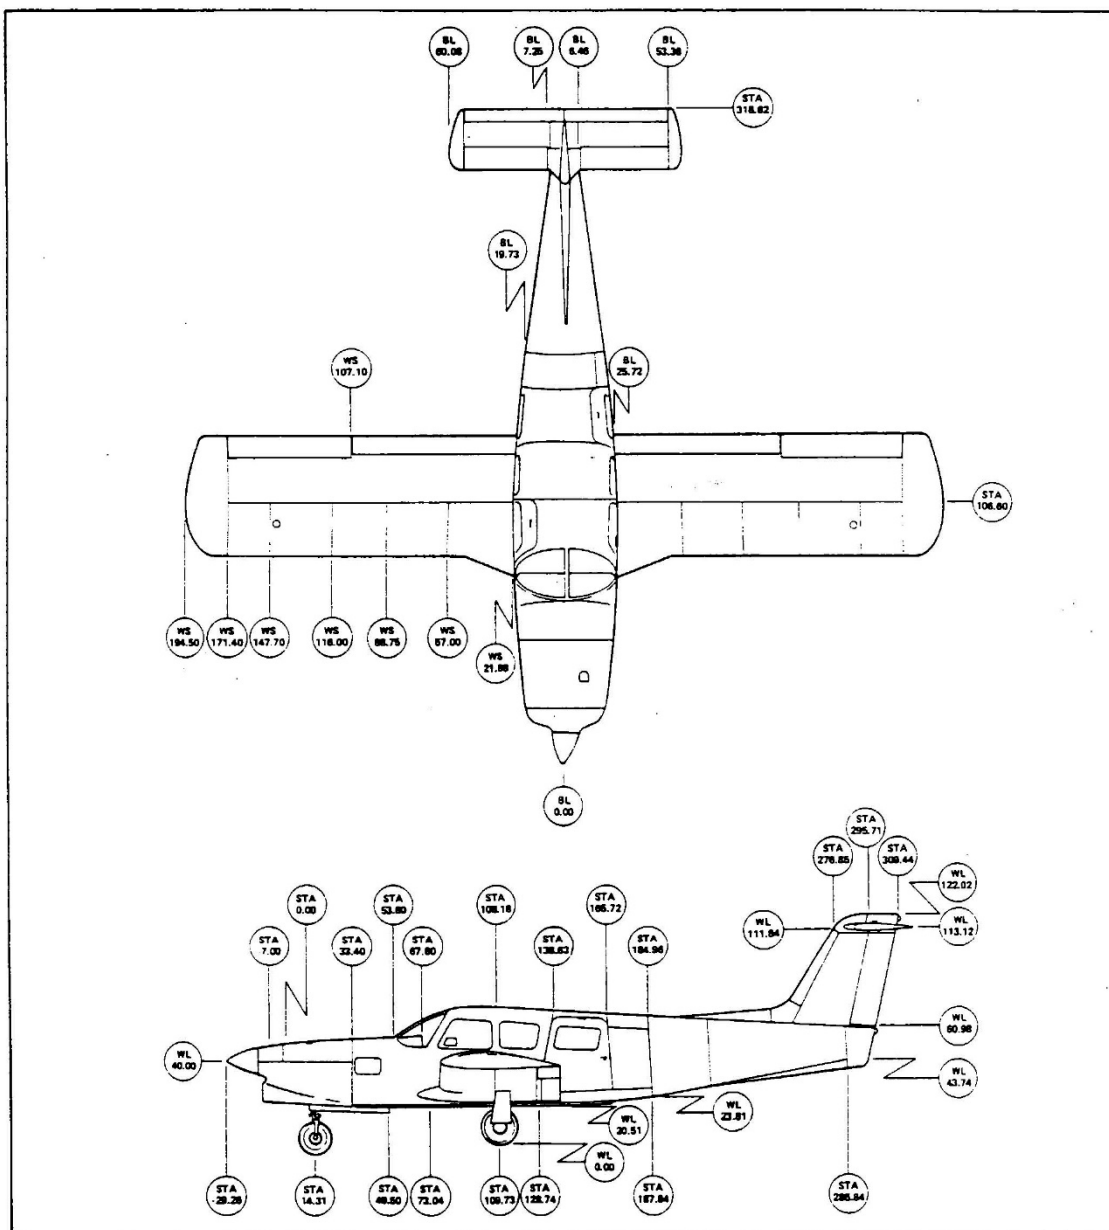
Figure 2-4. Station Reference Lines (PA-32RT-300T)

The right stabilator main spar was fractured near the root rib at stabilator station (SS) 7 (Photo 16). The upper skin on the right stabilator and inboard face of the leading edge root rib exhibited green paint transfer (Photo 17). The inboard 10 inches of the forward spar was deformed aft. The right upper stabilator skin was separated from the rear spar, with the exception of the outboard 5 inches. The outboard trim tab hinge was intact at the outboard end of the rear spar. The right lower stabilator skin was separated from the rear spar, with the exception of the outboard 20 inches. About 32 inches of the rear spar remained attached to the right stabilator. About 29 inches of the right trim tab remained attached to the rear spar at the outboard and center hinges. No evidence of paint transfer was observed on the lower skin of the right stabilator. The right stabilator upper and lower skins exhibited significant damage and deformation.

The left stabilator main spar was fractured near SS 17. The entire left stabilator rear spar was separated (Photo 18). There was green paint transfer on the left stabilator upper leading edge skin (Photo 19). A section of the rear spar about 30 inches in length, with the center tab hinge and a portion of left upper stabilator skin attached was separated from the stabilator. The inboard half of the left lower stabilator skin was separated and not recovered. The outboard 25 inches of left trim tab was separated from the stabilator.
