**GROUP CHAIRMAN'S FACTUAL REPORT OF  
INVESTIGATION**

**WPR16FA055**

| Aircraft: | Airbus Helicopters EC130T2, N11VQ |
| NTSB Number: | WPR16FA055 |

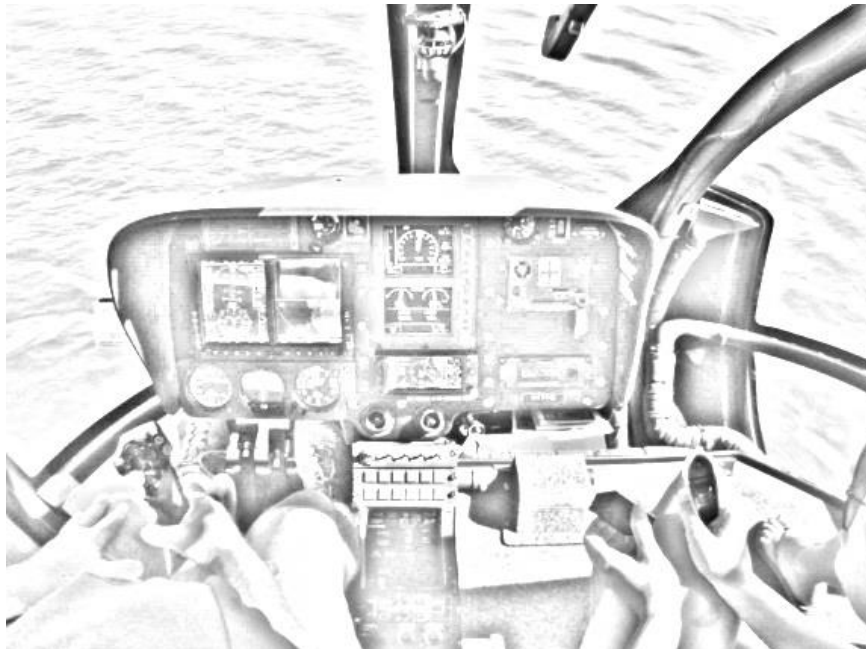
**Figure 2. A digital illustration of the Appareo Vision 1000's field of view as mounted on the accident rotorcraft during a flight previous to the accident flight.**

The imagery files recorded an over the shoulder view of the pilot from a centralized roof mounting position within the cockpit. The pilot's cyclic and pedal movements were visible. The collective and the pilot's left arm movement were not visible to the recorder. Much of the instrument panel and rotorcraft system controls were also visible. A view out of the forward windscreen was also visible. Figure 2 is a digital illustration of the Appareo V1000's field of view during the flight previous to the accident flight. The camera position remained unchanged for the accident flight.

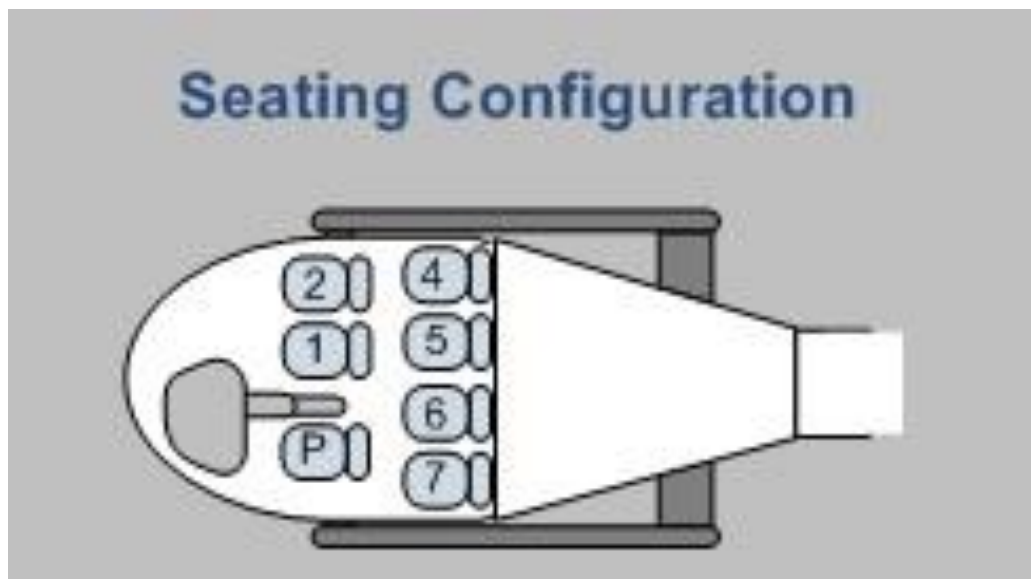
Figure 16. A chart depicting the seating arrangement of the rotorcraft.

The first portion of the transcript begins below and serves to document the seating and seatbelt use characteristics of the rotorcraft's occupants. All seating positions are as defined in figure 16.

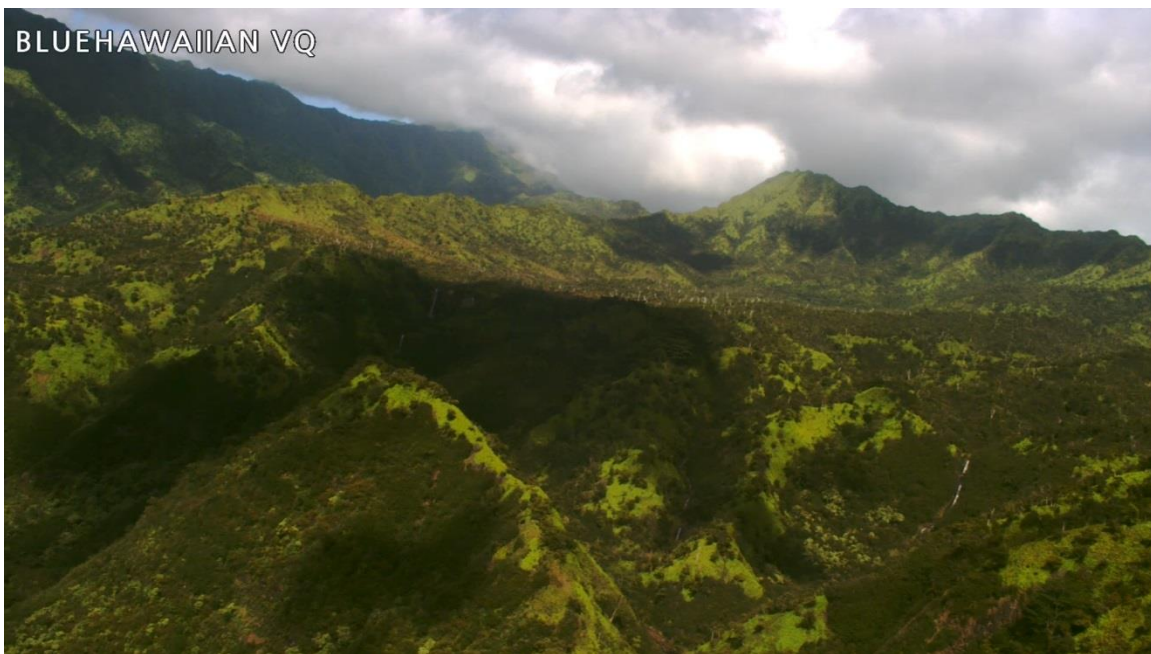
**Figure 18. A screenshot taken from the externally facing camera mounted on the right side of the rotorcraft.**

The thumb drive associated with the AirKnight HD4s initially contained three .AVI files. Those files were 160117\_140249\_141425.avi, 160117\_141425\_142523.avi and tmprecord.avi. The files were of 1920 x 1080 pixels in resolution and were recorded at a frame rate of 29.97 fps. The files contained an audio track that recorded intra-aircraft communications between the pilot and passengers<sup>2</sup>, air traffic control transmissions, the pilot's VOX<sup>3</sup> input, and occasional music. The pilot retained control over the rotorcraft's audio panel and camera selection controls for the AirKnight HD4s. Specific audio and video information captured on the recording were dependent upon which audio parameters the pilot had selected through the audio panel and which camera input the pilot was currently selecting. During most of the flight, the pilot switched between cameras that were externally mounted on the rotorcraft. Figure 15 is a diagram of the cameras associated with the Datatoys AirKnight HD4s that were mounted to the rotorcraft. Figure 16 is a graphic that depicts the seating arrangement of the rotorcraft. Figure 17 is an illustrated image of the internal cockpit camera's view. Figure 18 is a screenshot taken from one of the rotorcraft's external cameras.

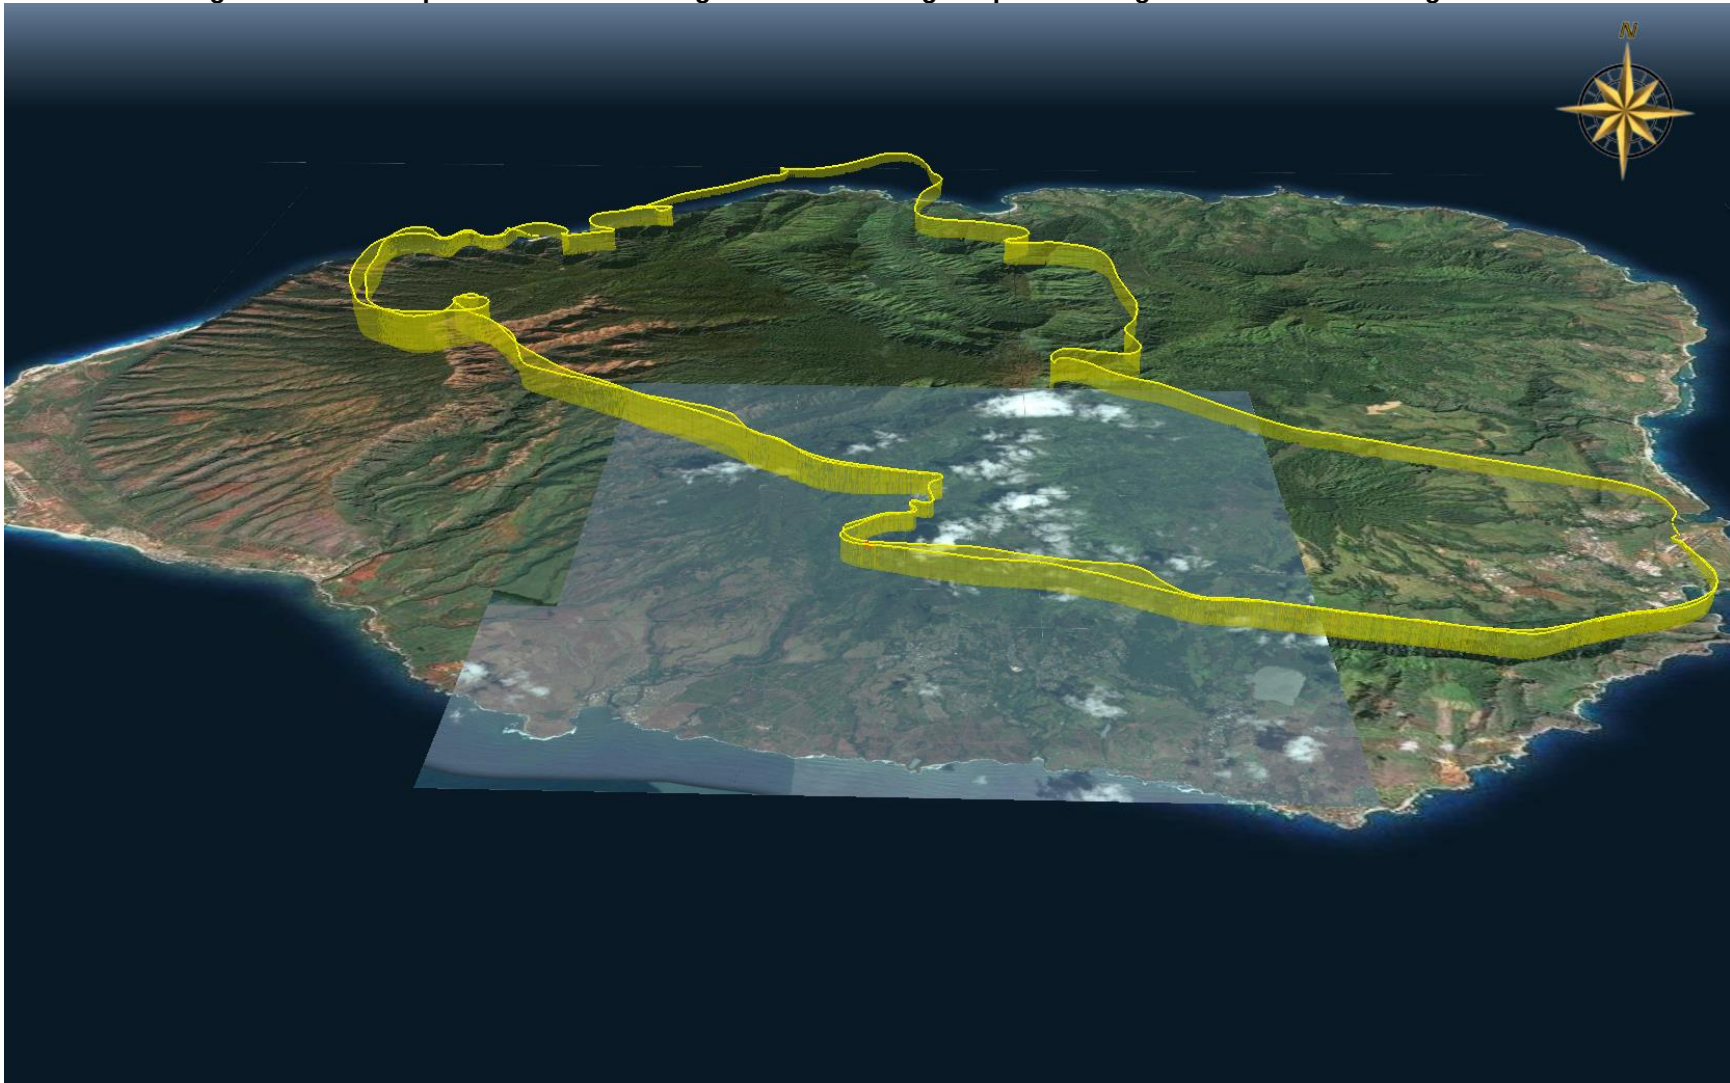
**Figure 7. GPS tracklogs showing the homogeneity between the previous flight and the accident flight.**

Figure 7 is a graphical representation of the rotorcraft's GPS tracklogs showing the homogeneity between a portion of the previous flight and the accident flight.

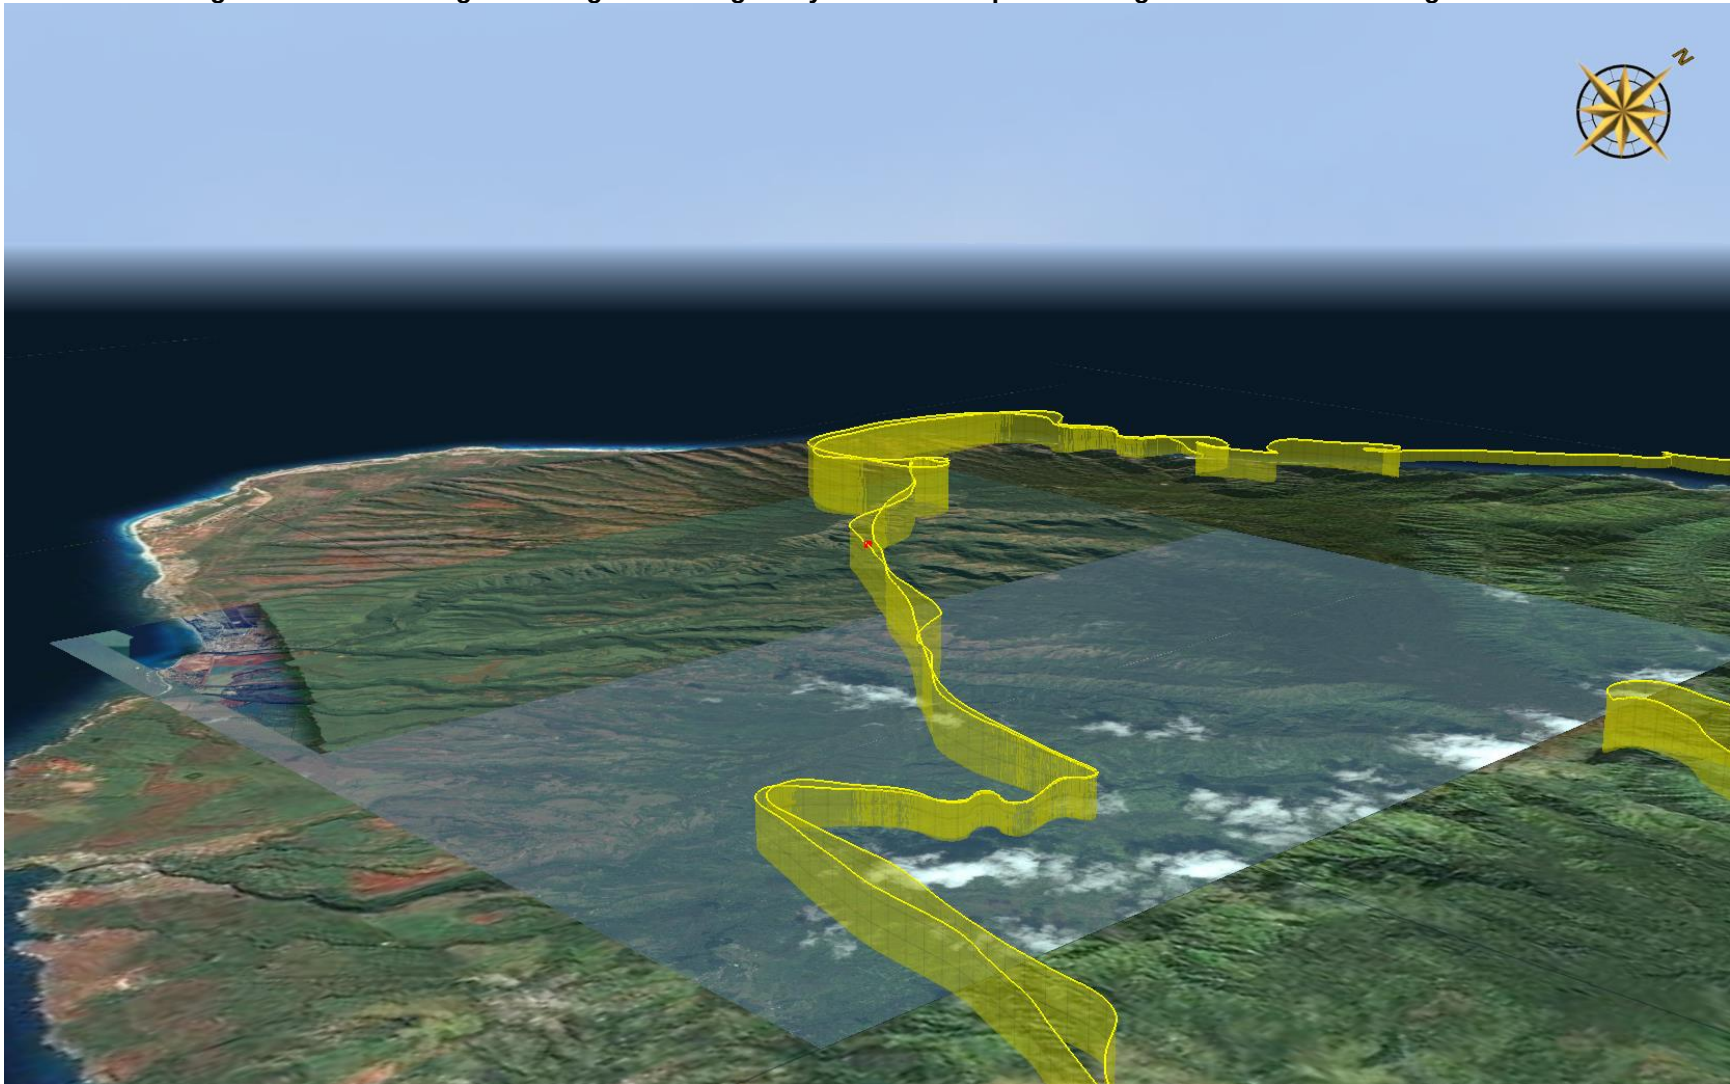
Figure 8. GPS tracklogs for the accident flight only.

Figure 8 is a graphical representation of the rotorcraft's GPS tracklogs for the accident flight only.

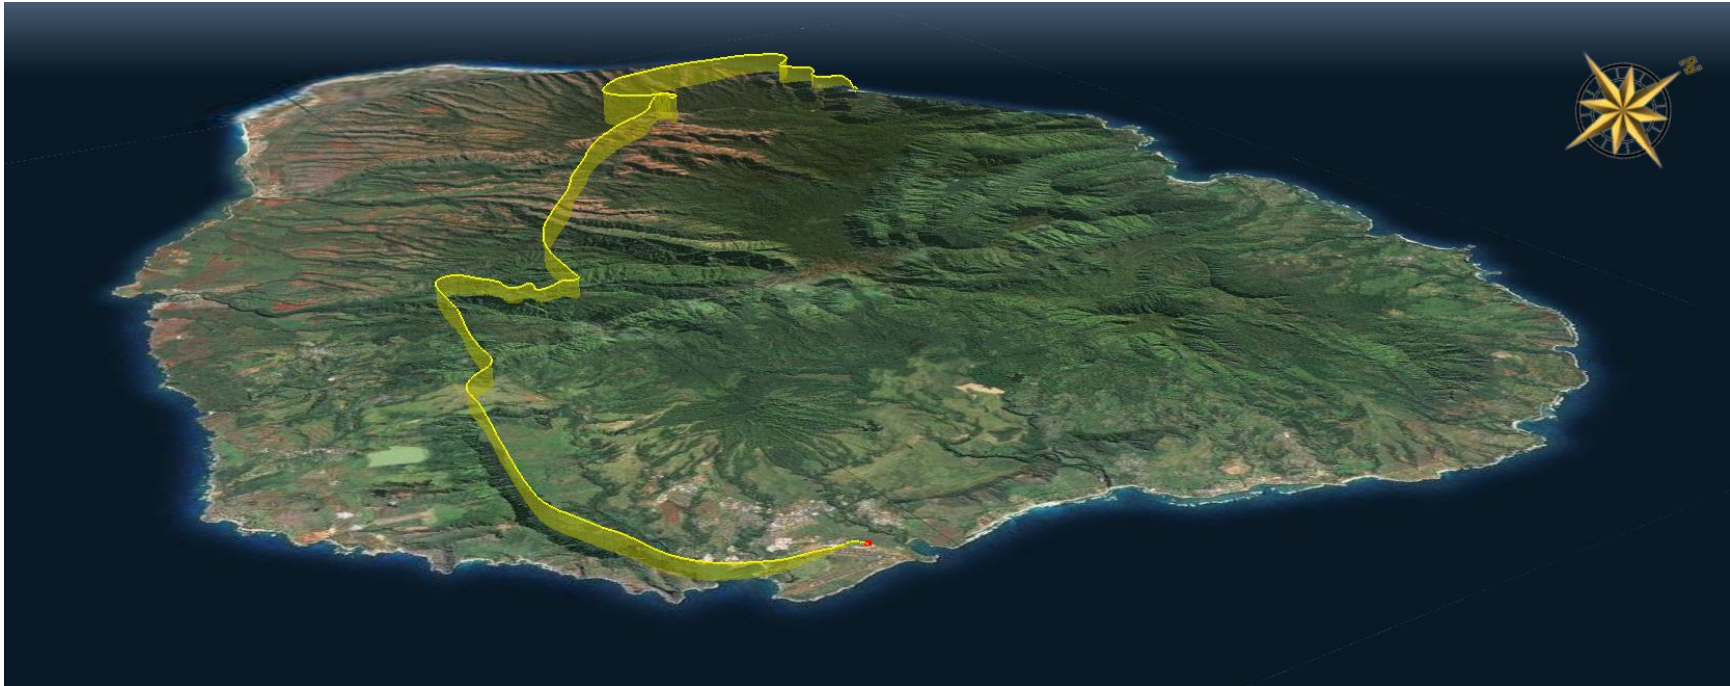
Figure 9. GPS tracklogs showing the rotorcraft's departure from Lihue Airport (KLIH), Kauai, Hawaii.

Figure 9 is a graphical representation of the rotorcraft's GPS tracklogs showing the rotorcraft's departure from Blue Hawaiian's operation area at Lihue Airport (KLIH), Kauai, Hawaii.

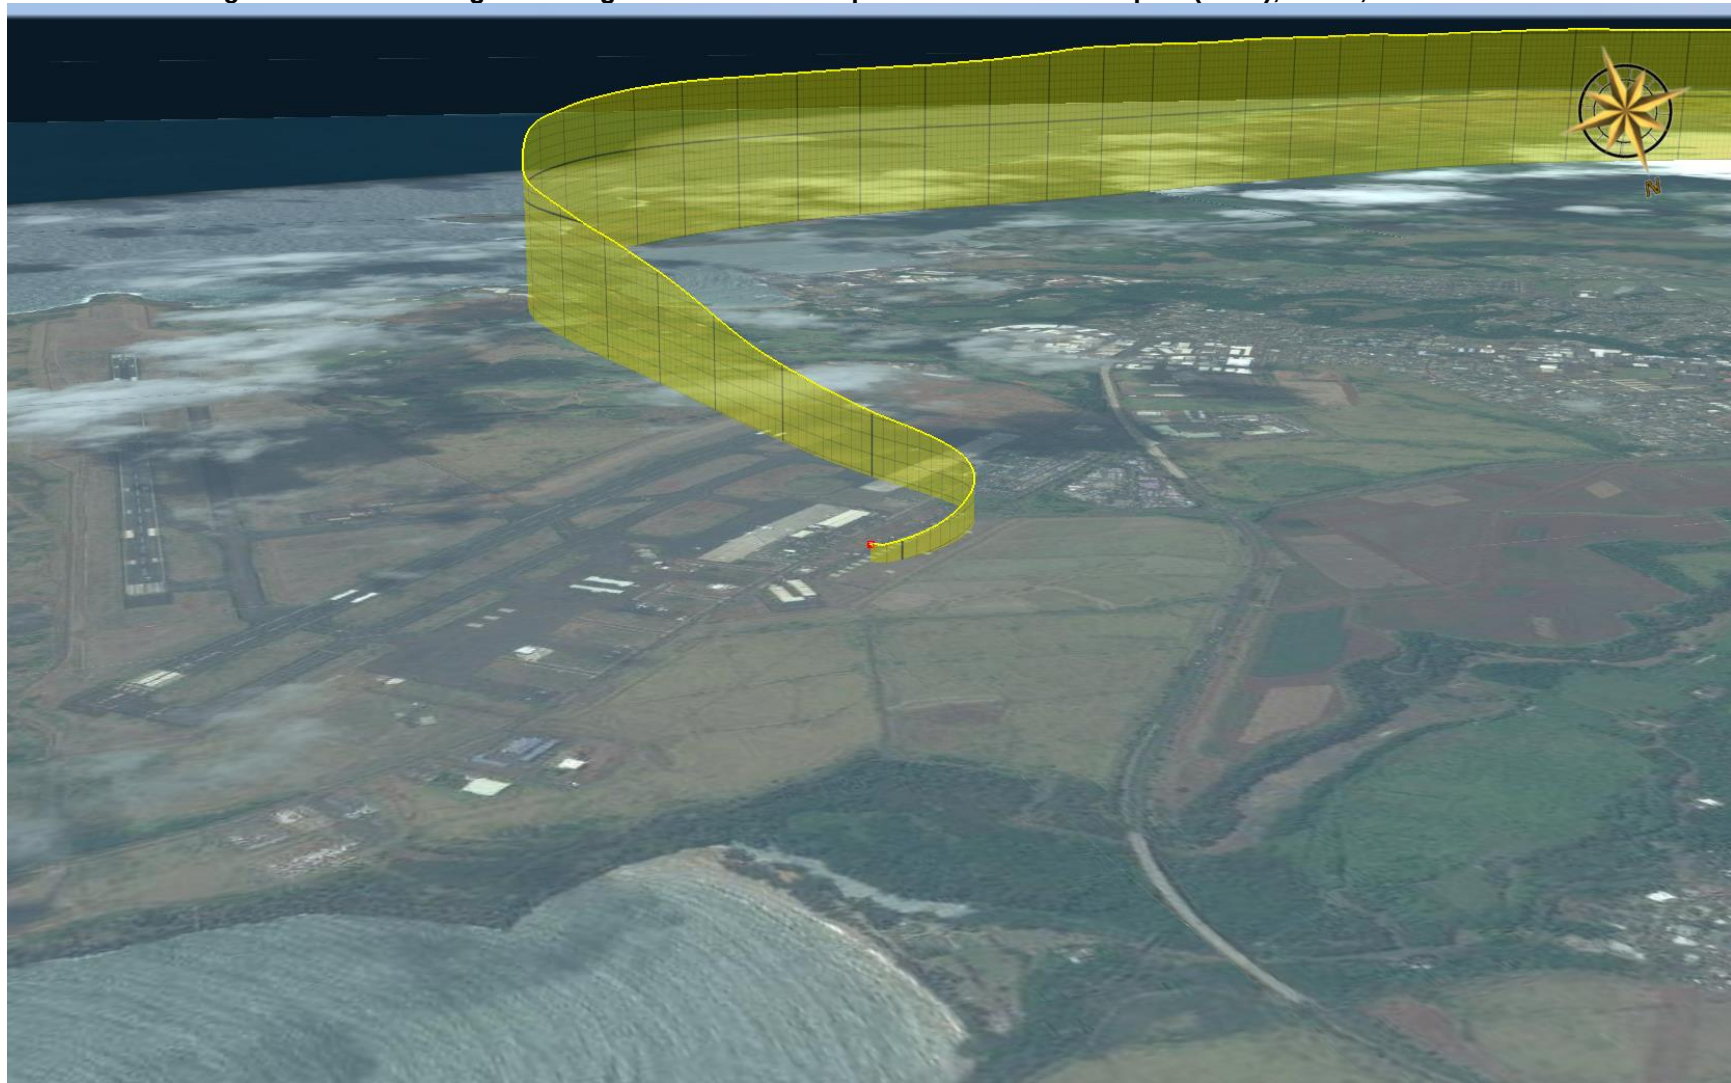
Figure 10. GPS tracklogs showing a north up view of the final portion of the accident flight.

Figure 10 is an approximate north up oriented view showing a graphical representation of the rotorcraft's GPS tracklogs during the final portion of the accident flight.

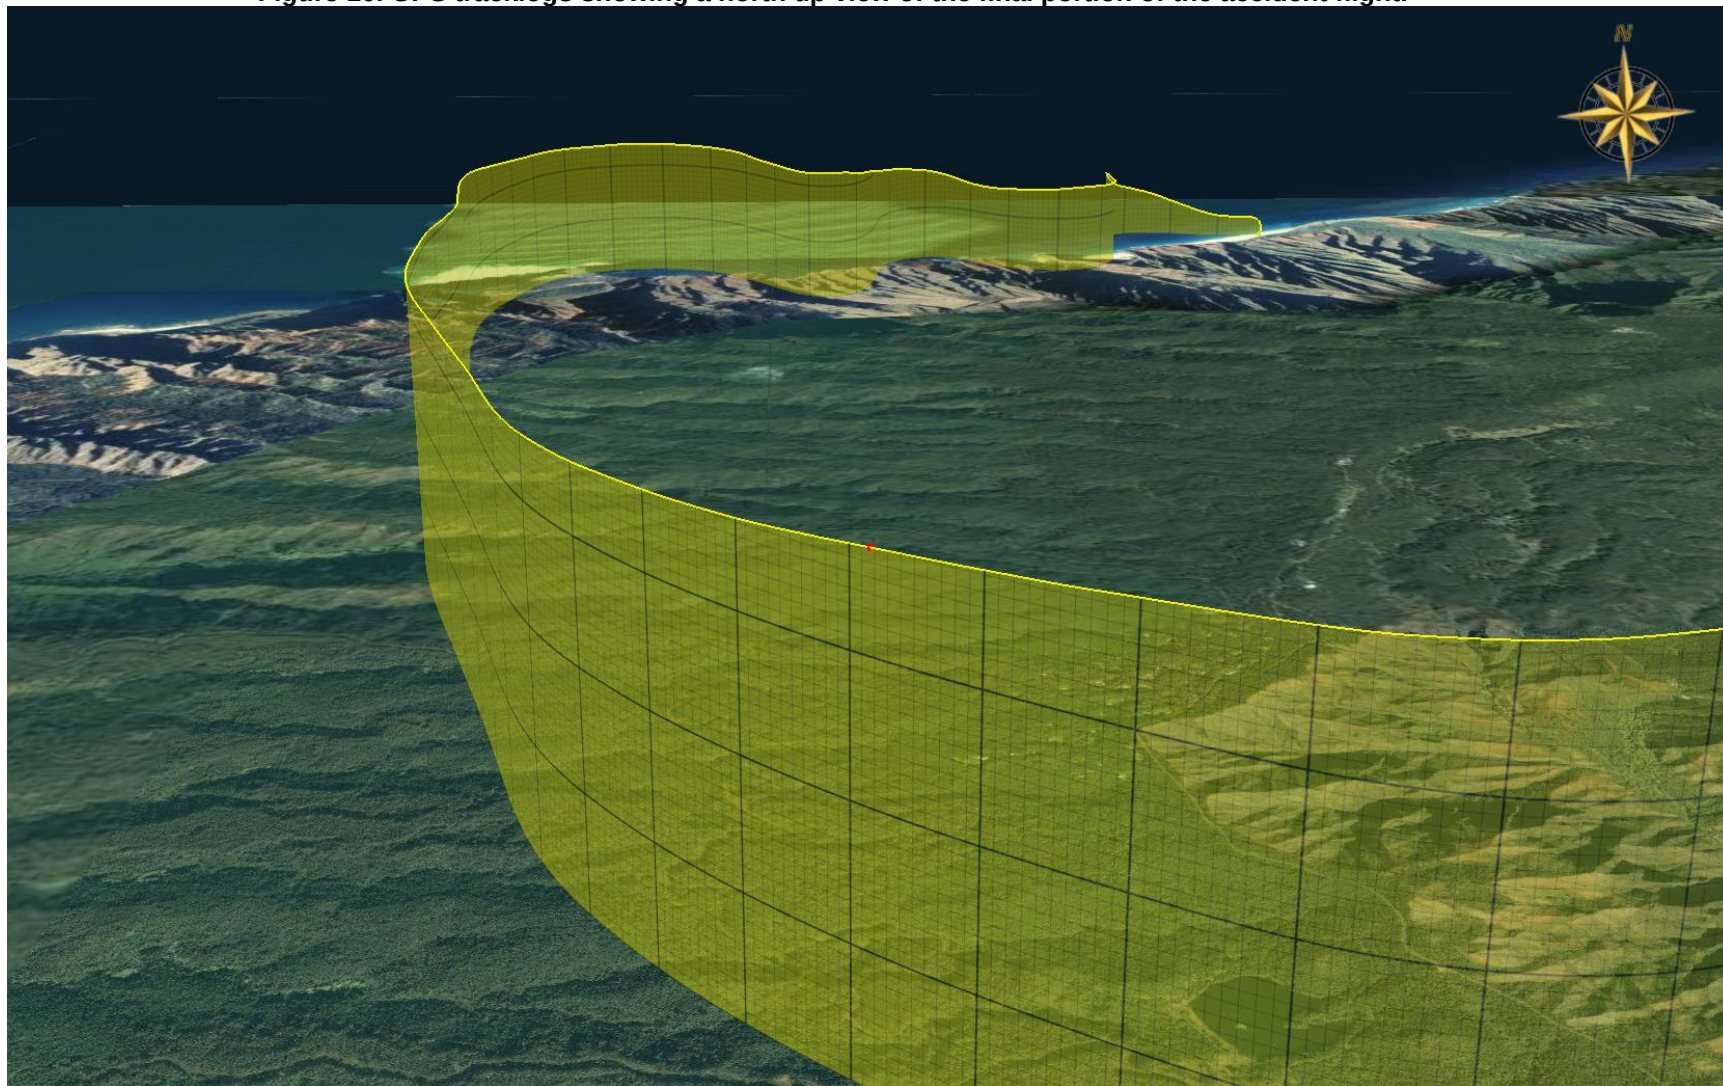
**Figure 11. GPS tracklogs showing an alternate, closer view of the final portion of the accident flight.**

Figure 11 is an approximate north up oriented view showing a graphical representation of the rotorcraft's GPS tracklogs during the final portion of the accident flight. The figure is zoomed to show the landing area.

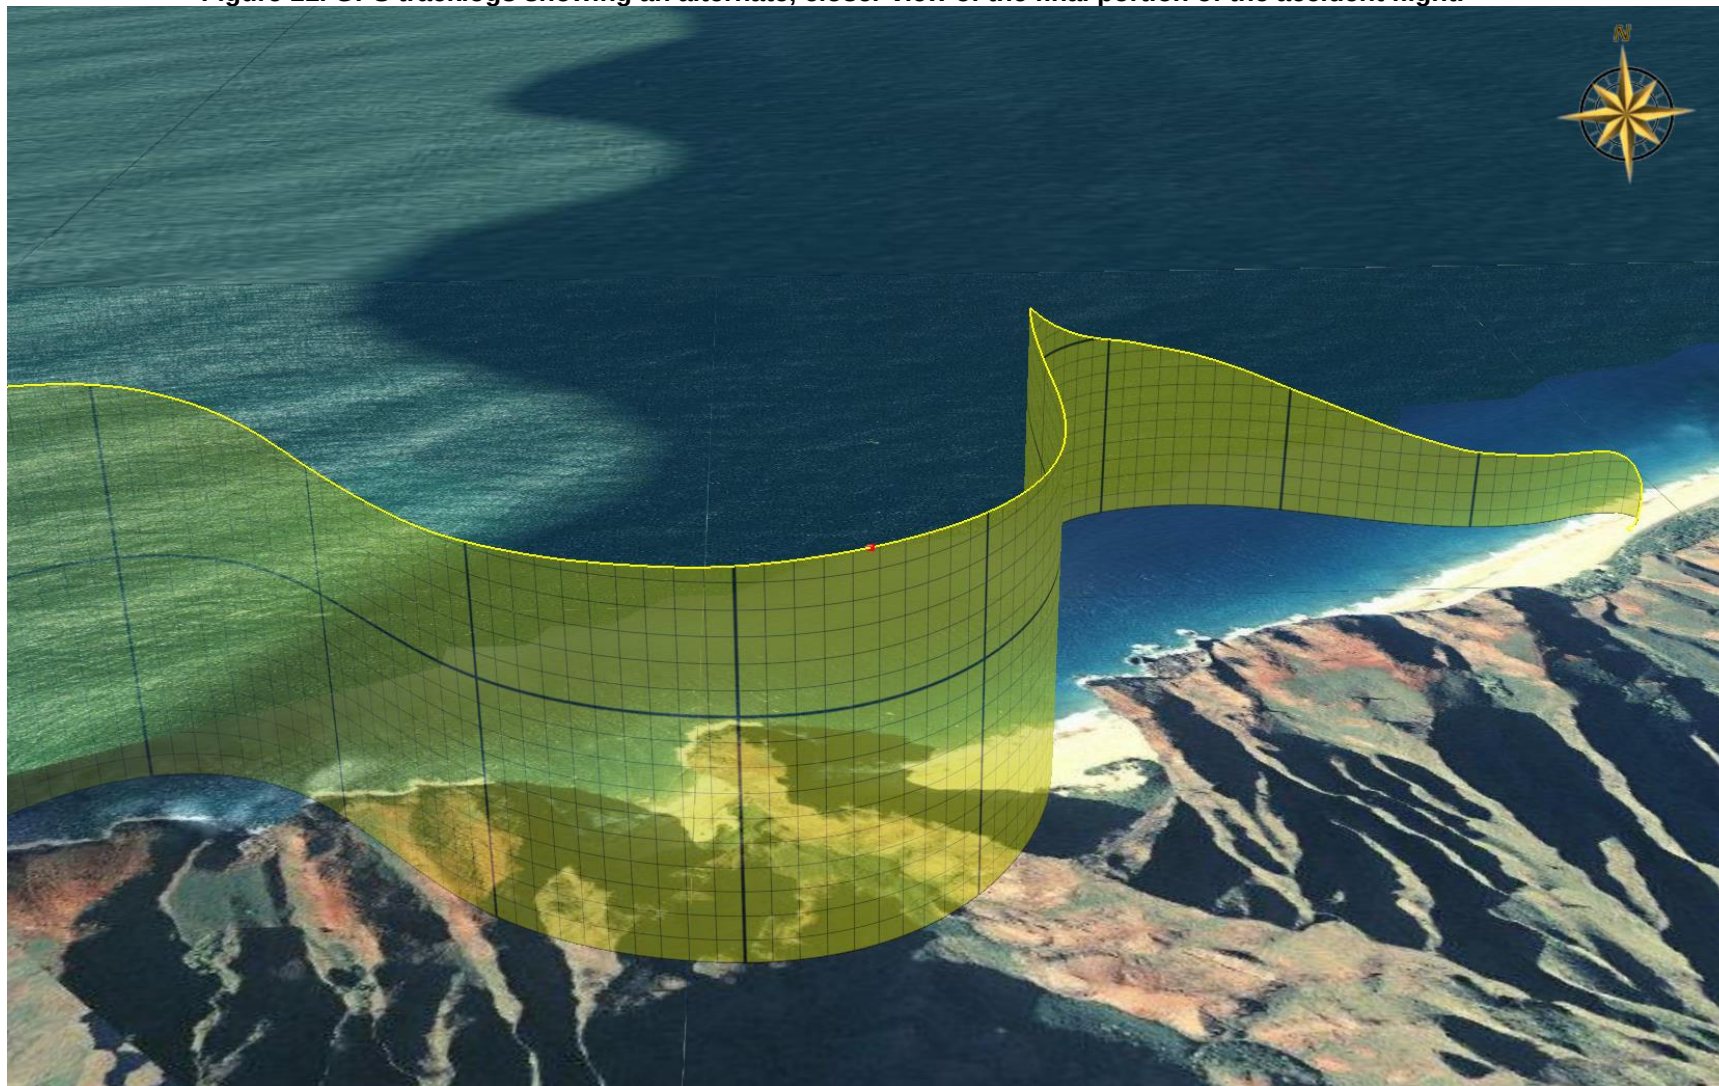
**Figure 12. GPS tracklogs showing an alternate, closer view of the final portion of the accident flight.**

Figure 12 is an alternate view showing a graphical representation of the rotorcraft's GPS tracklogs during the final portion of the accident flight. The figure is zoomed to show the landing area.

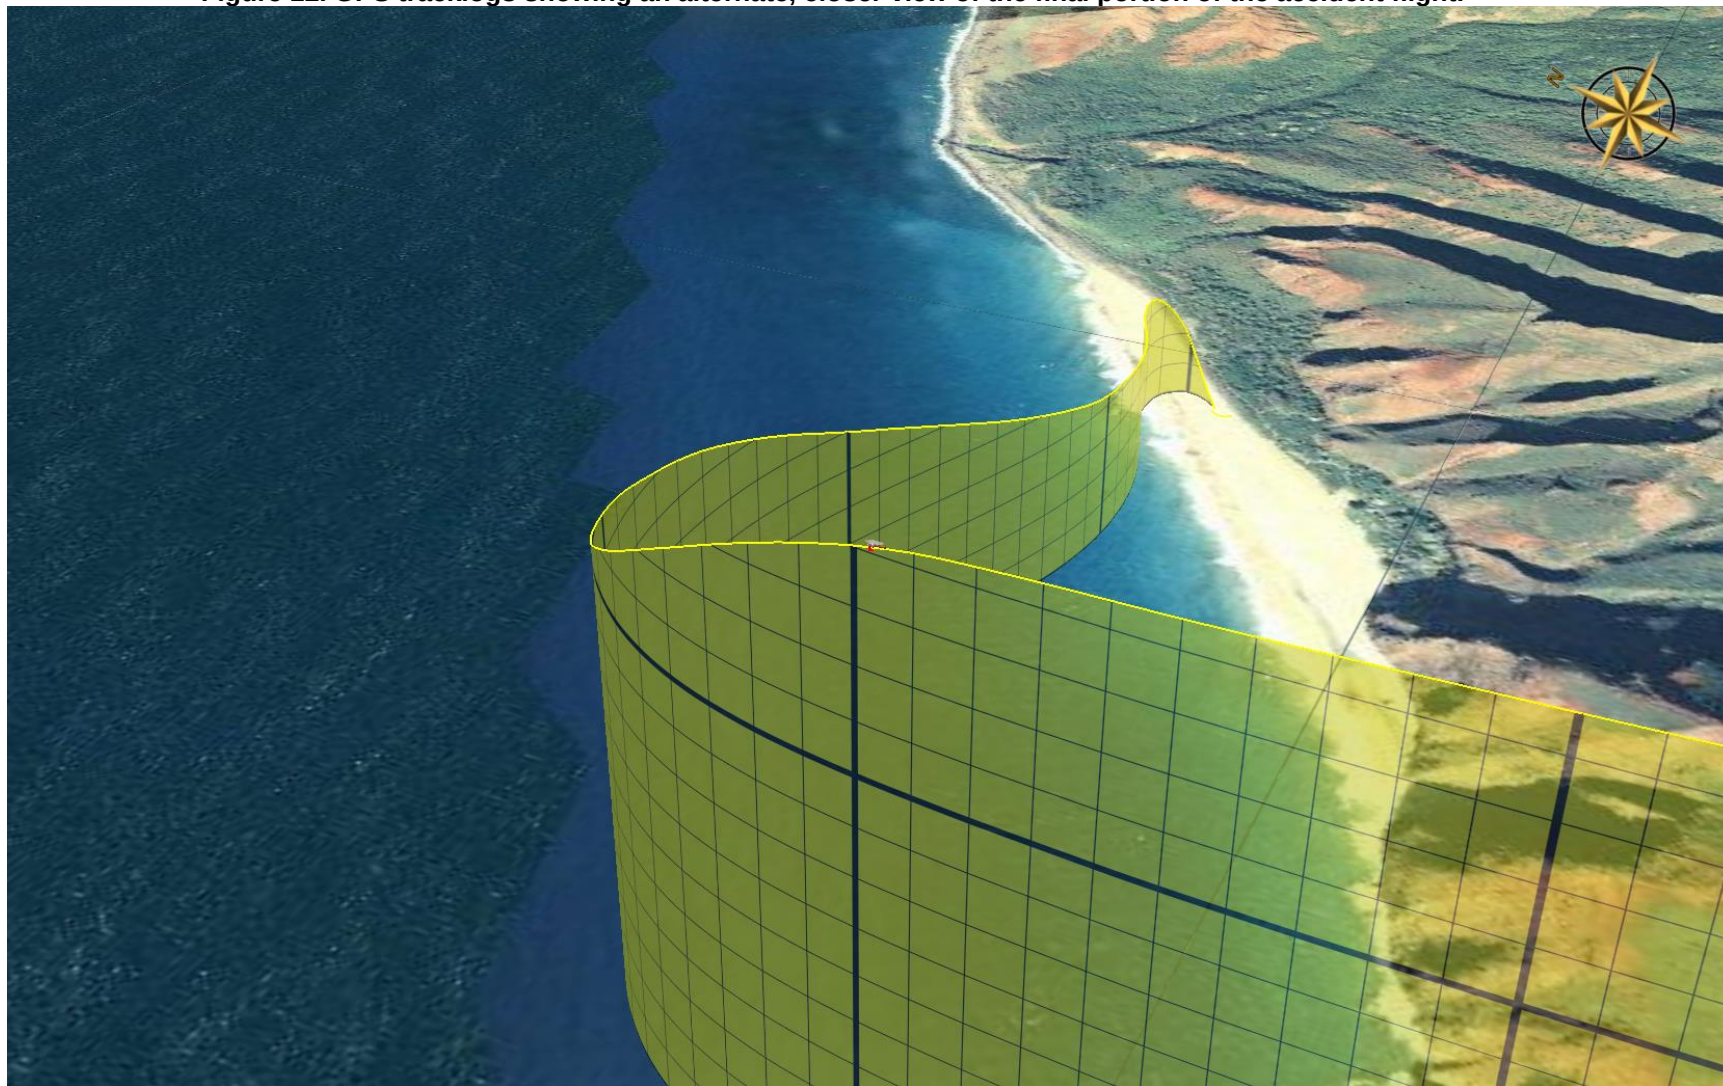
**Figure 13. GPS tracklogs showing an alternate view of the final portion of the accident flight.**

Figure 13 is an alternate view showing a graphical representation of the rotorcraft's GPS tracklogs during the final portion of the accident flight. The figure is zoomed to show the landing area.
