**Equipment: STARTER GENERATOR**  
**AIRBUS P/N: 704A46101011**  
**THALES AES P/N: 524-031 AMENDMENT J**  
**Title: EC130T2 –N11VQ NTSB Investigation- Thales Submission**  
**Doc. Ref. THALES TAES-20\_048\_DIN\_PMA**

| <b>THALES</b><br>AVIONICS ELECTRICAL SYSTEMS | <b>AIRBUS HELICOPTER<br/>EC130 – STARTER<br/>GENERATOR</b><br><br><b>EC130T2 –N11VQ NTSB<br/>Investigation- Thales Submission</b> | <b>20_048_DIN_PMA</b> | |

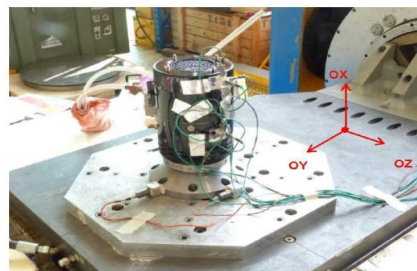
Photograph n°2 - Overall view along OY axis

As shown hereafter, the tests result under these Vibration criteria (DO160G, (Group 2, ZC) confirm that the starter-generator 524-031 amendment J is fully compliant.

The following photo depicts the testing installation used for this qualification test by SOPEMEA.
