## **NATIONAL TRANSPORTATION SAFETY BOARD**

# **AIRFRAME AND ENGINE EXAMINATION**

**WPR16FA087**

Location: Astoria, Oregon  
Date: March 23, 2016  
Aircraft: North American AT-6A, N7055D  
NTSB IIC: Elliott Simpson

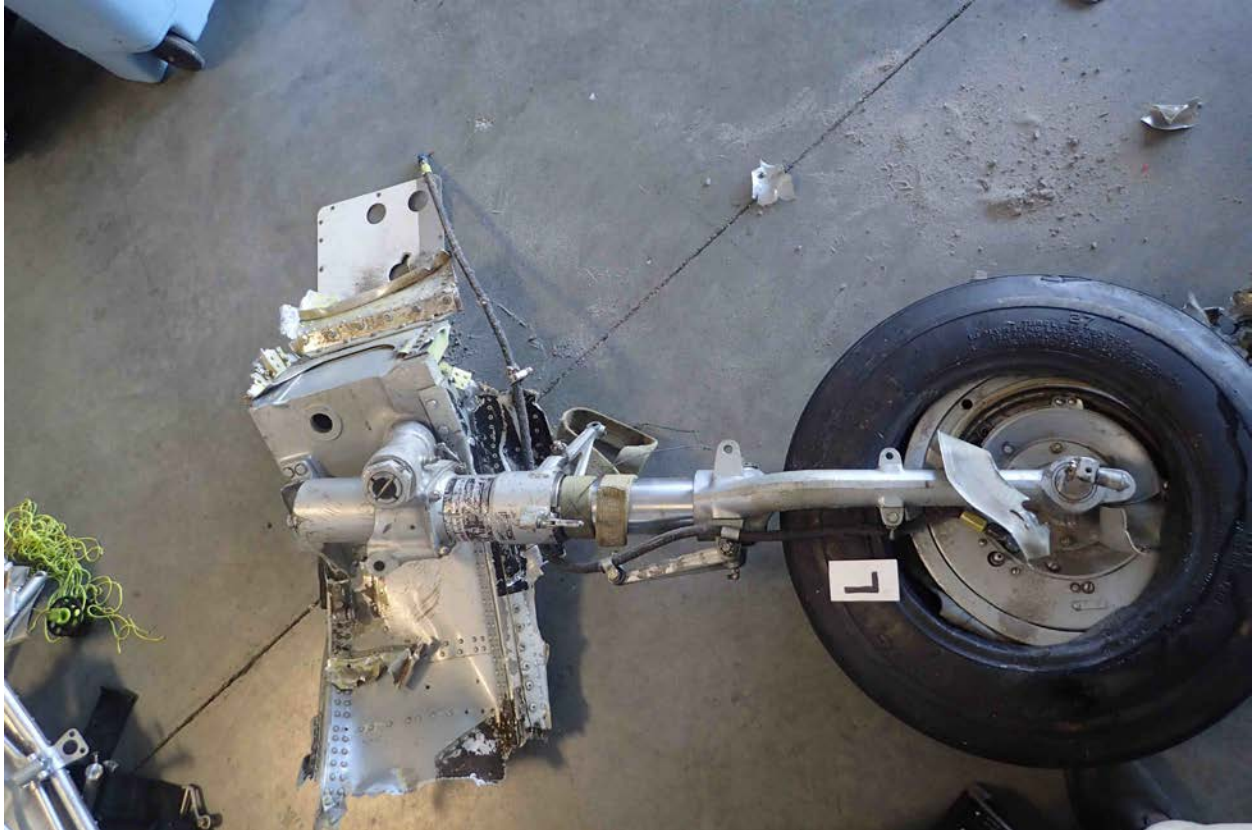
Photo 28 – Left Main Landing Gear

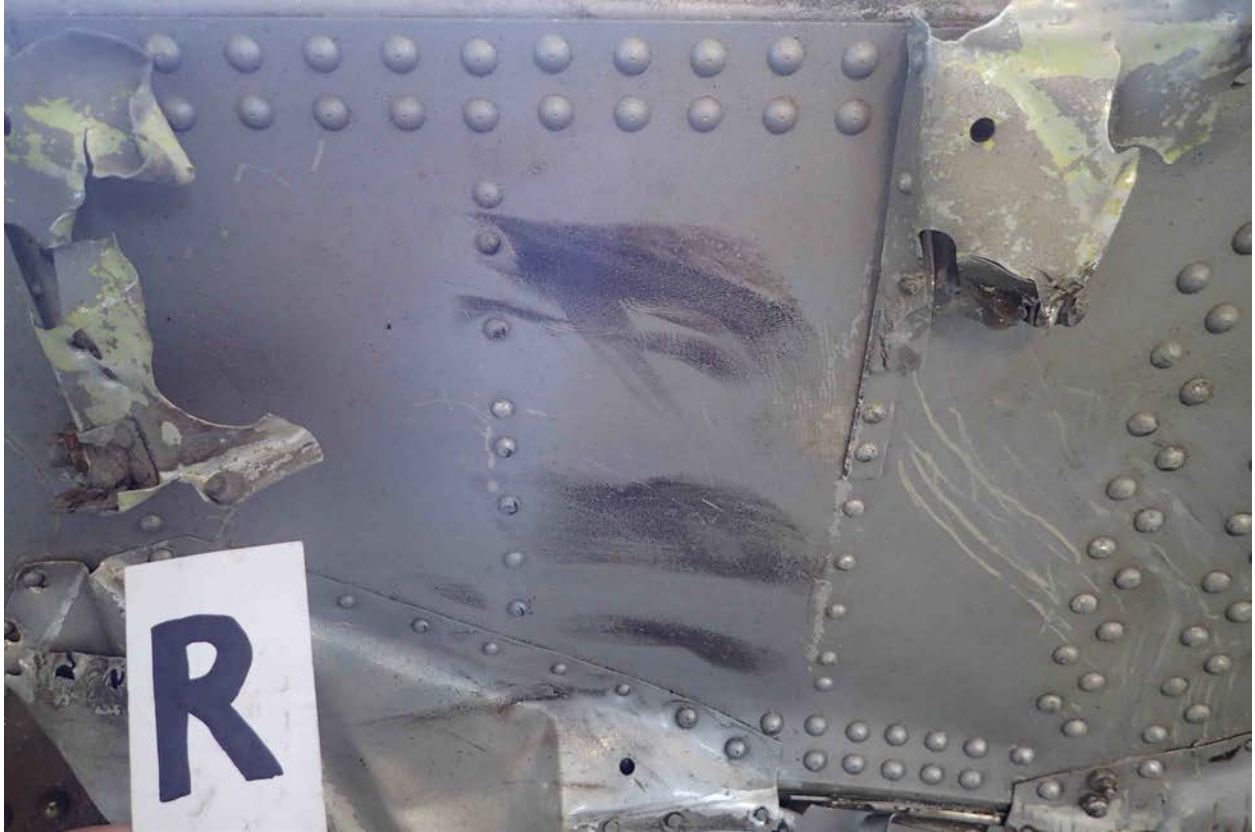
Photo 29 –Transfer Marks in Right Wheel Well

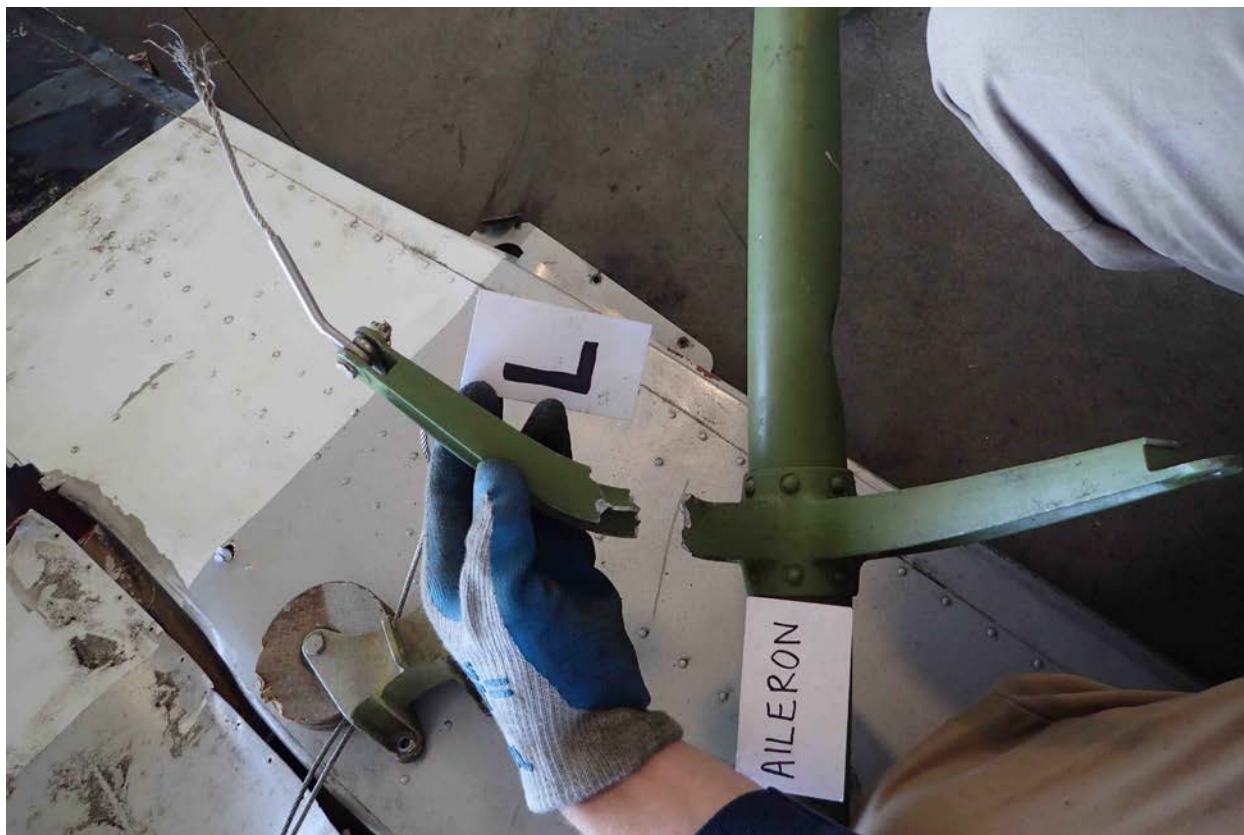
Photo 41 – Aileron Control Arm

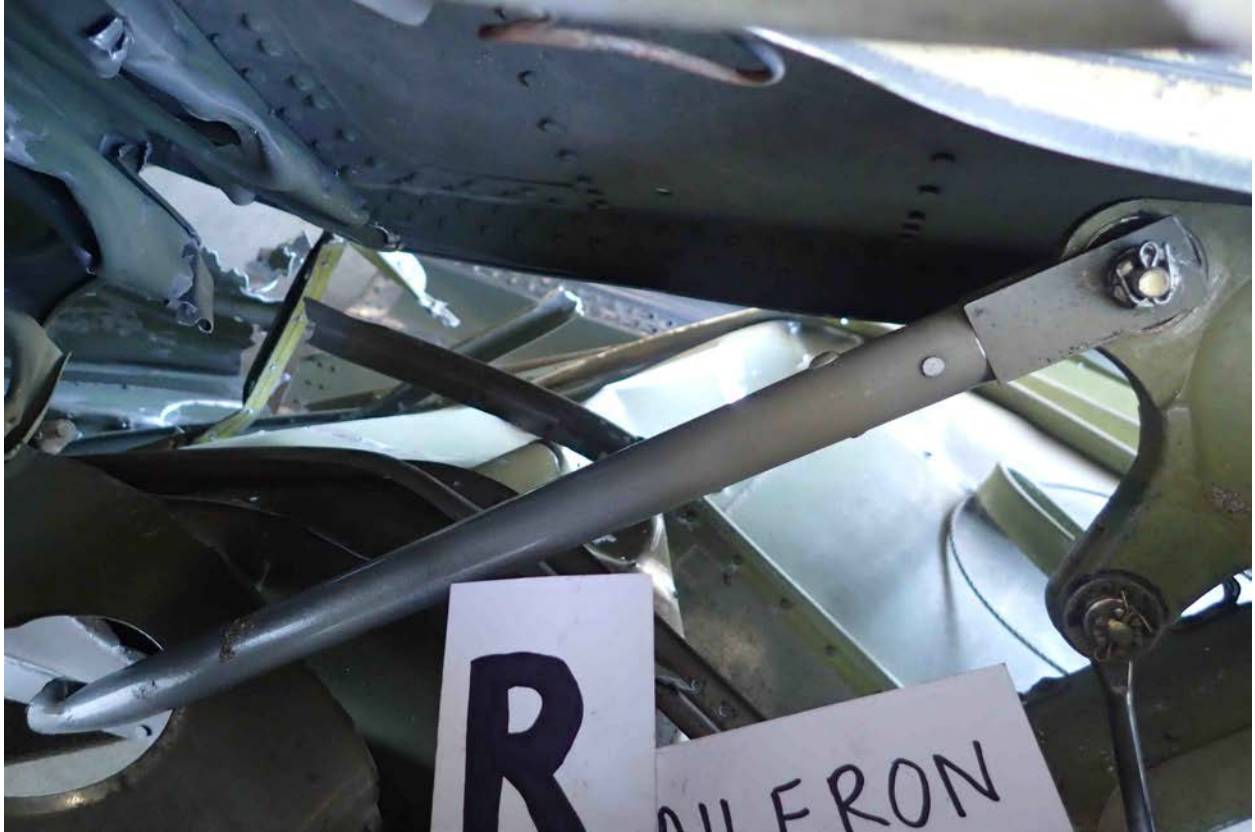
Photo 45 – Right Wing Aileron Bellcrank

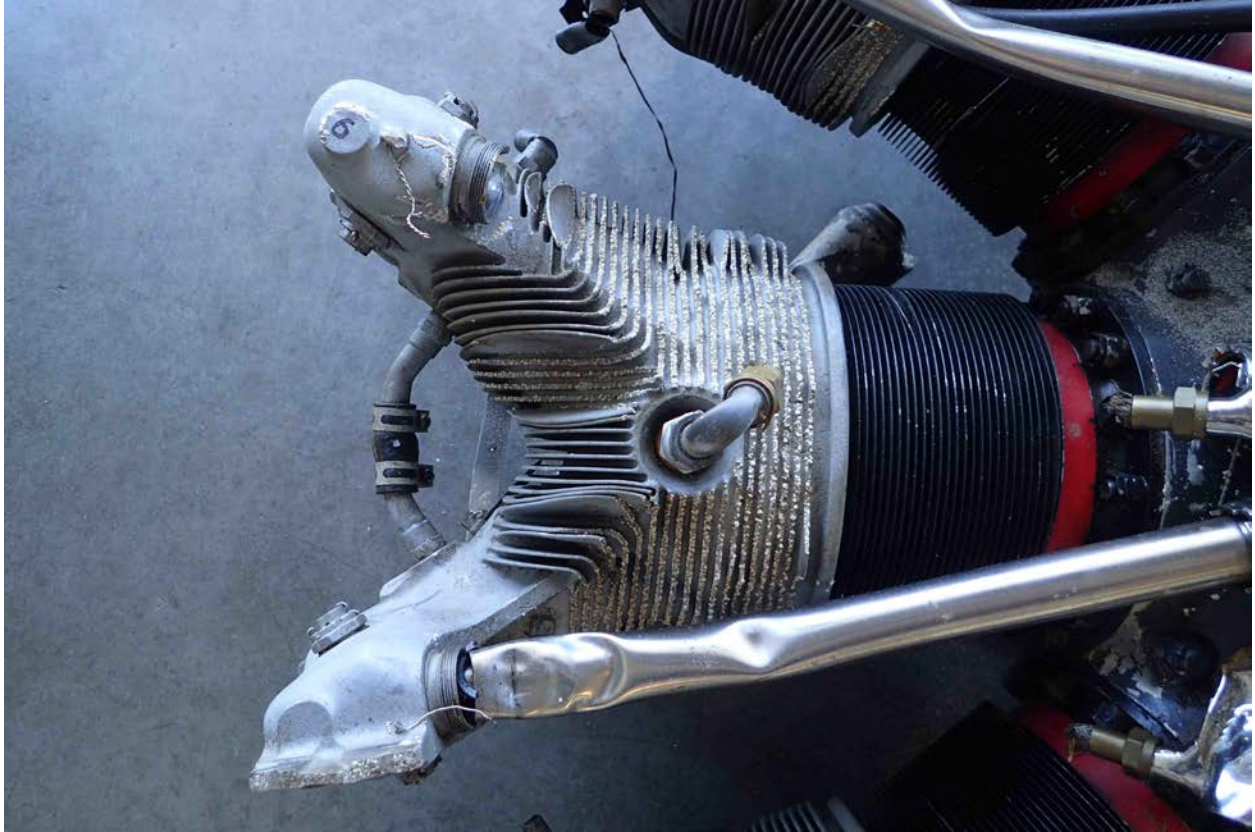
Photo 57 – Forward Fin Damage to Cylinder Head
