## **NATIONAL TRANSPORTATION SAFETY BOARD**

### **GYRO INSTRUMENT AIR PRESSURE SYSTEM**

**NTSB Accident: WPR16FA158  
Accident Date: August 2, 2016**

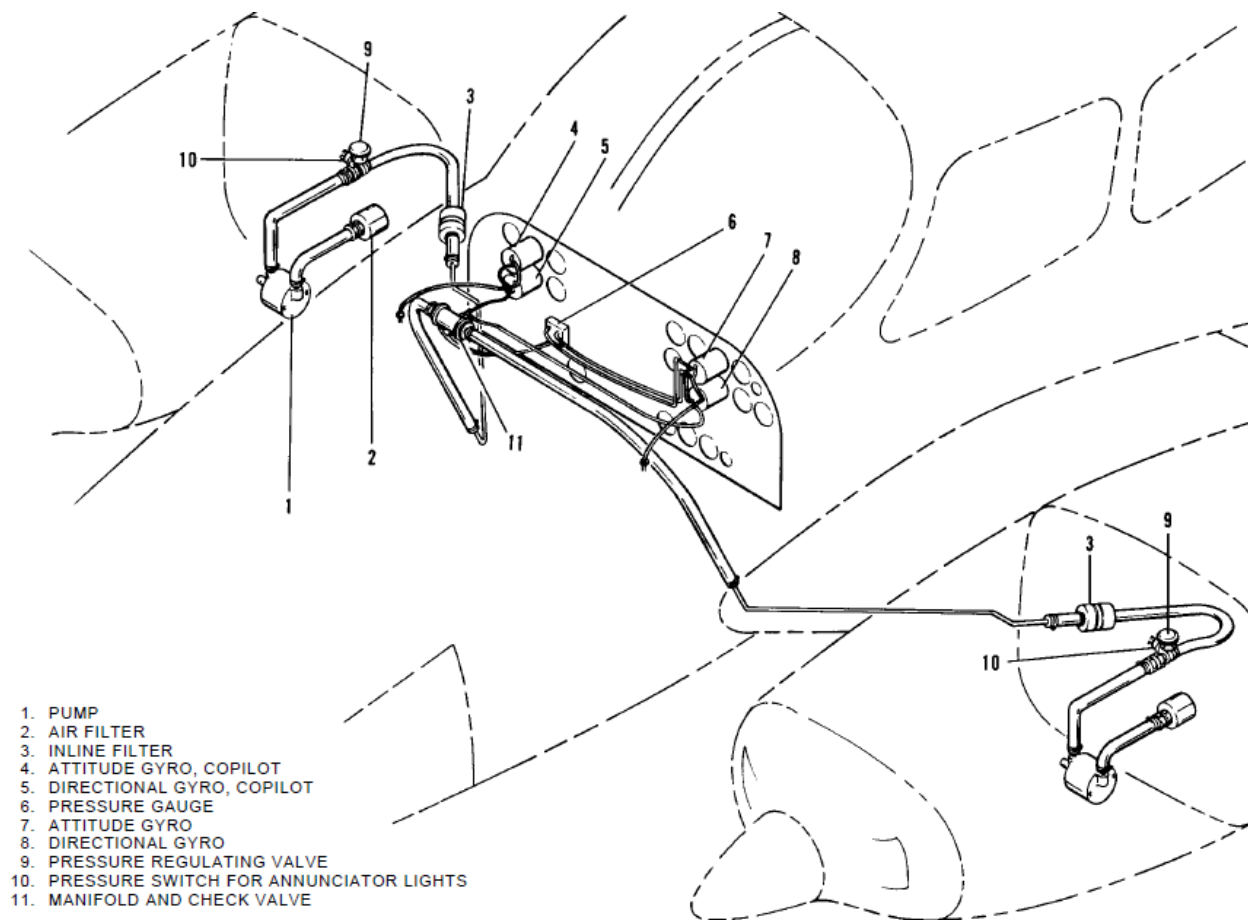
Figure 1 - Instrument Air Pressure System

The directional gyros and attitude indicators are driven by positive air pressure. The pressure system (Figure 7-17) consists of a pressure pump on each engine, plus plumbing and regulating equipment. Air for the system is taken from the engine nacelle area through inlet filters and passed through pressure pumps installed on the engines. Pressure regulators mounted on the fire walls maintain the air at constant pressure to prevent damage to the instruments. An inline filter is located in each nacelle. Check valves and a pressure air manifold are mounted in the cabin at the forward bulkhead. The check valves close to allow pressure instruments to function during single-engine operation or in the event of malfunction of one of the pressure pumps. The instruments receive air from the manifold. A pressure gauge on the instrument panel, to the left of the copilot's control wheel shaft, is connected to the manifold and indicates the pressure the gyros are receiving. After air has passed through the gyro instruments, it is exhausted overboard through the forward bulkhead.

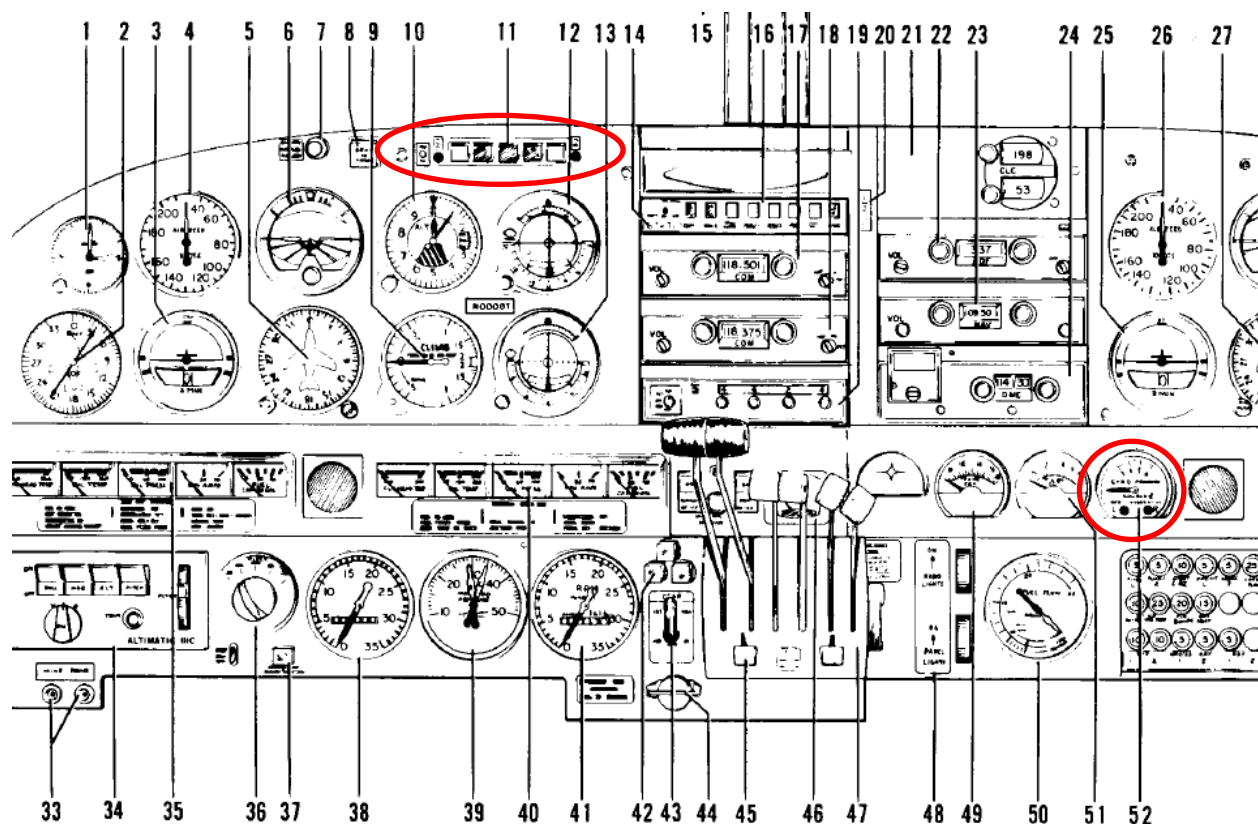
Figure 2 - Instrument Panel (with air pressure system items circled)

- The annunciator panel was located to the upper left of the radios [item 11 below]
- It included a discrete annunciator light for "gyro pressure"
- The illumination of these lights in flight is an indication of a possible system malfunction. The pilot should closely monitor instrument panel gauges to check the condition of a system whose corresponding light on the annunciator panel illuminates.
- When an engine is feathered, the alternator, gyro air and engine oil pressure annunciator lights will remain illuminated.
- The annunciator panel incorporated a press-to-test feature
- During preflight, the operational status of the annunciator panel should be tested by use of the press-to-test button. When the button is depressed, all annunciator panel lights, except auxiliary fuel pump lights, should illuminate.

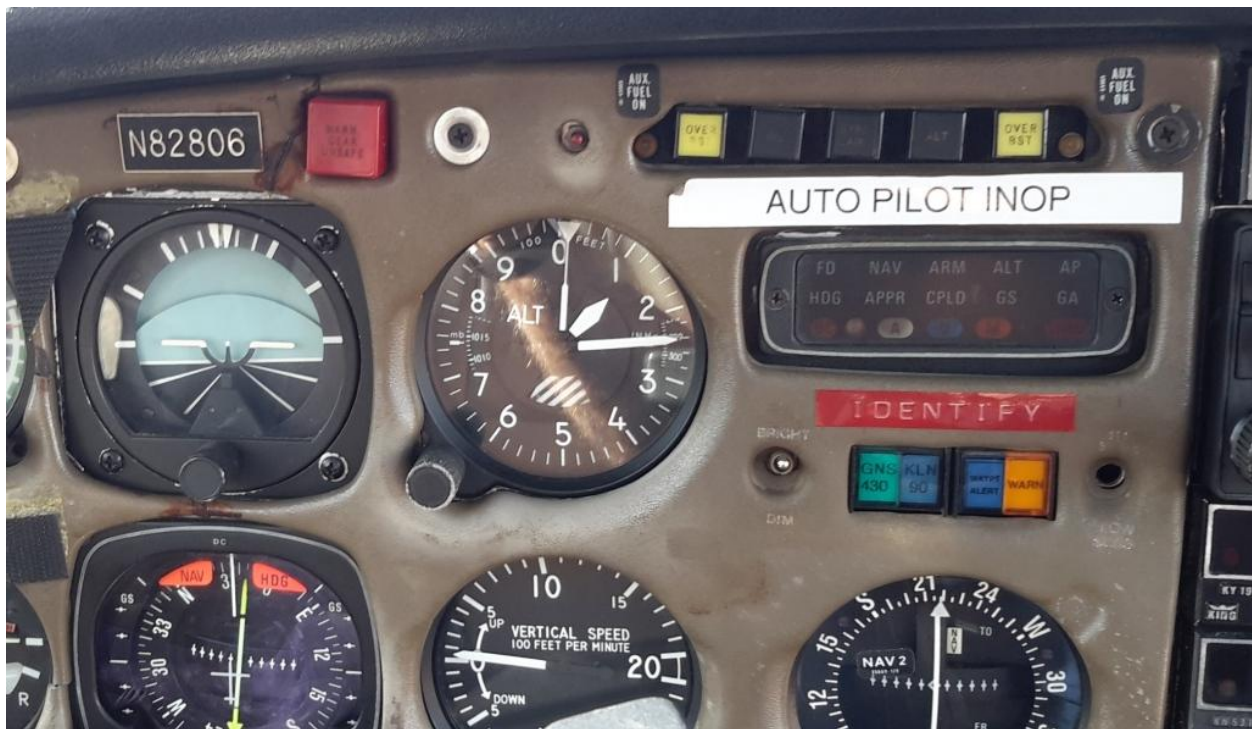
Figure 4 - Annunciator Panel

The annunciator panel, pump air pressure gauge, pressure switch, regulating valves, and check valves were not identified in the wreckage. Therefore, the pre-impact condition and functionality of those components, and the overall switching and alerting system, were not able to be determined. Impact damage precluded the determination of the pre-impact condition and functionality of the gyro instruments, as well as the pre-impact condition and integrity of the pressure system lines.
