## **NATIONAL TRANSPORTATION SAFETY BOARD**

### **SITE and EXAMINATION INFORMATION**

**NTSB Accident: WPR16FA158  
Accident Date: August 2, 2016**

Location: Flagstaff, Arizona  
Date: August 2, 2016  
Aircraft: Piper Seneca II, N82806, Serial # 34-8170021  
NTSB IIC: Michael Huhn

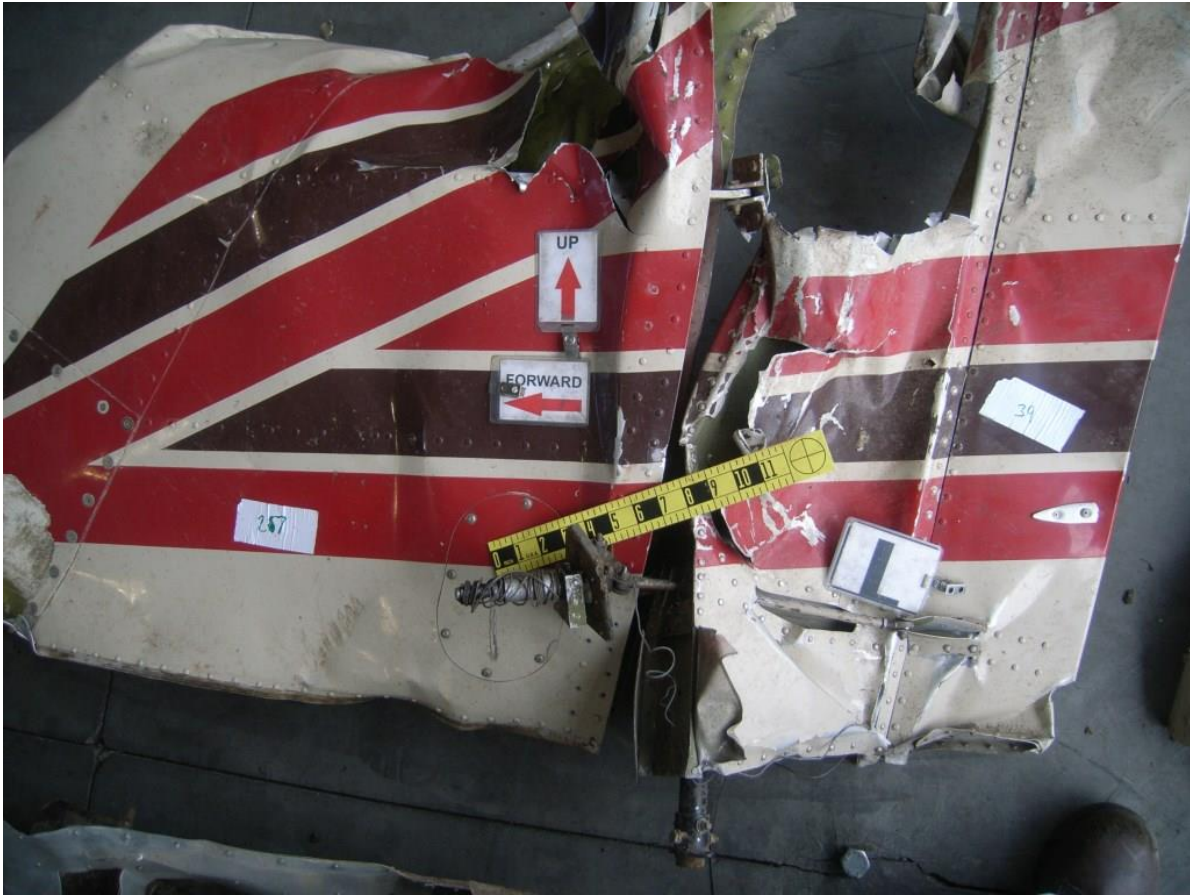
**Figure 45 - Vertical Stabilizer and Rudder Segments**

- The rudder trim actuator (drum) remained attached to the lower rudder
  - The actuator extension measurement and thread count were consistent with an approximately neutral setting of the rudder trim tab

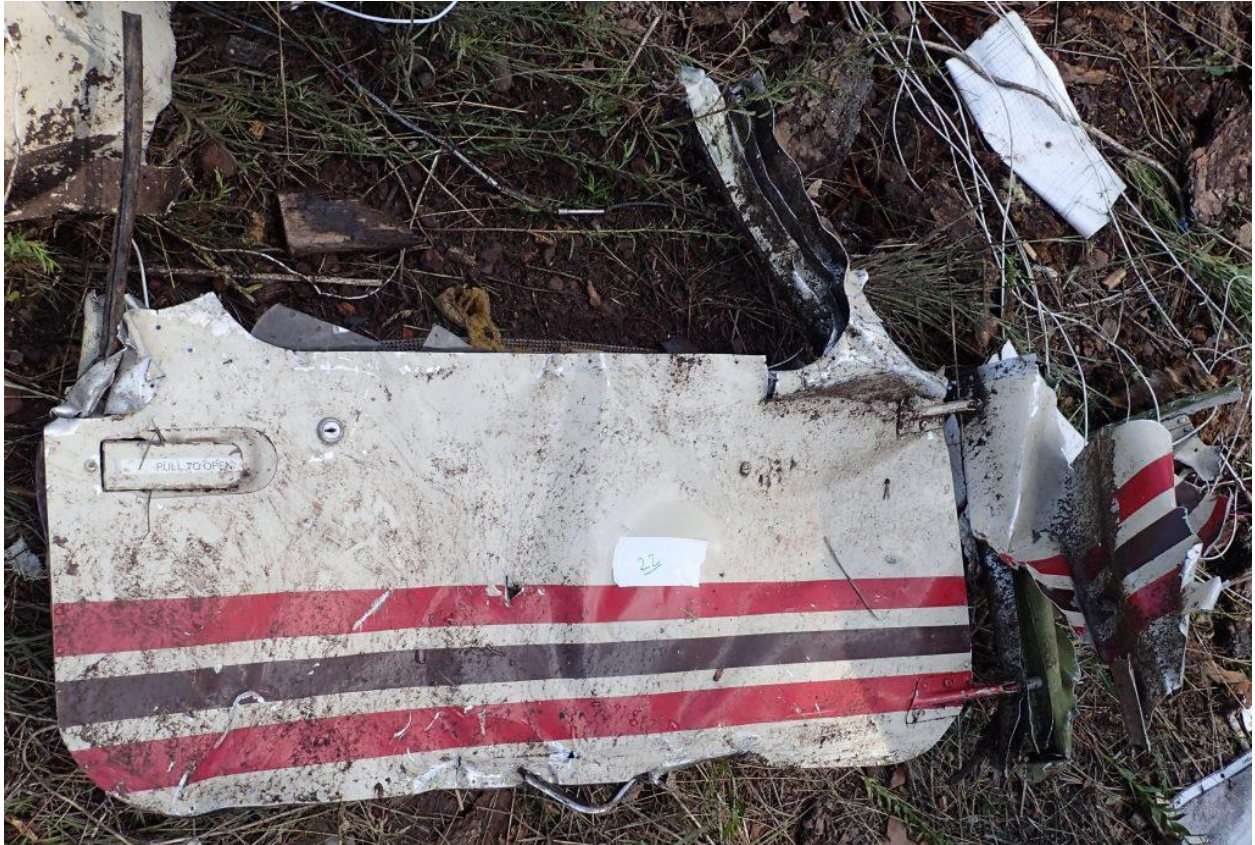
**Figure 50 - Starboard Entry Door (lower segment)**

- Damage precluded reliable determination of engine control (throttle, mixture, propeller, ignition) settings
- Damage patterns were consistent with the landing gear being in the fully-retracted position at time of impact
- Damage precluded definitive determination of the latched/unlatched status of the three (one starboard entry, two port aft cargo) doors
