# **NATIONAL TRANSPORTATION SAFETY BOARD**

## **DEBRIS FIELD INFORMATION**

**NTSB Accident: WPR16FA158  
Accident Date: August 2, 2016**

Location: Flagstaff, Arizona  
Date: August 2, 2016  
Aircraft: Piper Seneca II, N82806, Serial # 34-8170021  
NTSB IIC: Michael Huhn

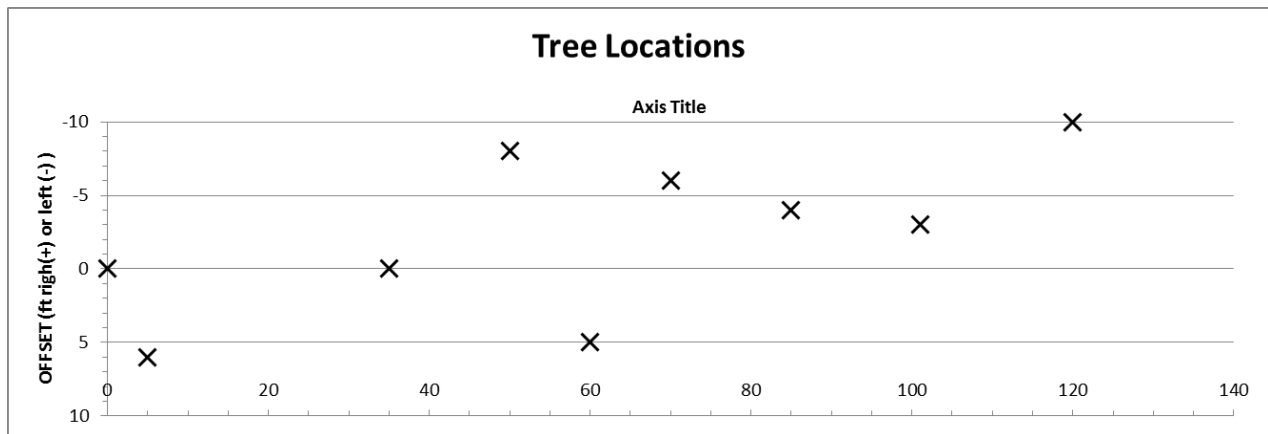
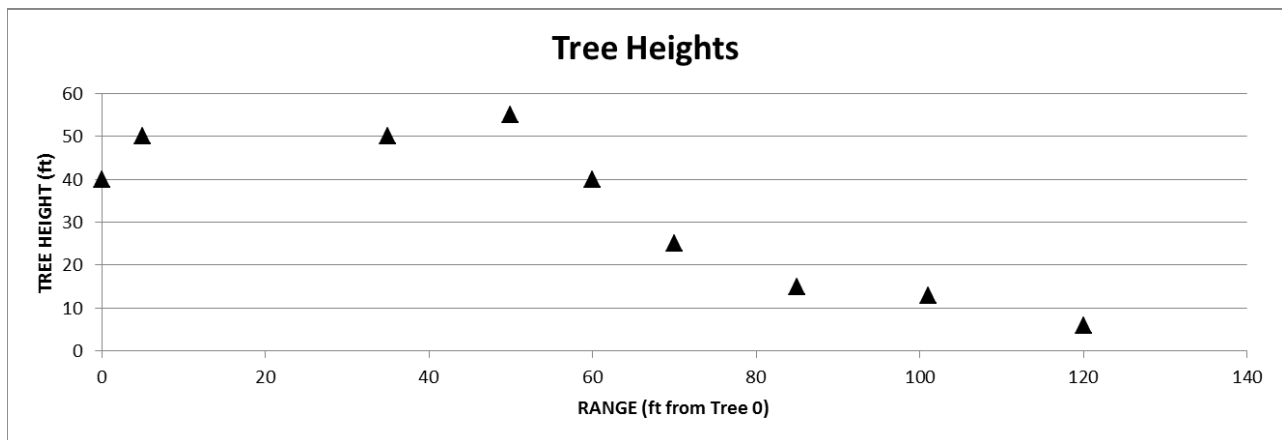
- The trees appeared to be primarily mature pine trees, from about 50 to 80 feet tall
- The topped trees ranged from about 10 to 15 inches in diameter at their fracture points
- A cluster of tree tops, branches, and limbs was situated from about 70 to 100 feet from Tree 0, approximately straddling the reference line
  - The cluster was not a result of any efforts by the first responders or other personnel to gather or re-locate the debris
- Many smaller-diameter & shorter limbs were scattered throughout the first 100 feet of the debris field
- Many tree limbs (up to about 6 inches in diameter) exhibited clean, fresh, diagonally-cut ends consistent with being severed by the propellers
