# Continental Motors

## ENGINE FIELD INSPECTION REPORT

| <b>ENGINE MODEL</b> | IO550C-6F converted to IO550B |
| <b>FILE NUMBER</b> | 16-143 |

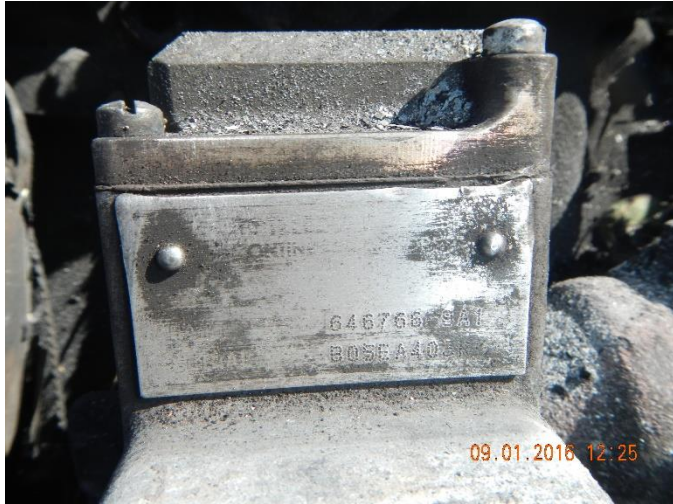
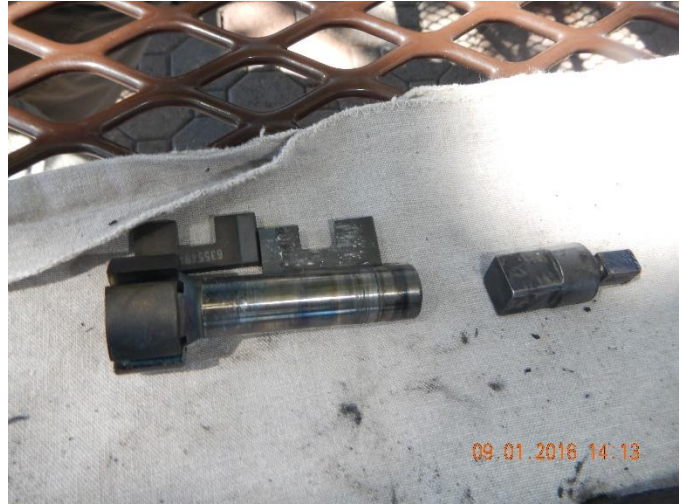
The fuel system throttle body-metering unit separated from its engine oil sump mount but was recovered. The control cables remained attached but were cut to facilitate removal of the throttle body-metering unit from the damaged engine. The individual throttle and mixture control arms remained attached and secured.
