# Continental Motors

## ENGINE FIELD INSPECTION REPORT

| ENGINE MODEL | IO-470-L21A |
| FILE NUMBER | 16-180 |

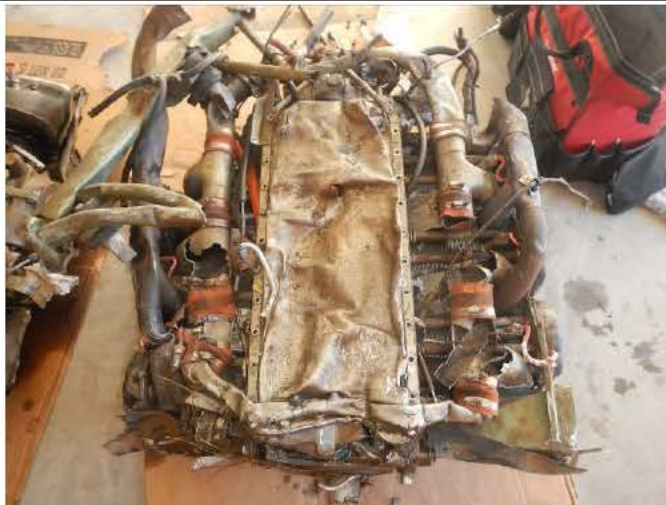
The exhaust system remained attached to the cylinders, but the risers and manifolds sustained cracking and deformation damage. The exhaust pipes were cut away by the aircraft recover crew to facilitate transport.

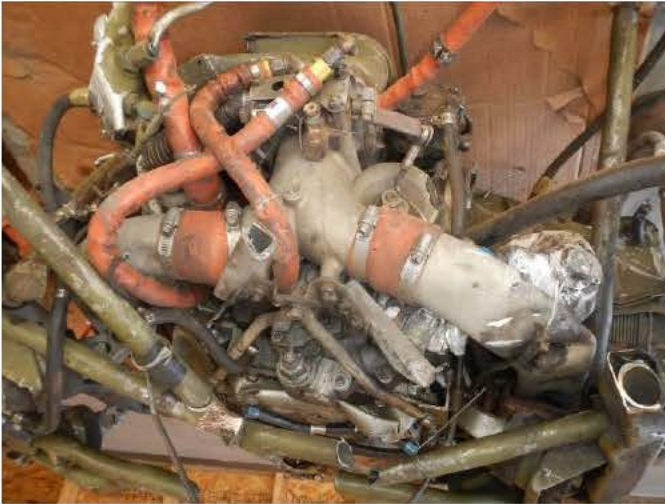
Condition: The intake filter and induction air box sustained deformation damage. The intake tubes were deformed and/or fractured. The balance tube was flattened against the oil pan. The throttle body remained attached to the backside of the engine and the throttle valve was found in a near full open position. The throttle lever remained attached to the throttle body and fuel metering unit. No pre-accident anomalies were noted with the induction system.

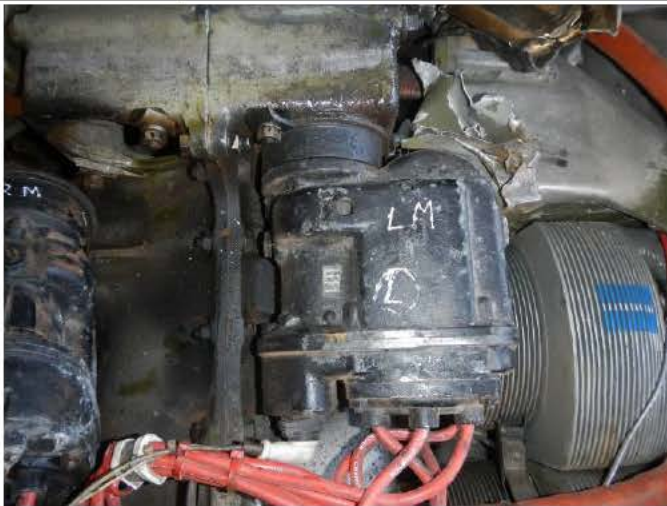
The left magneto remained secured to its mounting pad. Manual manipulation of the magneto did not result in any rotation or slipping. The ignition harness remained attached to the magneto. The magneto was removed and the top sparkplugs were inserted in the undamaged ignition terminals and the damaged terminal leads were cut to remove any impact-related shorts. The magneto's drive shaft was manually rotated and the impulse coupling made an audible snap with a corresponding spark from all of the sparkplugs or cut ignition leads. No pre-accident anomalies were noted with the magneto.

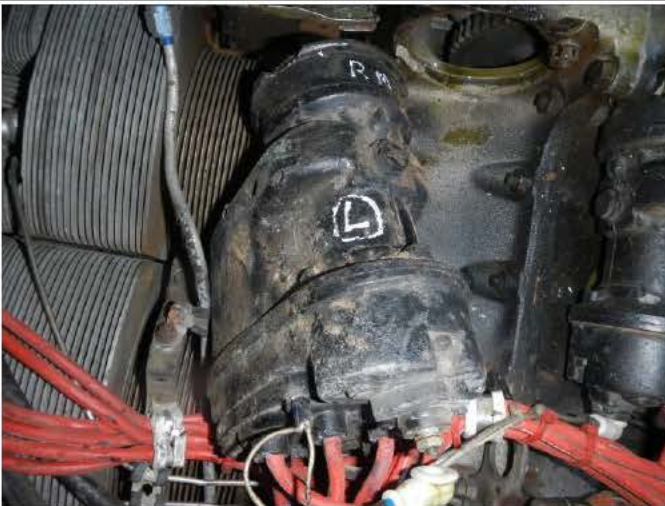
The right magneto was separated from its mounting pad and its flange was fractured in the area of the securing hardware. The ignition harness remained secured to the magneto. The top sparkplugs were inserted in the undamaged ignition terminals and the damaged terminal leads were cut to remove any impact-related shorts. The magneto's drive shaft was manually rotated and the impulse coupling made an audible snap with a corresponding spark from all of the sparkplugs or cut ignition leads. No pre-accident anomalies were noted with the magneto.

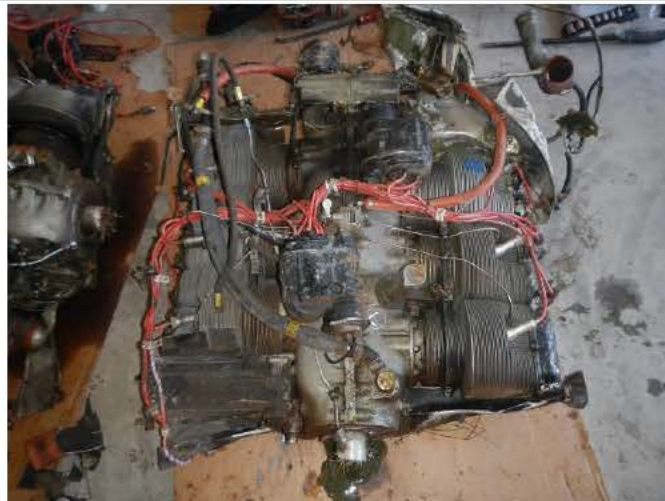
The ignition harness remained secured to the magnetos. The terminal ends remained secured to their respective sparkplugs. A couple of the bottom leads sustained impact-related pinching damage, but otherwise the leads were unremarkable. Each of the leads produced a spark during the magneto test with no pre-accident anomalies noted.

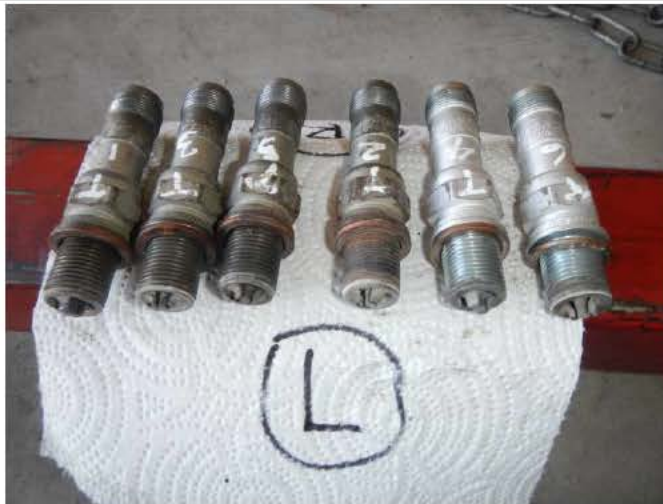
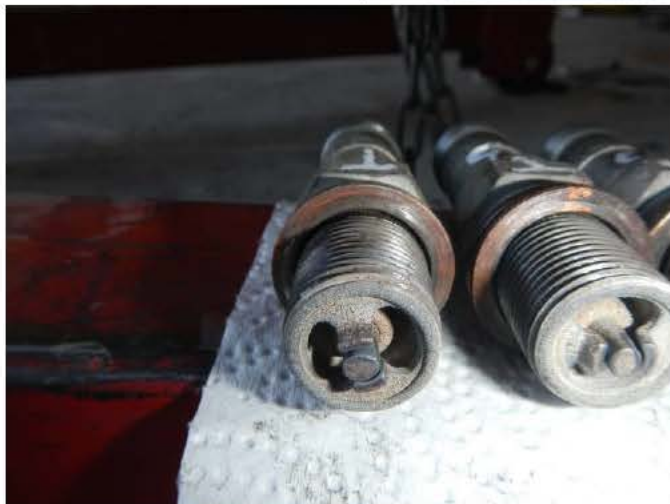
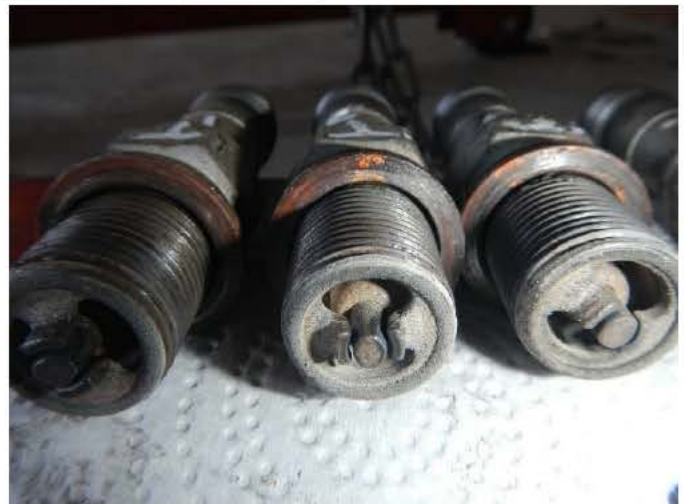
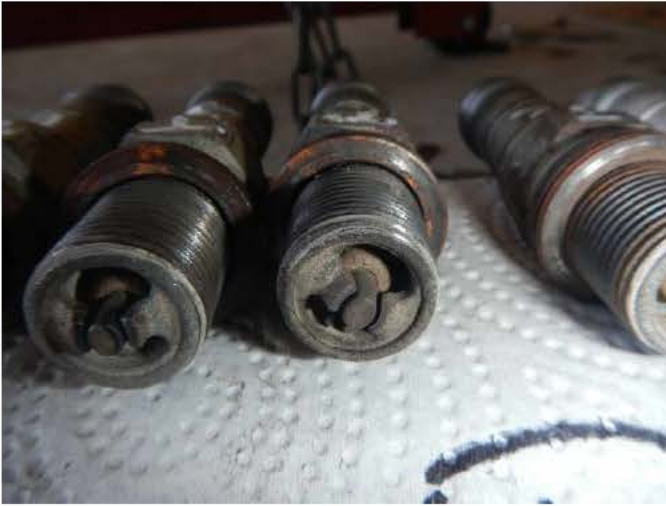
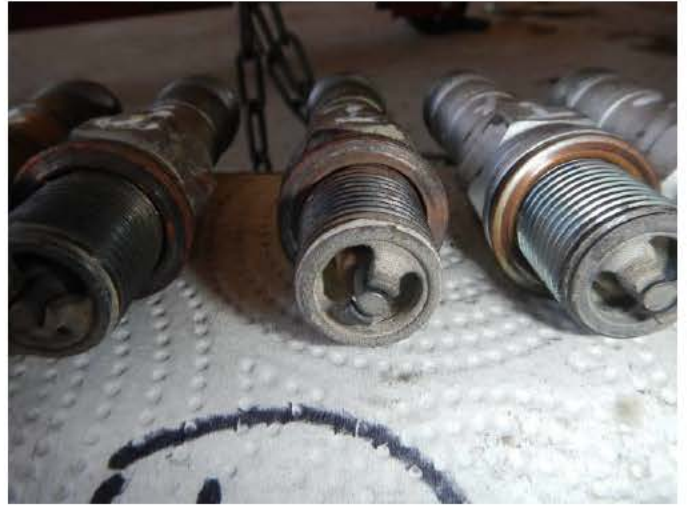
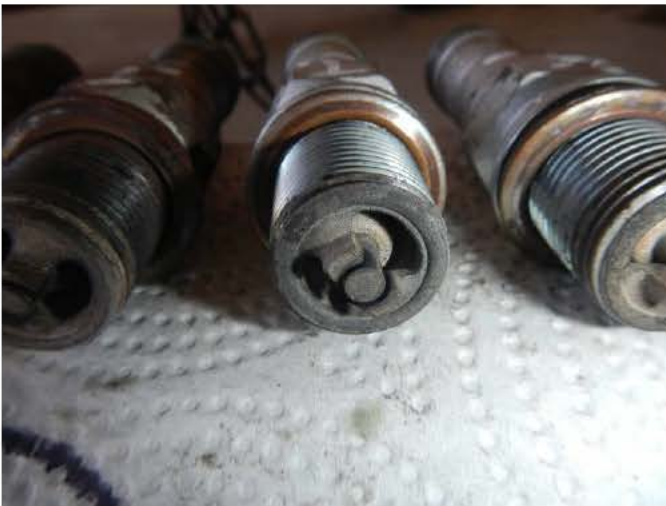
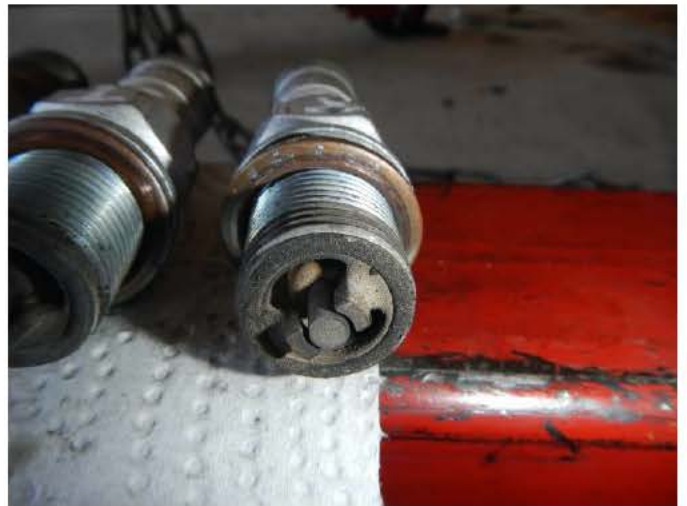
The sparkplugs remained secured to their respective cylinders and the ignition leads remained attached to the sparkplugs via their terminal ends. The #6 bottom sparkplug was fractured in the middle with one half remaining secured in the cylinder and the other remaining attached to the terminal end. The top sparkplugs were removed from the cylinders. The #1, #3, #5, and #2 sparkplugs displayed a normal worn condition and the #4 and #6 sparkplugs appeared relatively new. All six sparkplugs displayed normal combustion deposits with no signs of lead or carbon fouling.

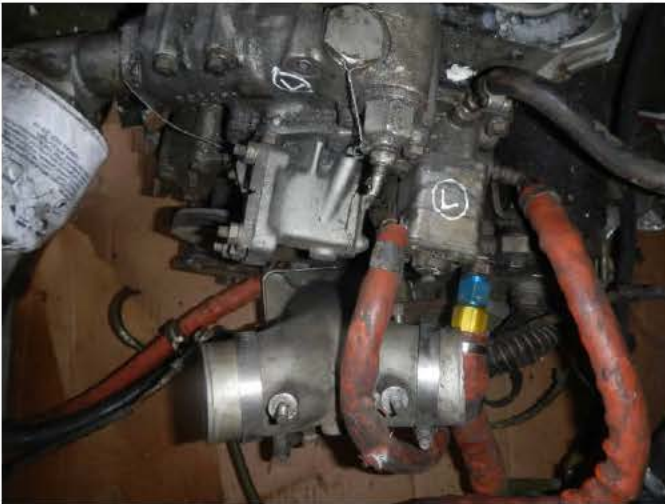
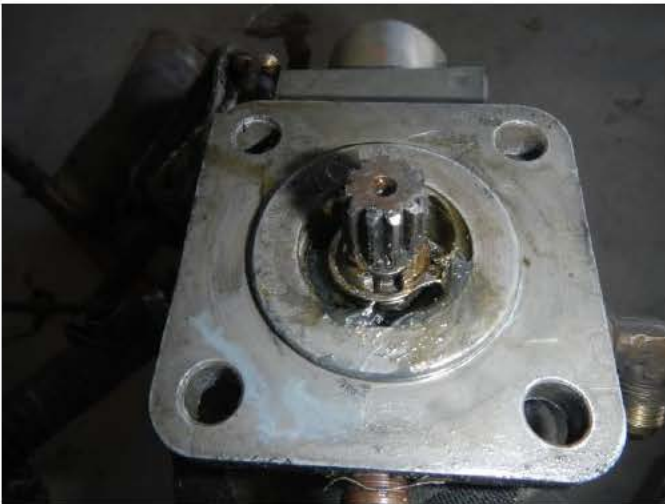
Condition: The engine-driven fuel pump remained attached to the backside of the engine and the fuel lines to and from the pump remained attached. The pump's low pressure relief valve adjusting screw was impinged by the left intake elbow. The low pressure relief valve cap was fractured. Manual rotation of the intact drive coupling resulted in a free and unbound rotation of the drive shaft. The fuel pump was disassembled and the low pressure relief valve diaphragm was torn. No obstructions or blockages were noted and the pump vanes were intact with no pre-accident anomalies noted.

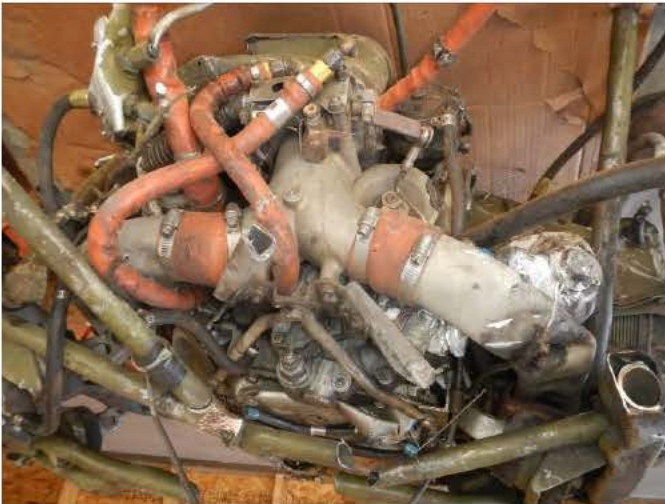
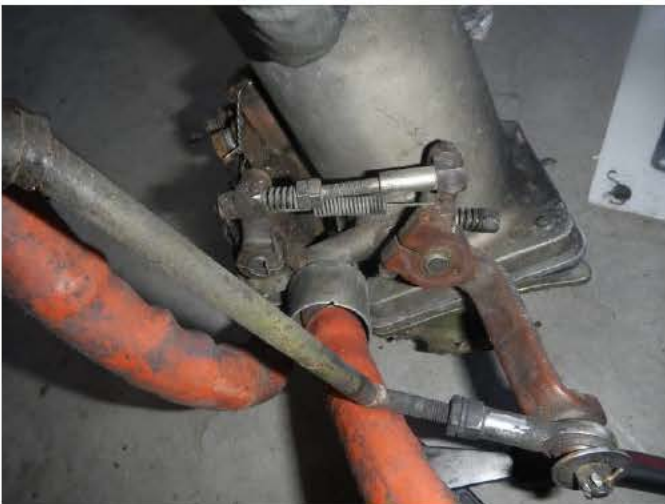
Condition: The throttle body remained attached to the backside of the engine and the fuel metering unit remained attached. The throttle and mixture control cables remained attached to the throttle and mixture control levers though the levers and cable rod ends were deformed. Rotation of the fuel metering unit's control levers resulted in a coinciding rotation of the shafts. The inlet fuel fitting was fractured. The inlet fuel screen was removed and no blockages or obstructions were noted. The fuel metering unit was disassembled and no pre-accident anomalies were noted with the internal components.

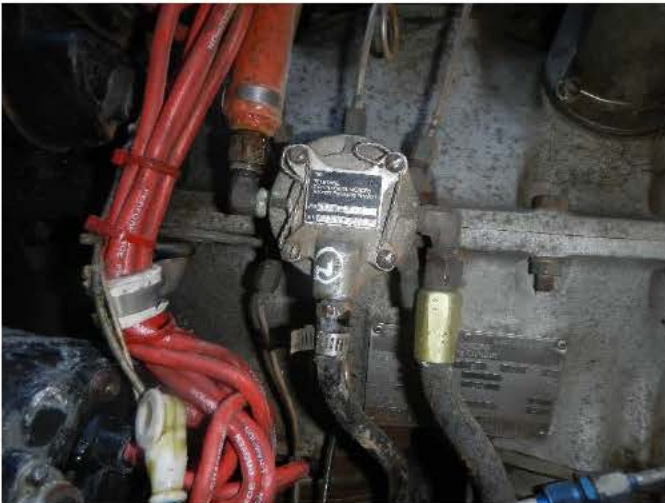
The fuel manifold valve remained attached to the topside of the engine and the fuel lines to and from the manifold valve remained attached. The manifold valve was disassembled and the plunger remained attached to the diaphragm and the screen was clean and unobstructed.

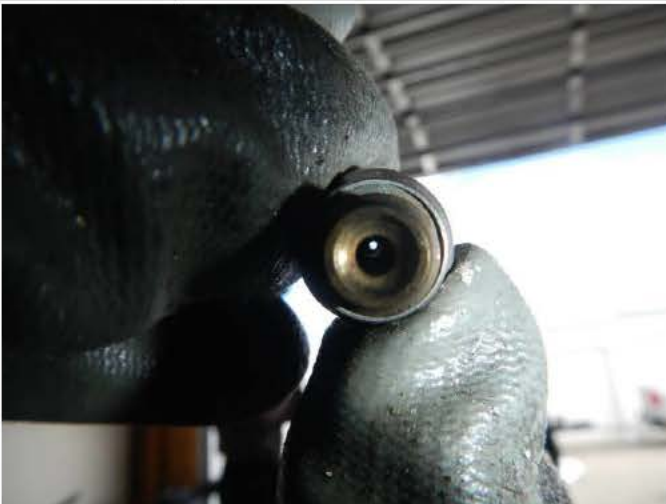
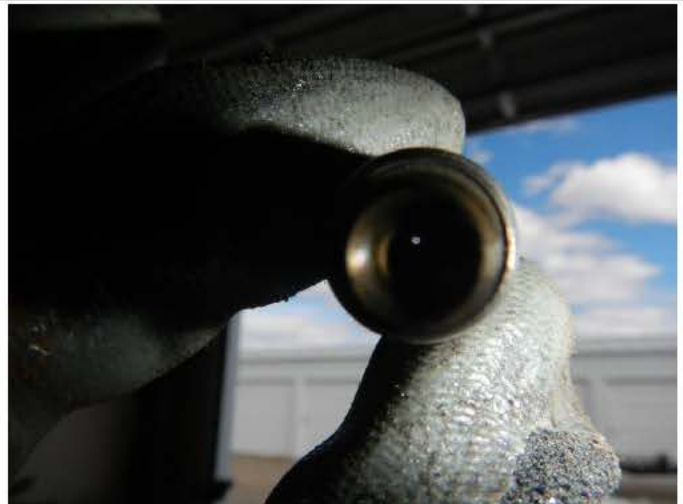
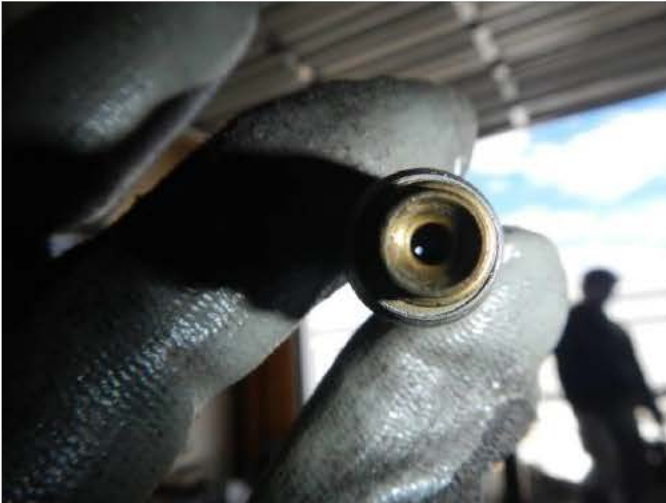
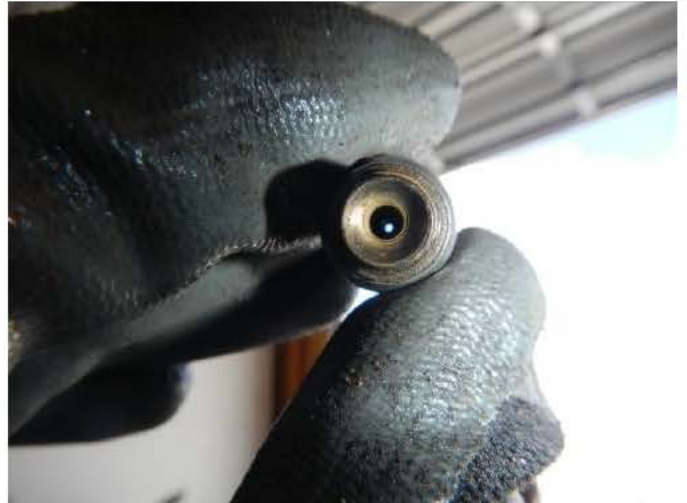
The fuel injector lines remained attached to the fuel nozzles and all of the nozzles remained attached to their respective cylinders. The nozzles were removed and examined. Almost all of the nozzles contained debris consistent with organic material found at the accident site. The debris was easily cleared from the nozzles and no signs of lead fouling or obstruction were noted.

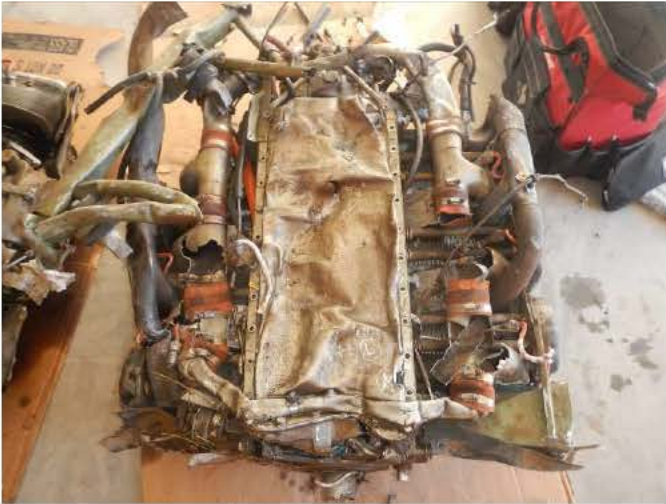
#### OIL SUMP

Condition: The oil sump remained attached to the bottom side of the engine. It was displaced upward and flattened and sustained puncture damage. The oil sump was removed and no pre-accident anomalies were noted.

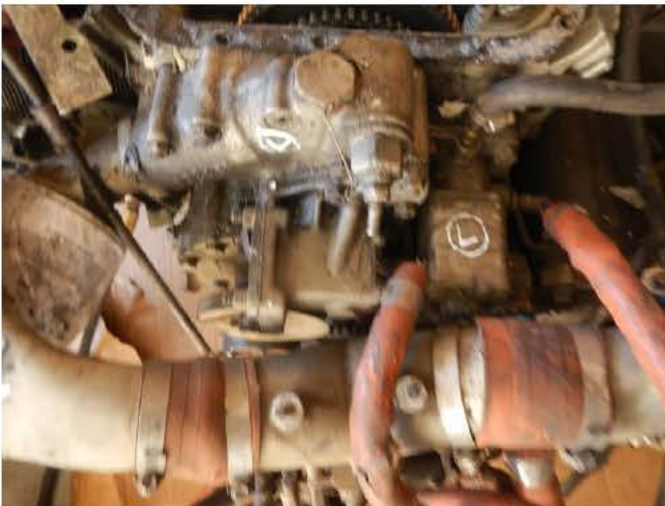
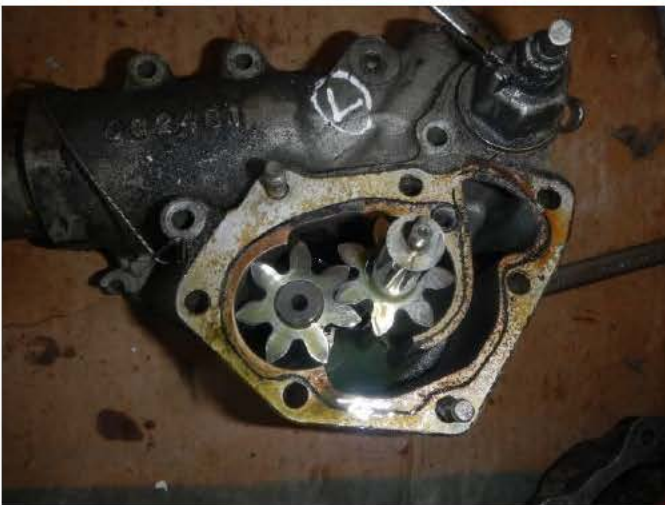
### OIL PUMP

Condition: The oil pump remained attached to the backside of the engine, though all but one of the mounting studs were sheered where the pump housing meets the crankcase. The pump was removed and examined. Oil coated all of the components. Surface corrosion was noted on the pump gears. Slivers of metal consistent with fresh shavings from the internal pump walls was observed on the gears. There were no signs of operational distress noted with the pump gears or housing.

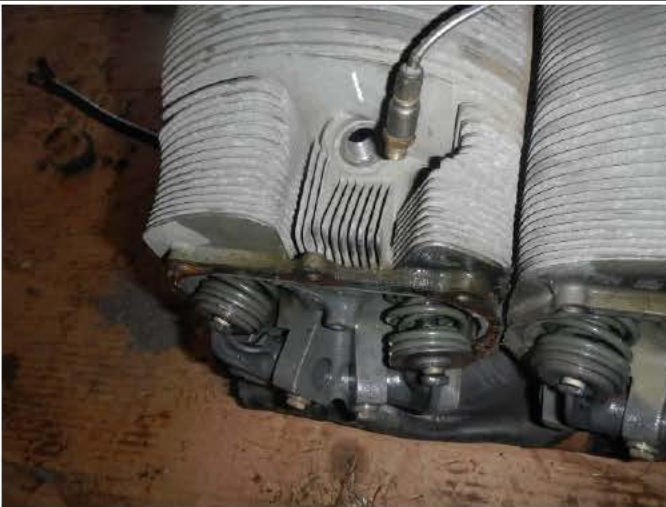
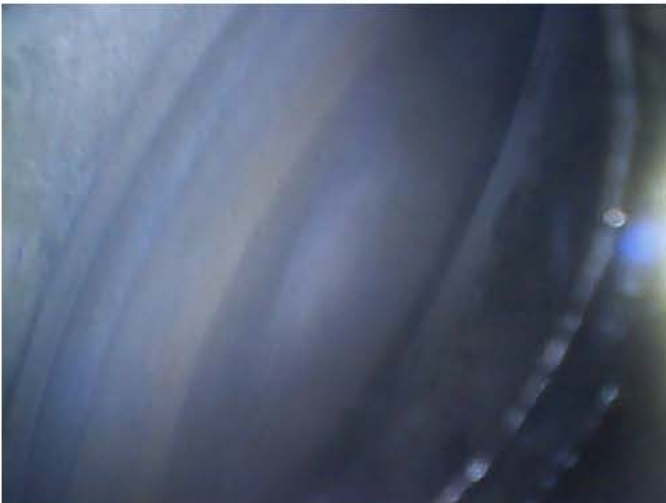
#### CYLINDER #1

Condition: The cylinder remained attached to the crankcase with no external signs of operational distress. The rocker cover was removed from the cylinder and the rockers were intact and well lubricated. The valve springs were intact and showed no signs of operational distress. The internal cylinder components were examined with a lighted borescope and no pre-accident anomalies or signs of operational distress were noted. Thumb compression was obtained during crankshaft rotation and valve operation was confirmed during the compression test.

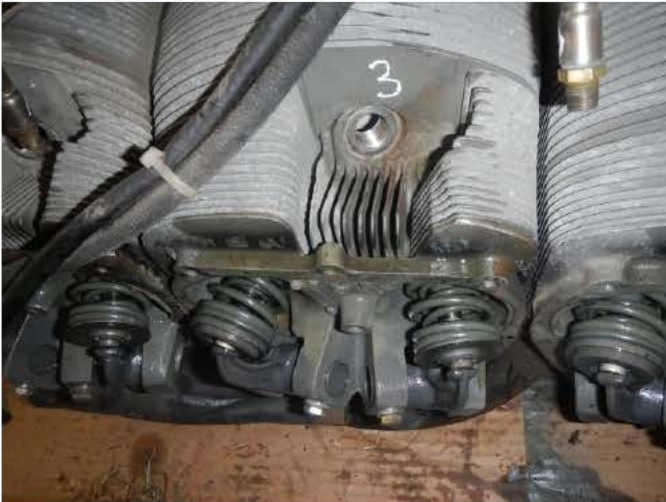
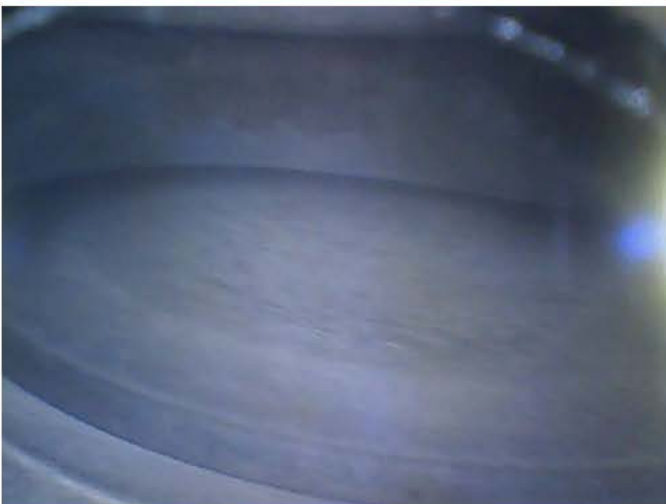
### CYLINDER #3

Condition: The cylinder remained attached to the crankcase with no external signs of operational distress. The rocker cover was removed from the cylinder and the rockers were intact and well lubricated. The valve springs were intact and showed no signs of operational distress. The internal cylinder components were examined with a lighted borescope and no pre-accident anomalies or signs of operational distress were noted. Thumb compression was obtained during crankshaft rotation and valve operation was confirmed during the compression test.

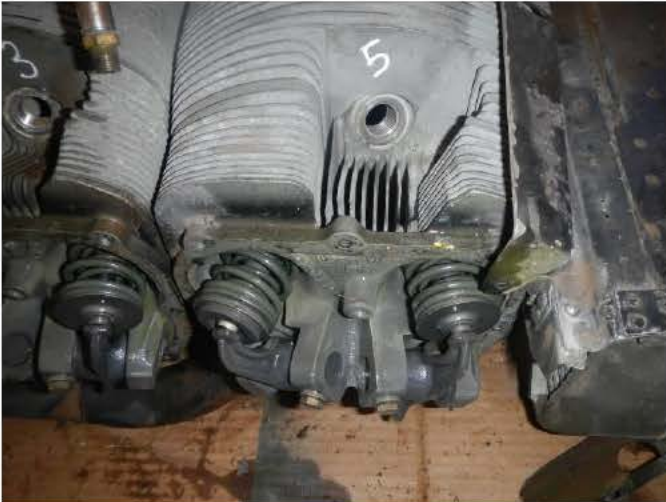
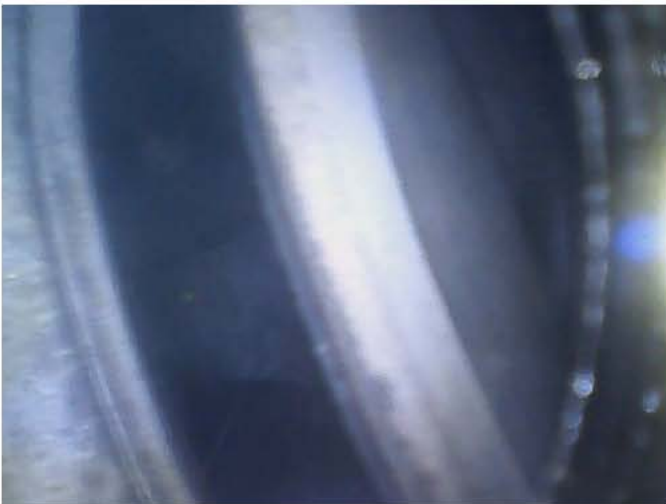
### CYLINDER #5

Condition: The cylinder remained attached to the crankcase with no external signs of operational distress. The rocker cover was removed from the cylinder and the rockers were intact and well lubricated. The valve springs were intact and showed no signs of operational distress. The internal cylinder components were examined with a lighted borescope and no pre-accident anomalies or signs of operational distress were noted. Thumb compression was obtained during crankshaft rotation and valve operation was confirmed during the compression test.

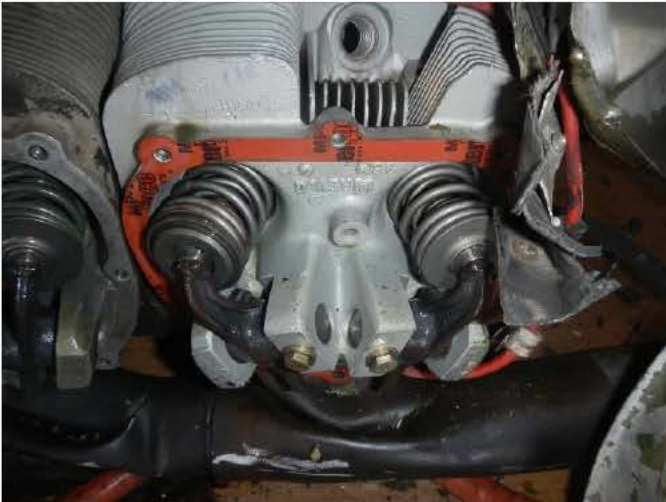
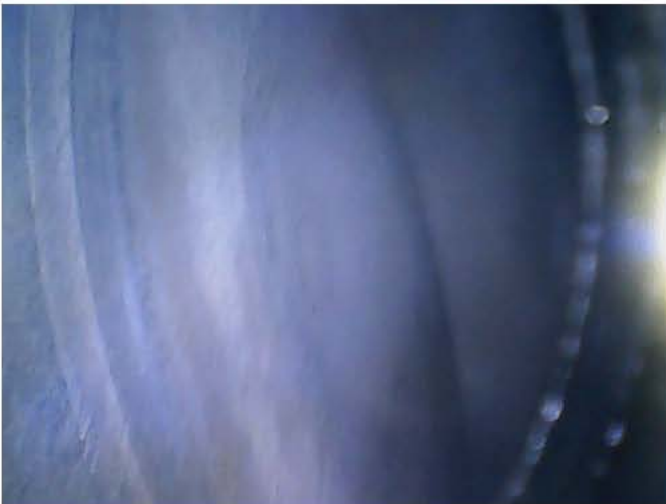
### CYLINDER #2

Condition: The cylinder remained attached to the crankcase with no external signs of operational distress. The rocker cover was removed from the cylinder and the rockers were intact and well lubricated. The valve springs were intact and showed no signs of operational distress. The internal cylinder components were examined with a lighted borescope and no pre-accident anomalies or signs of operational distress were noted. Thumb compression was obtained during crankshaft rotation and valve operation was confirmed during the compression test.

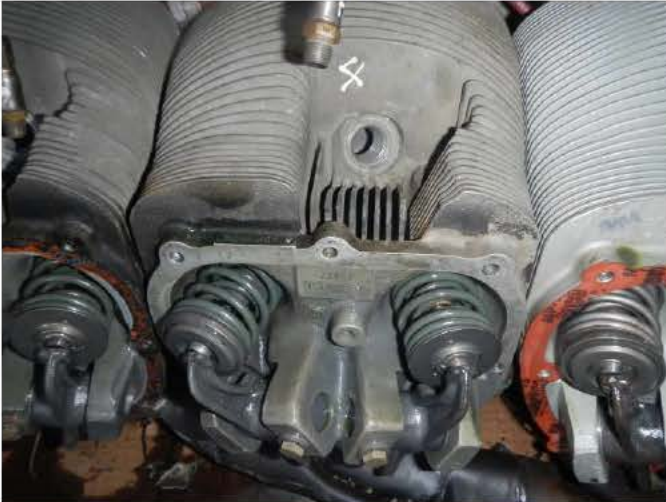
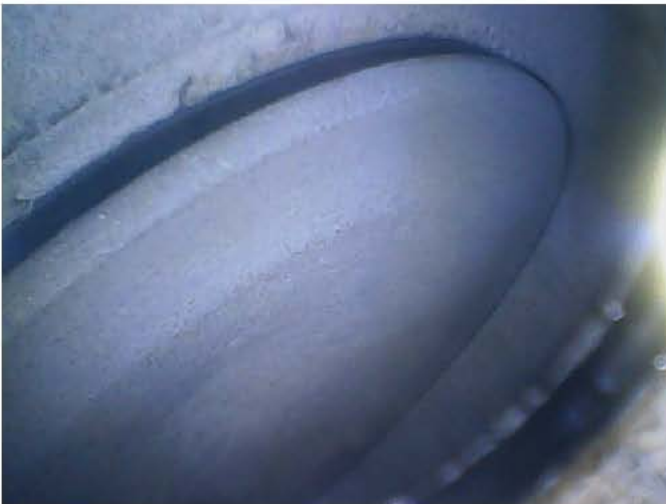
### CYLINDER #4

Condition: The cylinder remained attached to the crankcase with no external signs of operational distress. The rocker cover was removed from the cylinder and the rockers were intact and well lubricated. The valve springs were intact and showed no signs of operational distress. The internal cylinder components were examined with a lighted borescope and no pre-accident anomalies or signs of operational distress were noted. Thumb compression was obtained during crankshaft rotation and valve operation was confirmed during the compression test.

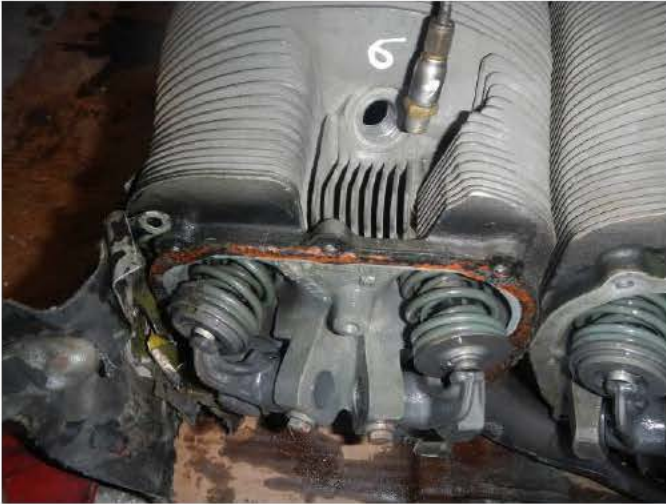
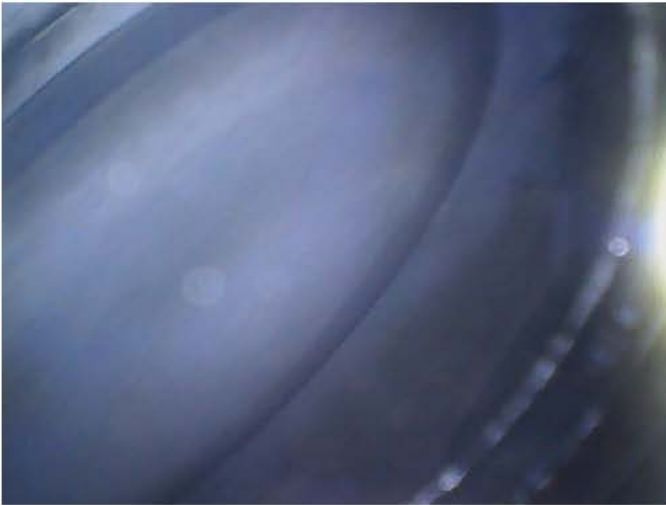
### CYLINDER #6

Condition: The cylinder remained attached to the crankcase with no external signs of operational distress. The rocker cover was fractured on the bottom side. It was removed from the cylinder and the rockers were intact and well lubricated. The valve springs were intact and showed no signs of operational distress. The internal cylinder components were examined with a lighted borescope and no pre-accident anomalies or signs of operational distress were noted. Thumb compression was obtained during crankshaft rotation and valve operation was confirmed during the compression test.

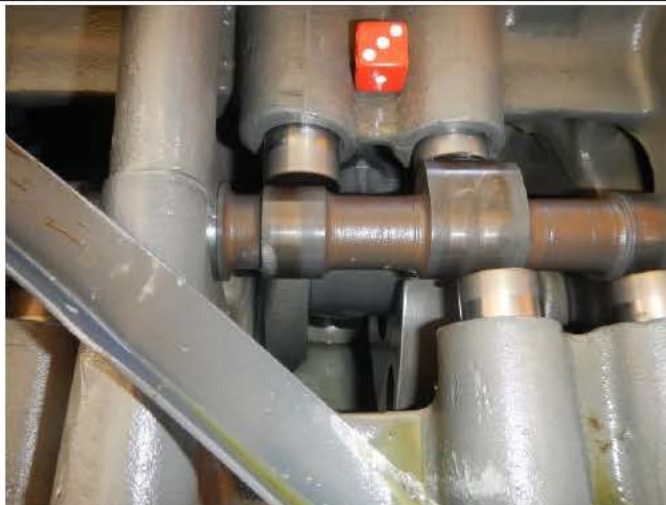
### #3 CONNECTING ROD

The connecting rod was viewed when the oil pan was removed from the engine crankcase. The connecting rod remained attached to both the crankshaft and piston pin with no signs of operational distress noted.

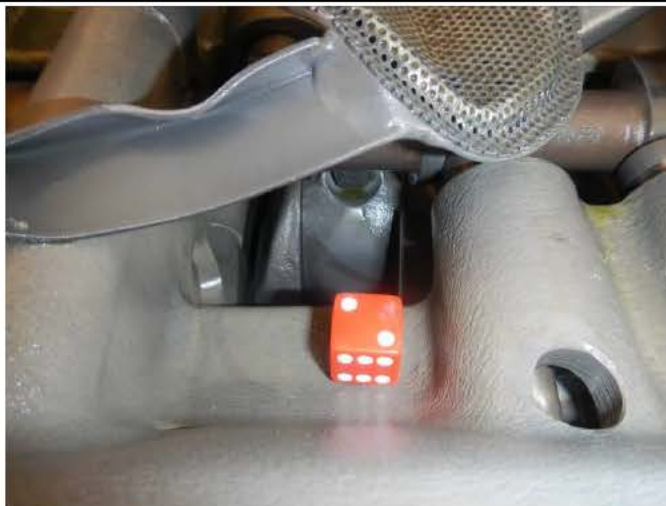
### #2 CONNECTING ROD

The connecting rod was viewed when the oil pan was removed from the engine crankcase. The connecting rod remained attached to both the crankshaft and piston pin with no signs of operational distress noted.

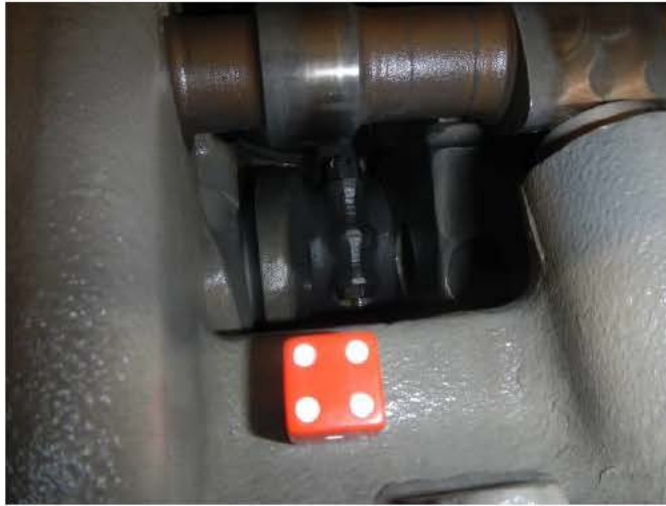
The connecting rod was viewed when the oil pan was removed from the engine crankcase. The connecting rod remained attached to both the crankshaft and piston pin with no signs of operational distress noted.

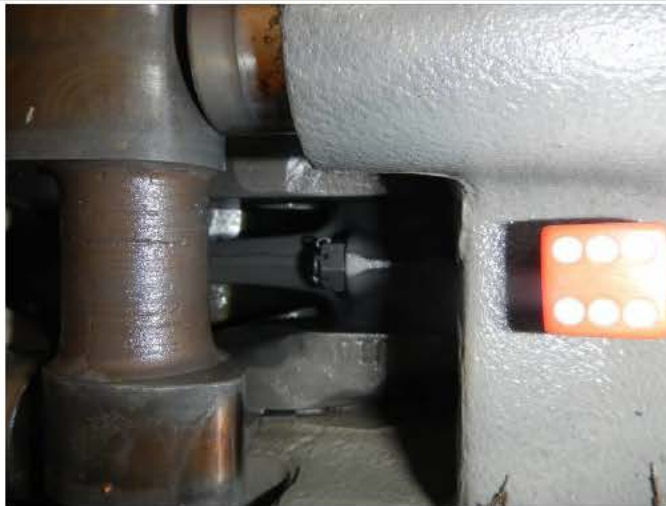
The connecting rod was viewed when the oil pan was removed from the engine crankcase. The connecting rod remained attached to both the crankshaft and piston pin with no signs of operational distress noted.

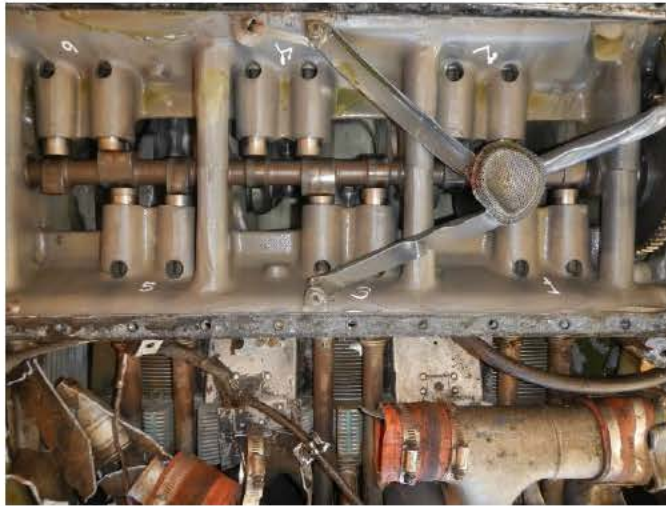
**Condition:** The camshaft remained intact from the accessory end to the governor drive gear, though the latter was bent aft on the bottom side. The lifters remained in place and all appeared well lubricated with no signs of pre-accident anomalies besides light surface corrosion on the side walls. Camshaft continuity was confirmed during a compression test with continuity confirmed from the camshaft, through the lifters, pushrods, rockers and valves.

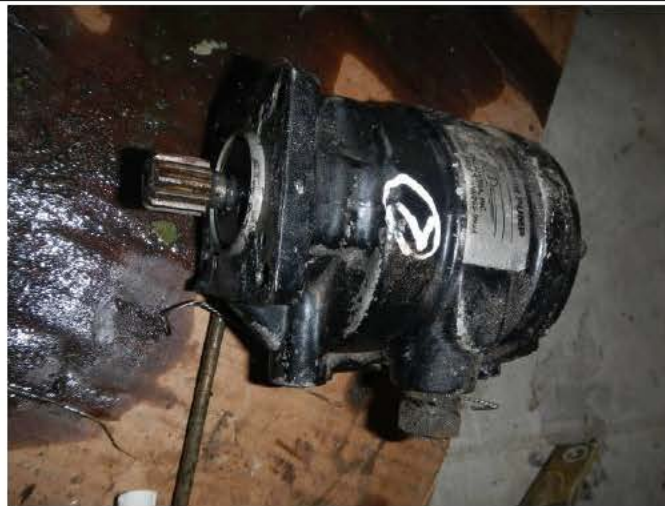
| <b>VACUUM PUMP</b> | Manufacturer: Aircraft Accessories | P/N: G455 | S/N: 73486 |

| Condition: | The vacuum pump remained attached to the backside of the engine. Removal of the vacuum pump and manual rotation of the drive shaft resulted in free rotation of the vacuum pump. | | |

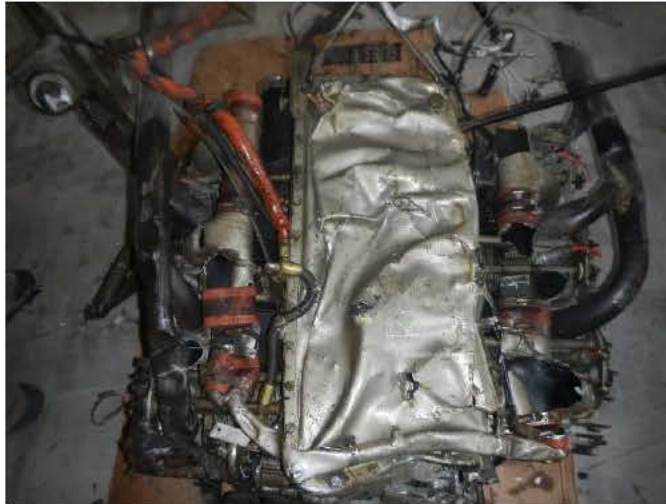
#### EXHAUST SYSTEM

Condition: The exhaust system remained attached to the engine via the exhaust risers but the exhaust pipes were flattened and the left side sustained deformation damage.

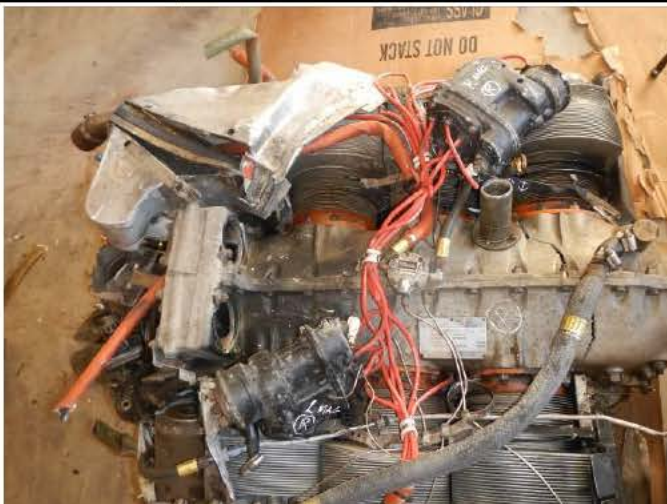
#### INDUCTION SYSTEM

Condition: The induction air box remained attached to the engine but it sustained deformation damage to it and the air filter. The air box was displaced from the throttle body and the throttle body was fractured as were many of the intake tubes and risers. The balance tube was flattened.

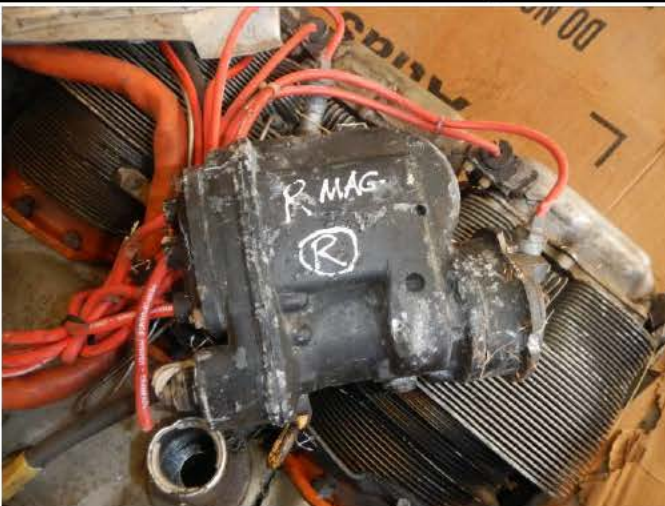
The left magneto was separated from its mounting pad and its flange was fractured in the area of the securing hardware. The ignition harness remained attached to the magneto but the harness cap sustained impact damage that deformed a few of the terminal towers. The top sparkplugs were inserted in the undamaged ignition terminals and the damaged terminal leads were cut to remove any impact-related shorts. The magneto's drive shaft was manually rotated and the impulse coupling made an audible snap with a corresponding spark from all of the sparkplugs or cut ignition leads, with exception of one that sustained the deformation damage. The ignition harness was removed and a piece of wire was inserted in the distributor tower and the drive shaft was again rotated. A spark was obtained from the damaged tower. No pre-accident anomalies were noted with the magneto.

**NOTE:** the left and right magnetos were mislabeled during the examination.

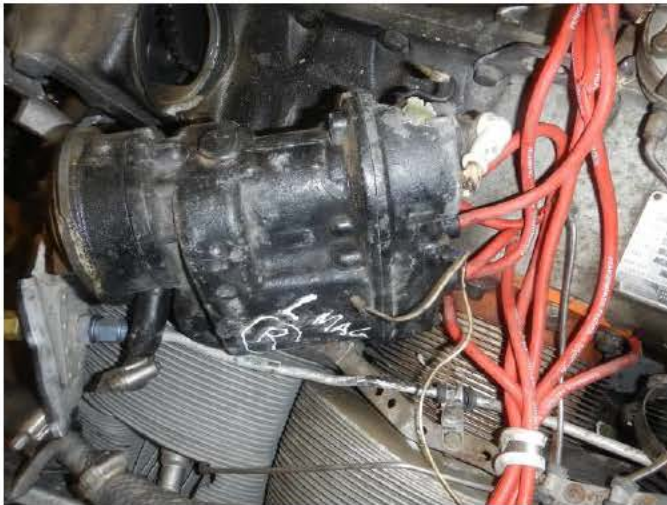
The right magneto was separated from its mounting pad and its flange was fractured in the area of the securing hardware. The housing also sustained fracture damage in the area of the contact points. The coil lead flag terminal was separated from the contact point tab. The ignition harness remained secured to the magneto. The top sparkplugs were inserted in the undamaged ignition terminals and the damaged terminal leads were cut to remove any impact-related shorts. The separated flag terminal was reinstalled on its tab. The magneto's drive shaft was manually rotated and the impulse coupling made an audible snap with a corresponding spark from all of the sparkplugs or cut ignition leads. No pre-accident anomalies were noted with the magneto.

**NOTE:** the left and right magnetos were mislabeled during the examination.

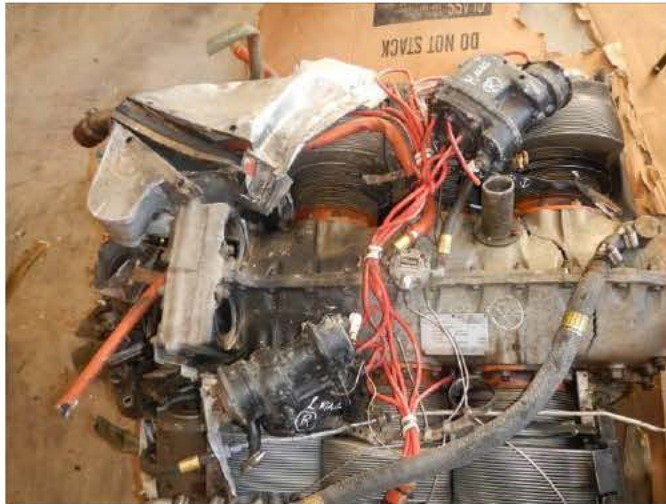
The ignition harness remained attached to the magnetos though the left harness cap sustained impact-related damage that impinged upon the distributor block. Some of the ignition leads sustained impact-related pinching damage. The damaged leads were cut to remove shorted areas and the harness was tested with each lead, but one, producing a spark during the magneto test.

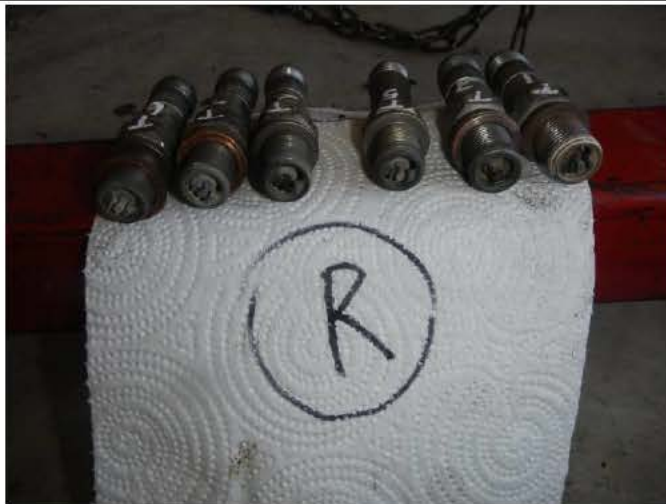
**SPARK  
PLUGS**Manufacturer: Combination  
of Unison Autolite and  
Champion

The sparkplugs remained secured to their respective cylinders and the ignition leads remained attached to the sparkplugs via their terminal ends. The top sparkplugs were removed from the cylinders. The sparkplugs displayed a normal worn condition and all six sparkplugs displayed normal combustion deposits with no signs of lead or carbon fouling.

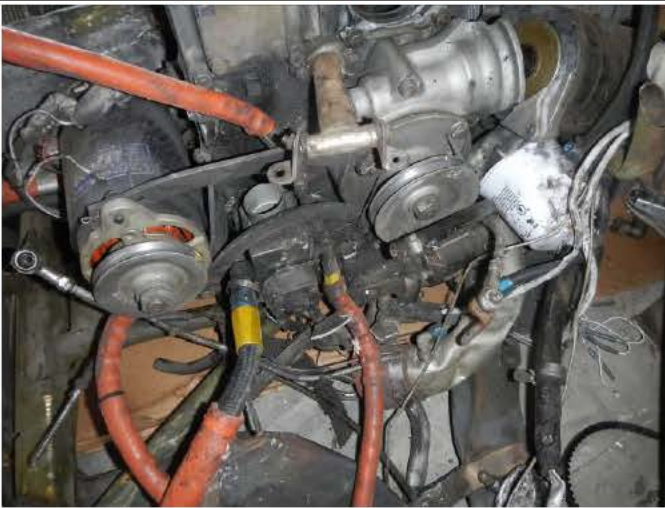
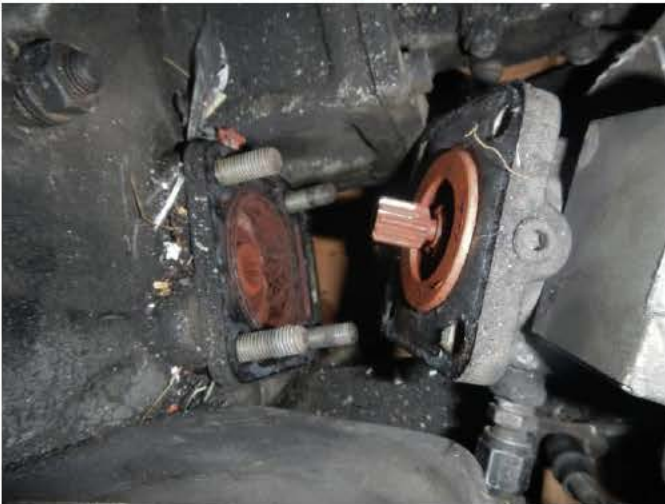
S/N: C127338RA

Condition: The engine-driven fuel pump remained attached to the backside of the engine and the fuel lines to and from the pump remained attached. The pump's low pressure release valve was slightly displaced. The adjustment screw was completely threaded into the cap. Manual rotation of the intact drive coupling resulted in a free and unbound rotation of the drive shaft. Manipulation of the fuel pump resulted in residual fuel pouring from the pump fittings. The fuel pump was disassembled and no obstructions or blockages were noted and the pump vanes were intact with no pre-accident anomalies noted.

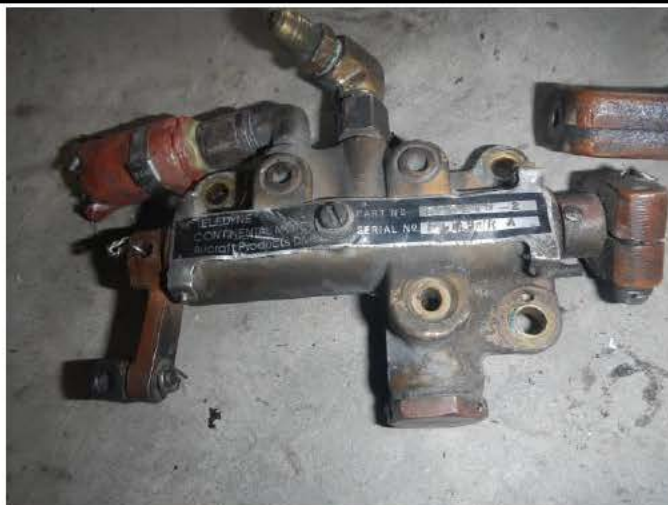
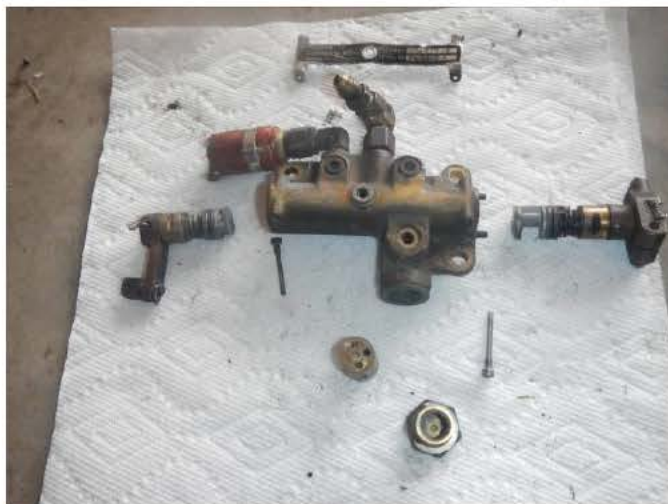
The throttle body remained attached to the backside of the engine, but the bottom wye was fractured. The mixture lever was cut by recovery personnel, but the portion that remained attached to the shaft was secured. The throttle cable and lever remained secured. The fuel metering unit's fuel inlet fitting was fractured. The inlet fuel screen was removed and no obstructions were noted. The fuel metering unit was disassembled with no pre-accident anomalies noted.

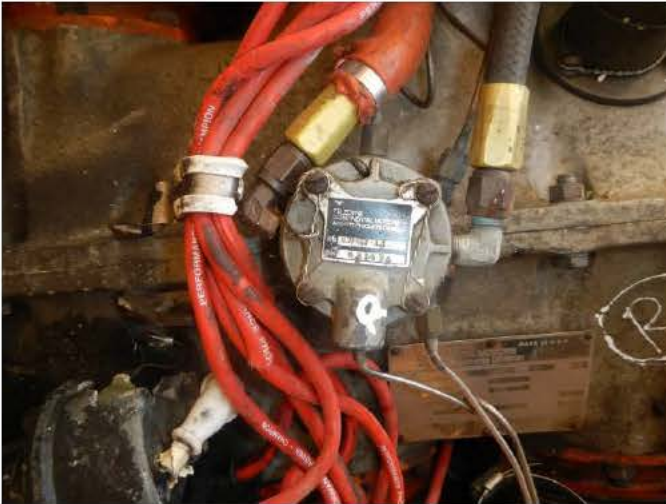
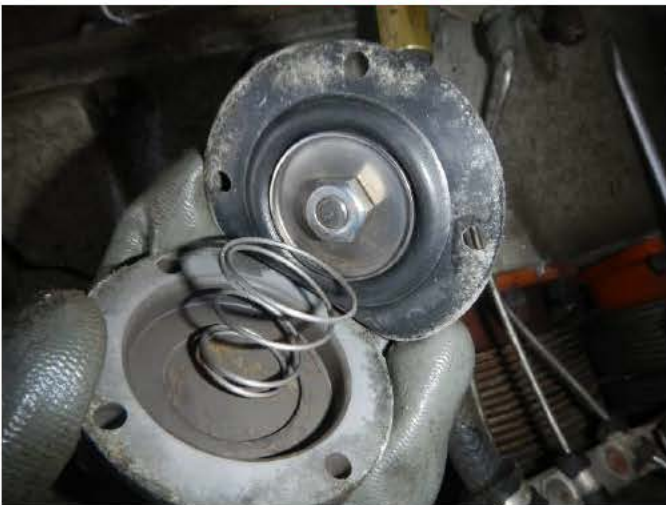
The fuel manifold valve remained attached to the engine. The #1 and #2 fuel injection line fittings and the fuel inlet fitting were fractured at the housing. The manifold valve was disassembled and the plunger remained attached to the diaphragm and the screen was clean and unobstructed.
