# Continental Motors

## ENGINE FIELD INSPECTION REPORT

| ENGINE MODEL | IO-470-L21A |
| FILE NUMBER | 16-180 |

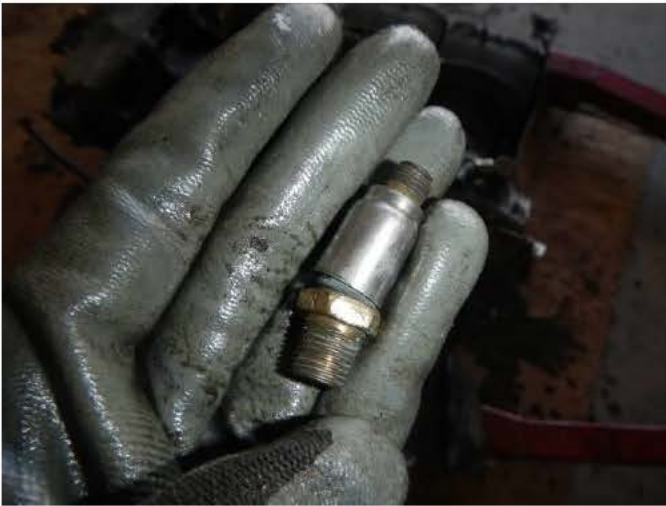
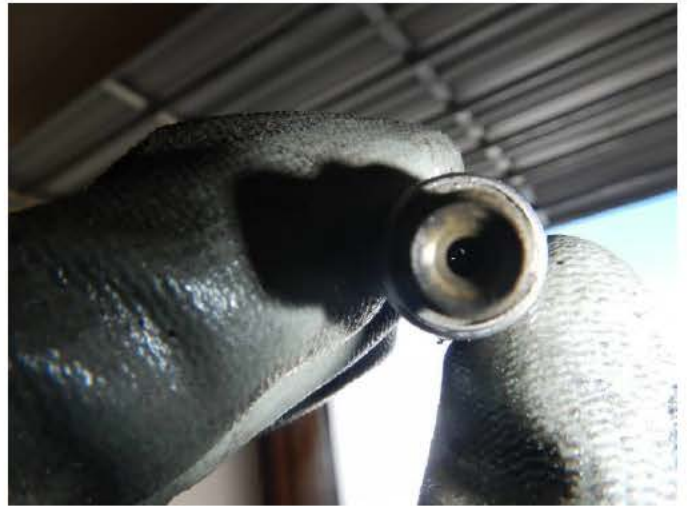
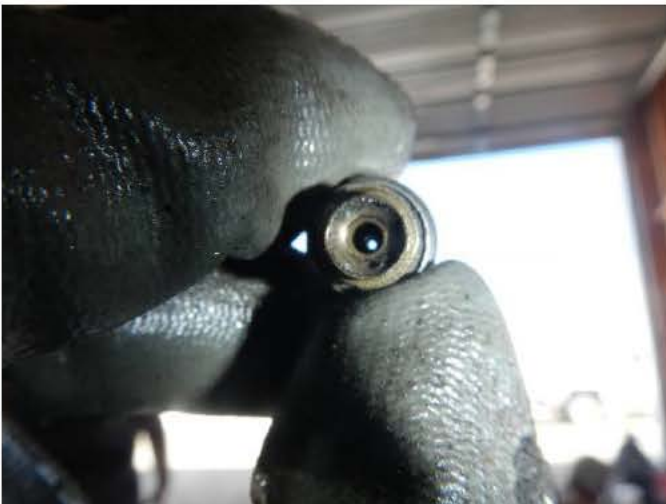
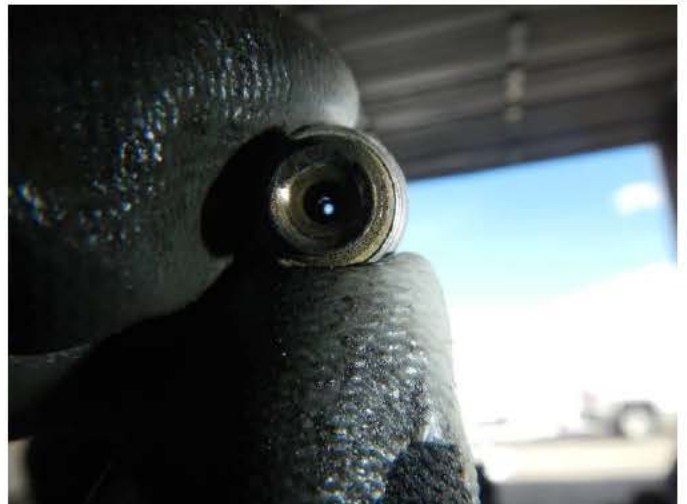
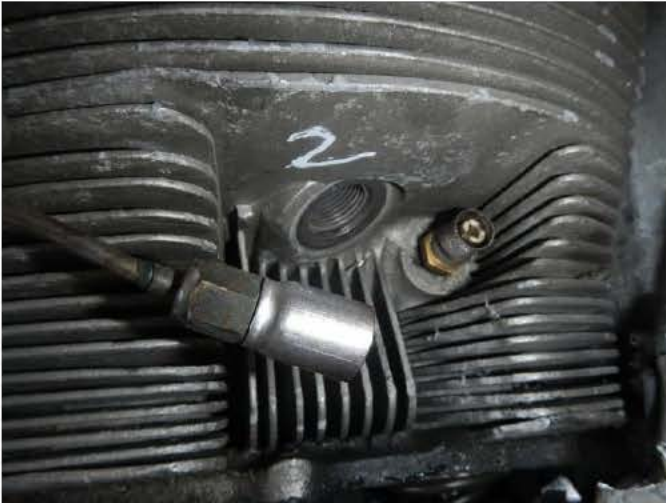
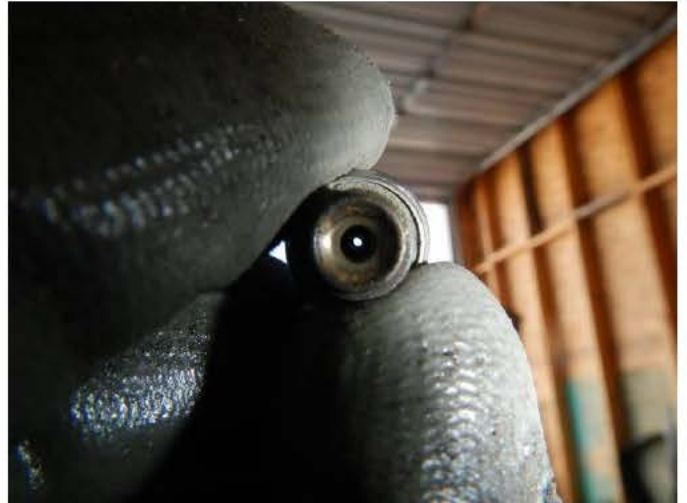
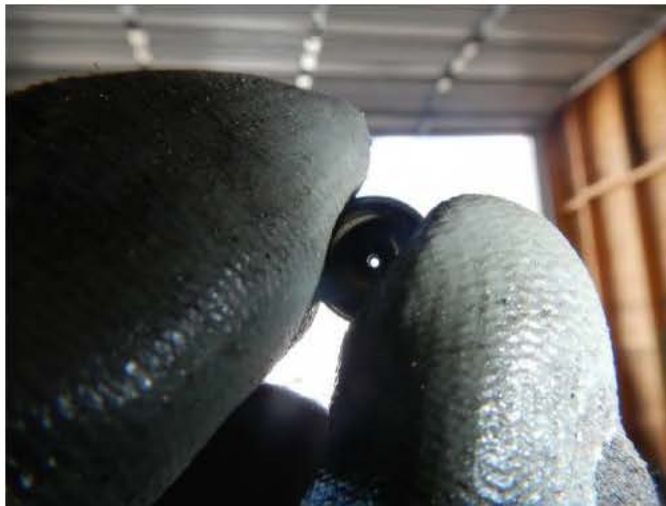
The #1 and #2 fuel injector lines were separated from the manifold, but the lines remained attached to the fuel nozzles and all of the nozzles remained attached to their respective cylinders, with the exception of the #2, which was fractured. The #1 nozzle was bent. The nozzles were removed and examined, with the exception of the #2. The nozzles were clear with no signs of lead fouling or obstruction noted.

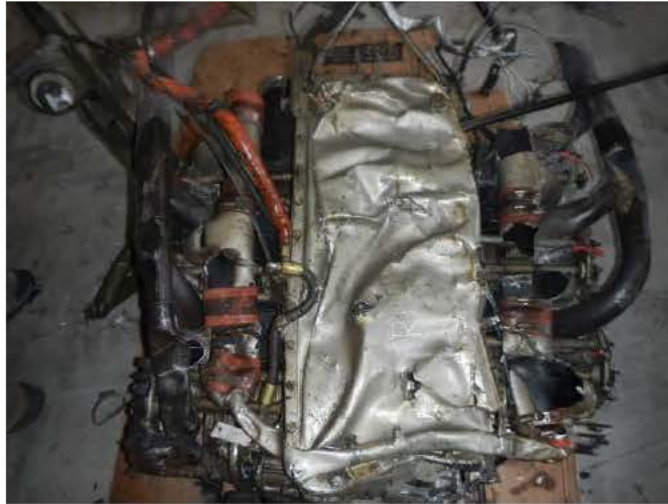
#### OIL SUMP

Condition: The oil sump remained attached to the bottom side of the engine. It was displaced upward, flattened, and punctured. The oil sump was removed and no pre-accident anomalies were noted.

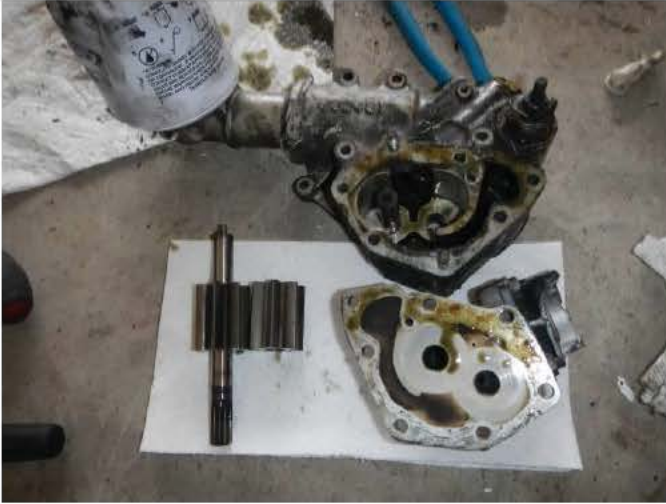
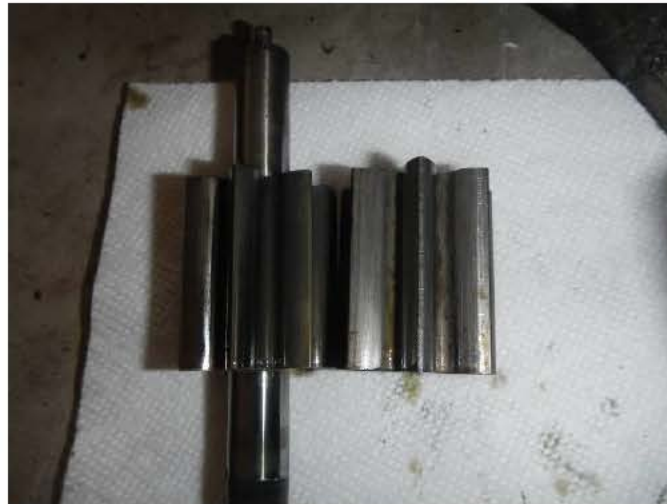
The oil pump remained attached to the backside of the engine. The pump was removed and examined. Oil coated all of the components. Surface corrosion was noted on the pump gears. Slivers of metal consistent with fresh shavings from the internal pump walls was observed on the gears. There were no signs of operational distress noted with the pump gears or housing.

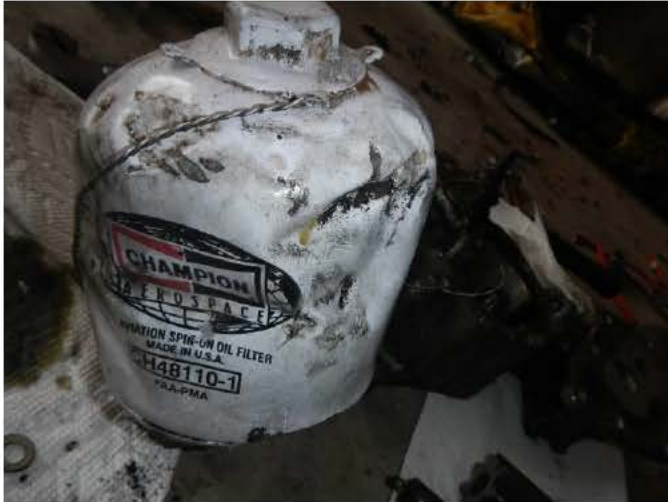
The oil filter remained attached to the oil filter adapter but it sustained deformation damage. The filter remained safety wired to the adapter. There was no sign of pre-existing leaks or anomalies.

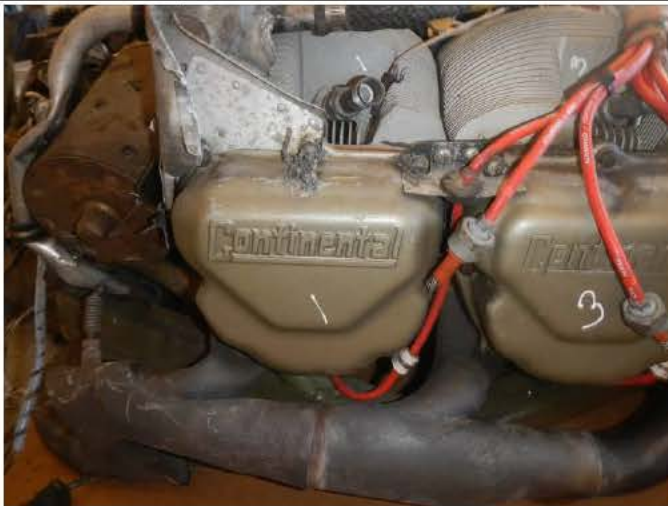
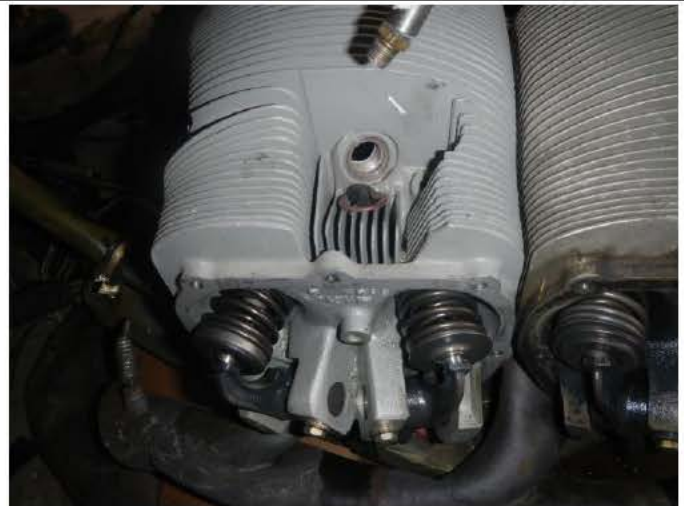
The cylinder remained attached to the crankcase with no external signs of operational distress. The rocker cover was removed from the cylinder and the rockers were intact and well lubricated. The valve springs were intact and showed no signs of operational distress. The internal cylinder components were examined with a lighted borescope and no pre-accident anomalies or signs of operational distress were noted.

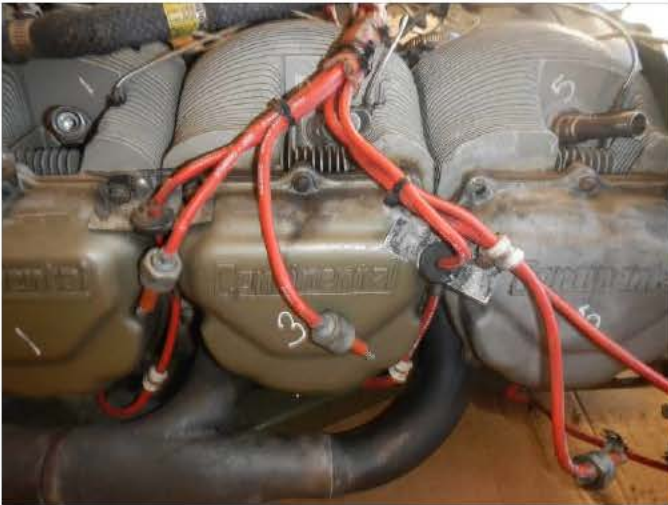
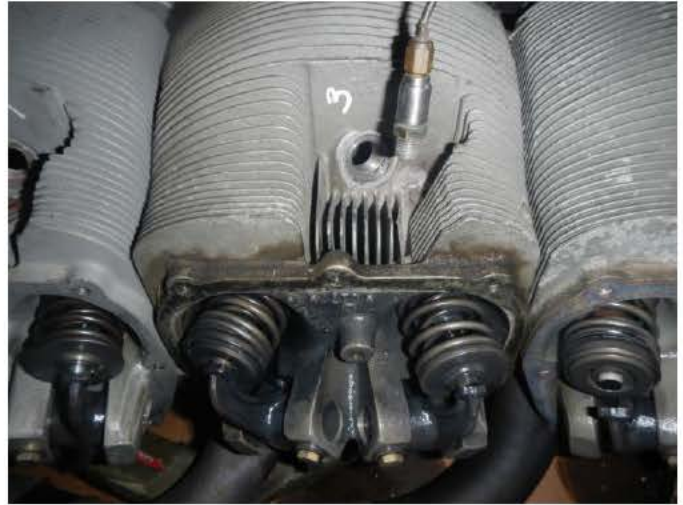
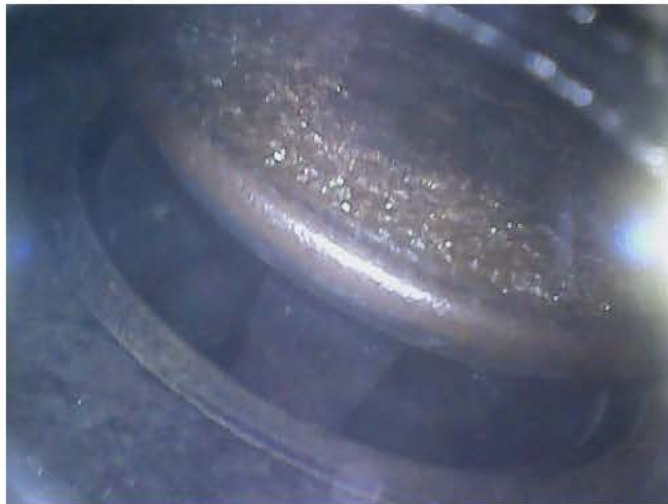
Condition: The cylinder remained attached to the crankcase with no external signs of operational distress. The rocker cover was removed from the cylinder and the rockers were intact and well lubricated. The valve springs were intact and showed no signs of operational distress. The internal cylinder components were examined with a lighted borescope and no pre-accident anomalies or signs of operational distress were noted.

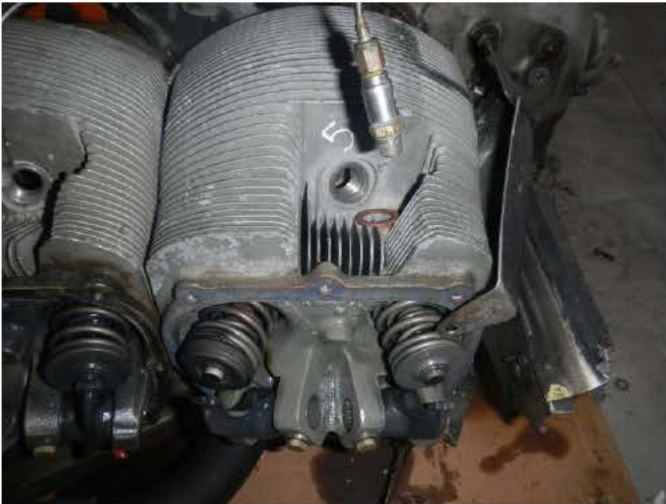
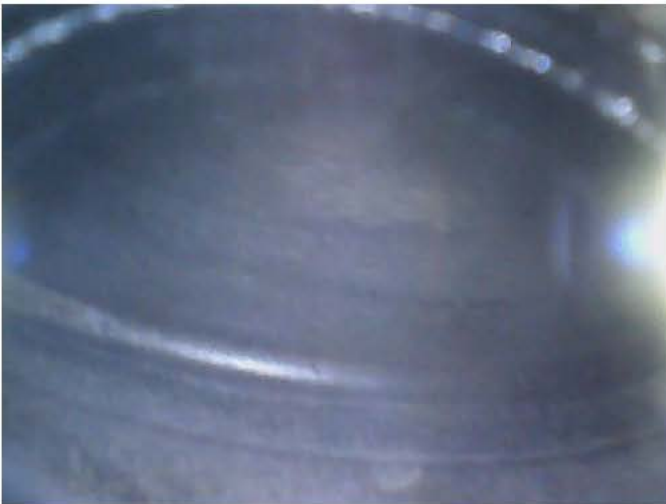
### CYLINDER #5

Condition: The cylinder remained attached to the crankcase with no external signs of operational distress. The crankcase was fractured just forward of the #5 cylinder. The rocker cover was removed from the cylinder and the rockers were intact and well lubricated. The valve springs were intact and showed no signs of operational distress. The internal cylinder components were examined with a lighted borescope and no pre-accident anomalies or signs of operational distress were noted.

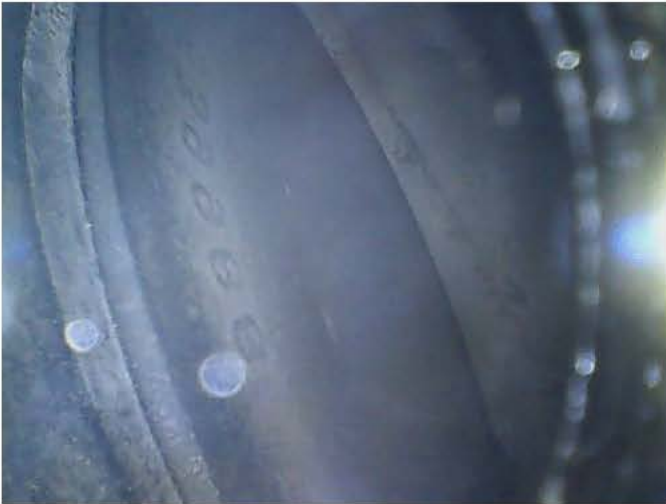
## CYLINDER #2

Condition: The cylinder remained attached to the crankcase with no external signs of operational distress. The rocker cover was removed from the cylinder and the rockers were intact and well lubricated. The valve springs were intact and showed no signs of operational distress. The internal cylinder components were examined with a lighted borescope and no pre-accident anomalies or signs of operational distress were noted.

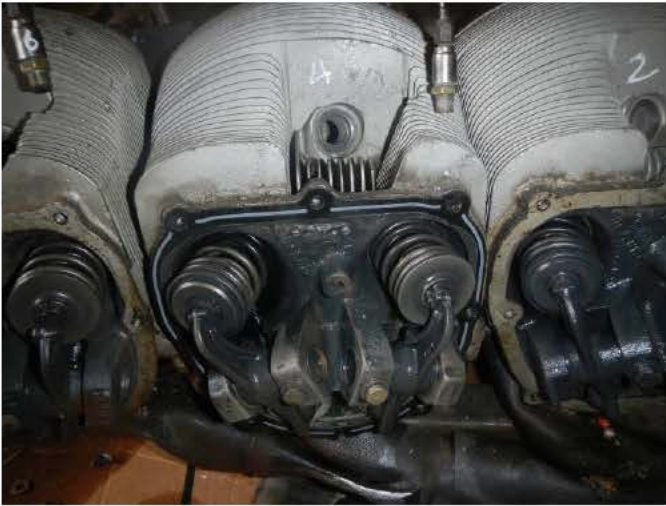
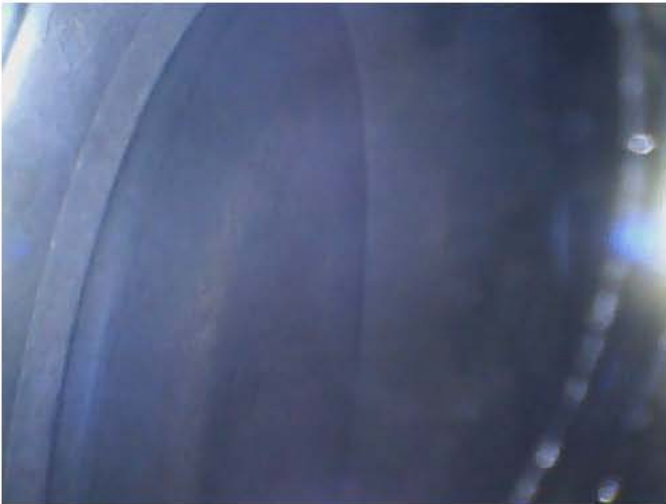
### CYLINDER #4

Condition: The cylinder remained attached to the crankcase with no external signs of operational distress. The rocker cover was removed from the cylinder and the rockers were intact and well lubricated. The valve springs were intact and showed no signs of operational distress. The internal cylinder components were examined with a lighted borescope and no pre-accident anomalies or signs of operational distress were noted.

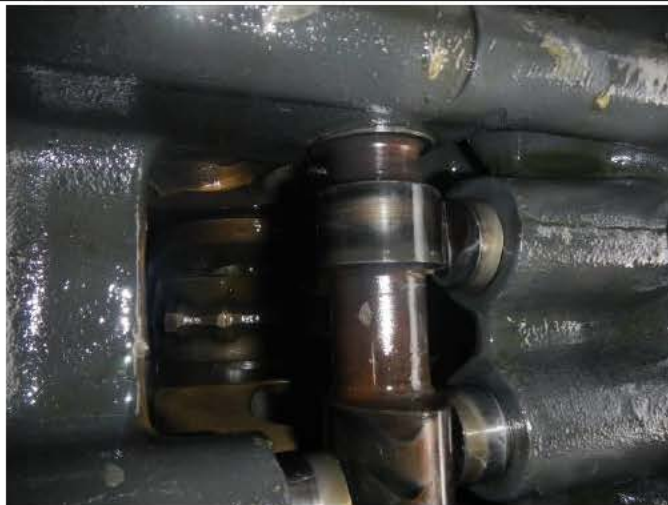
### #3 CONNECTING ROD

Condition: The connecting rod was viewed when the oil pan was removed from the engine crankcase. The connecting rod remained attached to both the crankshaft and piston pin with no signs of operational distress noted.

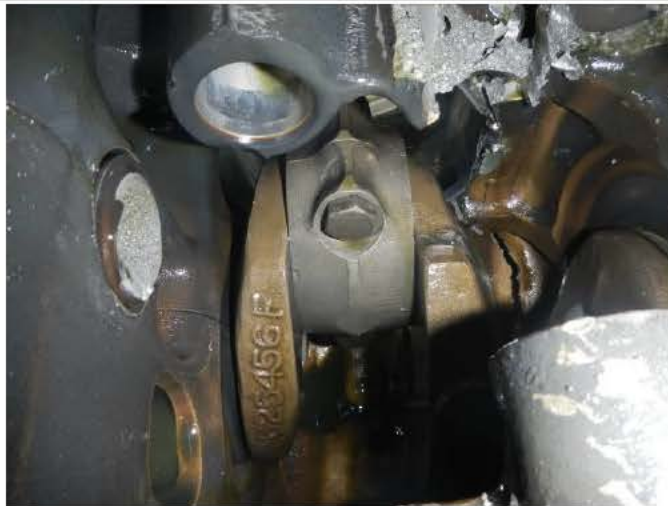
The connecting rod was viewed when the oil pan was removed from the engine crankcase. The connecting rod remained attached to both the crankshaft and piston pin with no signs of operational distress noted.

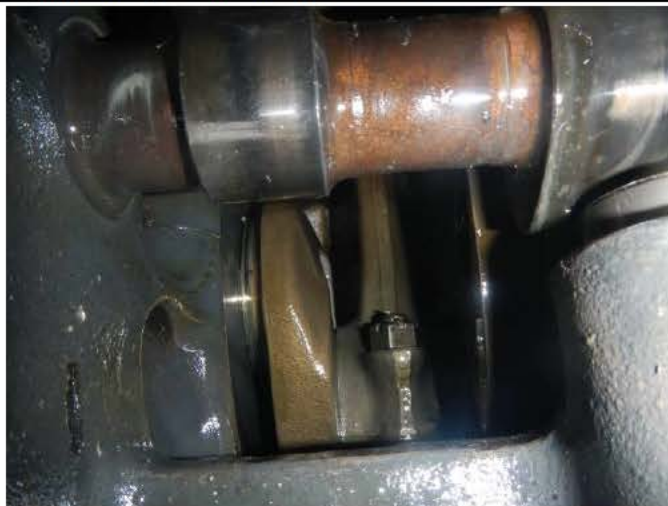
**#2 CONNECTING  
ROD**

The connecting rod was viewed when the oil pan was removed from the engine crankcase. The connecting rod remained attached to both the crankshaft and piston pin with no signs of operational distress noted.

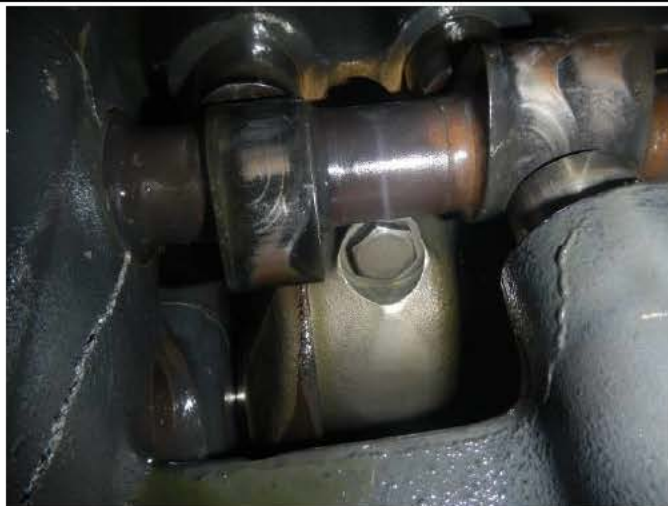
The connecting rod was viewed when the oil pan was removed from the engine crankcase. The connecting rod remained attached to both the crankshaft and piston pin with no signs of operational distress noted.

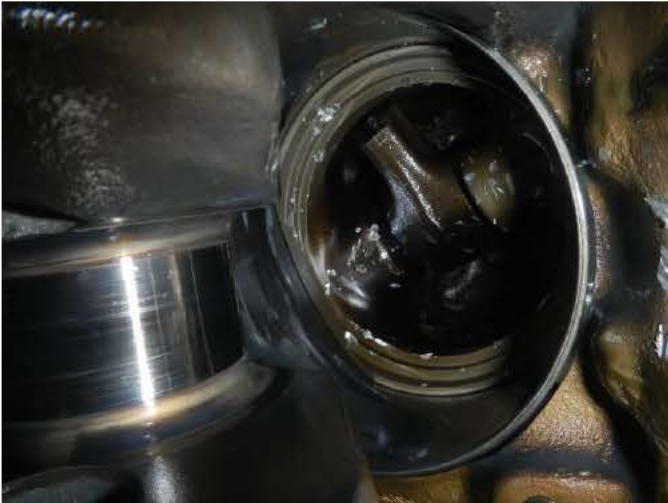
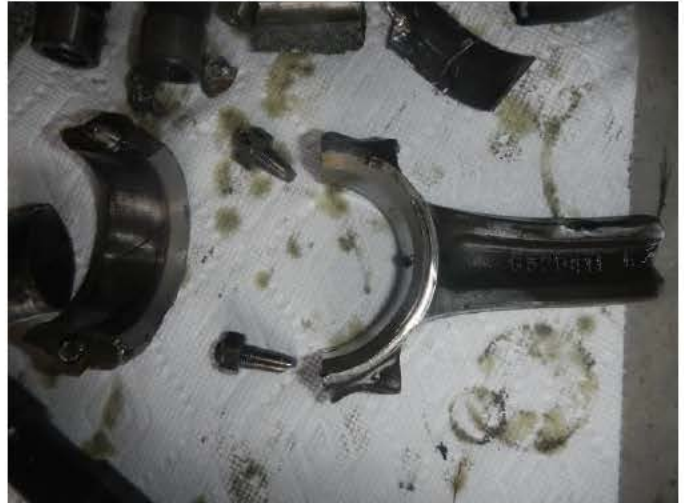
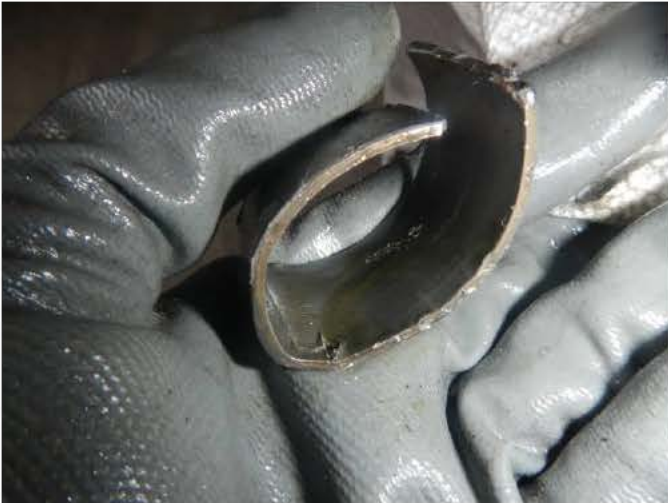
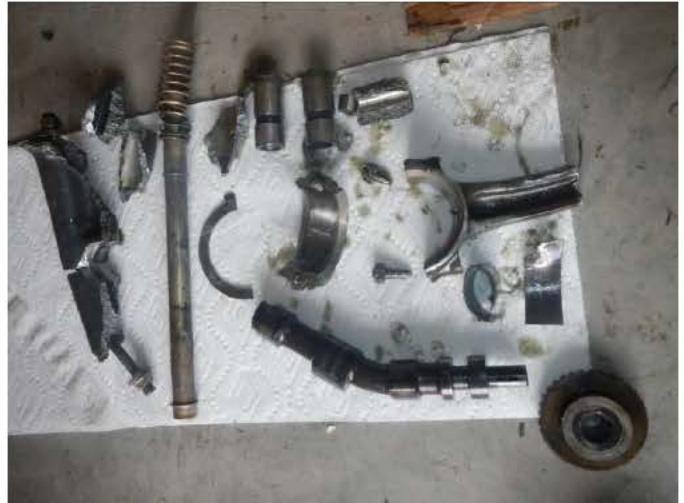
The #6 connecting rod was fractured into three pieces. The rod cap was displaced through the bottom of the engine and punctured the oil sump. The rod cap bolts were fractured with the bolts displaying notable necking deformation and irregular fracture surfaces. The bolt nuts remained threaded on the bolts with the cotter pin installed in each. The connecting rod i-beam was fractured approximately 2 inches from the piston pin. The fracture surfaces at the i-beam were smeared with stud a thread imprint noted on one of the fracture ends. The connecting rod was not discolored. The connecting rod bearings were found in the engine crankcase and they displayed deformation damage with no signs of pre-impact anomalies.

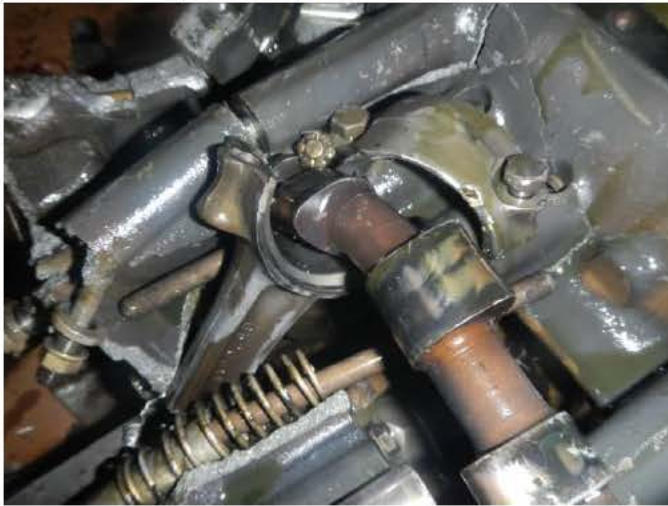
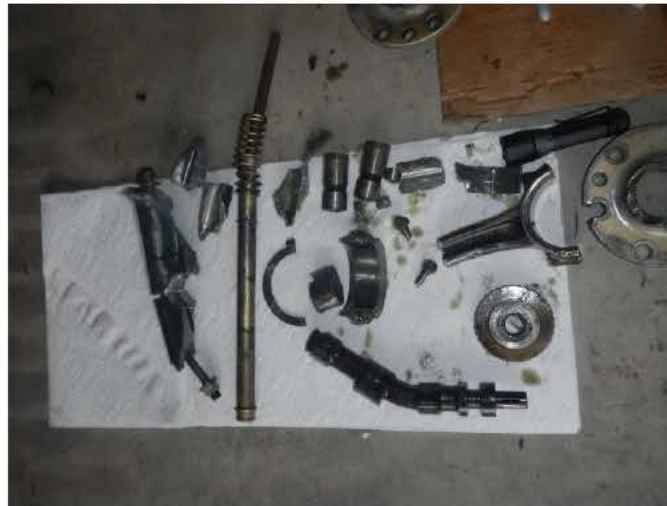
**PAGE 32 of 34****CAMSHAFT****CAMSHAFT**

**Condition:** The camshaft was bent between the #6 exhaust cam lobe and the #5 and #6 intake cam lobes. The camshaft was fractured aft of the #5 exhaust cam lobe and the fracture was irregular in shape. The #5 and #6 lifters were displaced from their normal positions and were found within the crankcase. There were no signs of pre-impact anomalies with the lifters or camshaft. The camshaft's governor drive gear was displaced from the end of the camshaft and was found in the crankcase.

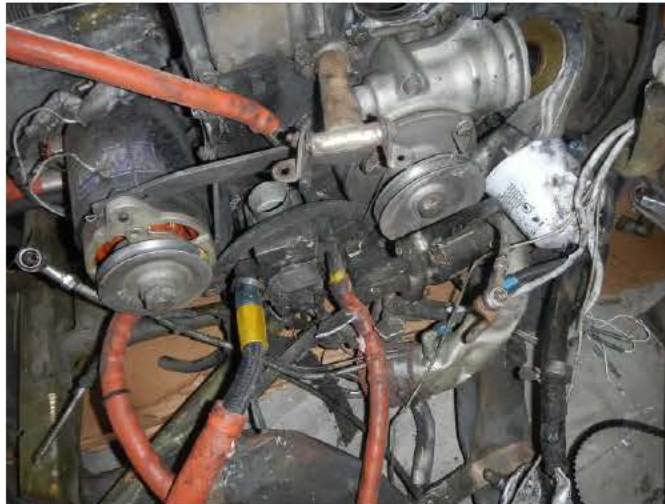
The starter adapter remained attached to the backside of the engine and its drive pulley was fractured.

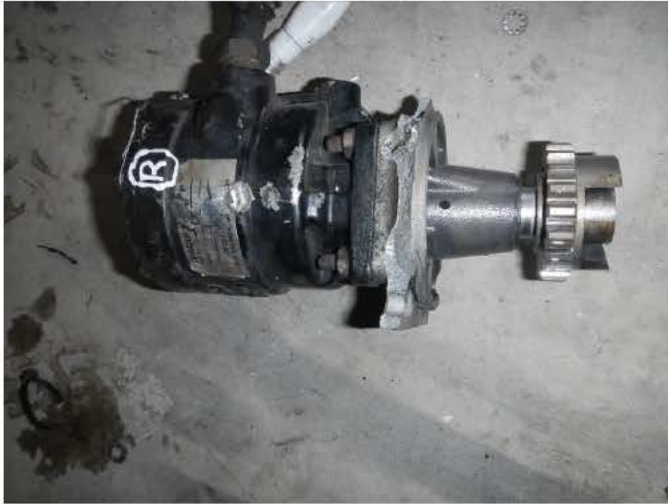
The vacuum pump remained attached to the mounting pad, but the pad was fractured. The drive gear remained attached to the vacuum pump with no anomalies noted with the gear or gear teeth. Manual manipulation of the drive gear did not result in rotation of the drive shaft. The pump was not disassembled.
