# NATIONAL TRANSPORTATION SAFETY BOARD

## MATERIALS LABORATORY FACTUAL REPORT

Report No. 17-035

Place : Gilbert, AZ  
Date : 9/17/2016  
Vehicle : Cessna 182P, N20844  
NTSB No. : WPR16FA183  
Investigator : Albert Nixon

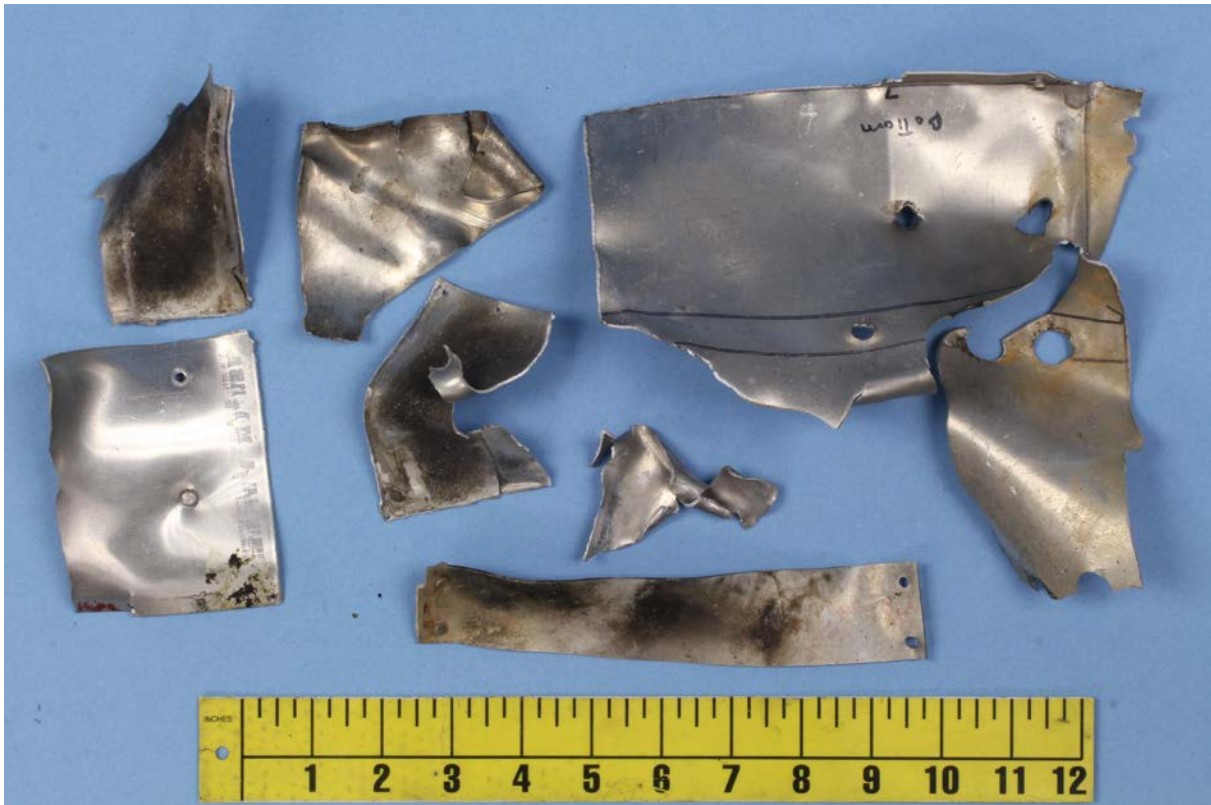
Eight portions of aluminum sheet metal were submitted for examination (figure 1).

Figure 1: Eight portions of aluminum sheet metal as received.

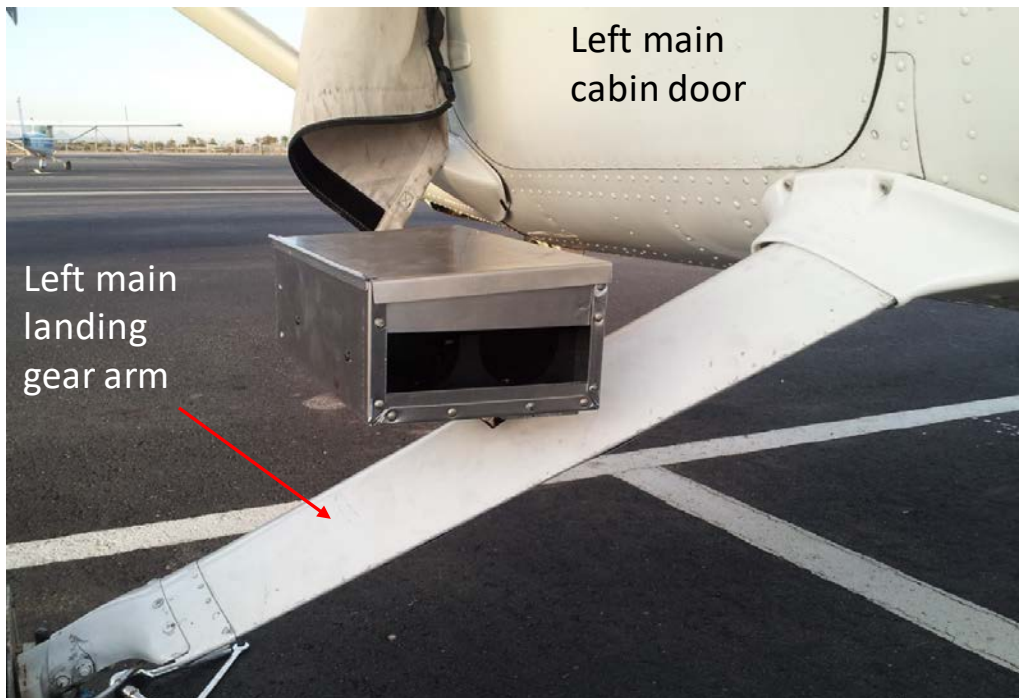
Figure 2: Pyrotechnics box as mounted on the left main landing gear arm.

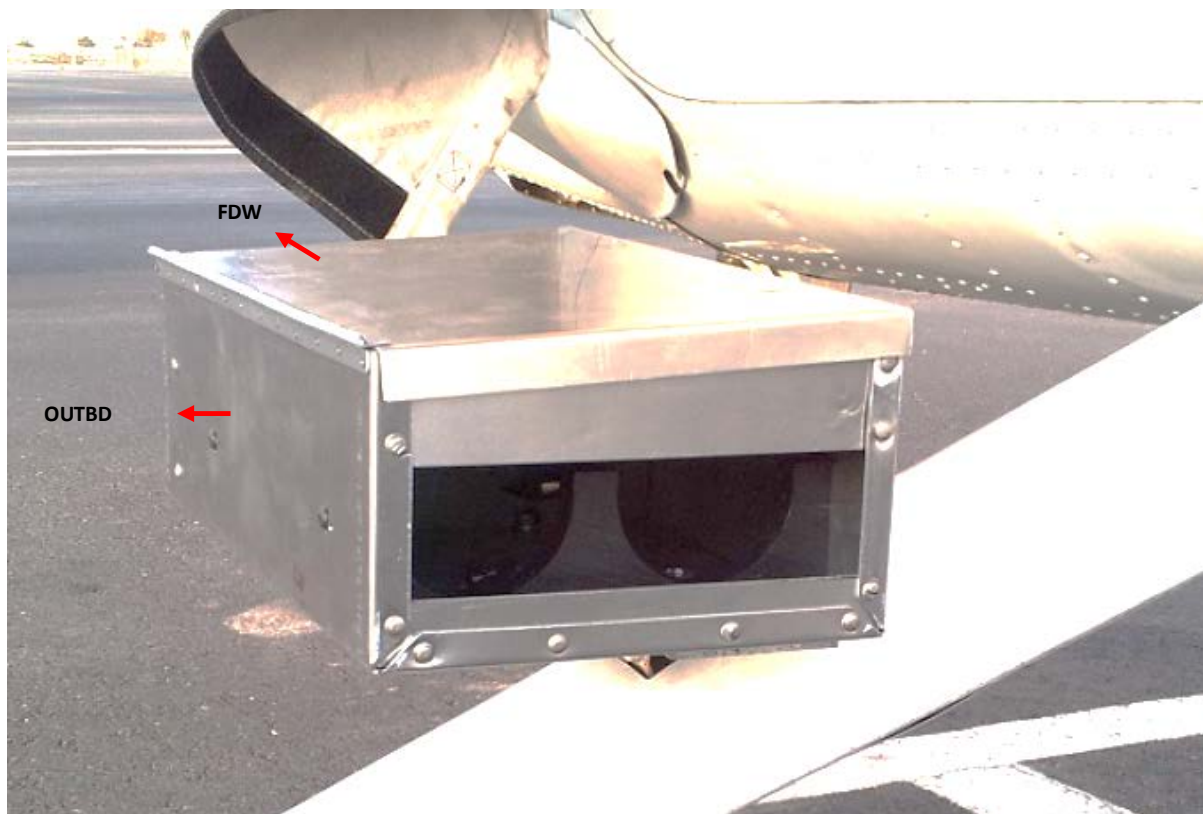
After examination of the recovered portions of the pyrotechnics box, and comparison with the photo in figure 3, their relative position with respect to each other is shown in figure 12. The red dotted line in figure 12 represents the bottom footprint of the pyrotechnics box. Portion #8 did not have any features from which to establish its position with respect to the other portions.

Figure 3: Magnified and brightened photo of the pyrotechnics box.

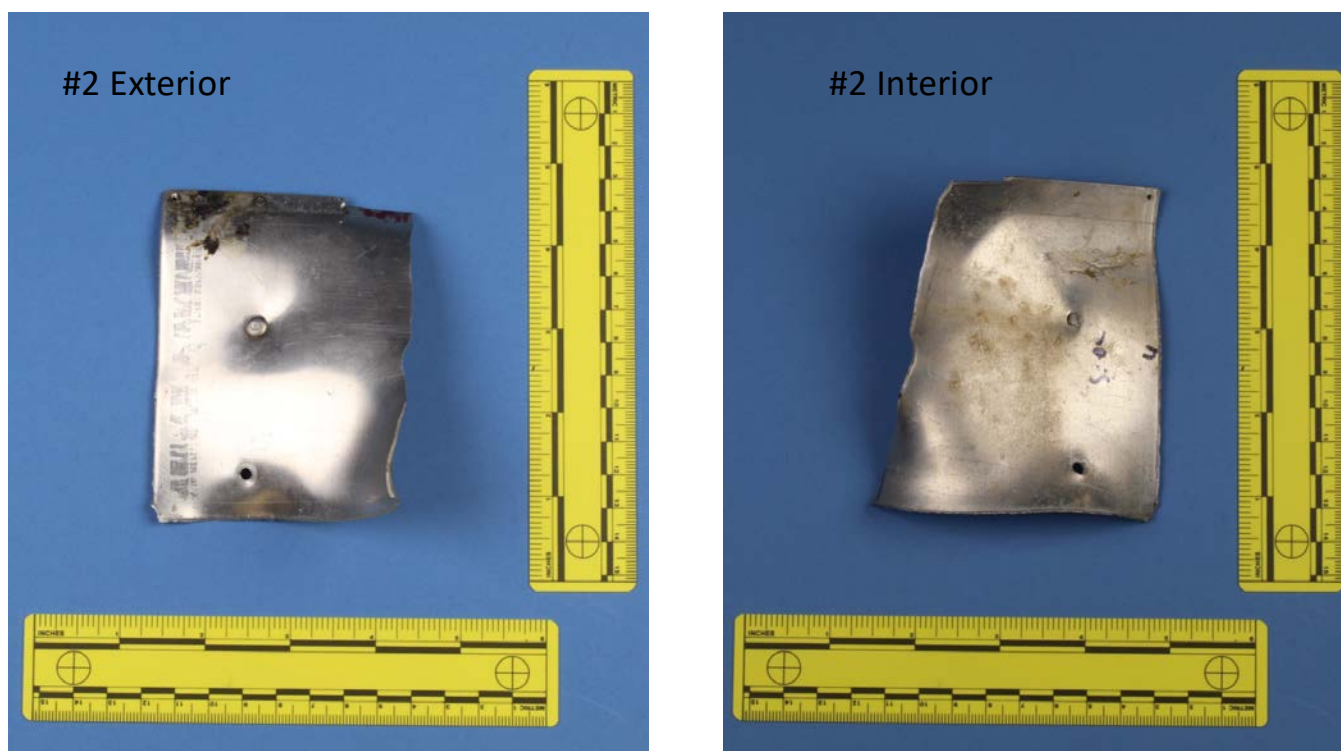
Figure 5: Portion #2 (both sides shown).

Portions #2, #4, #6 originated from the outboard side of the pyrotechnics box (Figure 13). The screw holes for the piano hinge are distributed along the top edge of these portions. Portion #2 had fractures on the sides along the fold lines of the box as well as a fracture separating it from portion #4 (the fractures in between portions #2 and #4 are not mating). The fractured edges between portions #2 and #4 are deformed in a direction suggesting the applied force originated from the inside of the box. Portion #4 exhibited a folded over edge resembling a folded leaf petal. This folded over edge feature is consistent with explosive damage. The screw holes on portion #4 were torn. Portion #6 exhibited fractures along the box fold lines. Portion #6 exhibited deformation consistent with the applied force originating on the inside of the box.

Portions #2 and #1 originated from the forward outboard corner of the pyrotechnics box (figure 15). These two portions separated from each other along the fold line. Both of these portions also exhibited fractures along the forward fold lines of the box.

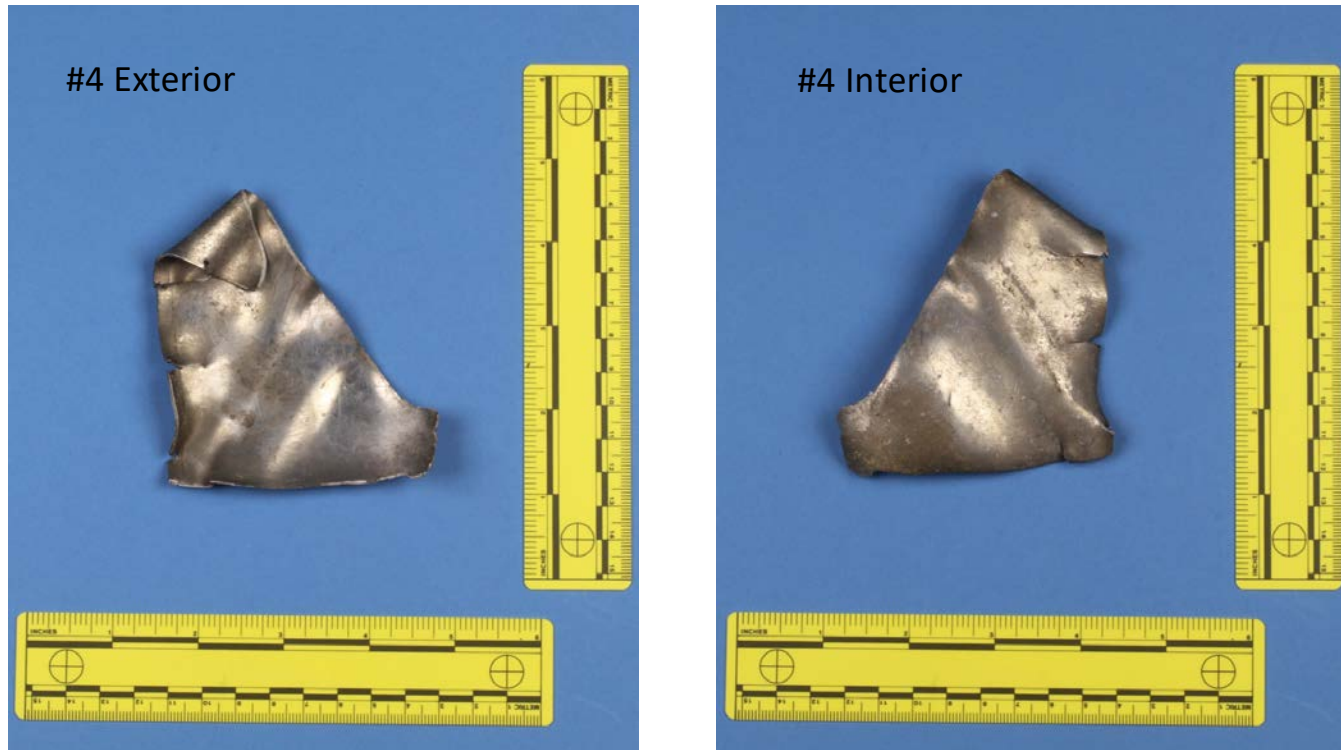
Figure 7: Portion #4 (both sides shown).

Portions #6, #5 and #7 all exhibited a blackened-sooty interior surface. Portion #4 did not exhibit this same level of staining but did exhibit a peppering of little craters on the surface of the interior side (figure 16). This evidence of cratering is consistent with high velocity particle impact associated with an explosion originating in the interior of the box. Similar cratering was observed on the interior sides of portions #5 and #6.

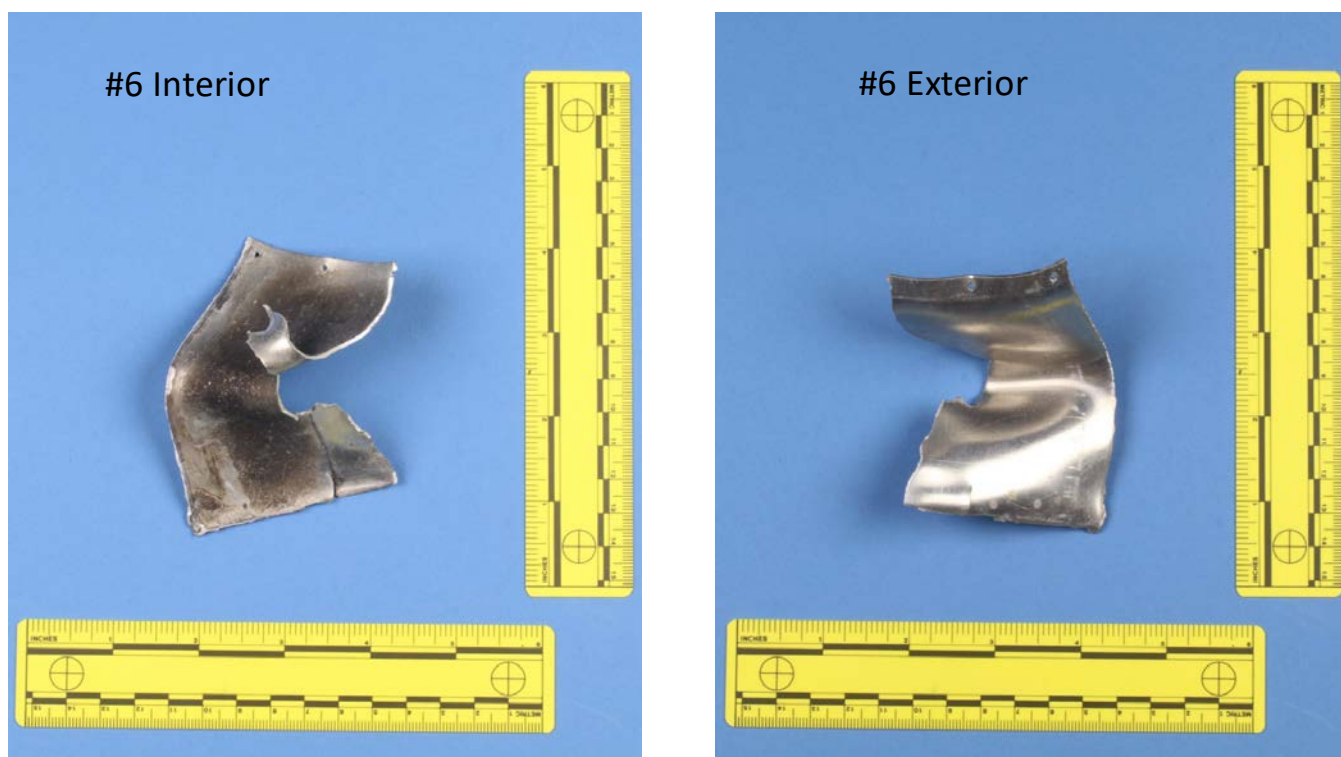
Figure 9: Portion #6 (both sides shown).

Portions #5 and #6 originated from the aft outboard corner of the pyrotechnics box (Figure 14). Both portions exhibited a blackened-sooted appearance on their inward facing surfaces. These two portions separated from each other along the fold line. Both of these portions also exhibited fractures along the aft fold lines of the box. There was a rivet hole in portion #6 that fractured and was deformed inward with the rest of portion #6 being deformed outward.
