# Continental Motors

## ENGINE FIELD INSPECTION REPORT

| ENGINE MODEL | TSIO-520-M |
| FILE NUMBER | 12-214 |

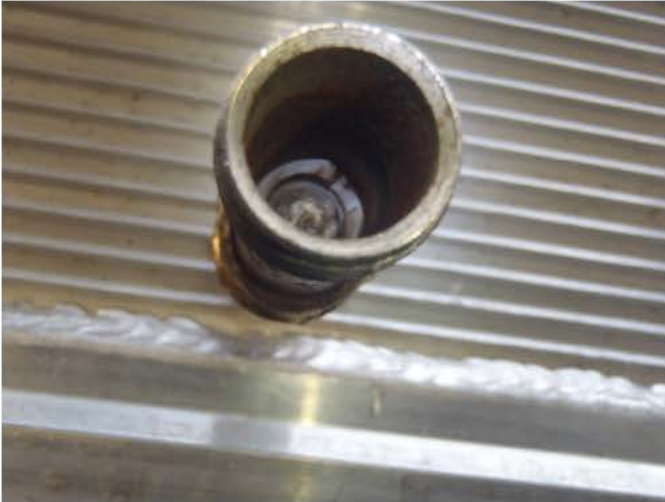
#2 Top Spark Plug

All of the spark plugs were secured to their cylinders and to their ignition leads. All of the spark plugs were removed for inspection and testing. It was noted that the #2 top spark plug insulator was broken inside the spark plug and the spark plug electrodes displayed a significant accumulation of combustion deposits. The inside of the #2 top spark plug and insulator displayed discoloration consistent with the ignition lead arcing to the inside of the spark plug. All of the other spark plugs displayed normal operating and wear signatures. All of the spark plugs were reattached to their ignition leads. During impulse coupling operation it was noted that the #2 top spark plug would not conduct a spark between the center and ground electrodes; all of the other spark plugs were capable of conducting a spark between the center and ground electrodes. There were no further anomalies noted.

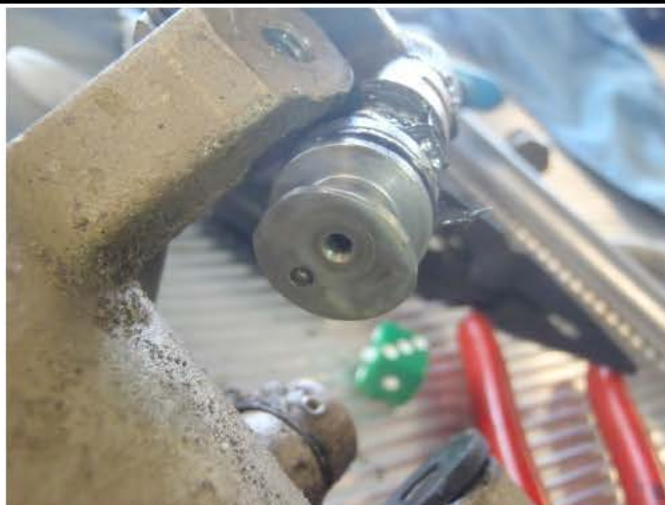
Throttle Fuel Control

The throttle and fuel metering assembly remained attached to its mounting location and displayed some impact damage signatures. Both of the control arms remained secured to their shafts and the control cable rod ends were secured to the control shafts. The throttle control rod end was bent at an approximate 45° angle; the damage was consistent with impact damage. The throttle and fuel metering assembly was removed and disassembled for a visual inspection. The internal components displayed normal operating signatures and the fuel inlet screen was clear of any contaminants. There were no anomalies noted with the throttle and fuel metering assembly.

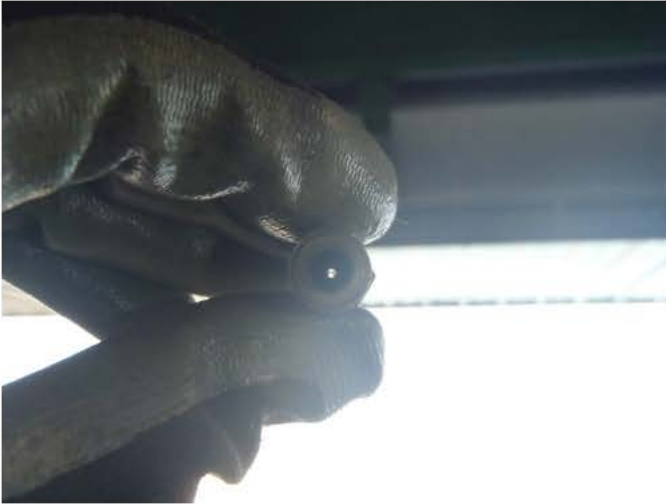
#1

| FUEL NOZZLES AND LINES | Manufacturer: CMI | | | | | |
|---|---|---|---|---|---|---|
| Condition: | All of the fuel nozzles remained installed in their cylinders and were undamaged. The fuel nozzles were removed and visually inspected; it was noted that the #6 fuel nozzle displayed a significant amount of oxidation on the outside of the nozzle. All of the nozzles were found to be clear of any blockages. | | | | | |

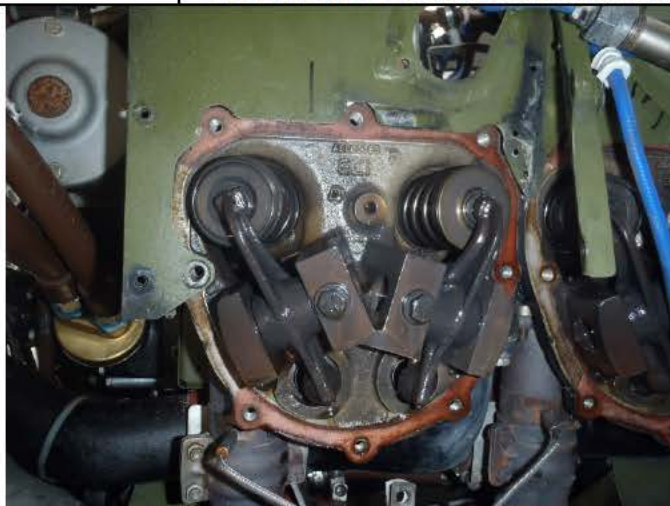
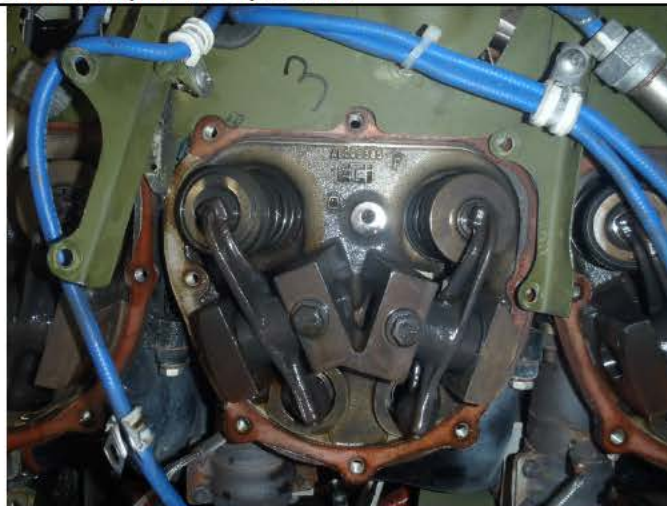
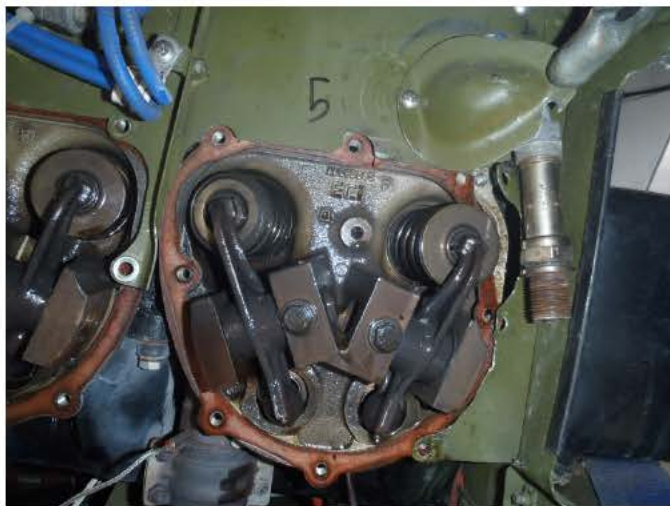
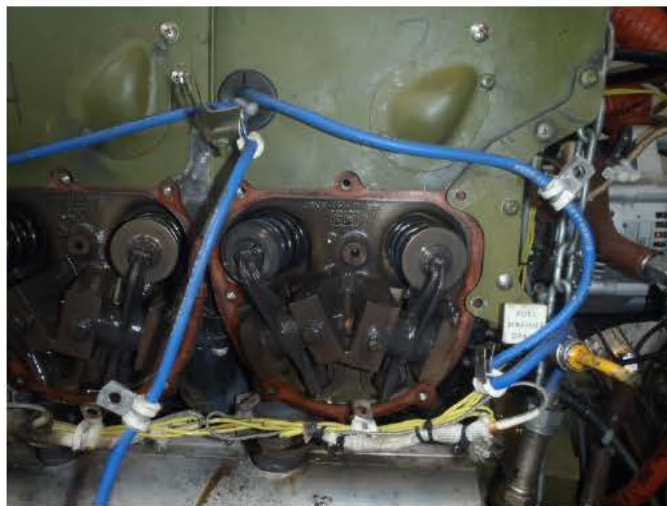
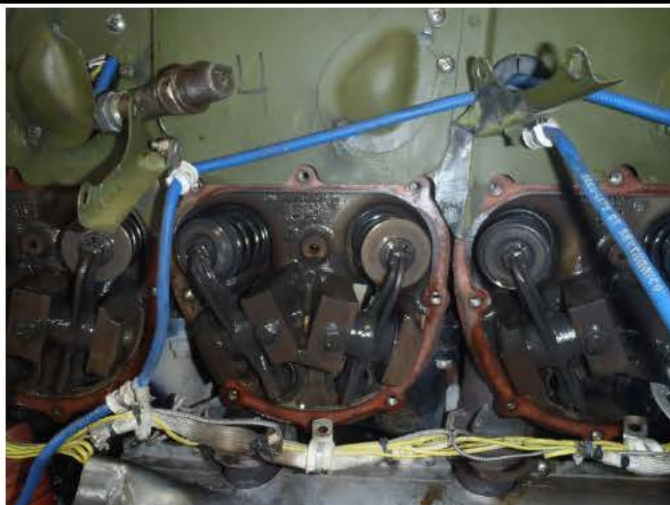
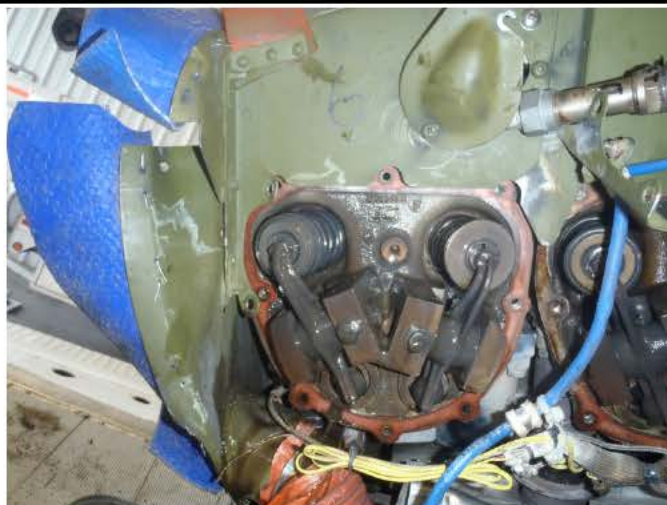
| CYLINDERS | Manufacture: ECI | P/N: Inaccessible | S/N: Inaccessible |
|---|---|---|---|
| Condition: | All of the cylinders remained attached to their cylinder bays and were undamaged. All of the rocker arm box covers were removed and the overhead components were inspected, the overhead components displayed normal operating and lubrication signatures. All of the cylinders were inspected using a lighted borescope, the cylinder bores, piston faces, and valve heads displayed normal operating and combustion signatures. During crankshaft rotation it was noted that all of the cylinders displayed good thumb compression and suction. There were no anomalies noted with any of the cylinders. | | |

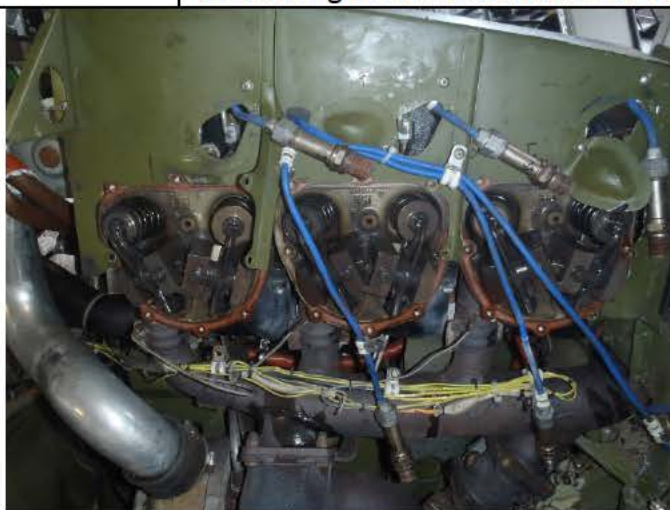
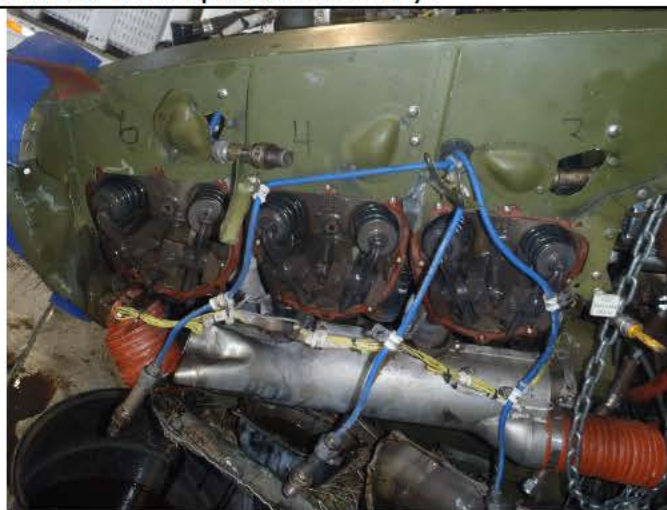
Condition: All of the rocker arms displayed normal operating and lubrication signatures. It was noted that during crankshaft rotation all of the rocker arms operated normally.

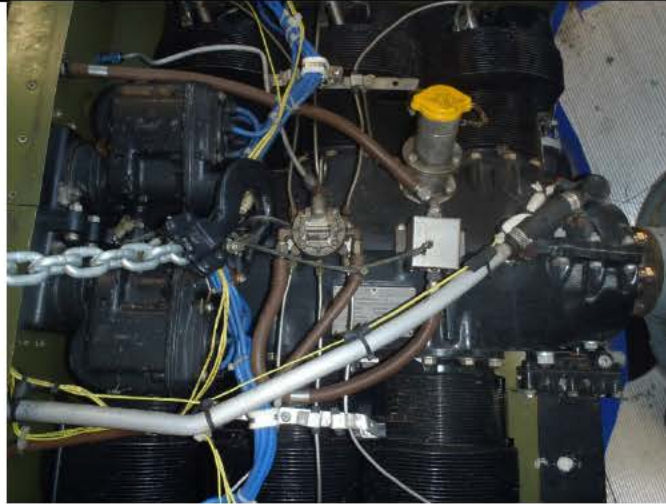
| Condition: | The crankcase was intact and undamaged. There were no anomalies noted with the crankcase. | | | |

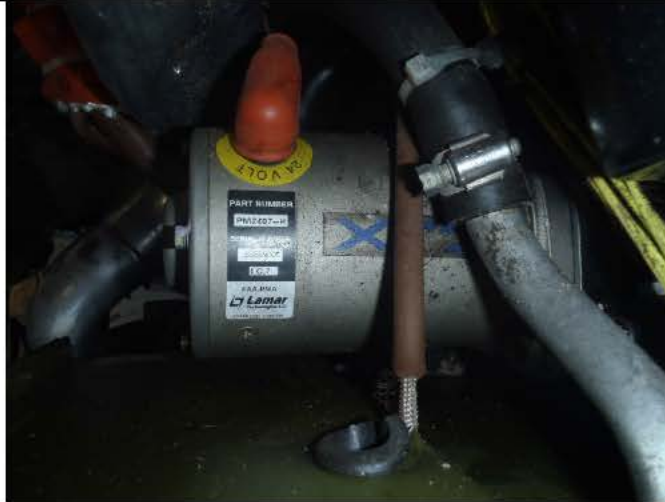
The starter remained attached to the starter adapter and was undamaged. There were no anomalies noted with the starter.

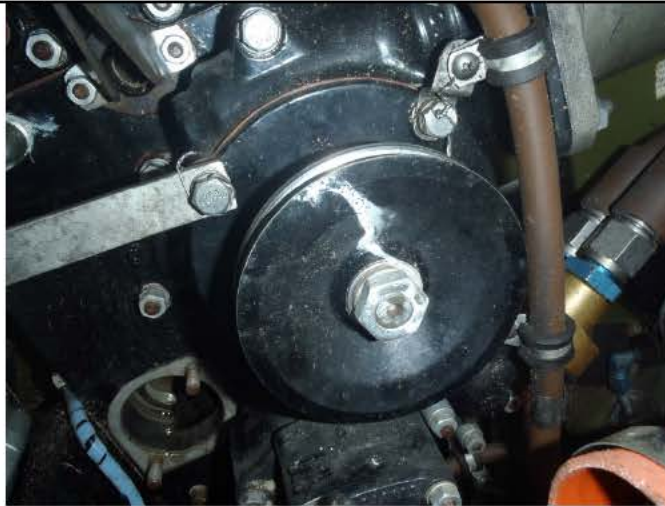
The starter adapter remained intact and undamaged. There were no anomalies noted with the starter adapter.

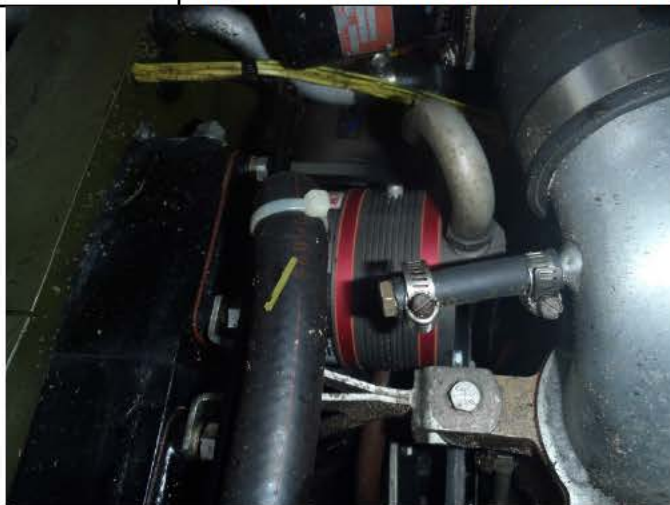
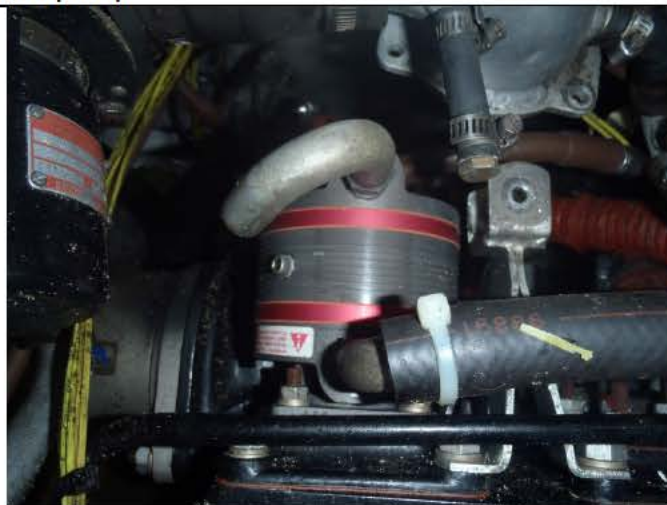
The vacuum pump remained attached to its installation point and was undamaged. There were no anomalies noted with the vacuum pump.

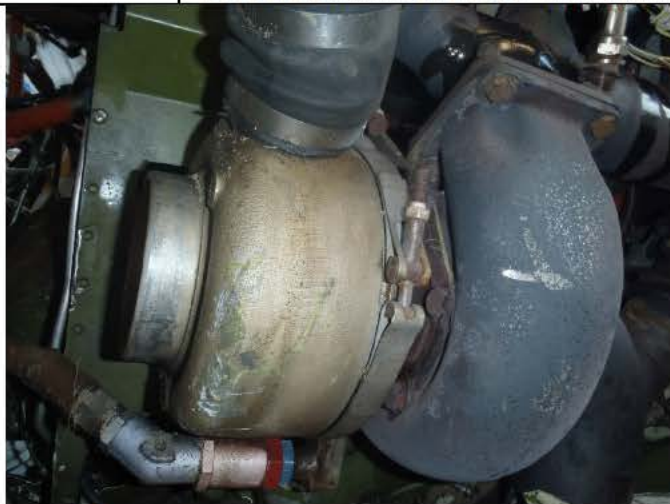
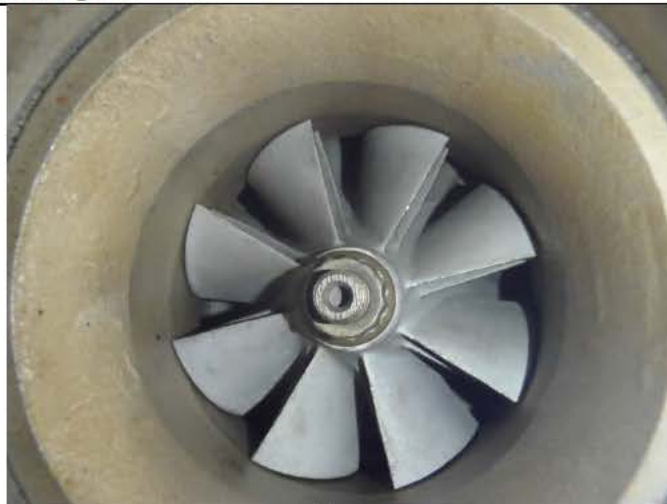
The turbocharger remained attached to the exhaust and induction system and was undamaged. The induction tubing going to the compressor section was removed and the compressor was inspected; the compressor blades displayed normal operating signatures and the compressor was capable of rotation by hand with no unusual resistance. There were no anomalies noted with the turbocharger.

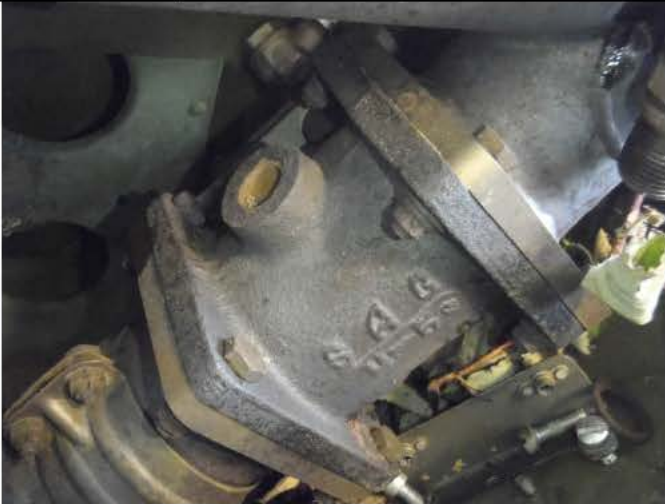
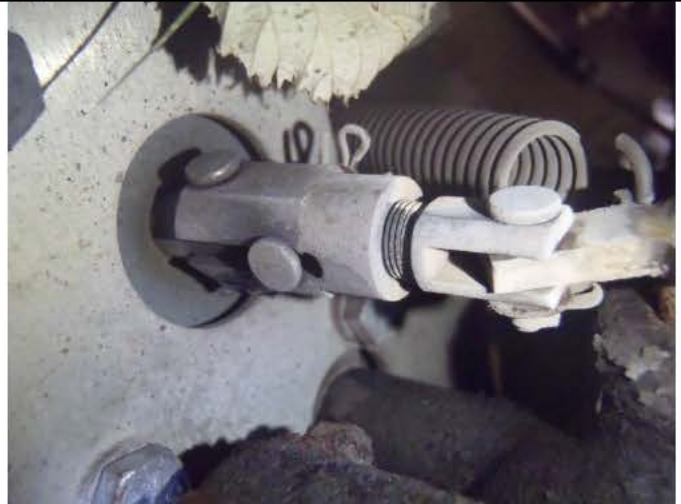
The wastegate remained attached to its installation point and was undamaged. There were no anomalies noted with the wastegate.

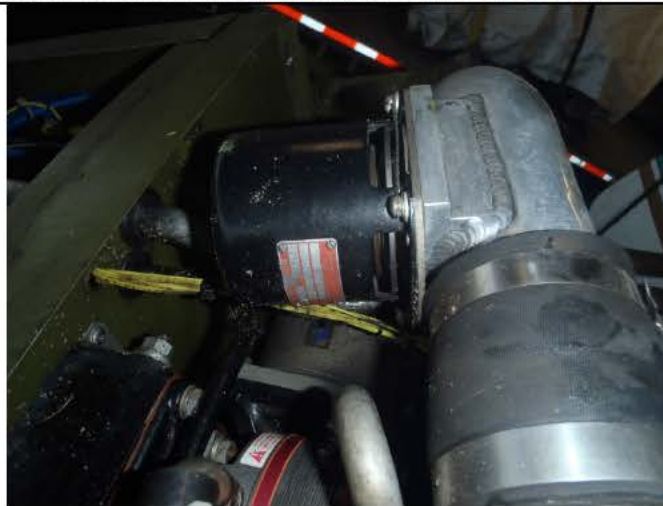
The overboost valve remained attached to its installation point and was undamaged. There were no anomalies noted with the overboost valve.

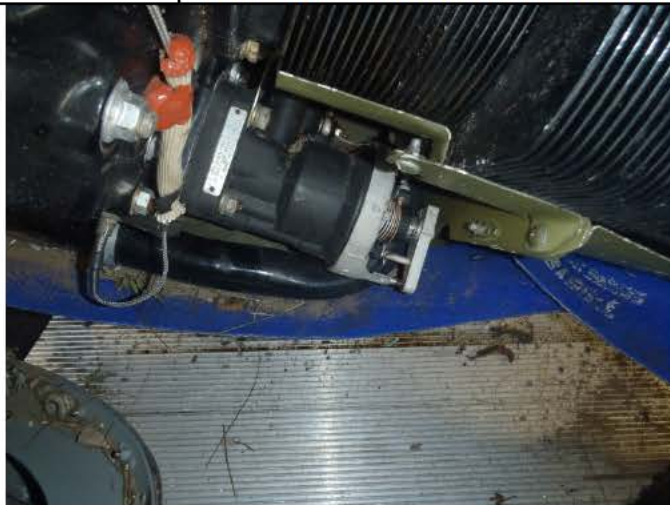
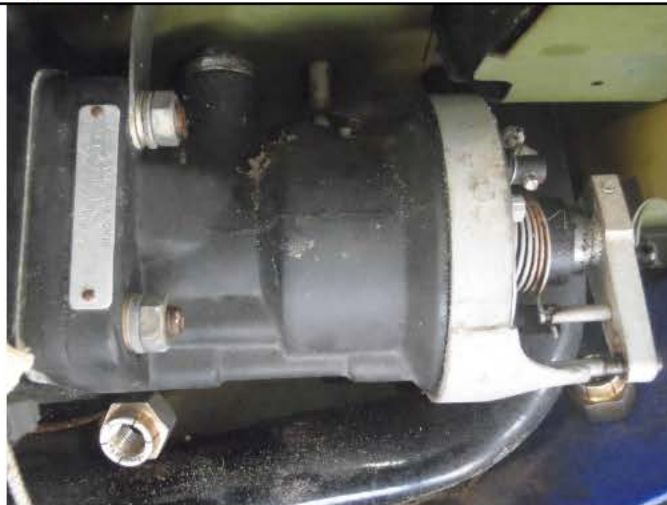
The propeller governor remained attached to its installation point and was undamaged. There were no anomalies noted with the governor.
