## **NATIONAL TRANSPORTATION SAFETY BOARD**

### **COMPONENT EXAMINATIONS & TESTING**

**NTSB Accident: WPR16LA056  
Accident Date: January 22, 2016**

Location: North Las Vegas, NV  
Date: January 22, 2016  
Aircraft: Robinson R22, N7020U, Serial # 2837  
NTSB IIC: Michael Huhn

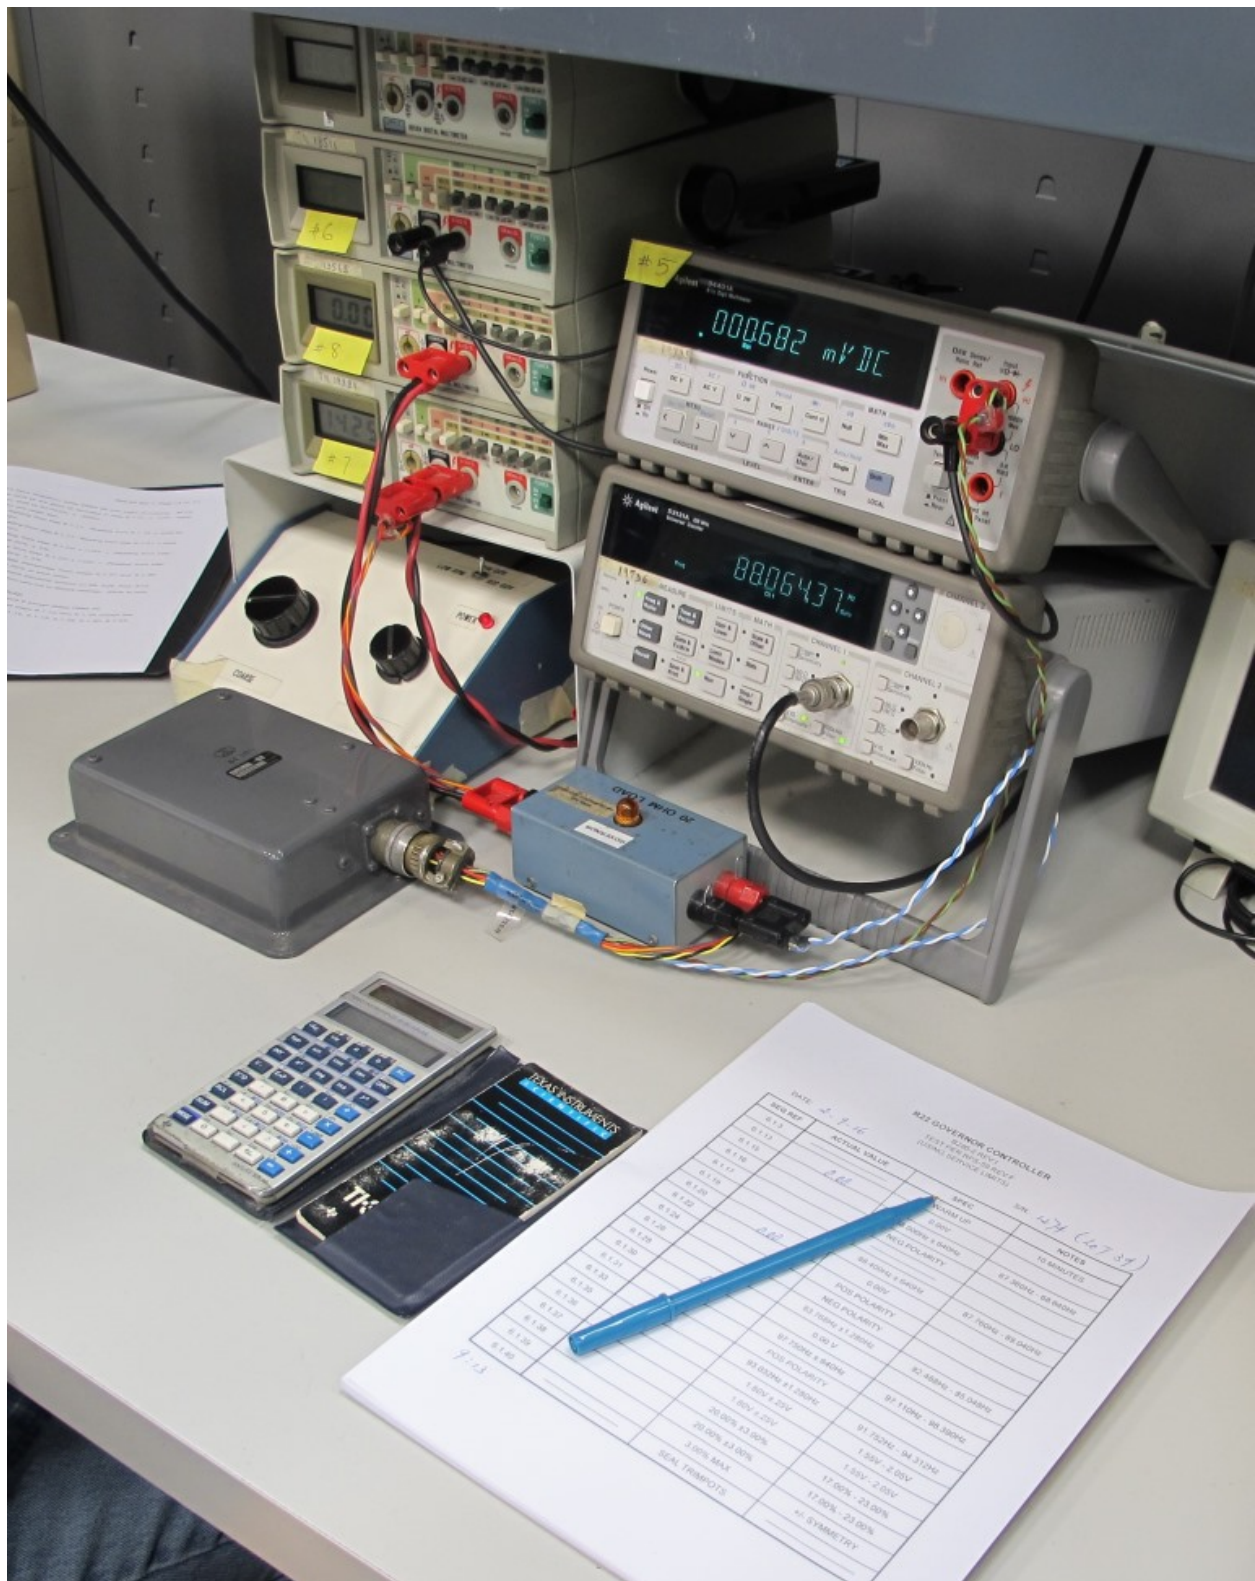
Figure 4 - Control Box Test Setup

The first component examined was a Governor Controller Box, part number B286-2, serial number 1274, Rev H, Lot 39. A visual inspection of the box revealed that the box had not been opened or overhauled since its production. No external damage, with the exception of a small area of bubbled paint, was present. The electrical connector was clean and undamaged. A functional test was performed using the production acceptance criteria. The Controller satisfactorily met (passed) all of the test criteria. A copy of the test results is attached.

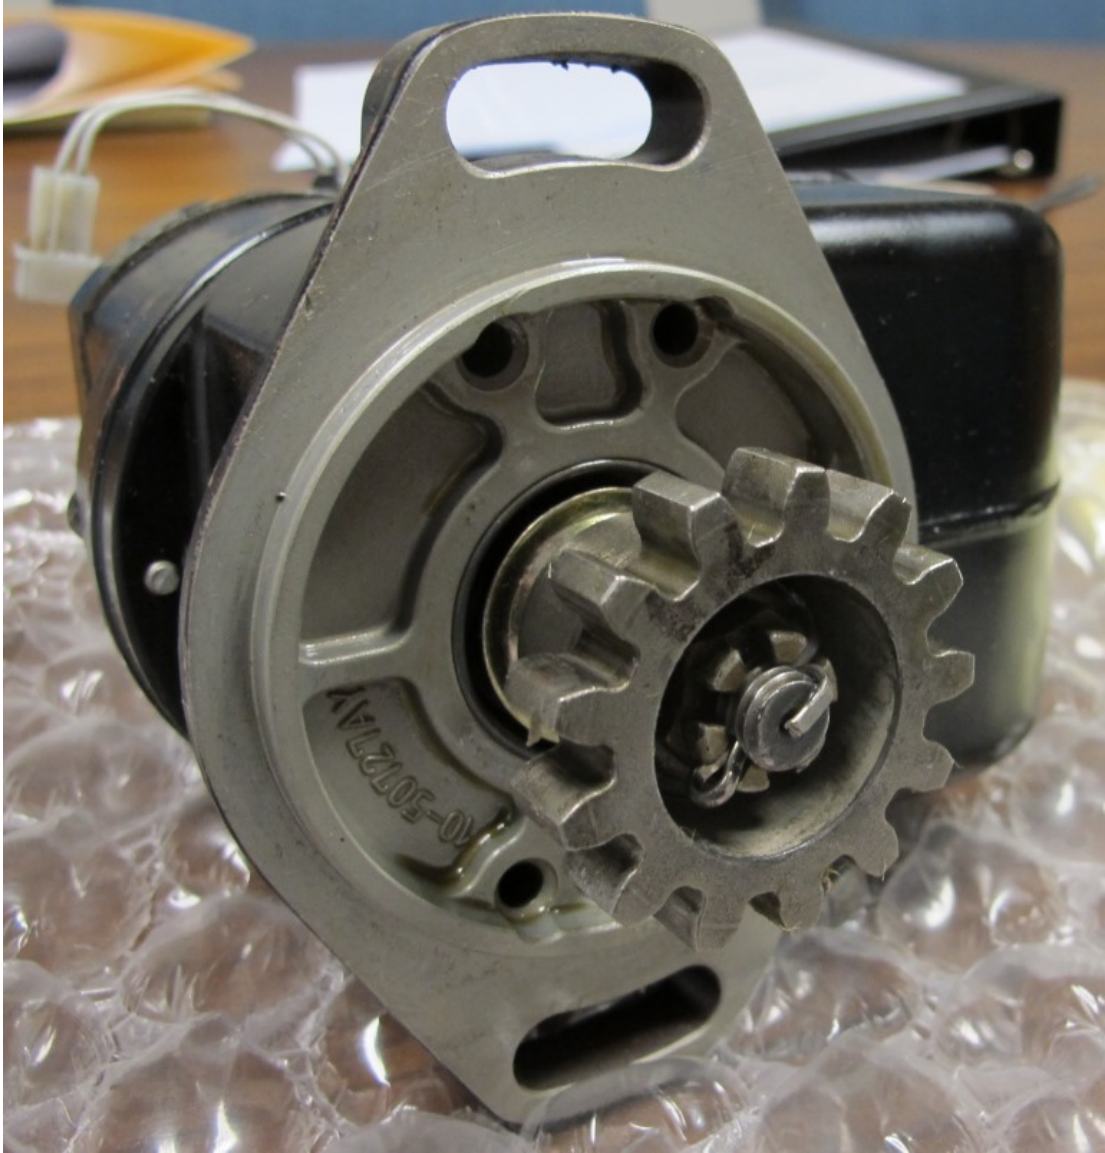
Figure 11 - Magneto Drive End

The second component to be examined was the (right) engine (helicopter left) Magneto, part number 10-600644-201, serial number EO7CA142. A visual inspection of the Magneto revealed that the data plate was yellow in color, indicating that it had been overhauled in the field (not by the manufacturer). No external damage was noted. The point cover was removed. There was no oil or grease contamination on or near the points. Although at least one point base holddown screw appeared to be slightly under-torqued, the tachometer ("tach") point base was secure, and all the proper hardware was in place. The points opened and closed on manual magneto rotation. The tach points, which provide a signal to the tachometer and the governor, had a gap between the contact points of less than .012 inches (manufacturers specification is  $.019 \pm .003$  inches). The tach points were removed for inspection. The points appeared undamaged and the contact pads were clean and smooth. The insulator spacers were undamaged.

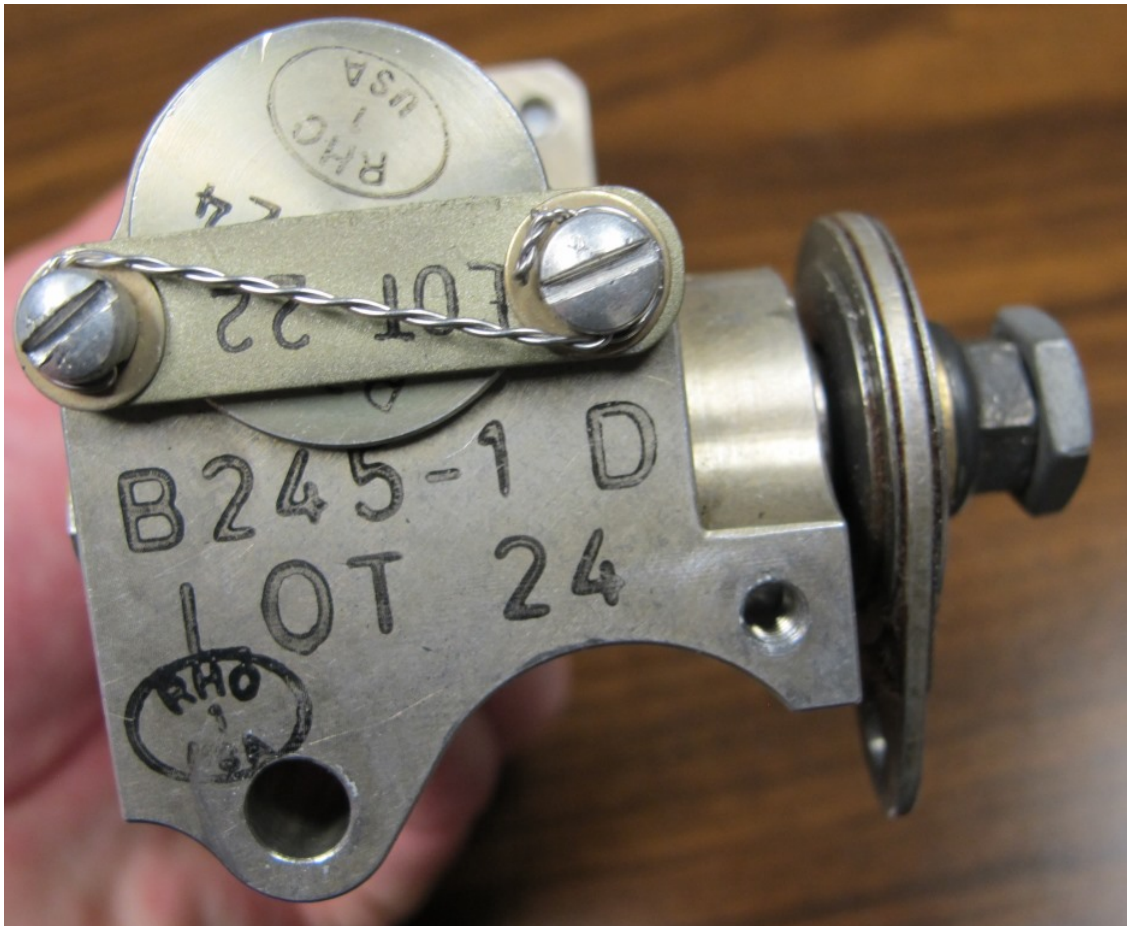
Figure 18 - Governor Motor End

The third component to be examined was a Governor Motor, part number B247-5, Lot 50. Visual inspection revealed no external damage. A functional test was performed on the motor with satisfactory results when compared to production specifications. The functional test included directionality, and appropriate "friction disc slippage," as indicated by motor current draw with a jammed actuator link at two power settings, 100% and 20 %. Maximum allowable draw was 0.7A; observed maximum values were typically 0.23A.
