## **NATIONAL TRANSPORTATION SAFETY BOARD**

### **AIRFRAME AND ENGINE EXAMINATION**

**NTSB Accident: WPR16LA071  
Accident Date: February 16, 2016**

Location: Buckeye Airport, Buckeye AZ  
Date: February 16, 2016  
Aircraft: Evolution Aircraft Revo, N107SB, Serial # 000608  
NTSB IIC: Michael Huhn

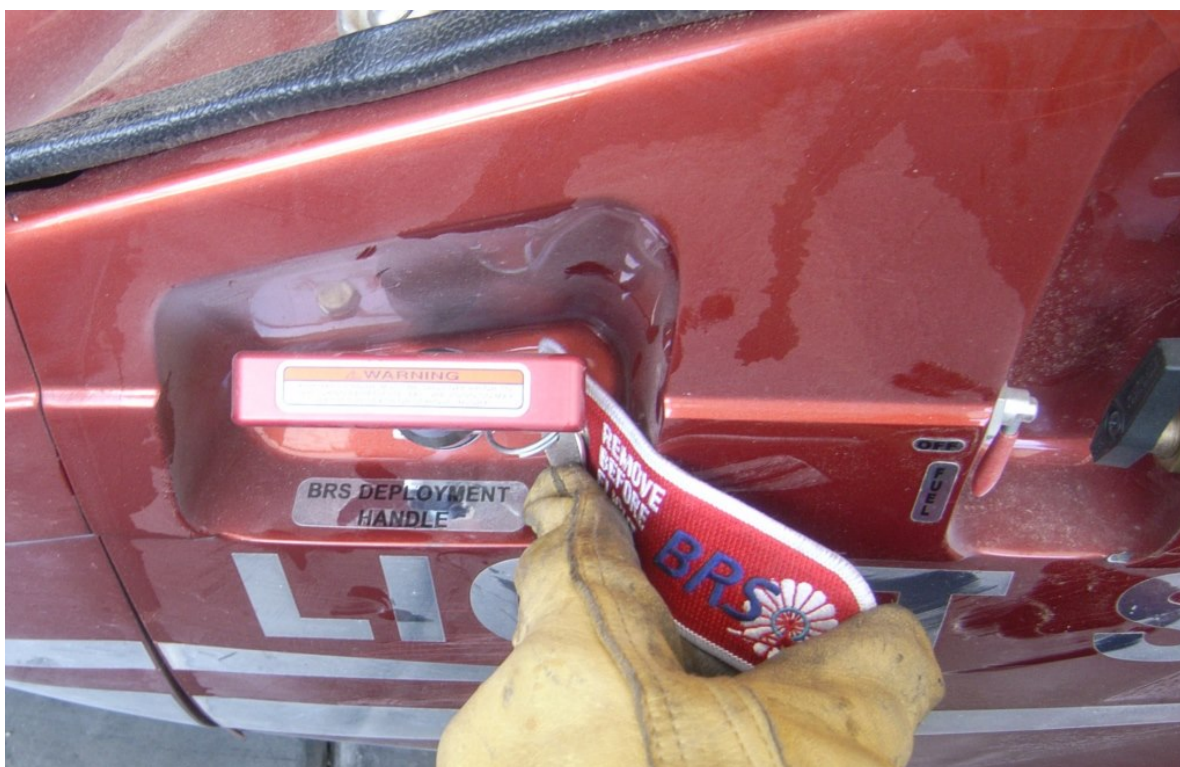
**Figure 7 - Parachute Deployment Handle**

- Fuel was observed in the fuel tank
- The rocket powered ballistic parachute was still in its case, and the extraction rocket had not been fired
- The aircraft was not equipped with any placards advising or warning first responders or any other personnel of the presence of the rocket

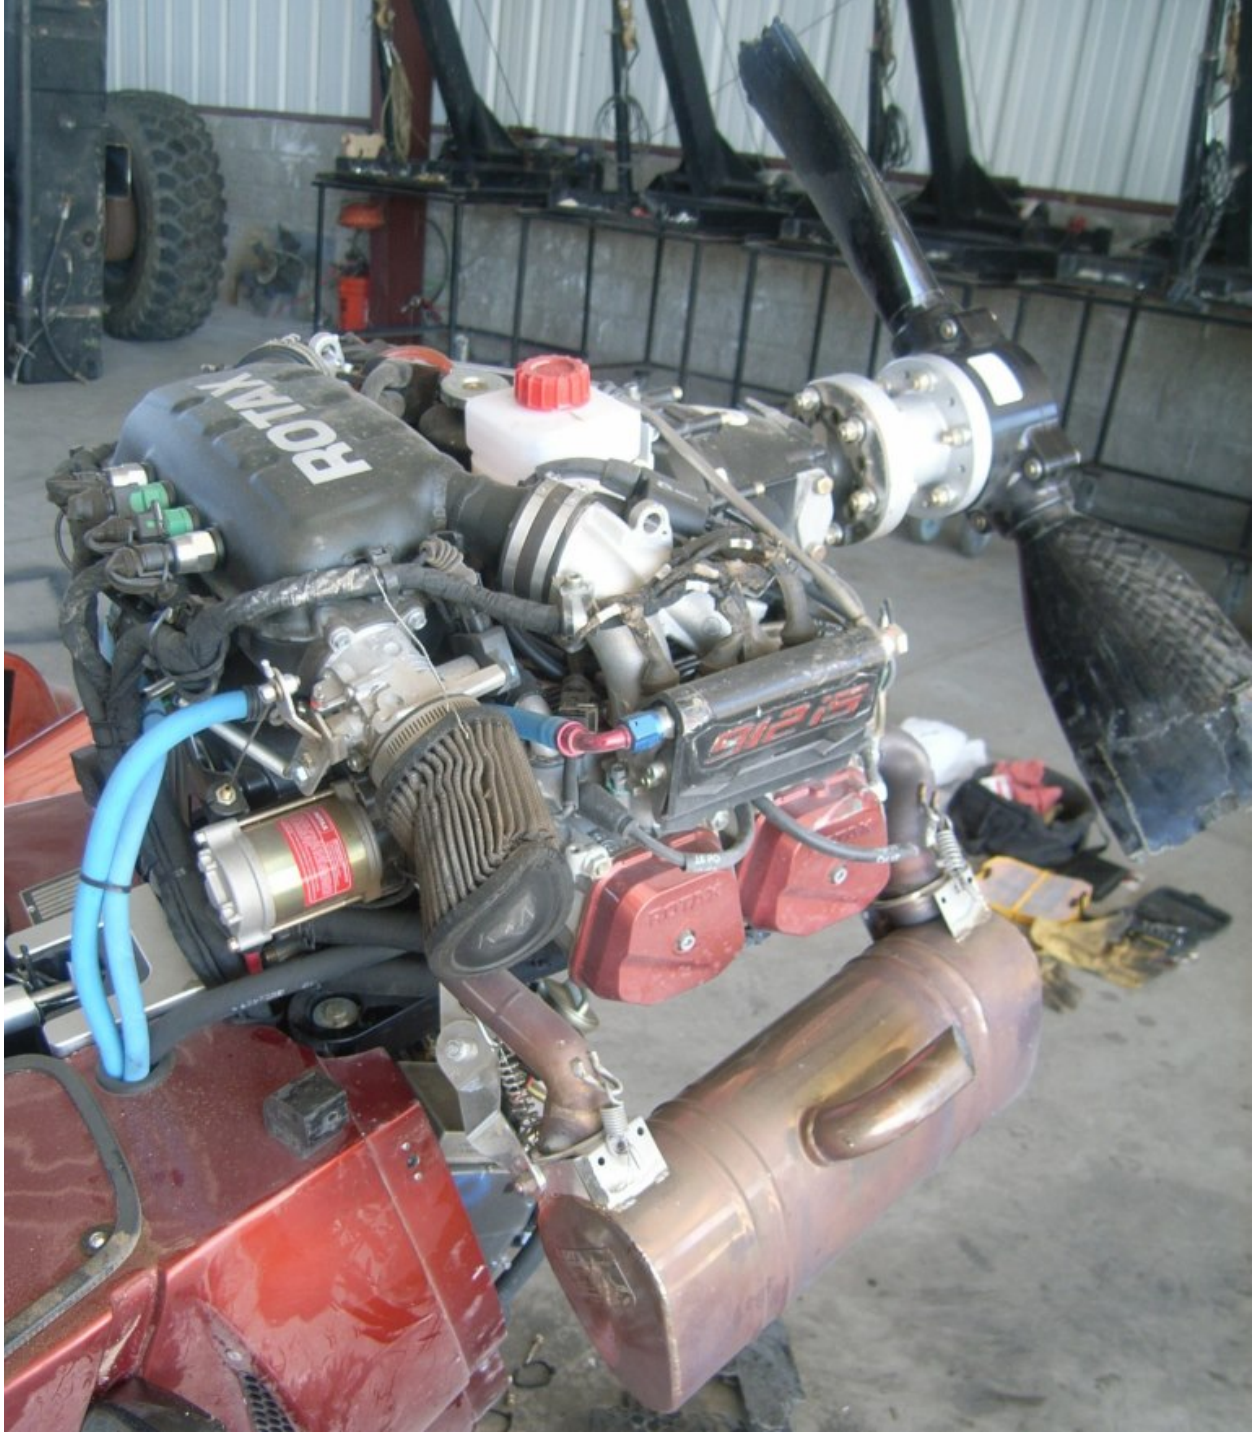
Figure 10 - Engine and Propeller Forward Left

- The engine (Rotax 912 IS) did not exhibit any signs of any pre-impact failures
- Engine damage appeared to be limited to some minor muffler crush and displacement from impact
- The four top spark plugs were pulled and the engine rotated freely by hand; thumb compressions were observed on all four cylinders
- The bodies and electrodes of the four top spark plugs (NGK- DCPR8E) all were unremarkable
- The engine control unit (ECU) was removed and retained for data download
  - o ECU Rockwell Collins PN ECU-204-102 B SN 12.0412
  - o Rotax PN 665566 00 then (per software update) 665568
- Both composite propeller blades were fracture-separated at their approximate 18 inch span locations
- Propeller blade damage was consistent with power at impact

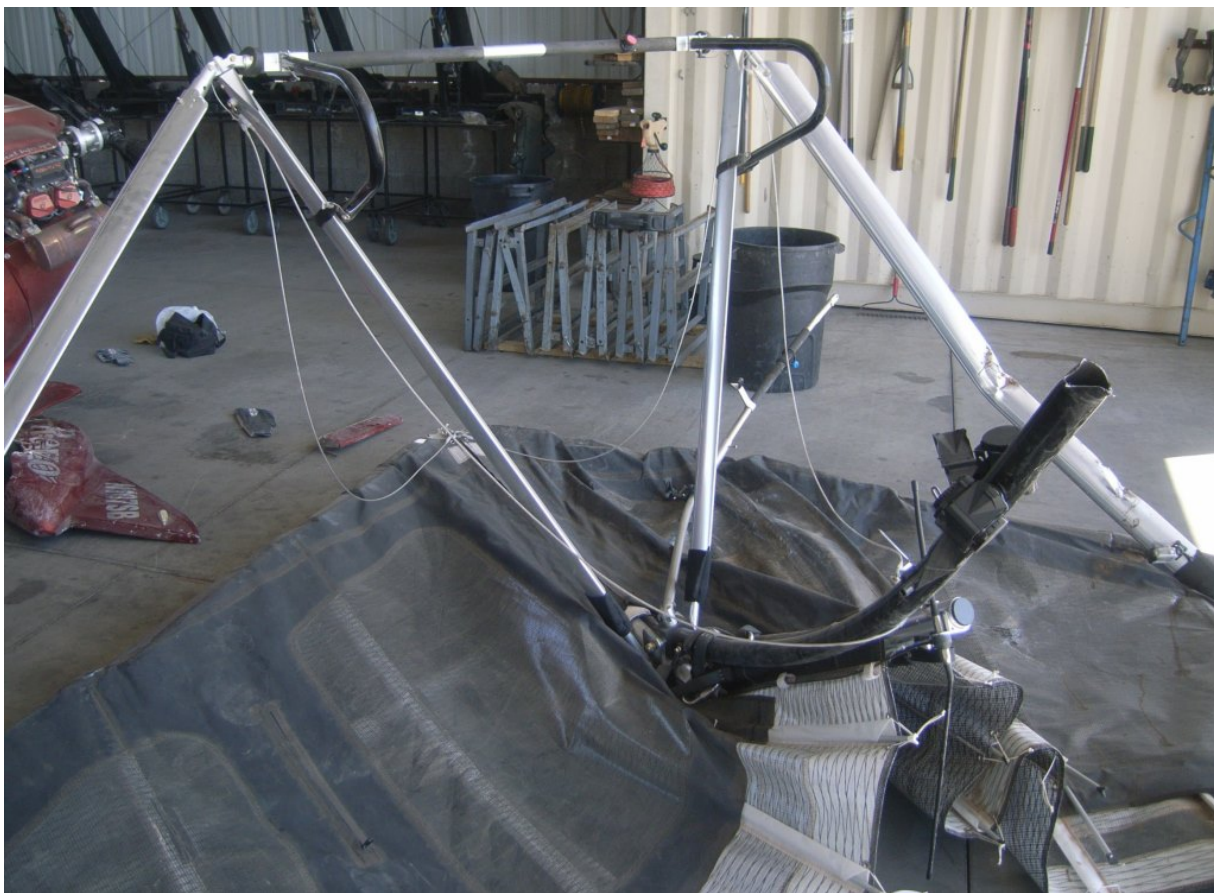
**Figure 13 - Wing and Control Bar**

- The main mast tube of the wing assembly had fracture-separated from the carriage at its attach point to the mast mount block
- The aluminum tube front spars formed the wing leading edges

- o The left front spar was fracture-separated at about its 2 foot span location
  - o The right front spar was fracture-separated about 5 feet inboard of the tip

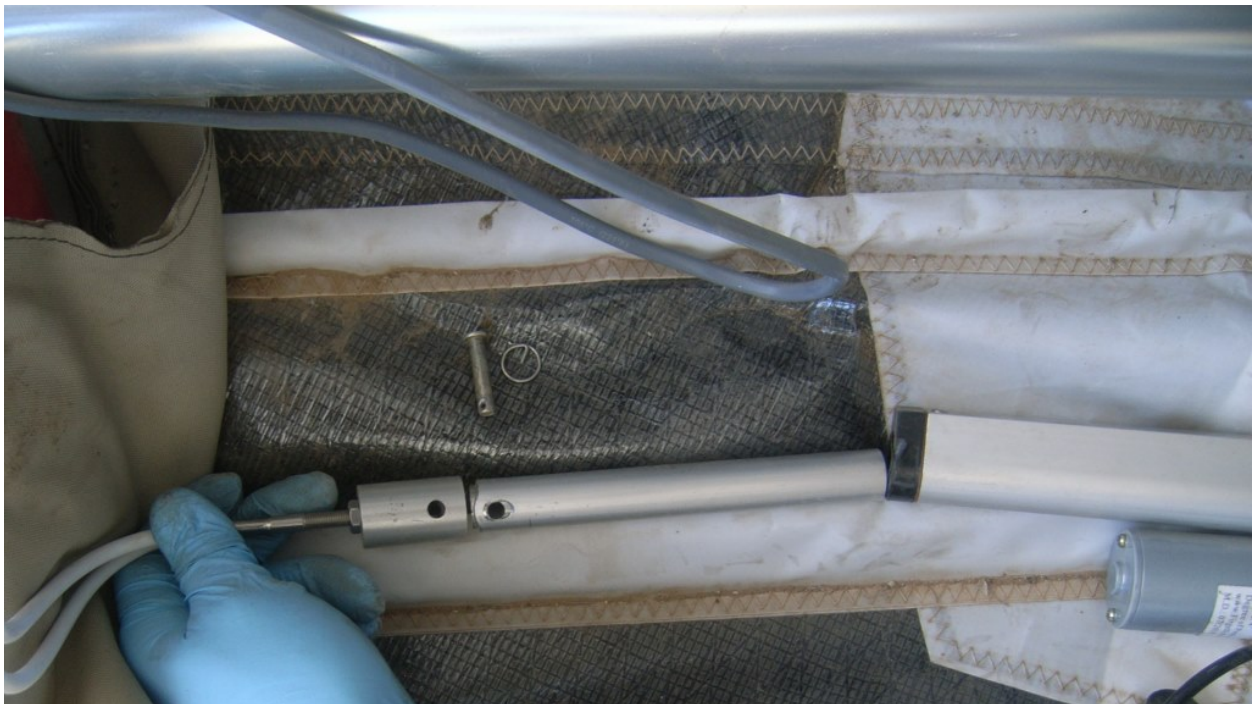
**Figure 20 - Pitch Trim Assembly (Pin removed by investigators)**

- The aft actuating tube assembly of the pitch trim mechanism was fracture-separated from the travel block of the main housing jackscrew
  - o On disassembly and inspection, it was revealed that the threads of the aluminum actuating tube had pulled aft over the jackscrew nylon travel block threads

- The aircraft manufacturer stated that based on the position of the jackscrew travel block, the trim was set close to the slowest speed of the aircraft. He also stated that that trim setting was acceptable for takeoff.
