# Engine Investigation Report

**Rolls-Royce Corporation  
Model 250-C30P  
Engine CAE 890152**

**Bell 206L-1  
Registration: N1076Y**

**Accident date: 14 June 2016  
Investigation date: 1-2 August 2016  
Report date: 7 December 2016**

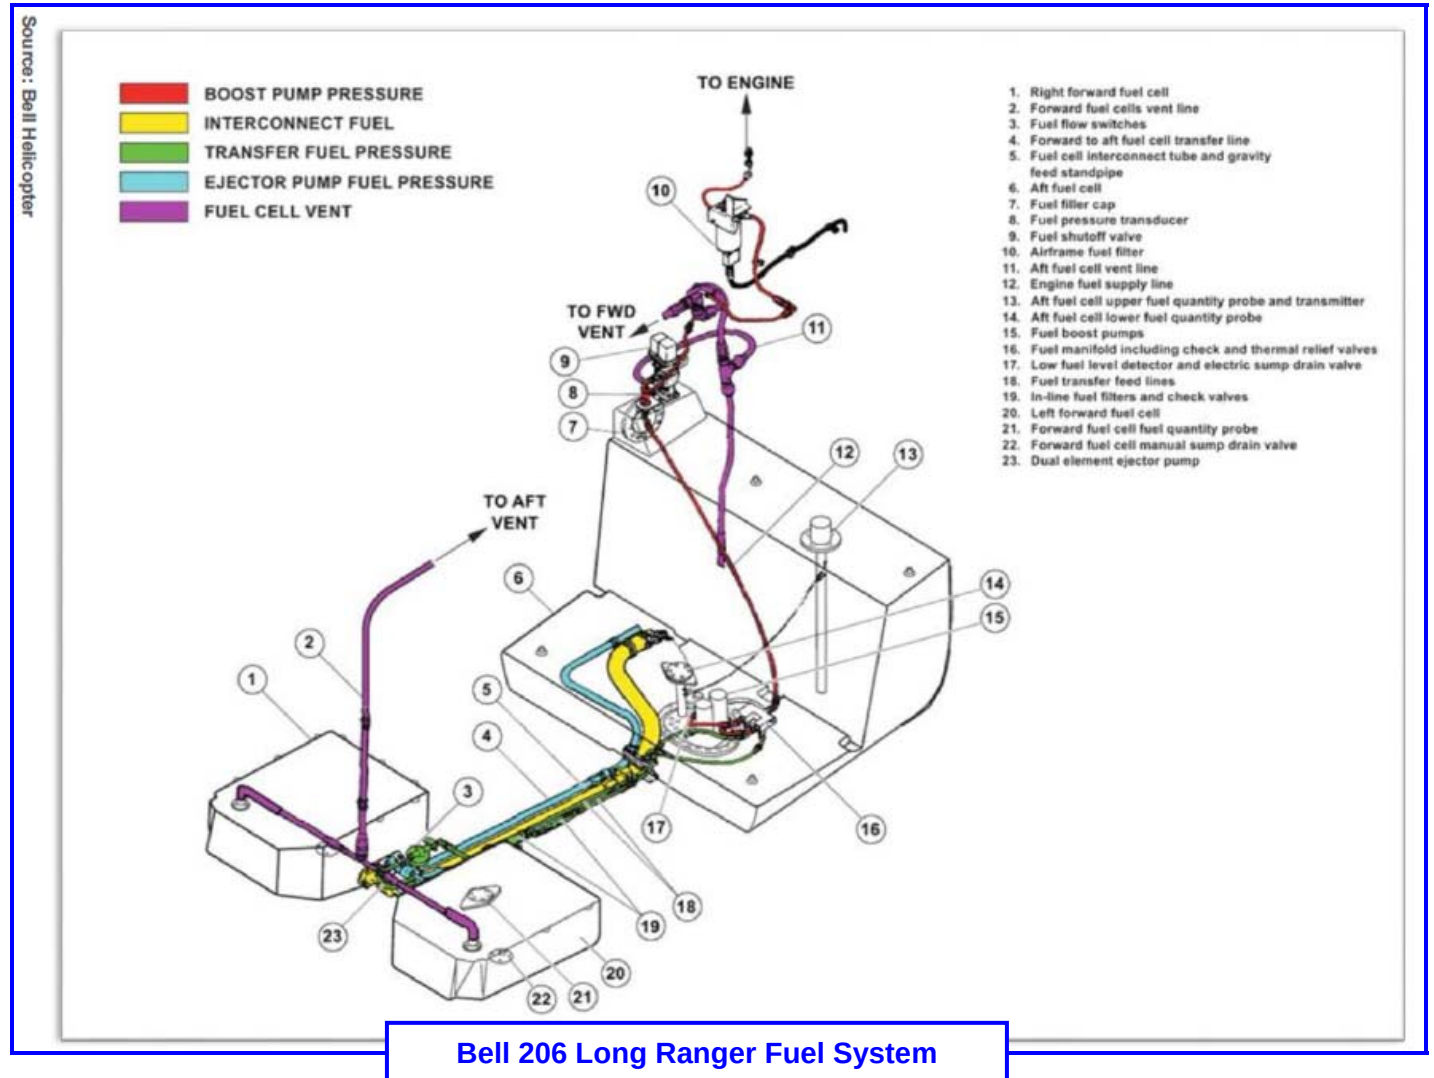
## Reference

Fuel is transferred from the forward tanks to the aft main tank via 2 boost pumps (LH & RH) located in the main tank and an ejector pump located between the 2 forward tanks. The flow of fuel through the ejector pump creates suction to transfer fuel from the forward tanks to the main tank. The Bell 206 Long Ranger operations manual requires boost pump operation when flying above 6000 feet.
