# NATIONAL TRANSPORTATION SAFETY BOARD

## MATERIALS LABORATORY FACTUAL REPORT

Report No. 17-027

Place : Gunnison, Utah  
Date : August 12, 2016  
Vehicle : Robinson R-44 II  
NTSB No. : WPR16LA165  
Investigator : Howard Plagens, AS-WPR

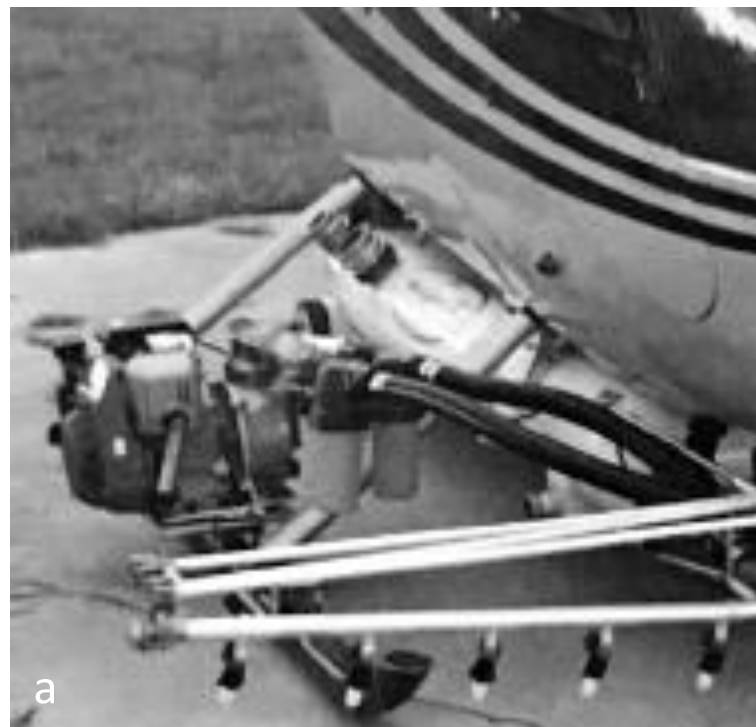
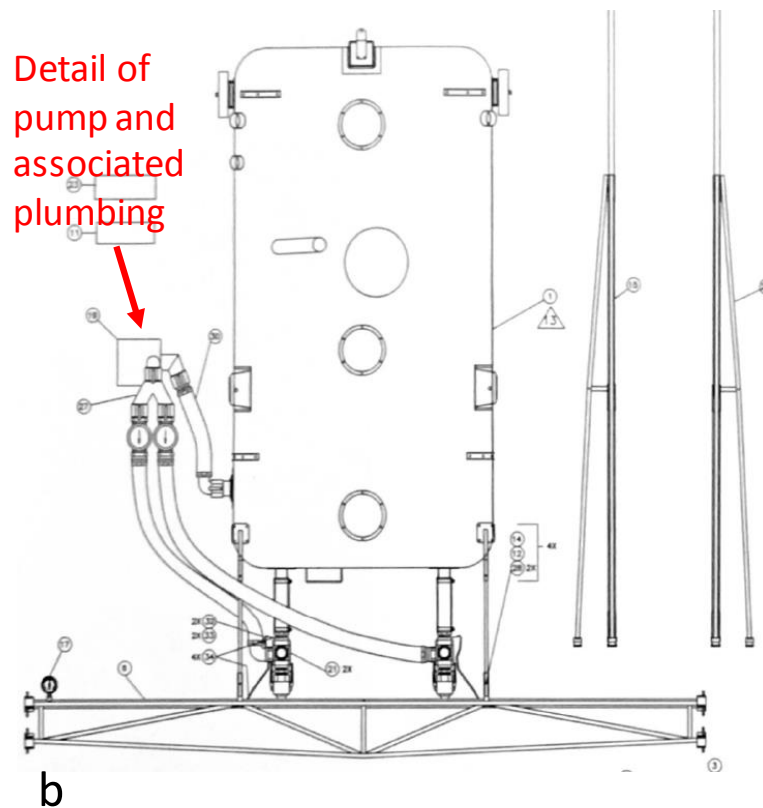
Figure 4 Images of the pump installation on the helicopter as depicted in the Simplex R44III spray system manual. View (a) shows the pump portion of the system as installed. View (b) is a top-down engineering schematic showing the relative location of the pump and its associated plumbing.

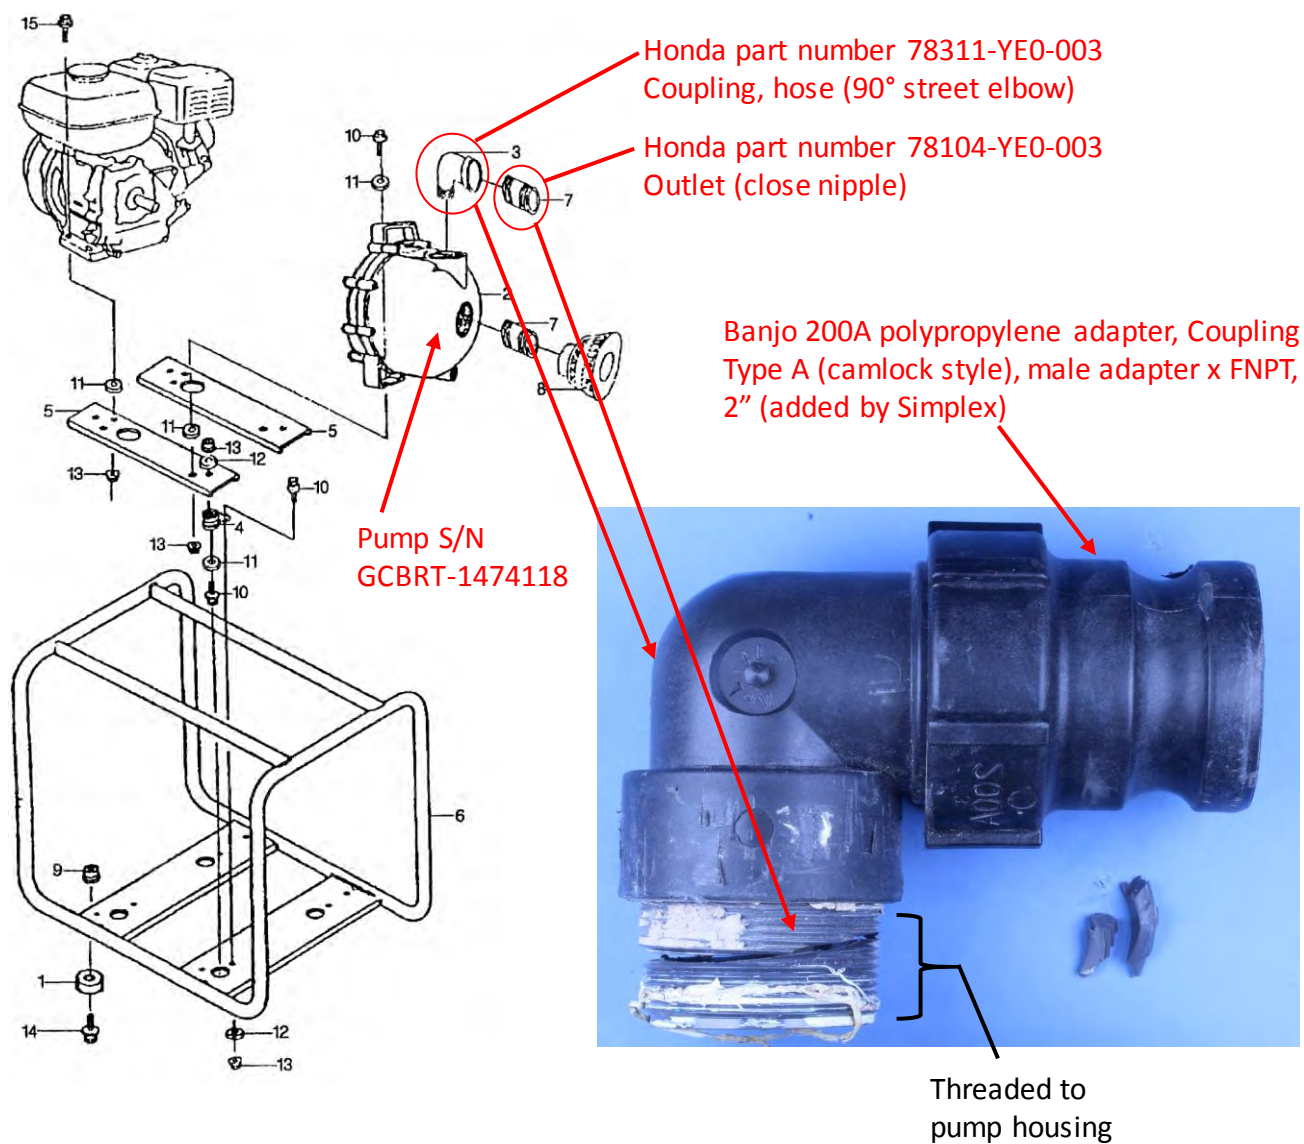
Specific details regarding the components and pieces in the submitted discharge fitting assembly are outlined in Figure 5. In the figure, the two primary close nipple pieces are arranged close to their pre-accident configuration (without fracture surface contact). The arrangement of the fitting components relative to the Honda illustrated parts diagram is shown in Figure 6. According to Figure 6 and a representative from Simplex, the close nipple was threaded directly to the pump housing discharge outlet. However, the parts diagram shows the male side of the elbow fitting to be threaded directly to the pump housing discharge outlet.

Figure 6 Illustrated parts diagram of the Honda WMP20 pump kit showing the manufacturer's arrangement of the 90° street elbow and the close nipple. Inset is an image of the same parts as installed on the R44III spray system by Simplex.
