## **NATIONAL TRANSPORTATION SAFETY BOARD**

### **SITE, ON-SCENE, & EXAMINATION INFORMATION Rev A**

**NTSB Accident: WPR17FA041  
Accident Date: December 26, 2016  
Examination Dates: 12/27 & 12/29 2016**

Location: Fresno, California  
Date: December 26, 2016  
Aircraft: Petrus Express S90, N176PA, Serial # 80842  
NTSB IIC: Michael Huhn

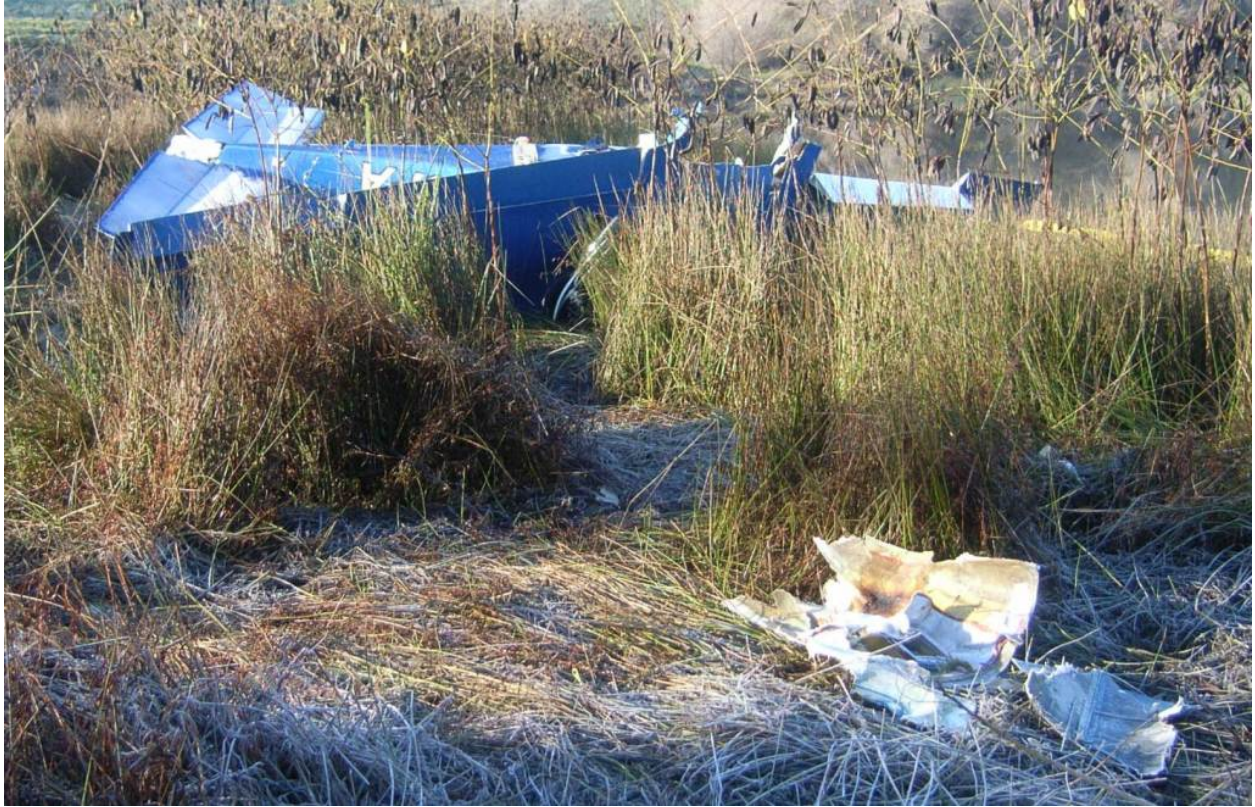
**Figure 2 - Airplane with Cowling Fragments in Foreground**

- Some cowling and wing fragments were dispersed in an area approximately east, and within 70 feet, of the main wreckage, and some of the marsh grass was flattened in this area as well. However, no significant gouges or other ground scars were observed in this region

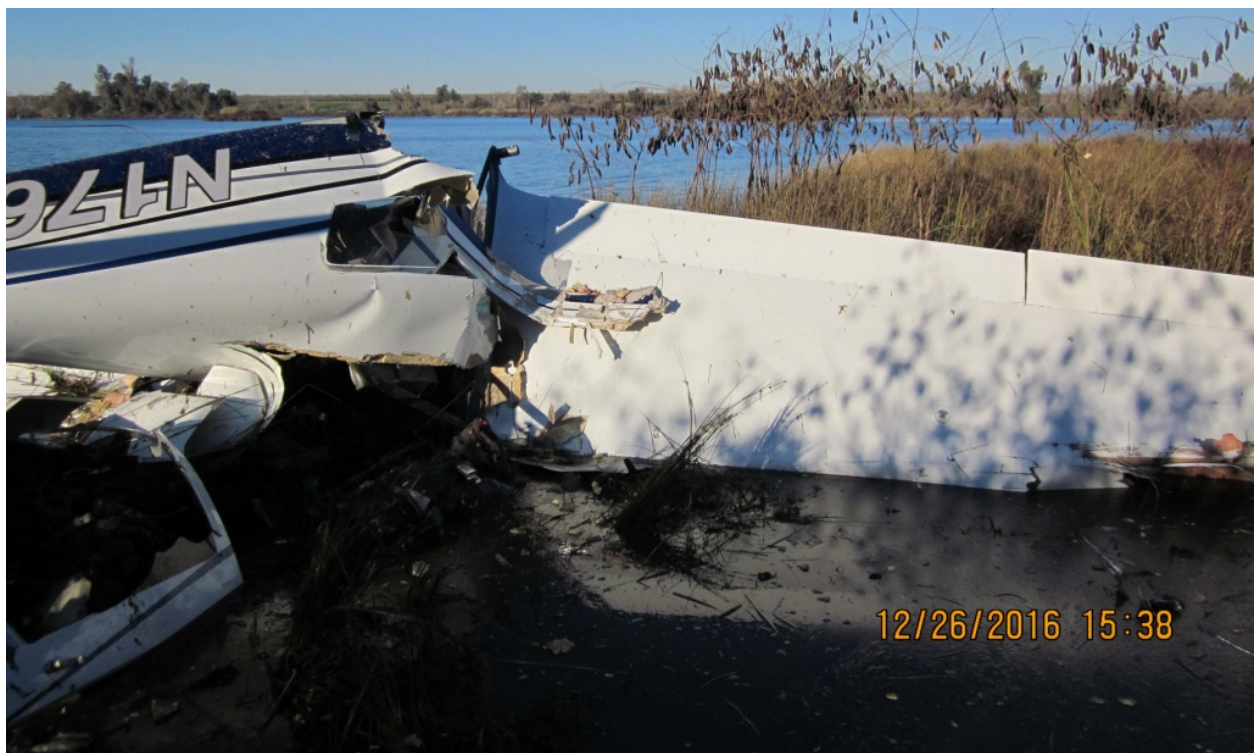
- The two wings remained attached to one another, and came to rest approximately perpendicular to the ground, leading edge down.
- The engine and attached propeller were fully immersed in the water and underlying mud/silt, with the significantly deformed and fractured cockpit remnants mostly above the waterline.

Figure 5 - Main Wreckage with Left Wing

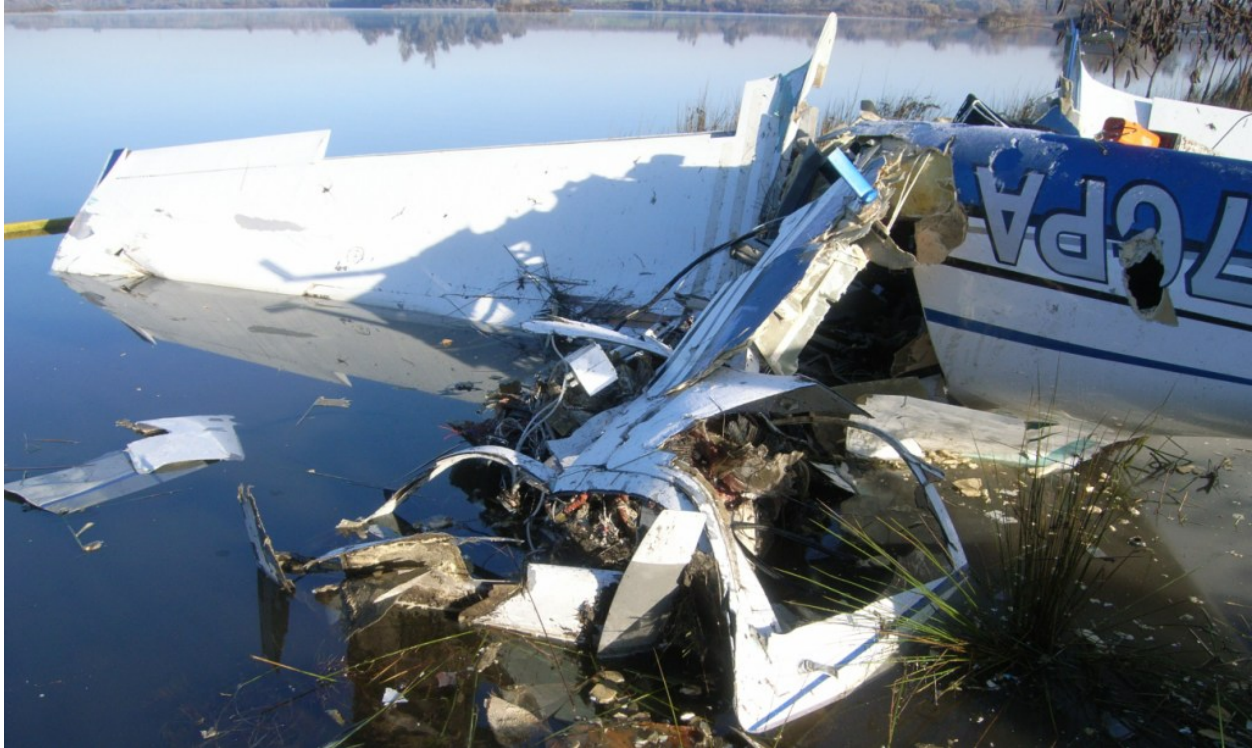
**Figure 6 - Main Wreckage with Right Wing**

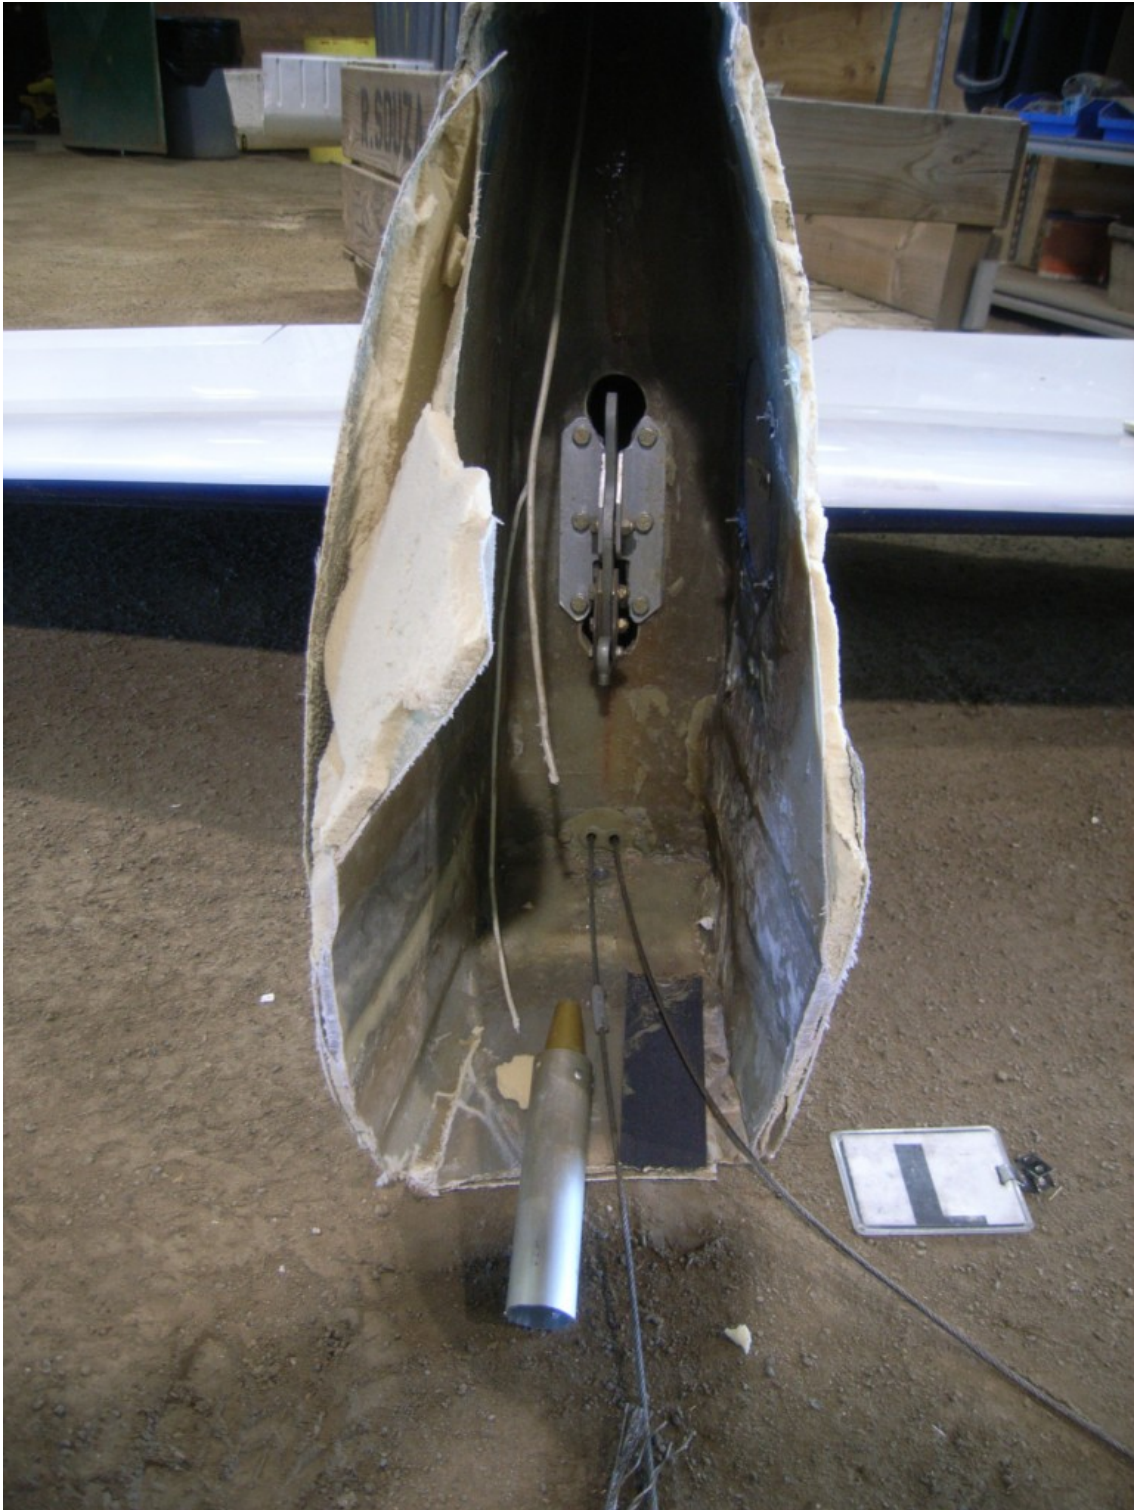
- The aft fuselage was almost completely fracture-separated from the cabin, at approximately the station of the aft end of the rear windows
  - The aft fuselage was nearly intact, except as follows:
  - A circumferential crack, of unknown depth, and located about 18 inches aft of where the vertical stabilizer faired into the aft fuselage, fully ringed the aft fuselage
  - Portions of this crack possibly fully penetrated the structure

**Figure 14 - Recovery-Separated Aft Fuselage**

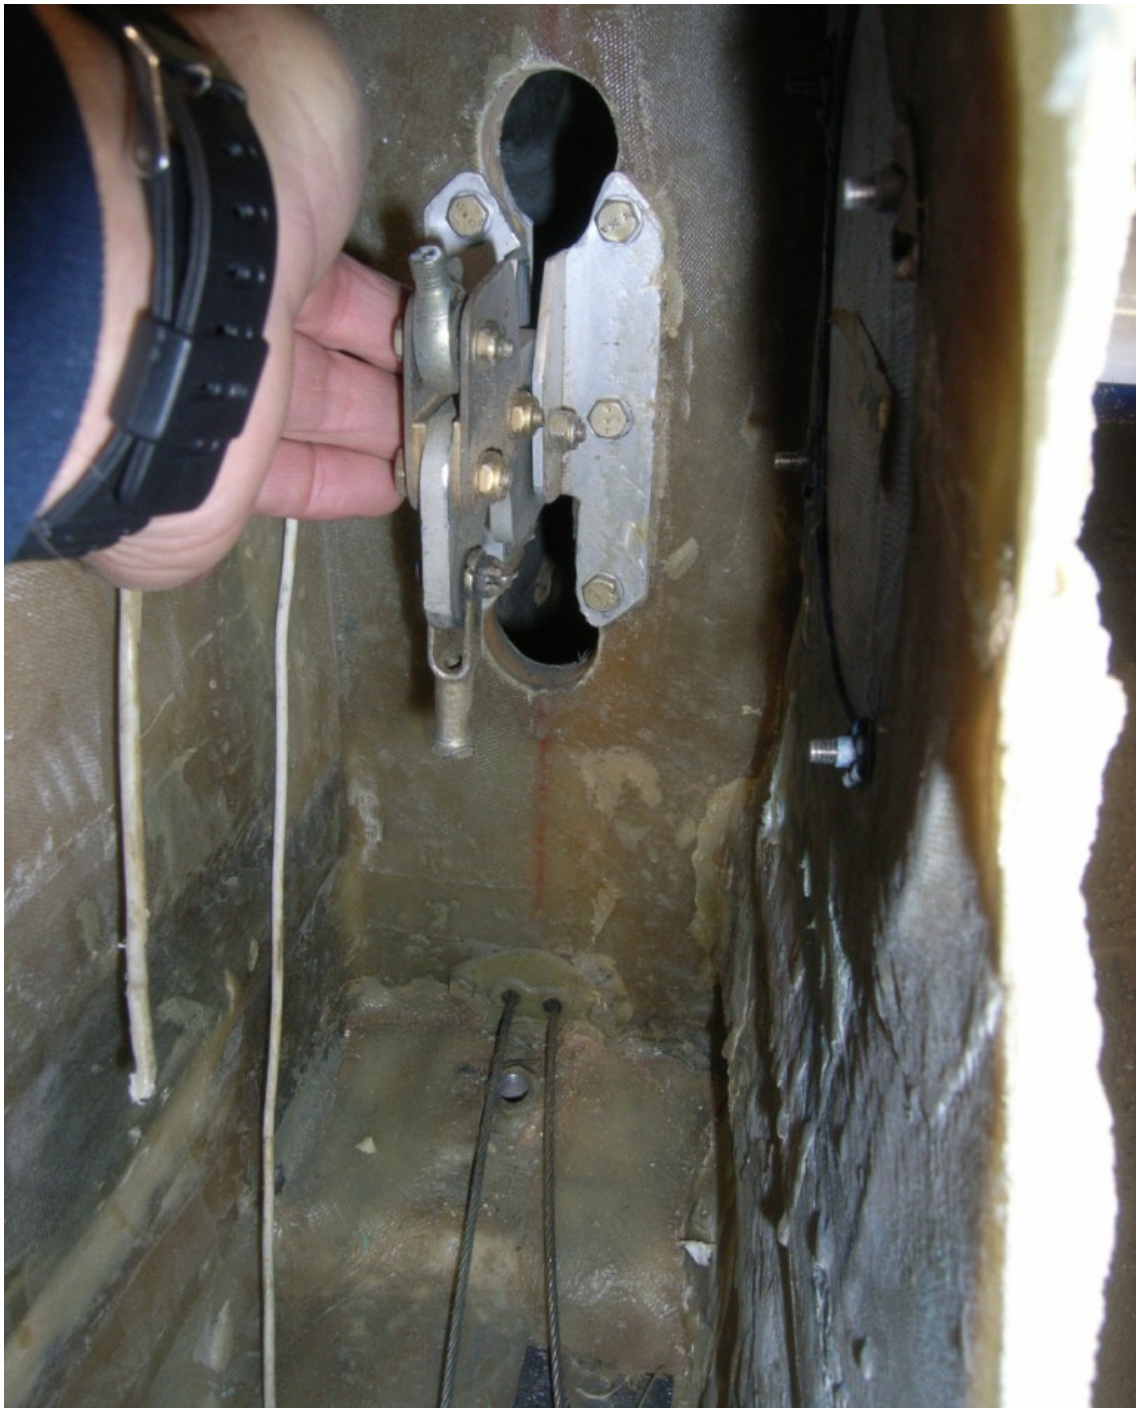
- The control rod from the aft fuselage bellcrank to the elevators remained connected to the elevators, but was fracture separated at the rod end at the aft bellcrank

- The control rod from the aft fuselage bellcrank to the mid fuselage bellcrank was fracture-separated at the rod end at the aft bellcrank, but remained attached to the mid fuselage bellcrank

- All fracture faces were consistent with one-time overload fractures, with no evidence of pre-existing failures

**Figure 15 - Elevator Bellcrank Assembly**

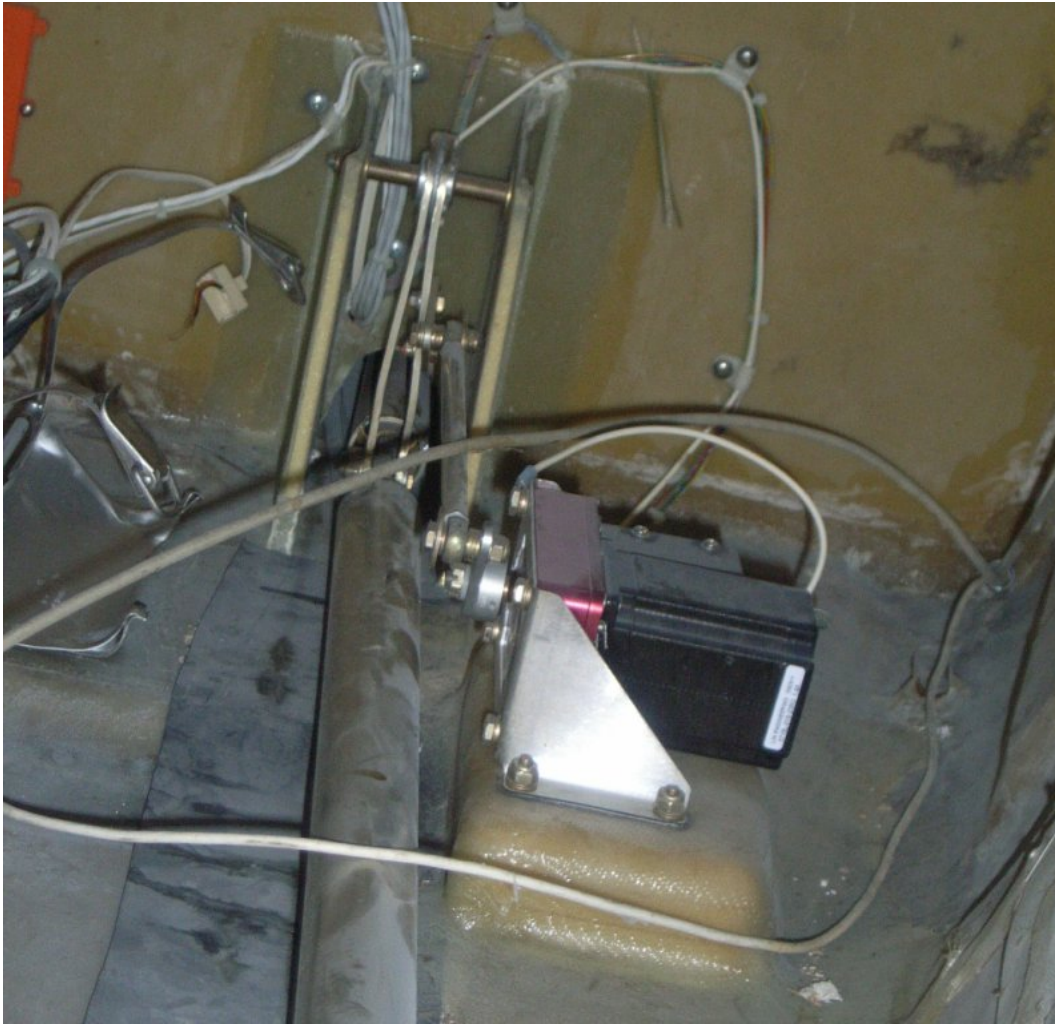
- Autopilot Pitch Servo
  - The electrically controlled and actuated autopilot pitch servo attached via links to the elevator control rod just aft of the cabin
  - The servo, links, and attach hardware remained intact
  - The pitch servo control- and power wires remained intact at the servo

**Figure 18 - Elevator Control Rod and Autopilot Pitch Servo**

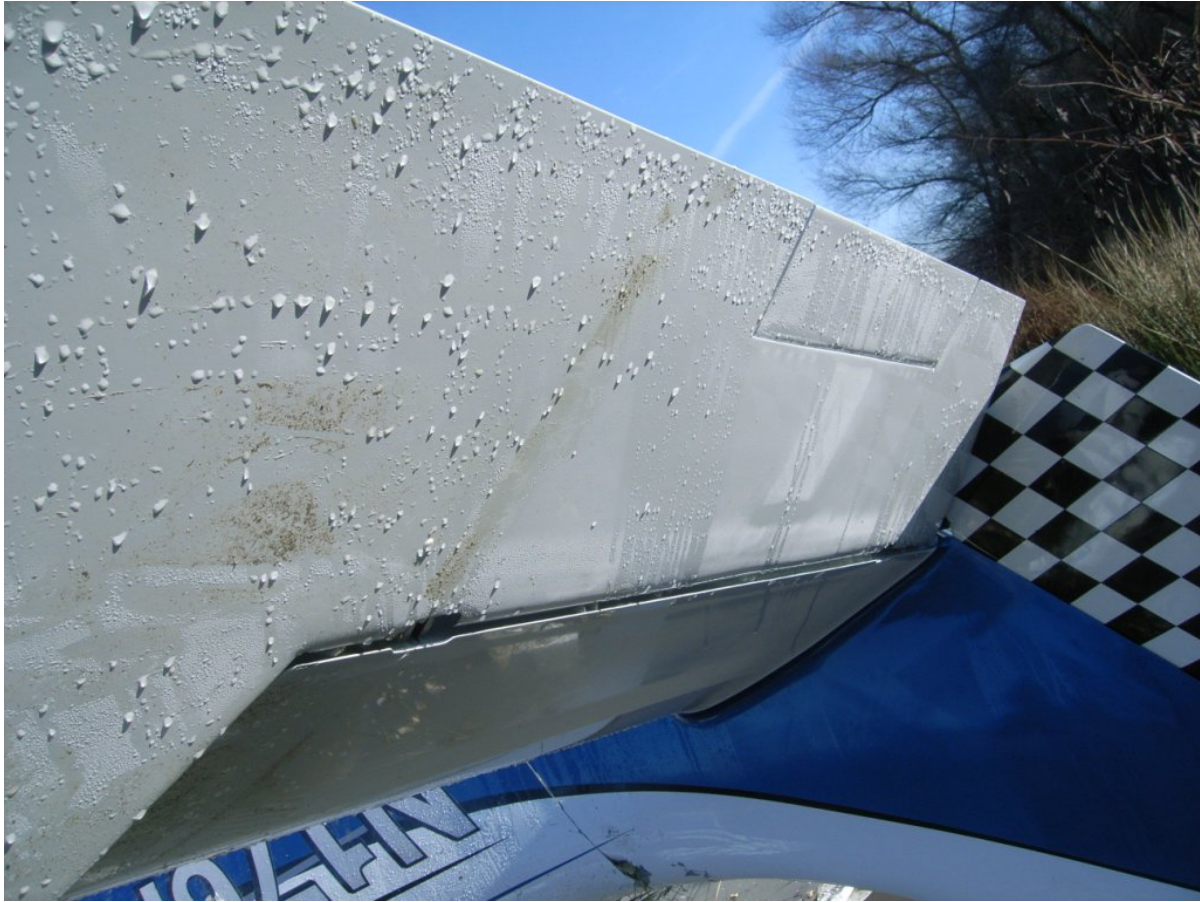
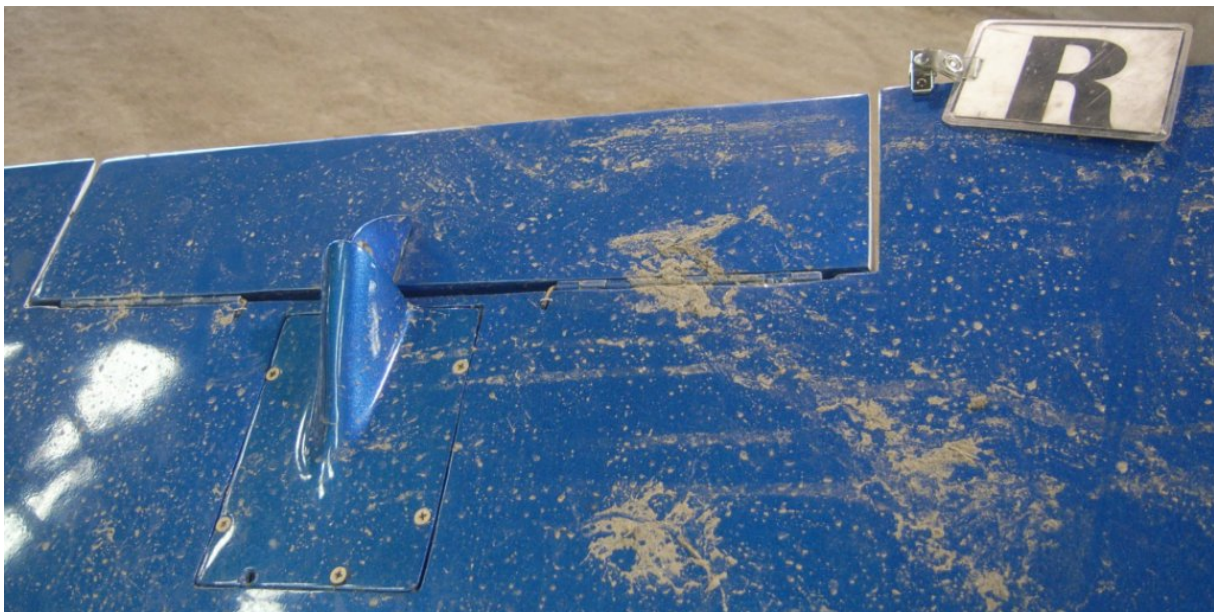
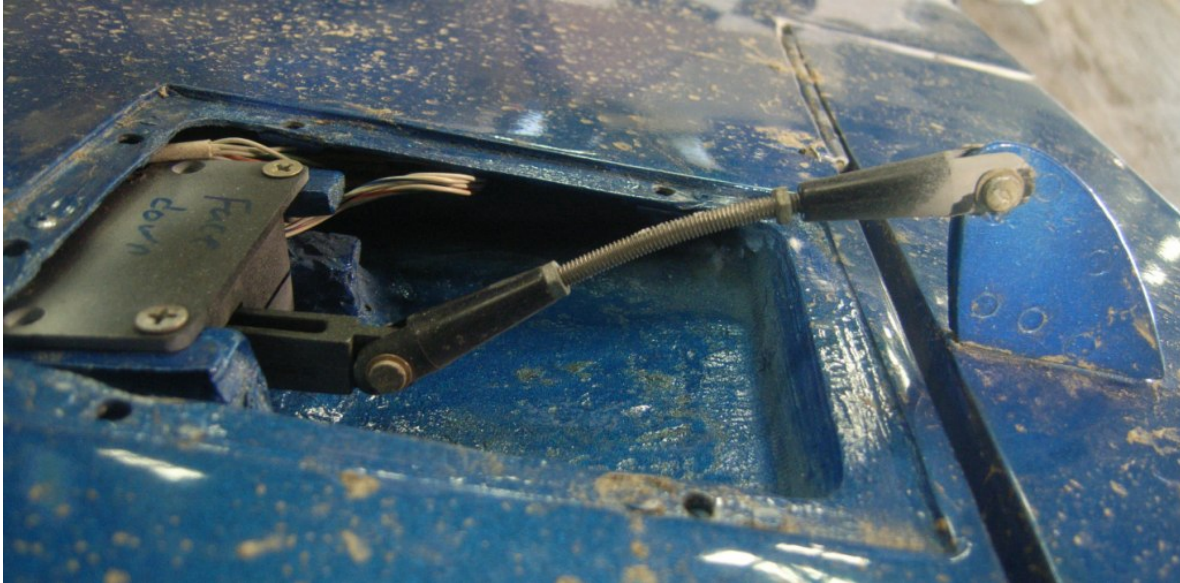
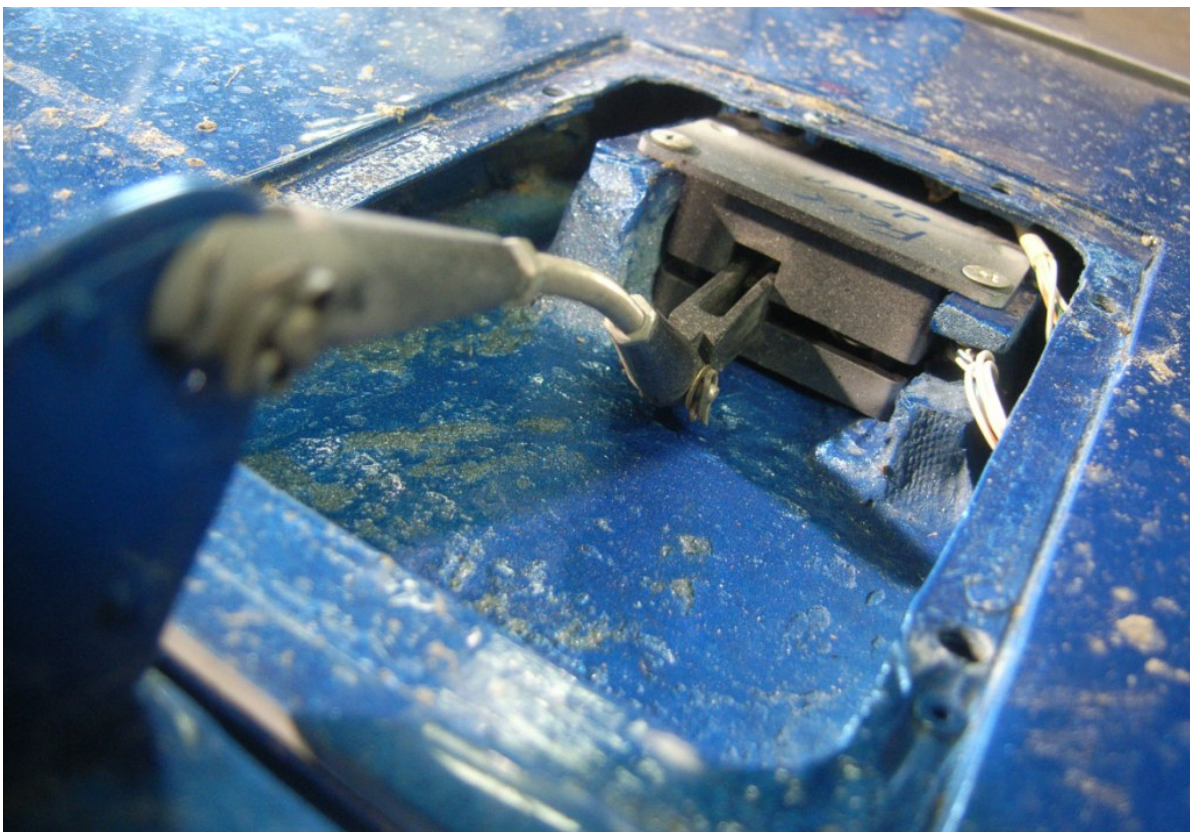
- The pitch trim tab remained securely attached to the right elevator, and appeared undamaged
  - It was locked/immobilized in the faired position
- The pitch trim tab was operated by an electrically controlled electric actuator mounted in the right elevator
  - Removal of the aerodynamic fairing revealed that the link rod from the actuator to the tab was bent about 5 degrees
  - The actuator plastic case halves were found to be partially separated
  - No impact or other scarring or damage was observed, and the cause(s) and timing of the actuator and link rod damage could not be determined
  - The control/power wires remained connected to the actuator

**Figure 19 - Right Horizontal Stabilizer with Trim Tab**

**Figure 20 – Pitch Trim Tab with Actuator Fairing**

**Figure 21 - Pitch Trim Tab and Actuator**

**Figure 22 - Pitch Trim Actuator and Rod**

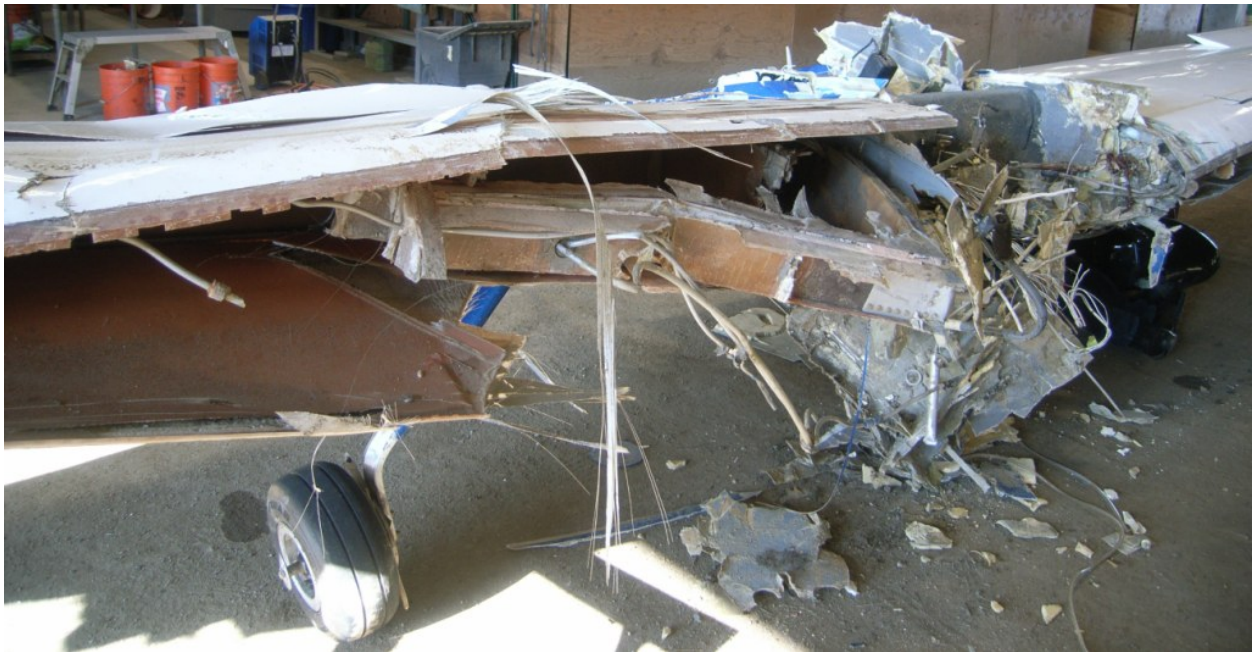
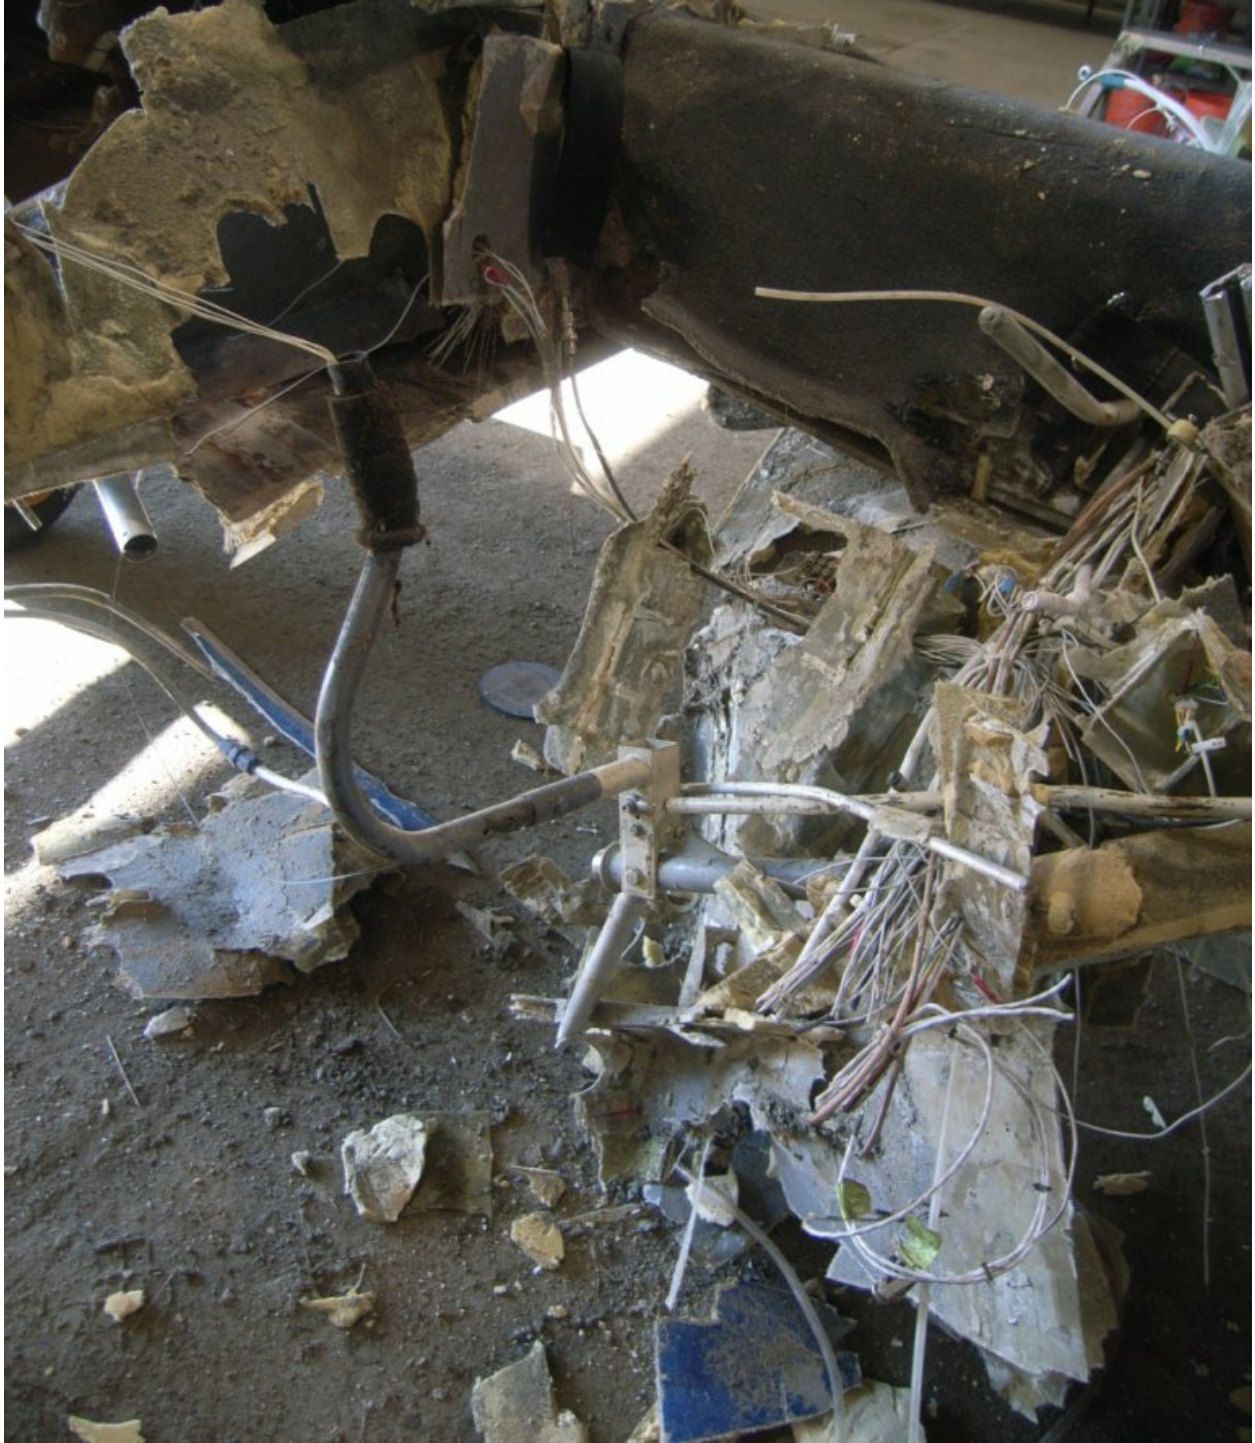
- The wing assembly (both wings and connecting structure) was standing in about 12 inches of water, and slightly embedded in the underlying silt
- Leading edge crush and fracture damage was continuous along the entire span

- Wing damage/disruption was generally absent aft of the main/forward spar
- Both removable (via multiple screws) wingtips were fracture-separated from their respective wings, and both wing-ends exhibited LE crush and fracture damage

- The dual control stick assembly was partially fracture-separated from its cockpit mounts and the airplane control rods
  - All fractures were consistent with one-time overload failure

**Figure 23 - Wings and Center Section**

**Figure 24 - Center Section with Flight Control Segments**

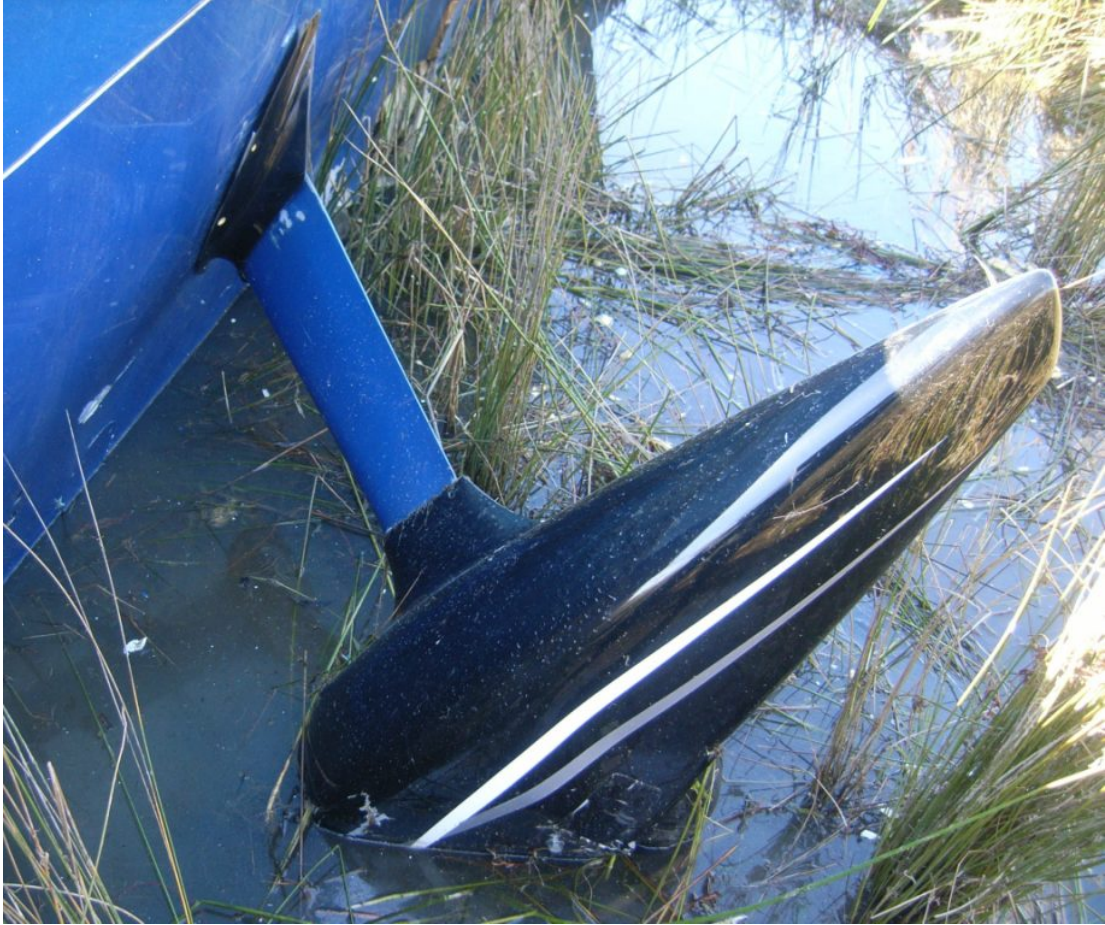
- Both gear legs retained their wheel, tire, and brake assemblies
  - The left wheel pant was partially crushed, and its forward portion was fracture-separated

**Figure 25 - Left Main Landing Gear**

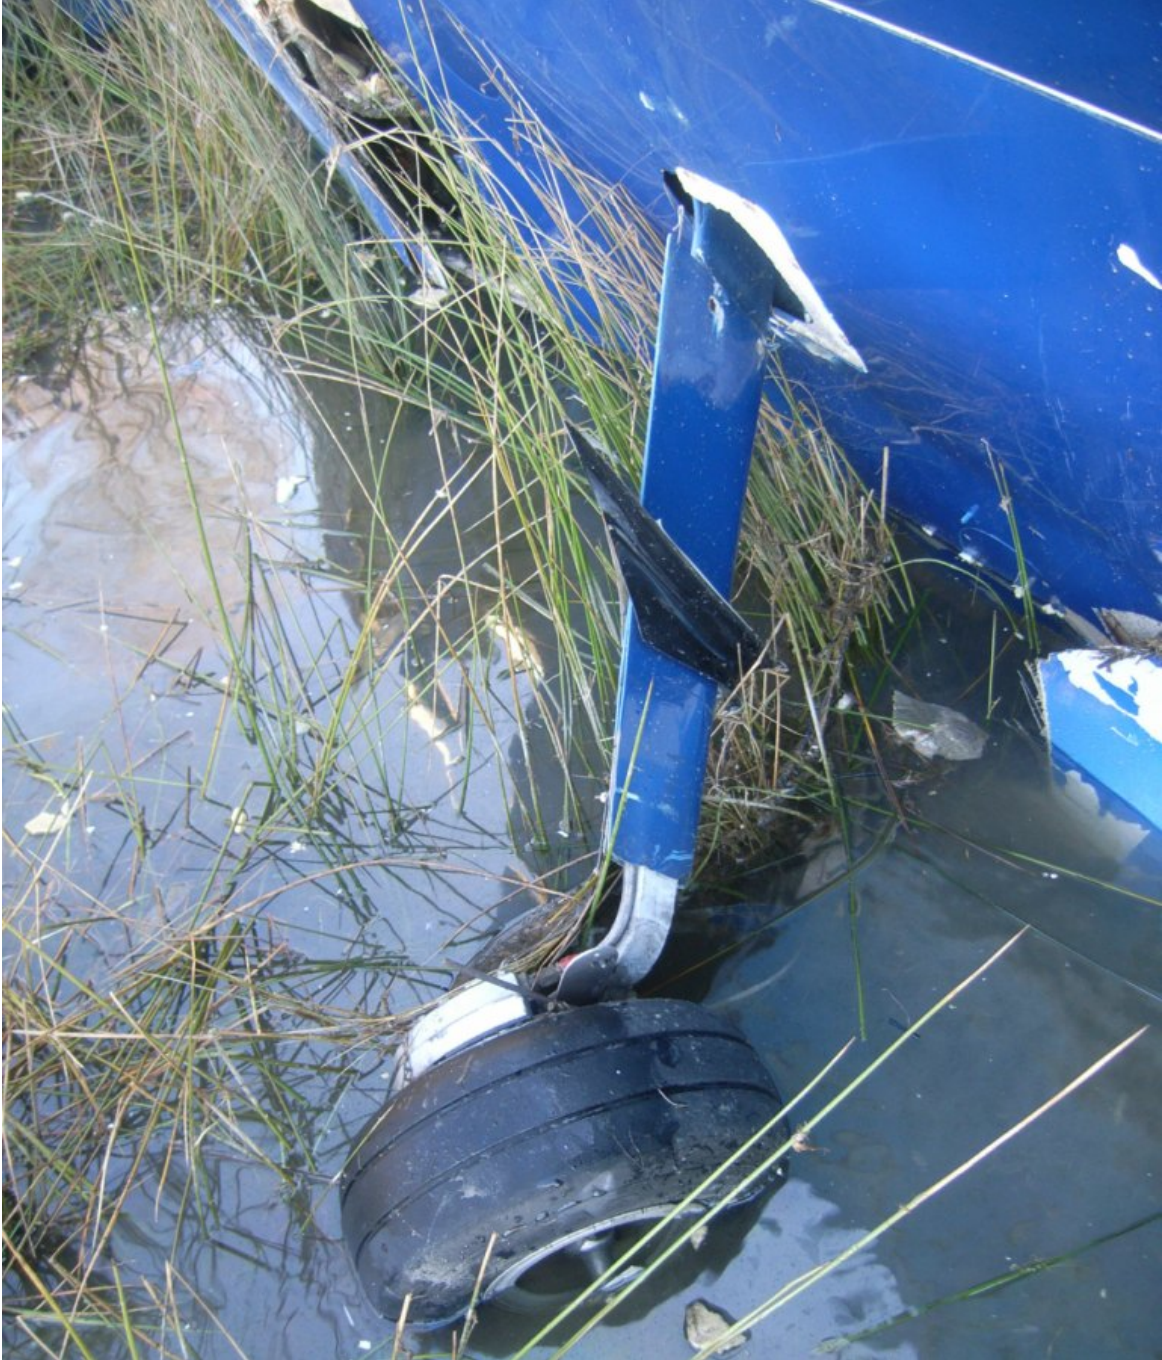
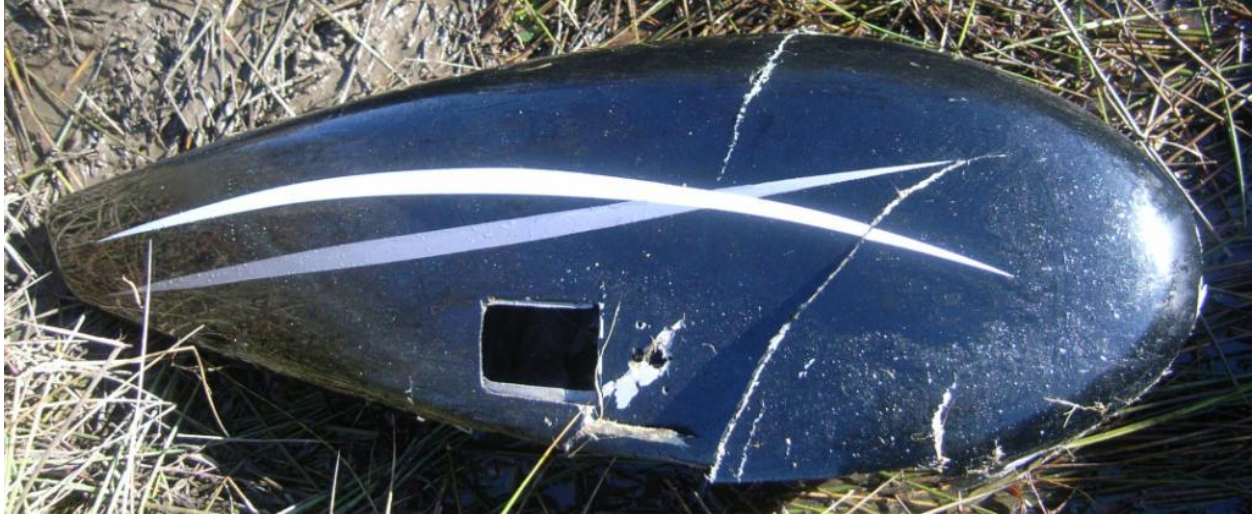
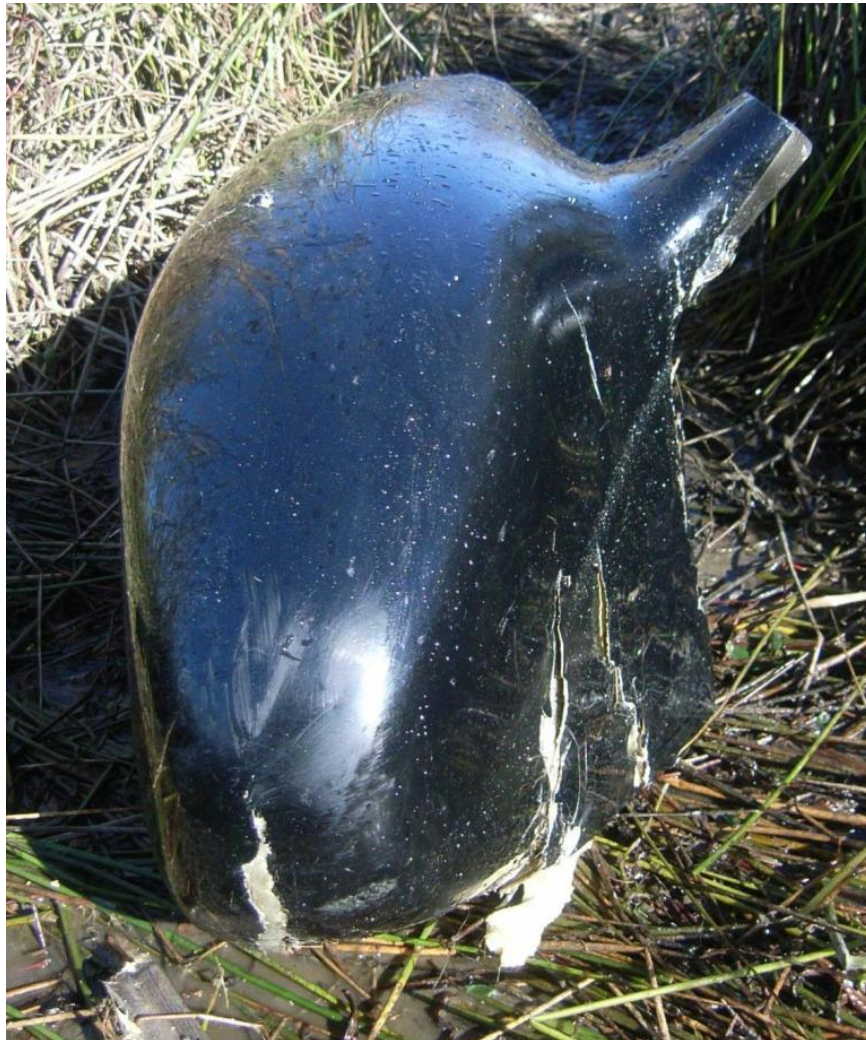
- The right wheel pant was fully fracture-separated from the gear, but relatively intact
- The nose gear leg remained attached to the airframe structure

**Figure 26 - Right Main Landing Gear**

**Figure 27 - RMLG Wheel Pant**

**Figure 28 - RMLG Wheel Pant**

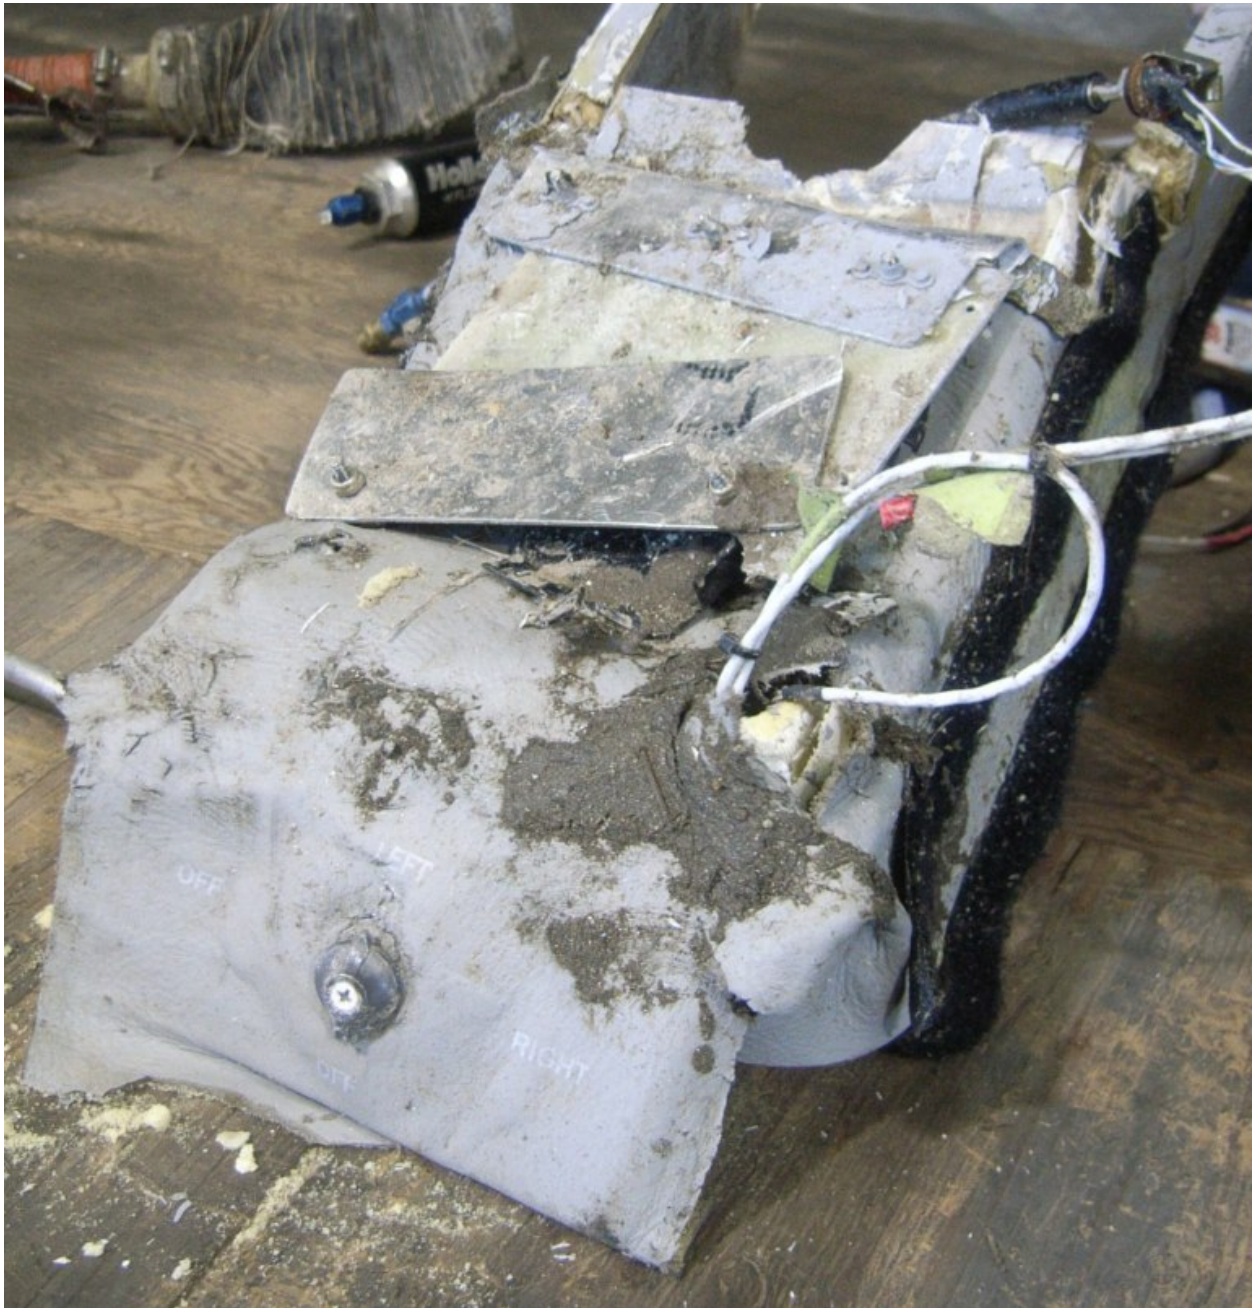
**Figure 31 - Cockpit Center Console (Forward to image top-right)**

- The fuel selector valve was found fully fracture-separated from the airplane, but captive by the console facing which bore the selector setting positions
  - This precluded ready determination of the as-found setting of the selector valve
  - Most of the selector valve handle was fracture-separated from the valve

- Comparison with pre-accident photos of the airplane, combined with damage and fracture information, indicated that the fuel selector valve was found in a position that likely corresponded to the left tank setting
- The valve passage from the (presumed) left tank line to the engine line allowed unobstructed passage of low pressure air
- The valve was unable to be rotated/actuated
- Upon disassembly, the rotatable internal valving/routing mechanism was found to be plastic/nylon, while the valve body appeared to be brass
  - No internal debris was observed in the valve body or passages

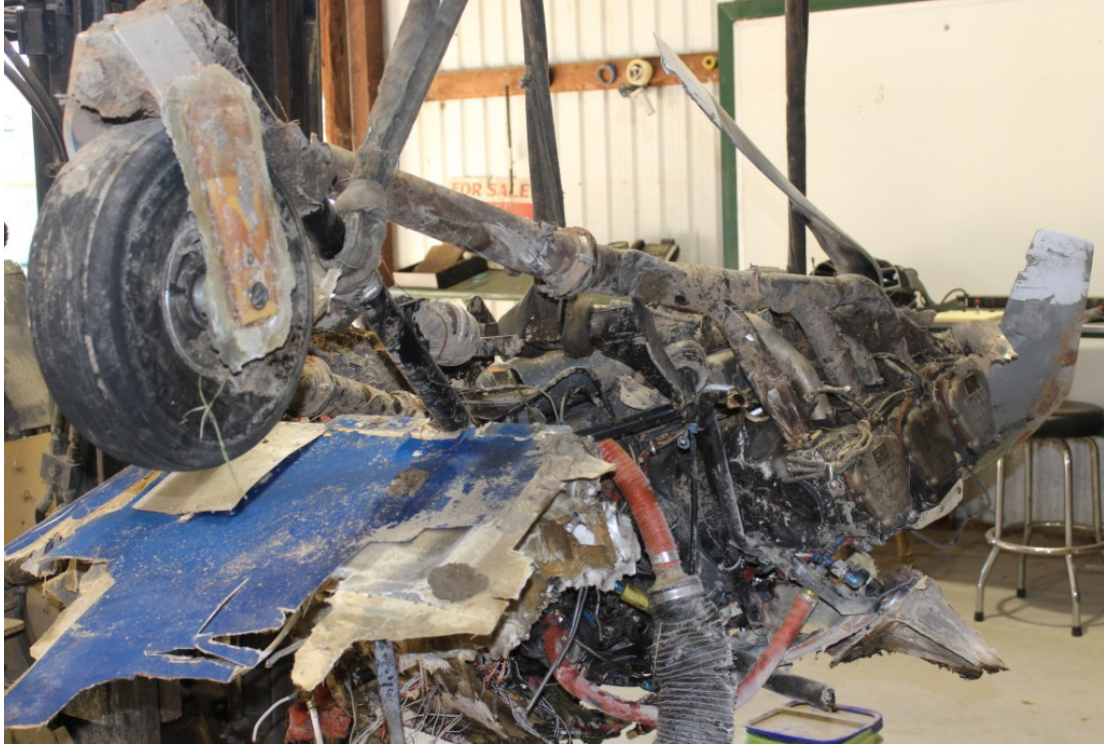
- The nose gear spring leg assembly, including the axle, wheel, and tire, remained partially attached to the firewall/engine mount structure
  - Some of the steel attach tubing was fractured
  - The nose gear assembly was deformed aft and up
  - The nose gear pant was fracture-separated from the gear leg, but fragments of it were identified in the wreckage
- Additional engine cowling fragments remained partially attached, or in close proximity, to the forward fuselage and engine area
  - No evidence of any fire, smoke or heavy oil streaking was observed on any cowl fragments
- No evidence of abnormal or heavy external smoke or oil streaking was observed on any of the airplane skins

**Figure 36 - Nose Gear Attached to Inverted Engine**
