## **NATIONAL TRANSPORTATION SAFETY BOARD**

### **SITE, ON-SCENE, & EXAMINATION INFORMATION Rev A**

**NTSB Accident: WPR17FA041  
Accident Date: December 26, 2016  
Examination Dates: 12/27 & 12/29 2016**

Location: Fresno, California  
Date: December 26, 2016  
Aircraft: Petrus Express S90, N176PA, Serial # 80842  
NTSB IIC: Michael Huhn

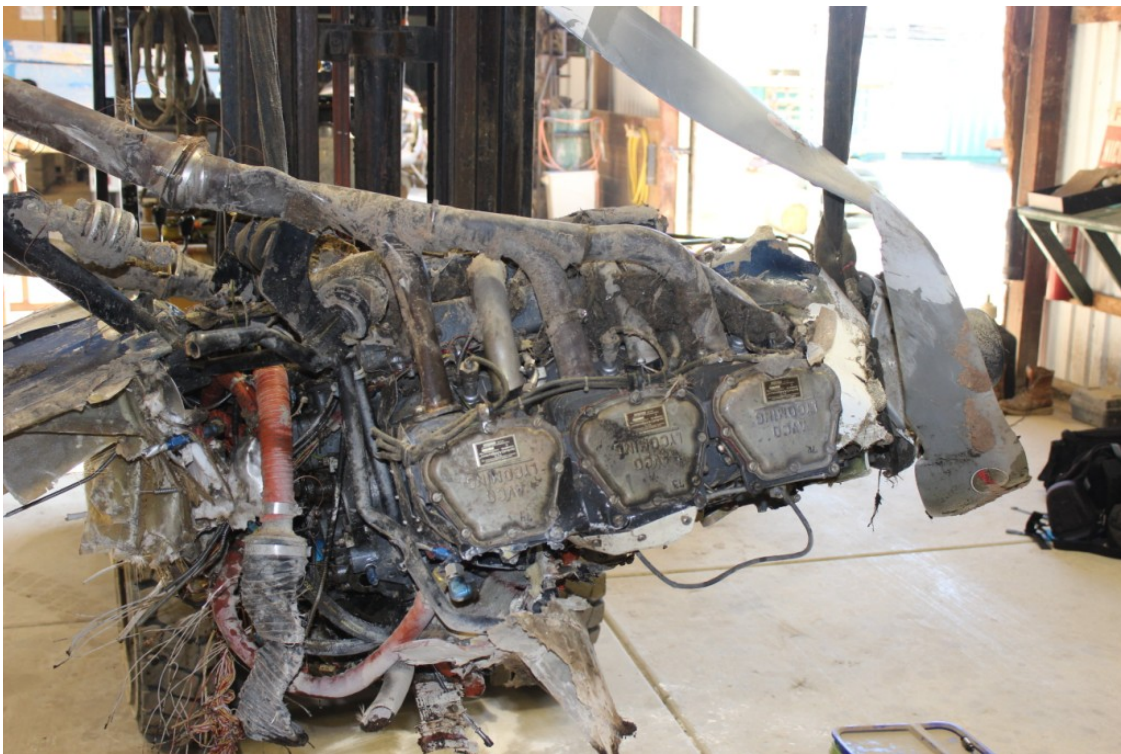
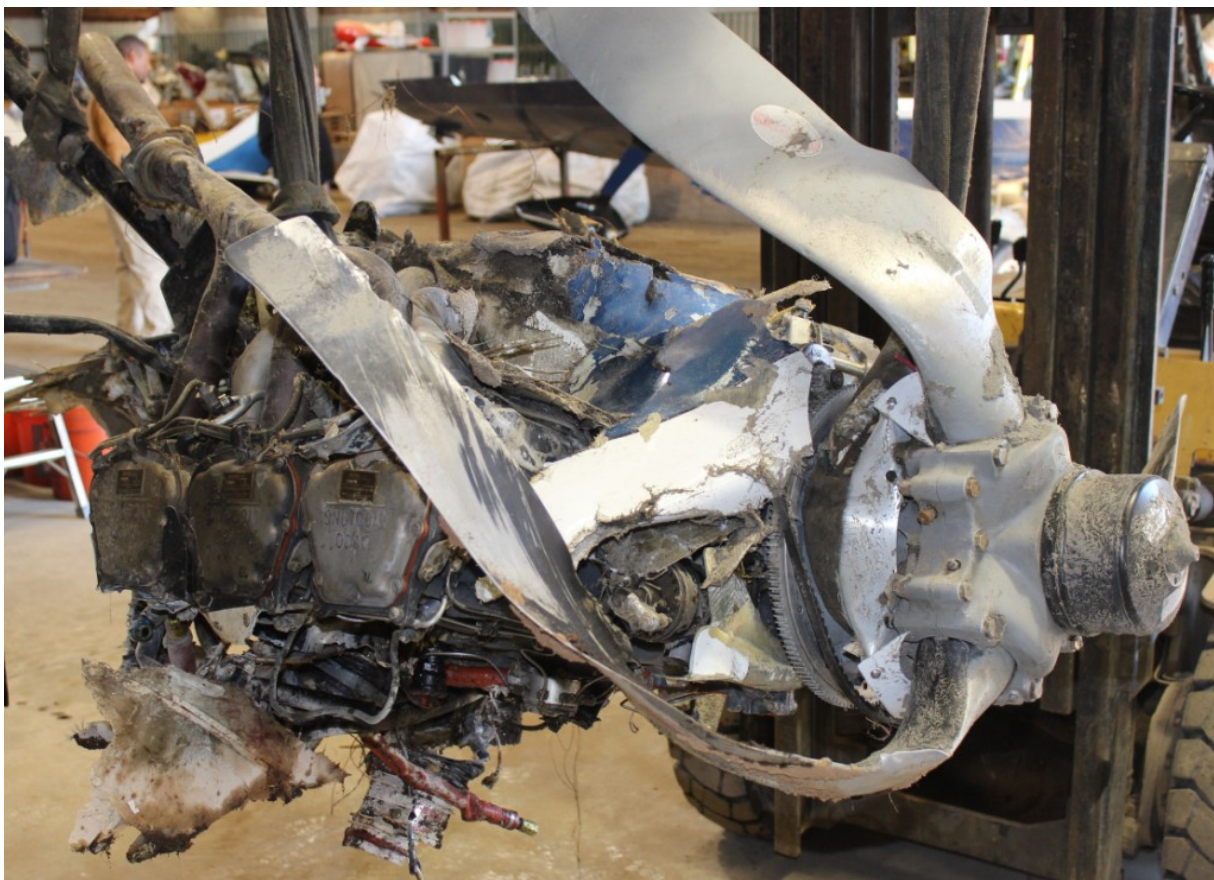
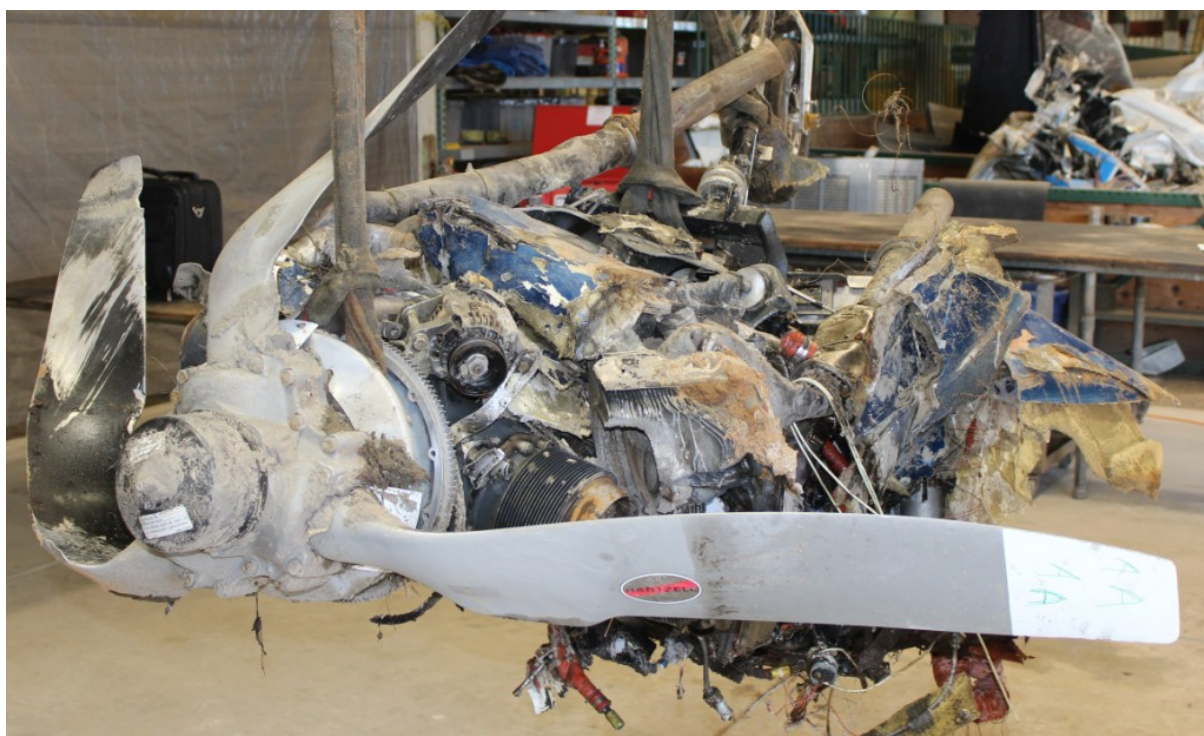
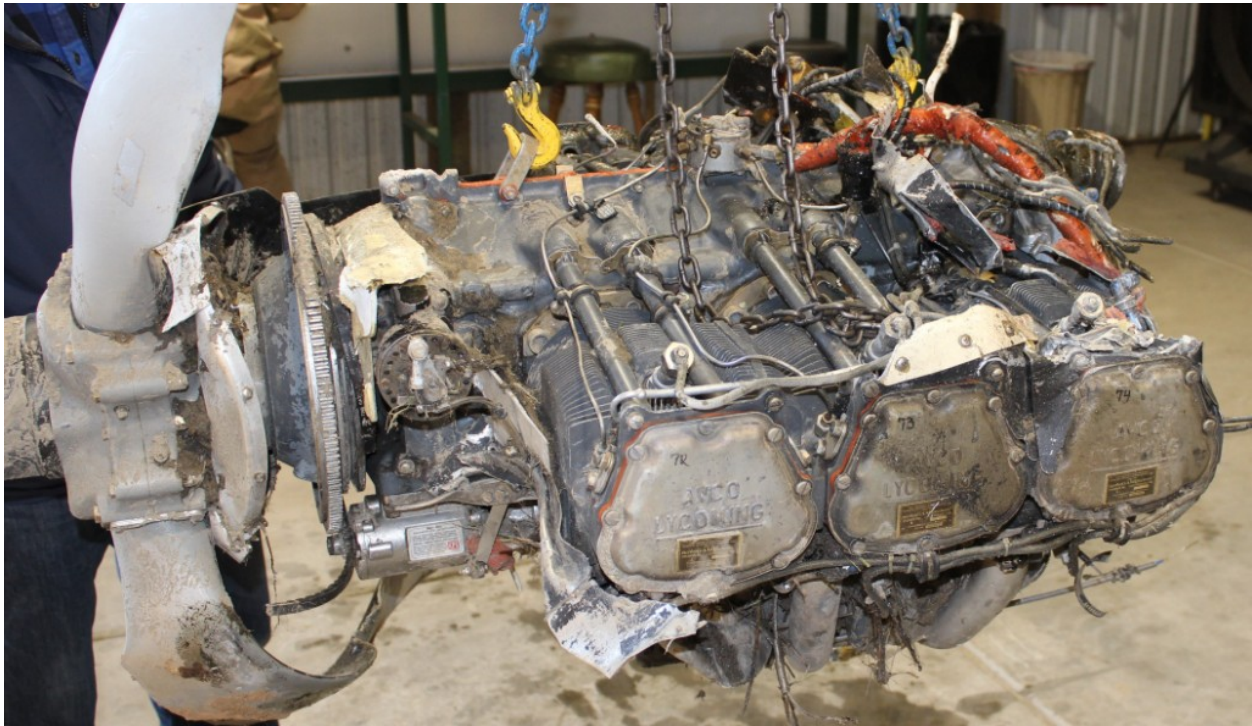
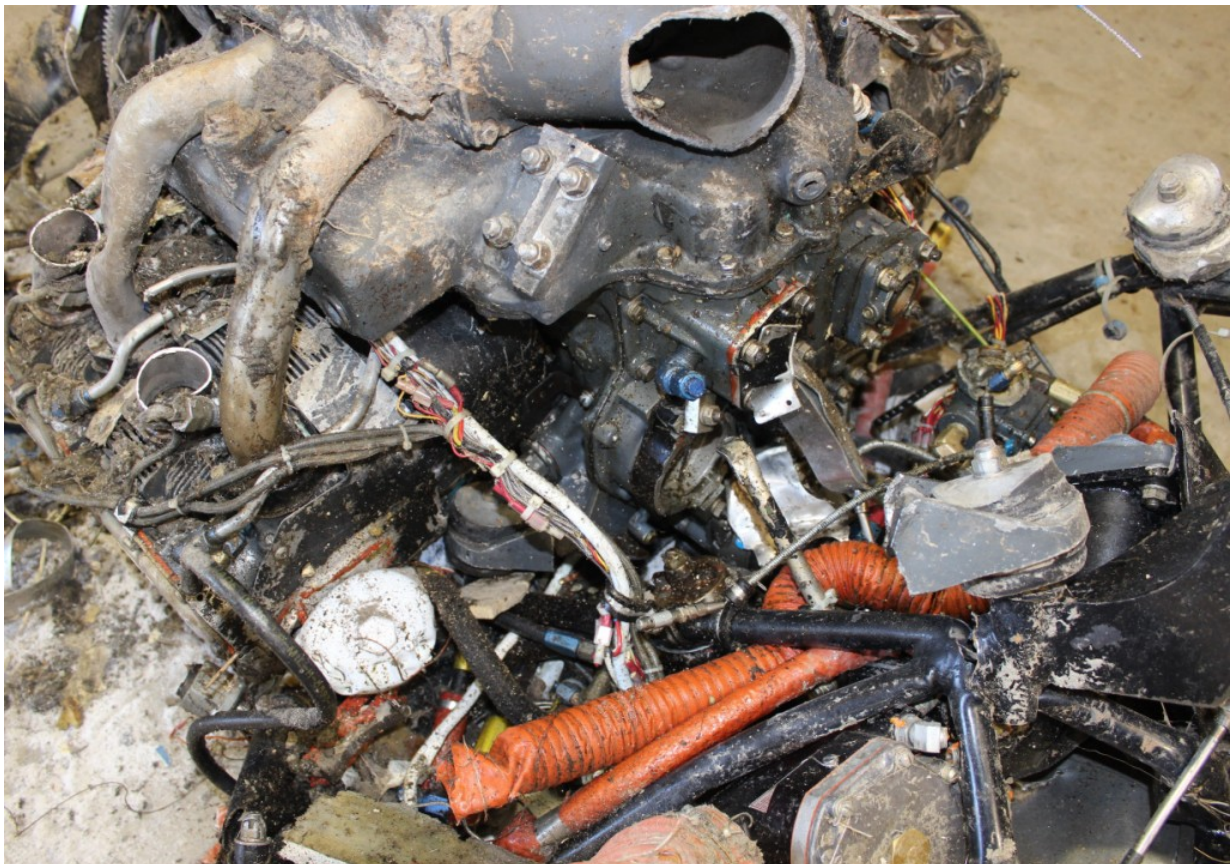
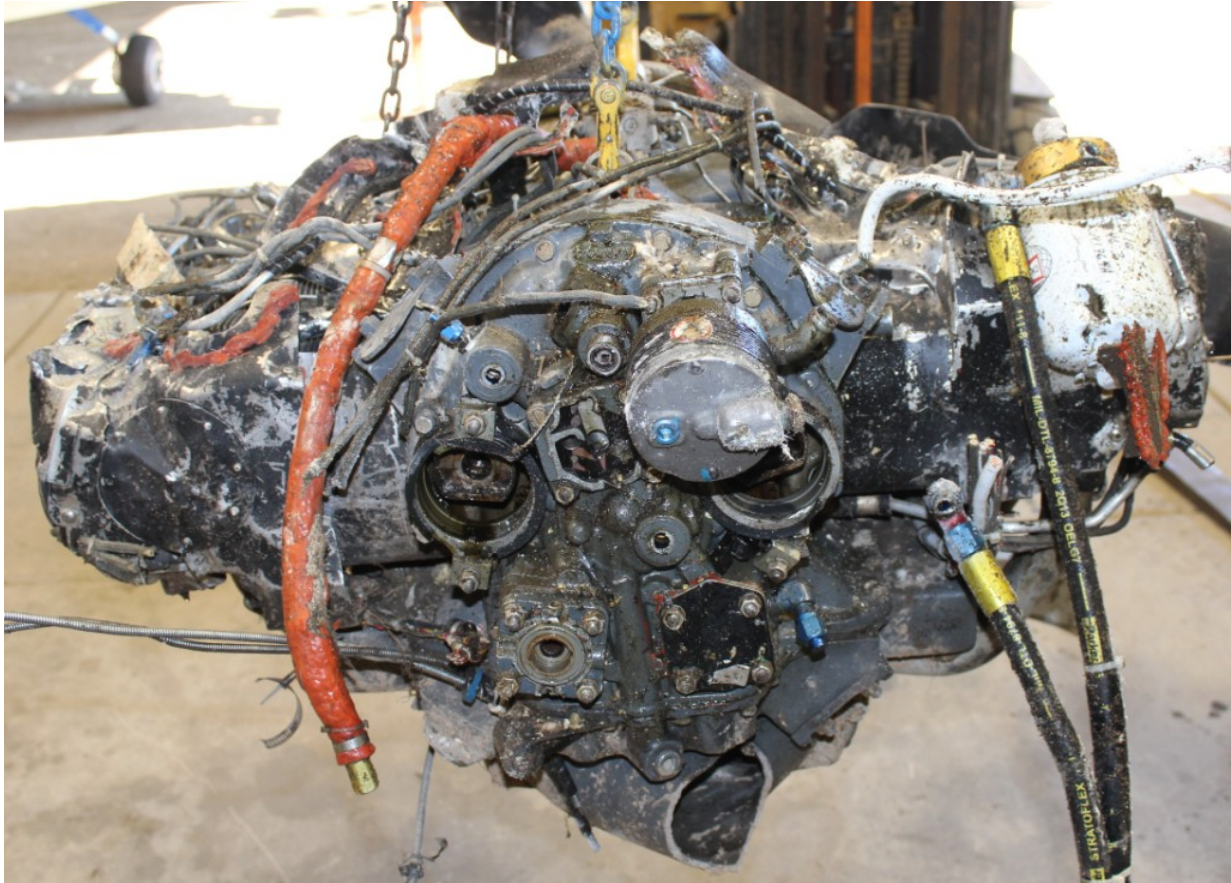
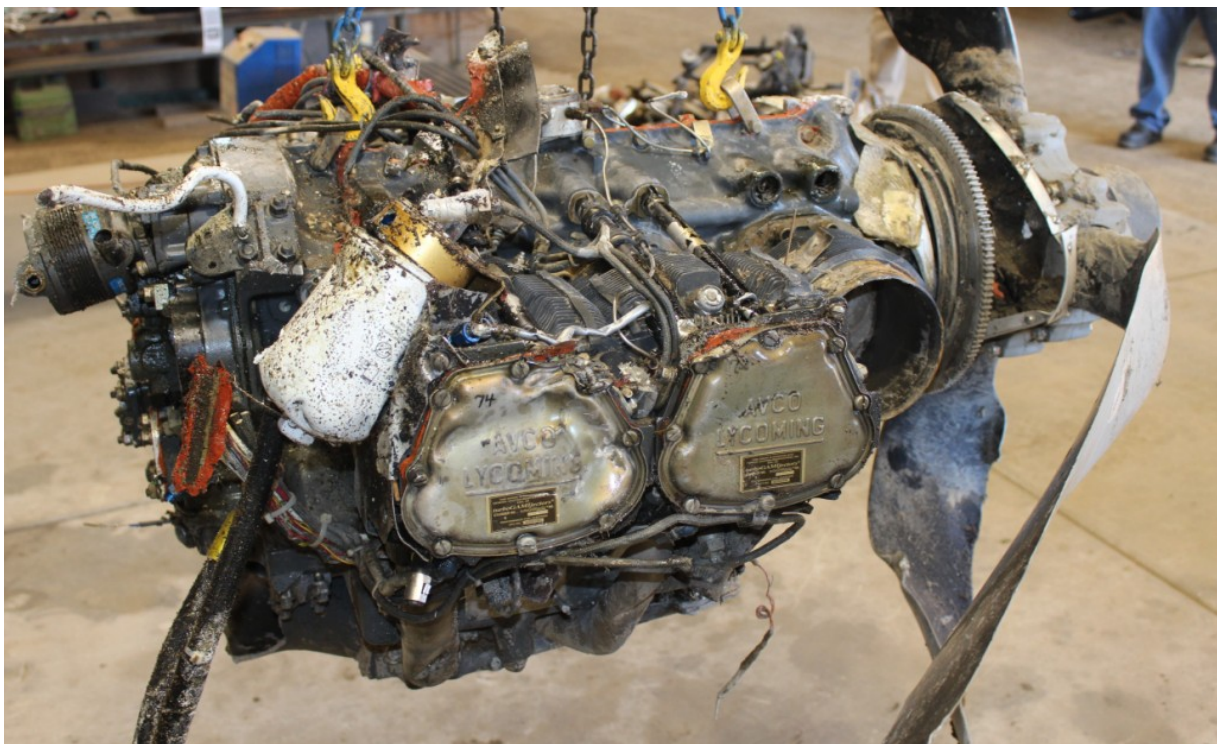
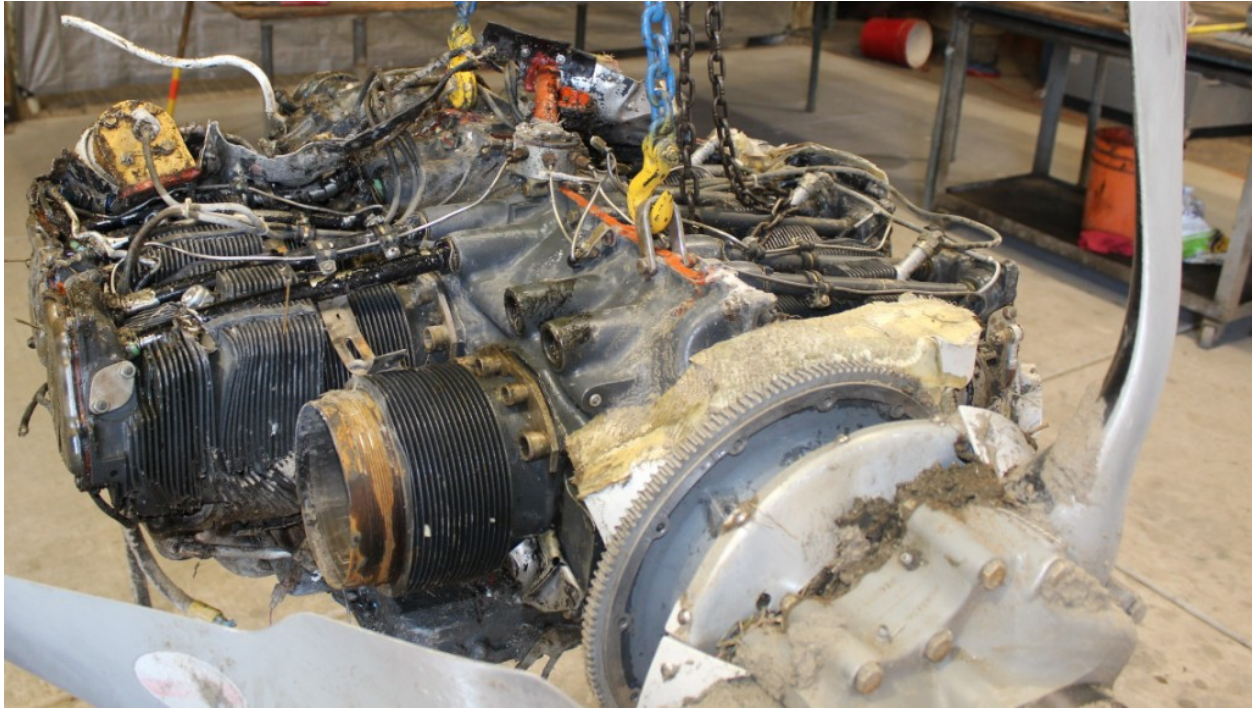
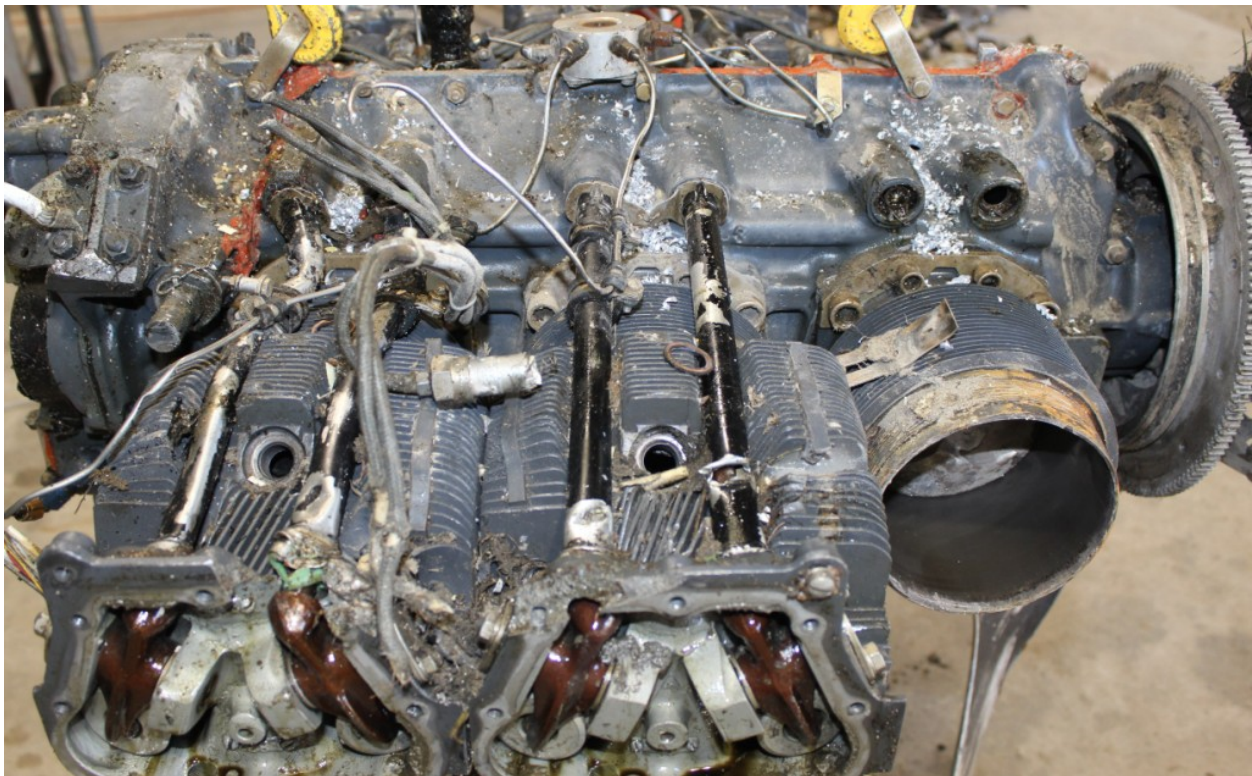
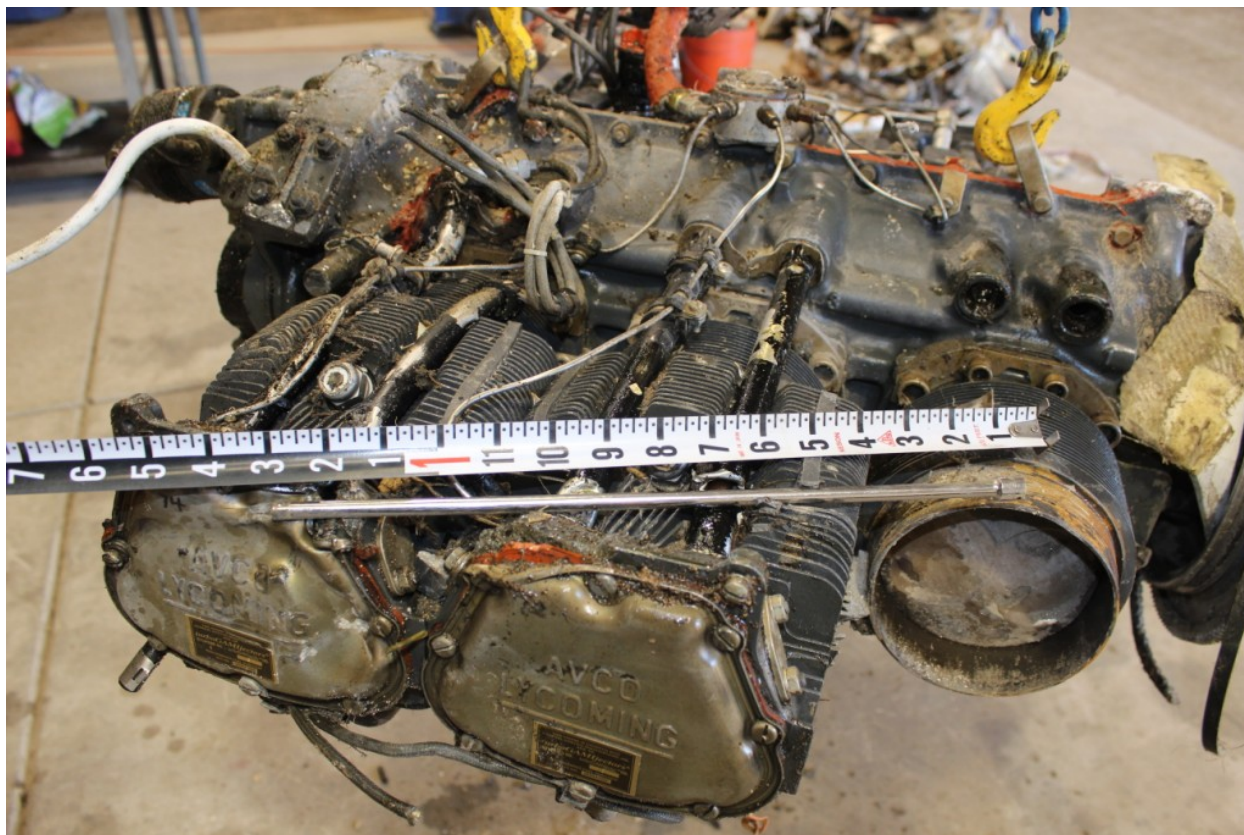
**Figure 37 - Left Side of Inverted Engine**

**Figure 38 - Front Left of Inverted Engine**

**Figure 39 - Front Right of Inverted Engine**

Figure 40 - Top Left of Upright Engine

- The engine data plate indicated that the engine was a Lycoming IO-540-K1E5, serial number L-11658-48
- The engine was moderately intact, but had sustained crush damage in the aft and up directions on the bottom and sides, and metallic object strike damage on top

- The head, valves, rocker assembly, and rocker cover were fracture-separated from the No.1 cylinder, but partially retained by the baffling and other components

- Some fragments of those components were identified on scene, consistent with their separation at the accident site
  - The No. 1 cylinder bore shear/smear damage consistent with being cut/sheared by a metal object

**Figure 41 - Aft Lower View of Inverted Engine**

**Figure 42 - Aft Face of Upright Engine**

**Figure 43 - Right Side of Upright Engine**

**Figure 46 - Front Upper Right of Upright Engine**

**Figure 47 - Top Right of Upright Engine**

**Figure 48 - Top Right of Upright Engine**

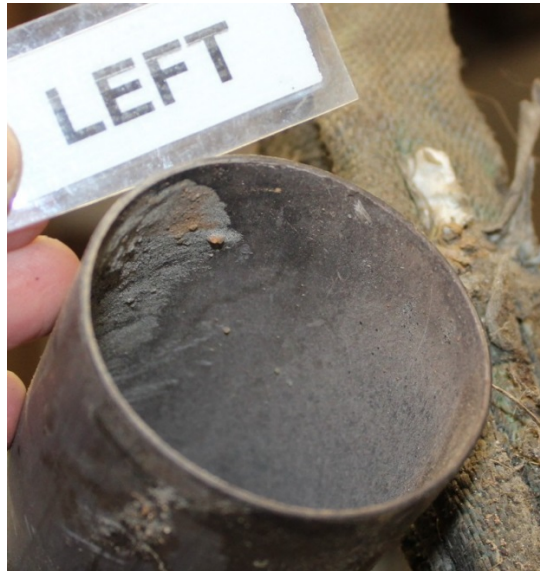
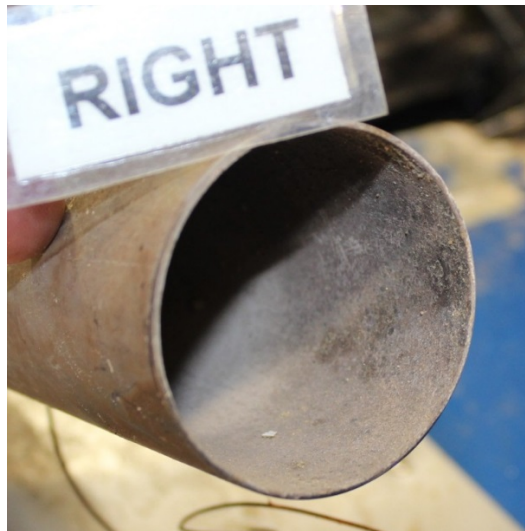
- The left side tubing was relatively undamaged, whereas the right side tubing displayed moderate crush damage
  - The interior surfaces of the two exhaust pipe exits appeared dark gray to tan in color, but were partially contaminated by silt from the lake, and displayed some light corrosion. There was no oil residue observed in the exhaust pipes.

**Figure 44 - Left Exhaust Outlet**

**Figure 45 - Right Exhaust Outlet**

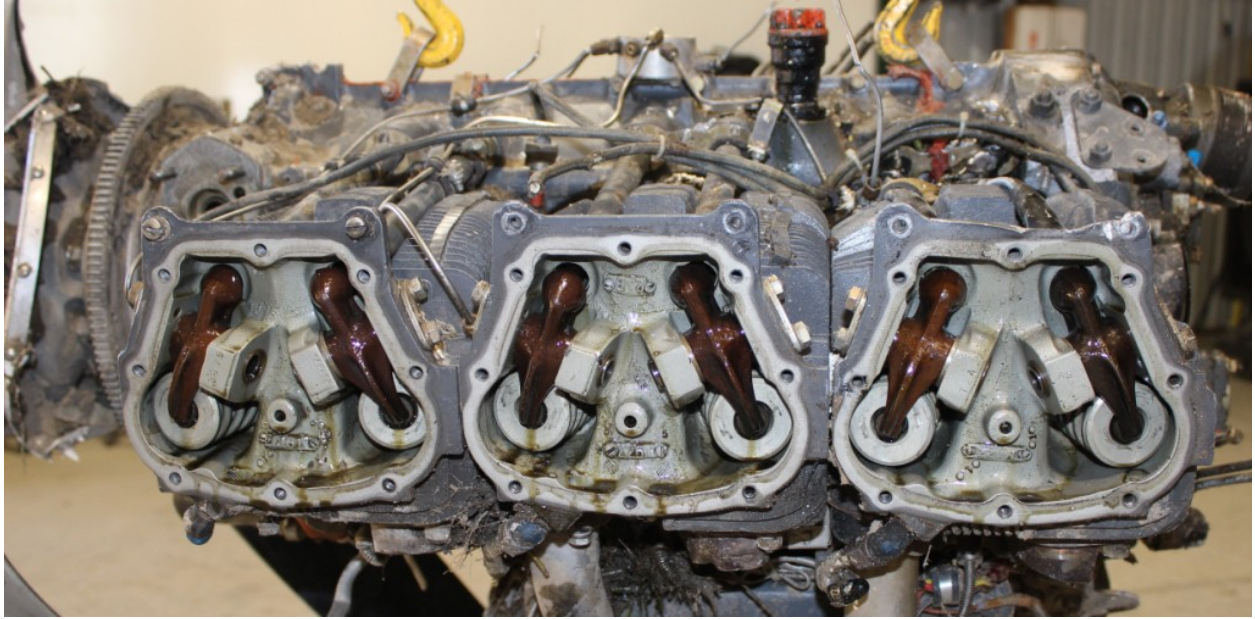
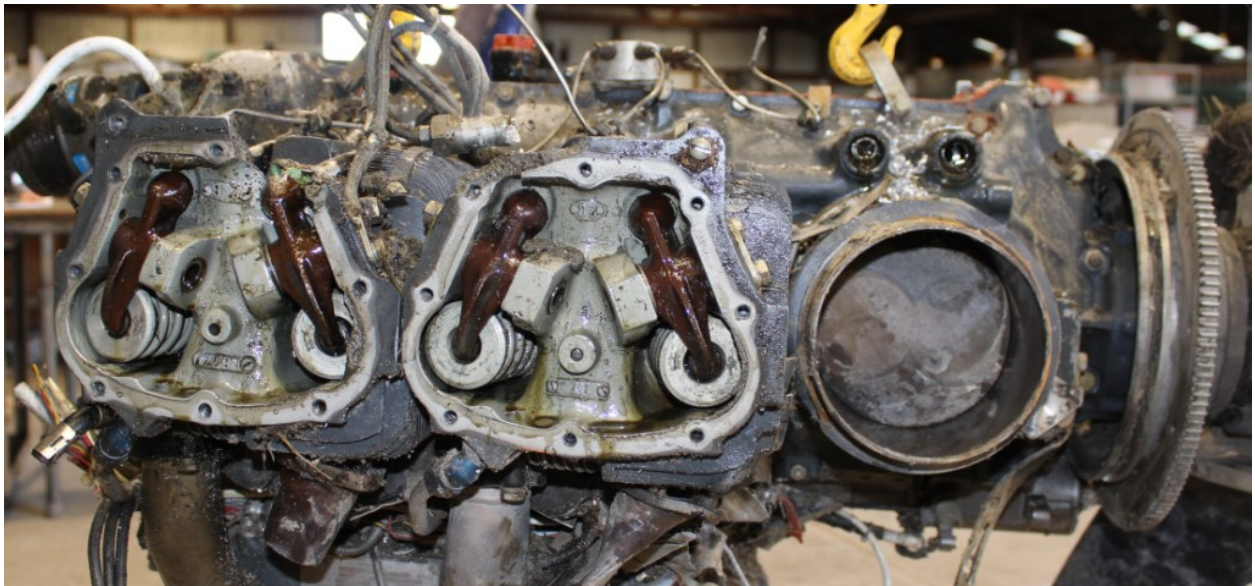
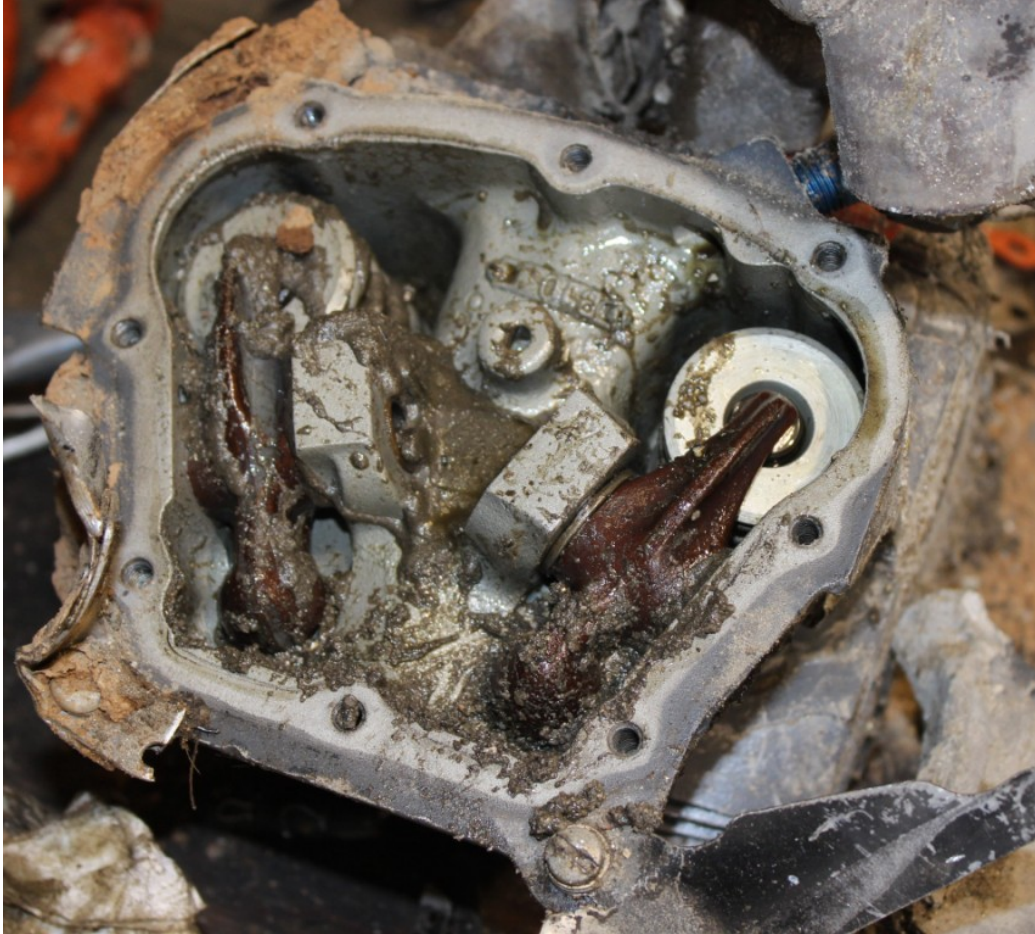
- Several pushrods and pushrod tubes were significantly damaged, and all damage was consistent with external impact
  - None displayed damage consistent with internal failure
- Exclusive of the valve assemblies struck by the propeller, none displayed any damage
  - No damage was consistent with any internal mechanical malfunctions or failures

**Figure 51 - Left Cylinder Bank Rocker Assemblies**

**Figure 52 - Right Cylinder Bank Rocker Assemblies**

**Figure 53 – No. 1 Cylinder Rocker Assembly**

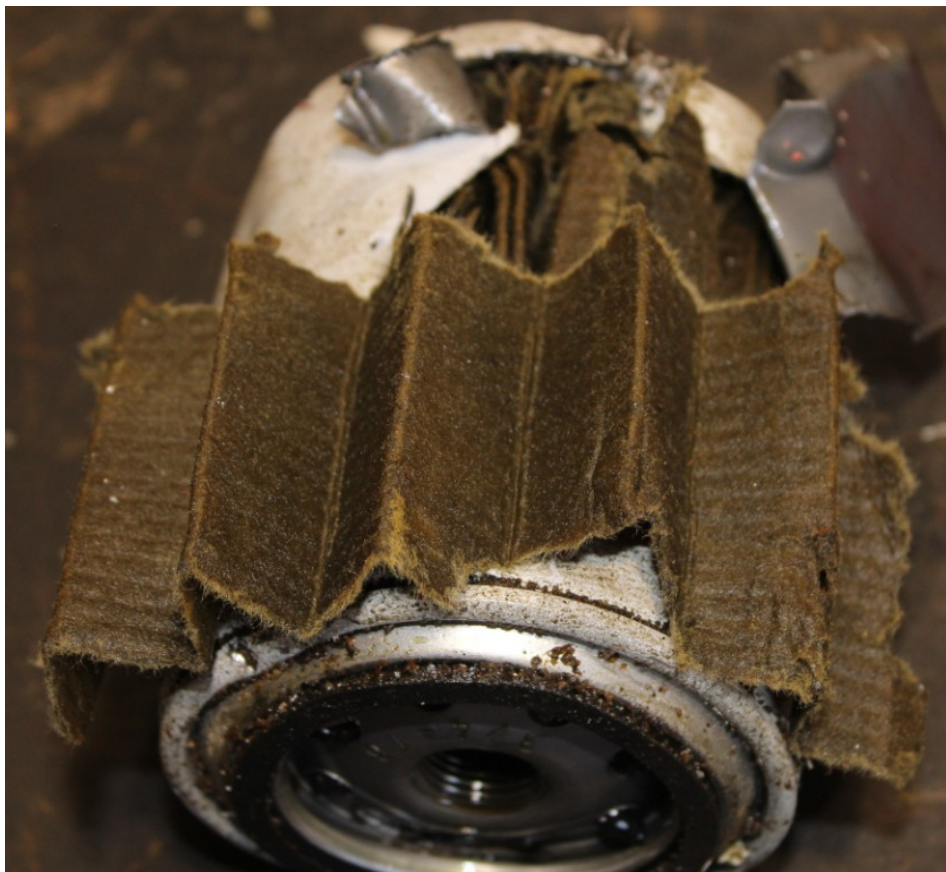
- The oil filler cap remained securely installed in its crankcase mount
- The engine internal oil screen was found to be clean/unobstructed
- The filter element of the externally mounted, spin-on oil filter was free of debris or contamination

**Figure 55 - External Oil Filter Internal Filter Element**

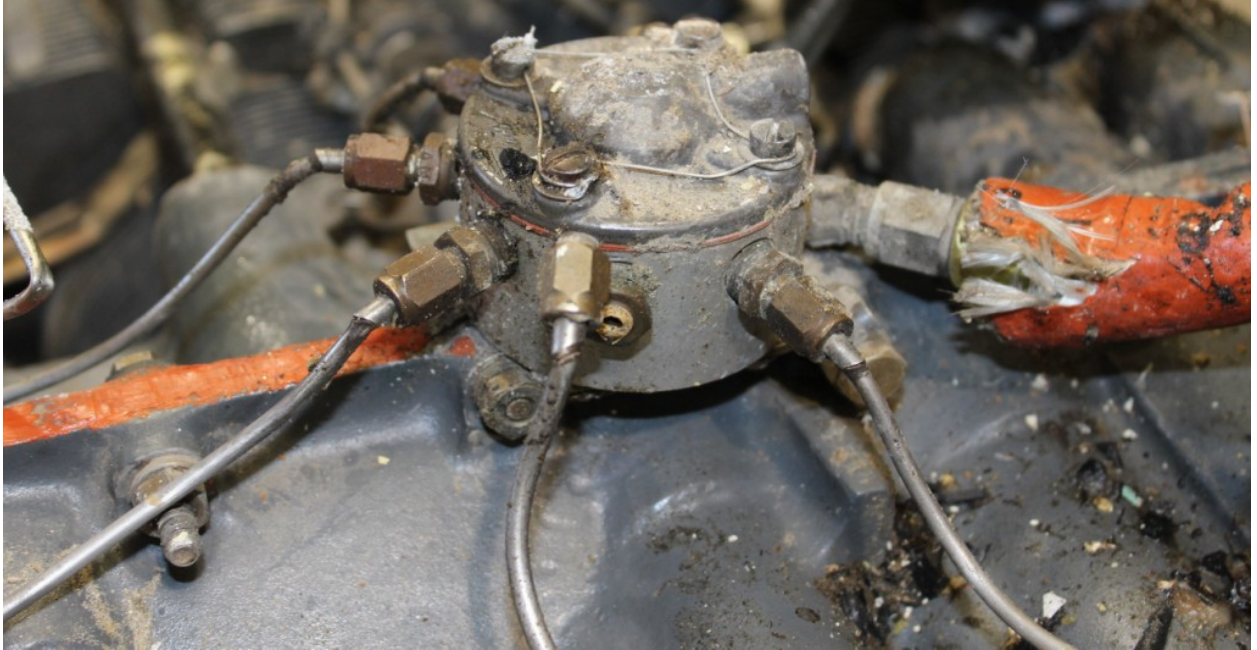
- The flow divider (fuel manifold distribution valve) remained intact and securely attached to the engine in its normal location
  - With one exception, all fuel line fittings and at least portions of their fuel lines were securely attached to the valve body
  - One was fracture-separated at the body/fitting interface; the fracture was consistent with one time overload
  - All lines were deformed down (towards the engine crankcase) by impact
  - When opened, the internal components of the valve were all clean and intact (including the diaphragm), and no foreign material or corrosion was observed

**Figure 57 - Flow Divider**

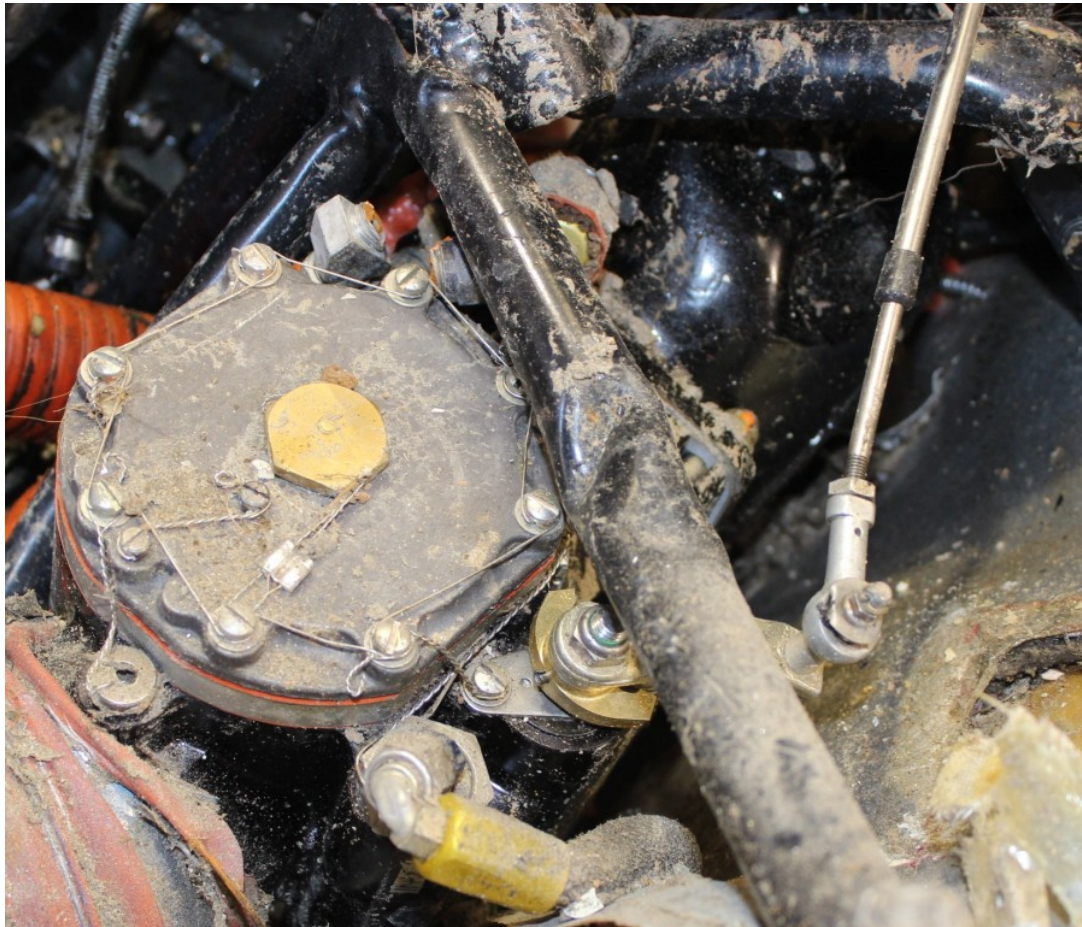
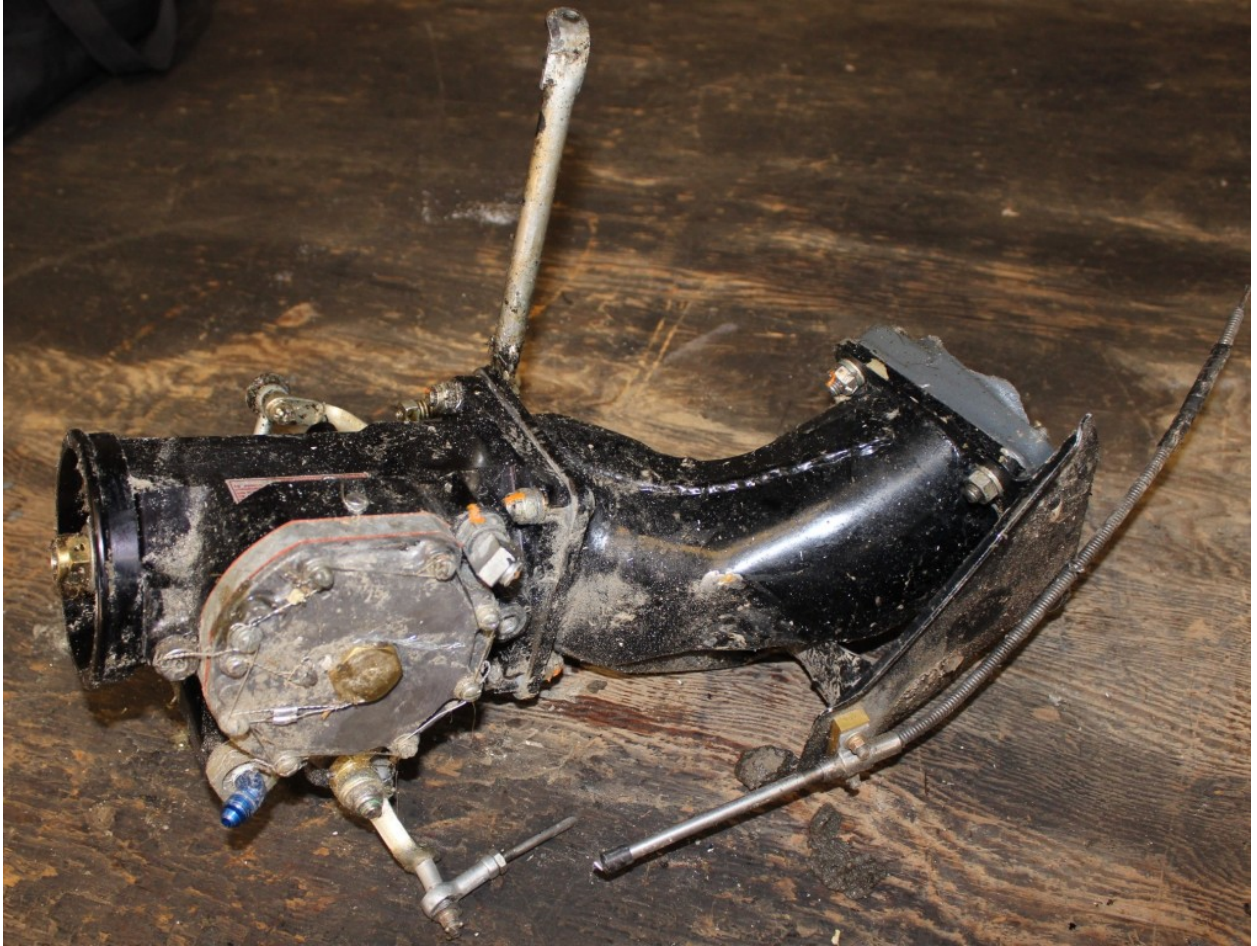
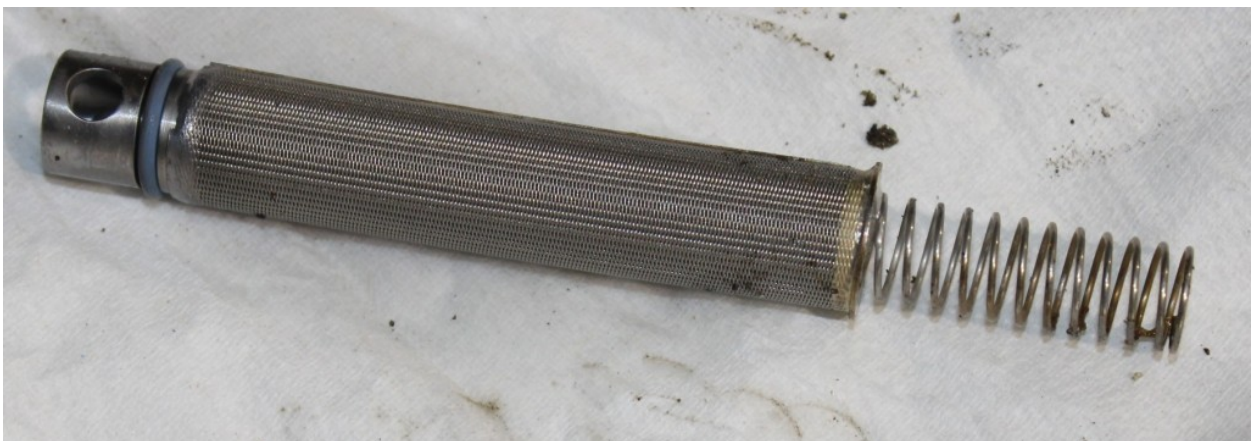
- Fuel Servo
  - Precision Airmotive Model RSA-10ED1
    - SN 72GP1101
    - Parts List No 2524298-12
    - "I.C." 38U
  - The throttle and mixture control rods remained securely attached to their respective control arms
  - The internal inlet fuel screen was clean and unobstructed

**Figure 60 – Partially Attached Fuel Servo**

**Figure 61 - Removed Fuel Servo**

**Figure 62 - Fuel Servo Screen**

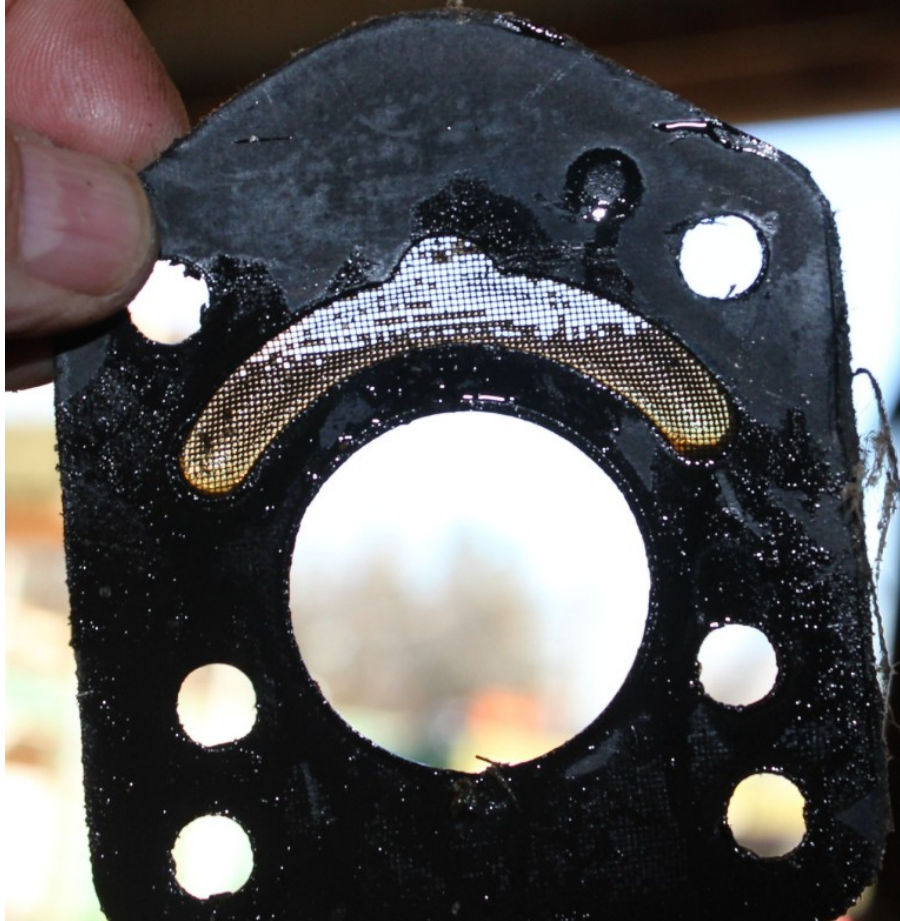
Figure 68 - Propeller Governor Screen

- The propeller governor remained securely attached to the engine in its normal position and orientation
  - o EDO-Aire PN 34-828-014-1 SN 8384
  - o The oil screen was clean & unobstructed
  - o The control rod was fracture-separated at the governor rod-end
  - o The fracture face was consistent with one-time overload

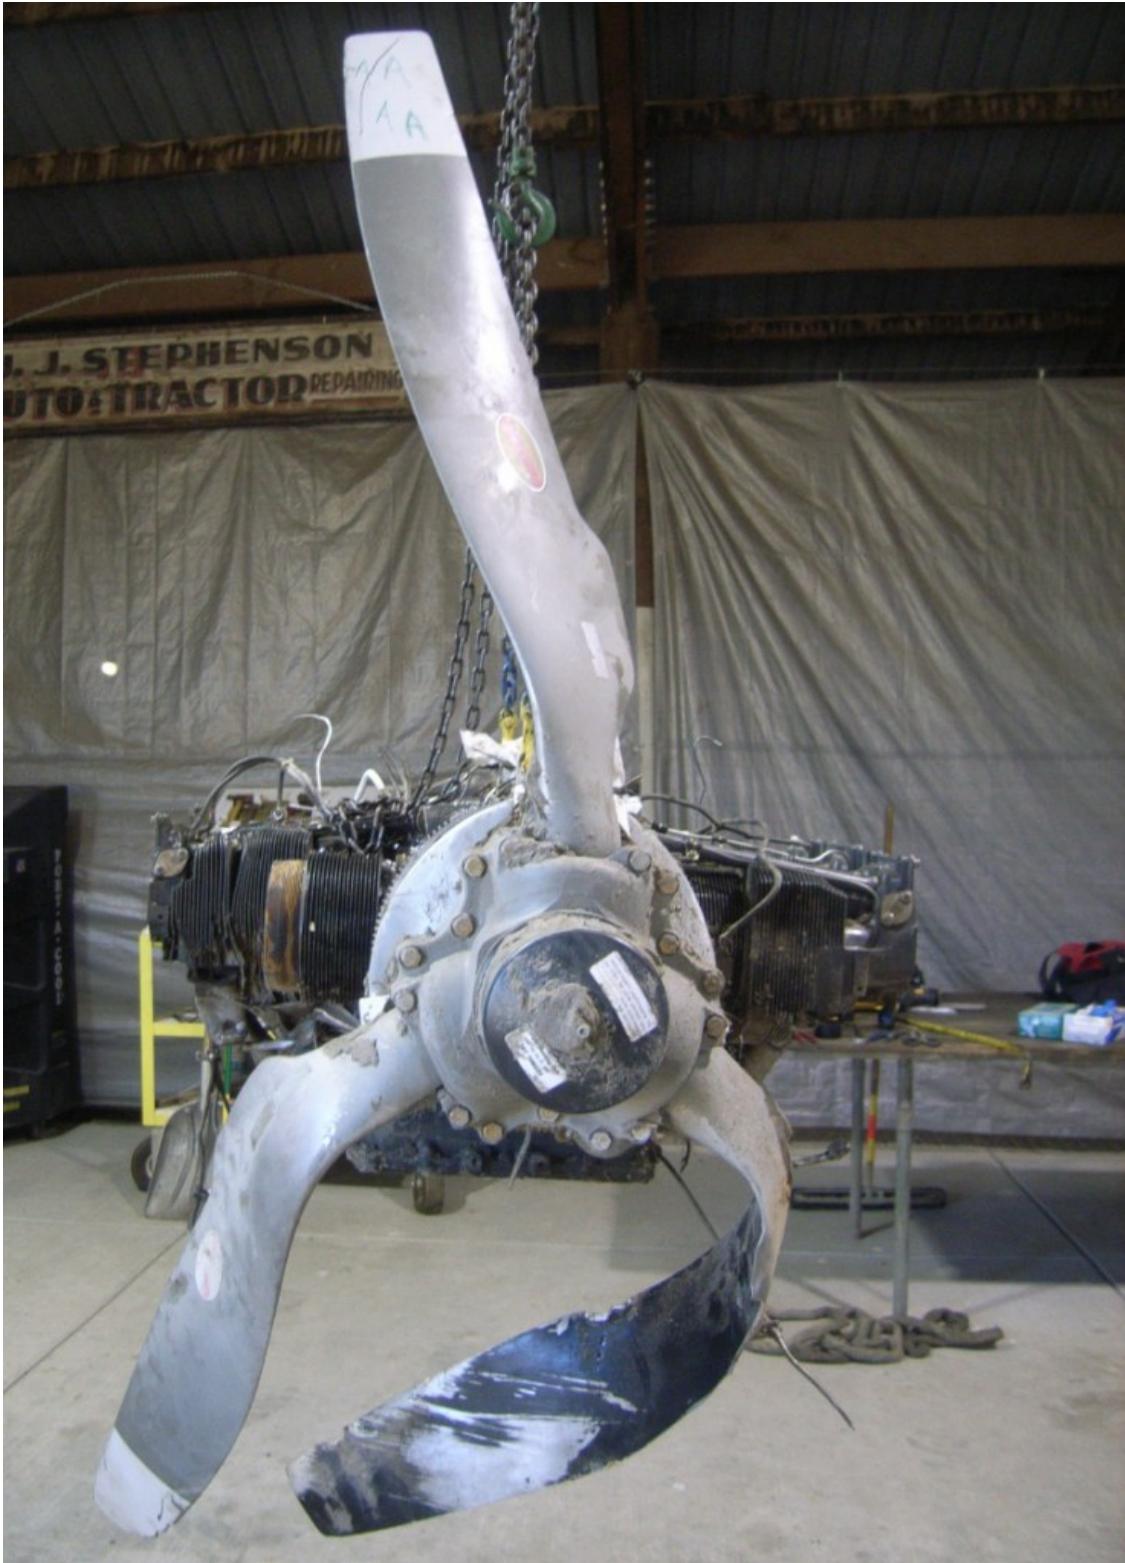
**Figure 69 - Propeller**

- The propeller was a Hartzell model HG (or HC)-C3YR-1RF, an all-metal, 3 blade, controllable pitch design
  - Hub SN DY4219A
- The propeller hub was intact, and all 3 blades were retained in the hub
  - At least one blade was able to be rotated in the hub
- All 3 propeller blades exhibited significant bending/twisting deformation, and scoring/gouging
- The spinner was not identified in the wreckage
  - The spinner attach screws remained in the spinner mounting flange that remained attached to the engine/propeller
  - The previous owner reported that the spinner was composite
