# Continental Motors

## ENGINE FIELD INSPECTION REPORT

| AIRCRAFT MAKE & MODEL | Cessna 150M |
| FILE NUMBER | 16-628 |

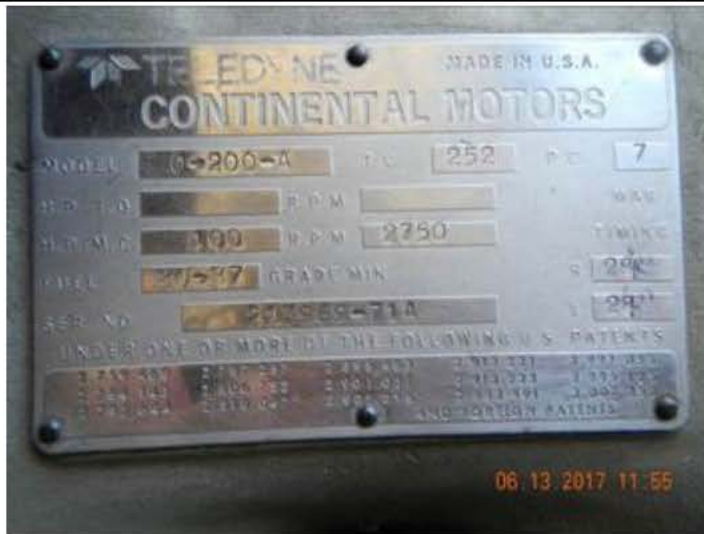
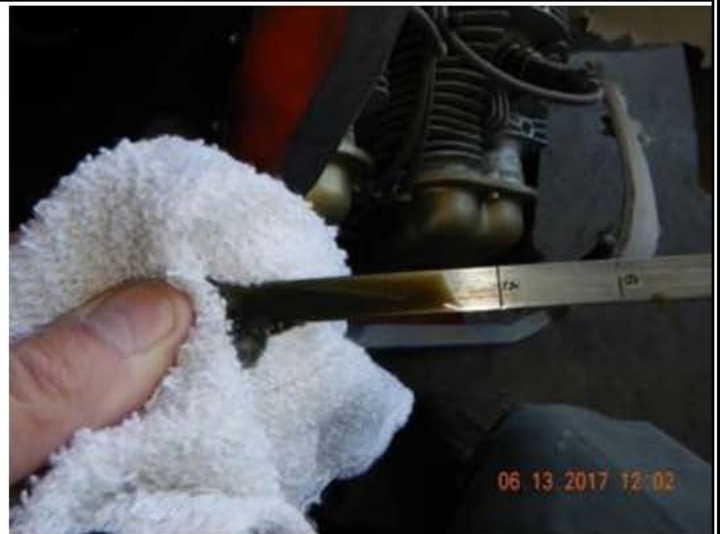
The damaged engine cowlings were removed to facilitate an inspection of the engine. The engine mount was broken and only engine control cables and wiring were securing the engine to the airframe. The engine exhibited only minor impact damage and the propeller remained attached to the crankshaft propeller flange.
