# Continental Motors

## ENGINE EXAMINATION REPORT

| ENGINE MODEL | IO-520-C3 |
| FILE NUMBER | 16-656 |

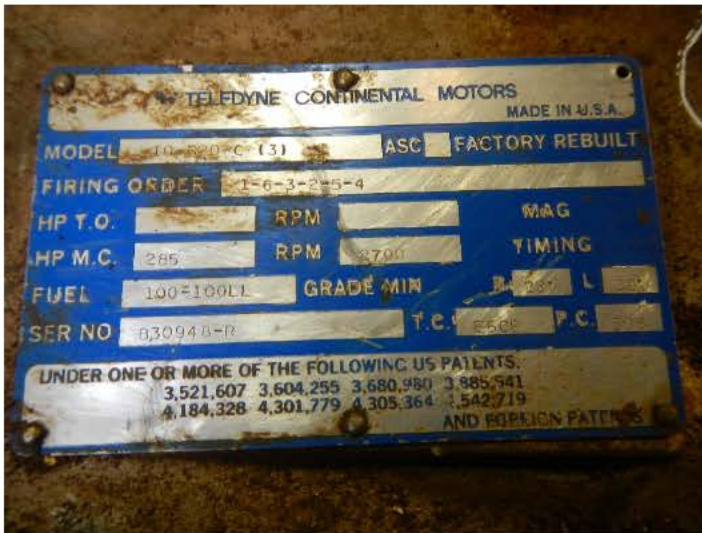
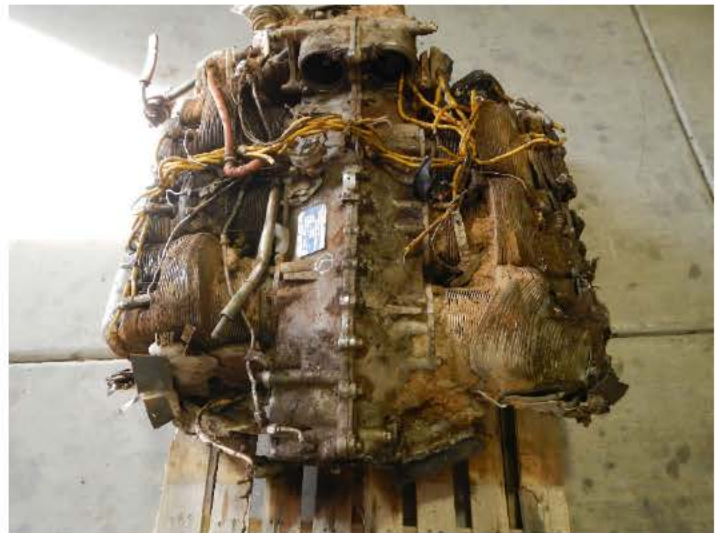
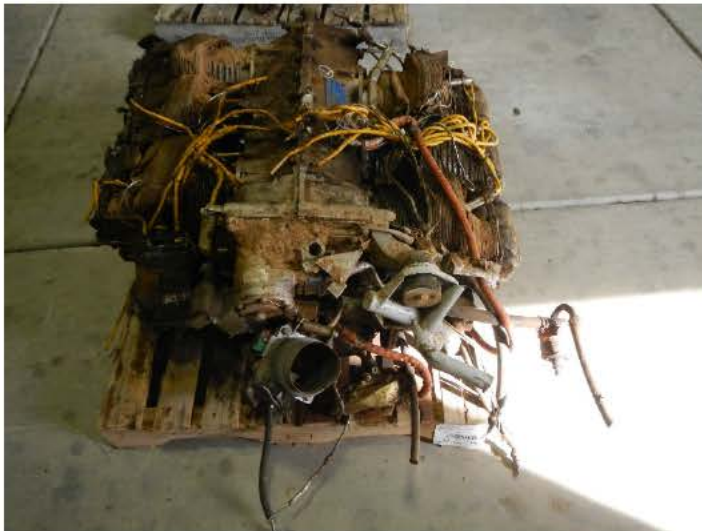
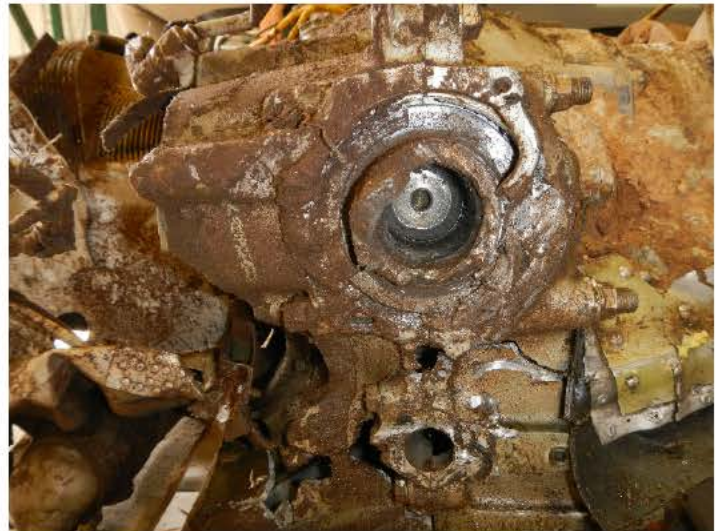
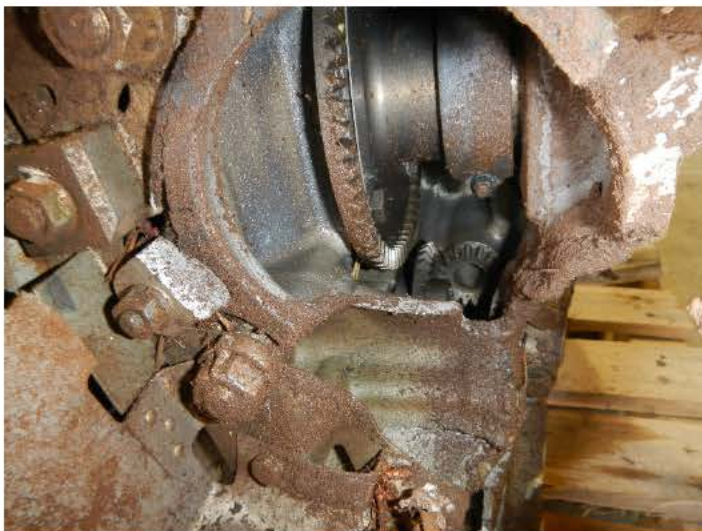
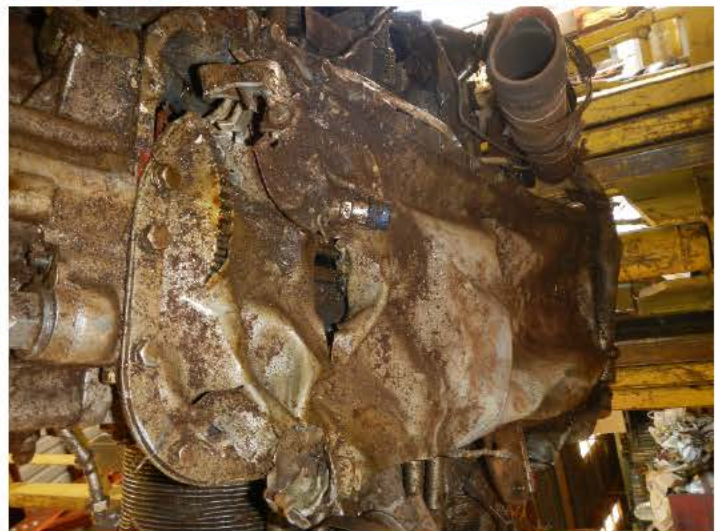
The propeller was separated from the engine and the engine was lying in an upright position on top of a wooden pallet. The crankshaft was fractured aft of the propeller flange and the crankcase around the nose seal sustained deformation damage. The exhaust system was separated from the engine as were the magnetos. All six cylinders sustained deformation or fracture damage to their cooling fins and/or rocker covers. The bottom front crankcase was fractured and the engine-driven alternator was separated from the engine. The alternator face gear and propeller governor drive and bevel gears were visible through the fractured case with no pre-accident anomalies noted. The crankshaft and oil transfer collar were intact and did not show any signs of lubrication distress.

The engine-driven fuel pump remained attached to the backside of the engine and the vapor return fitting was fractured. The throttle body remained attached to the engine. The throttle lever was bent and the throttle body was deformed around the throttle valve which was in the full open position. The fuel metering unit was separated from the throttle body. The throttle and mixture control cables remained secured to their control levers, but the levers were bent and deformed. The fuel manifold valve was separated from its mount and all injector lines were separated from the housing, except one.

The oil pump housing was fractured but the pump remained attached to the backside of the engine. Only the fractured remains of an oil filter were observed in the wreckage. The oil cooler was separated and deformed and the oil sump was deformed and fractured.

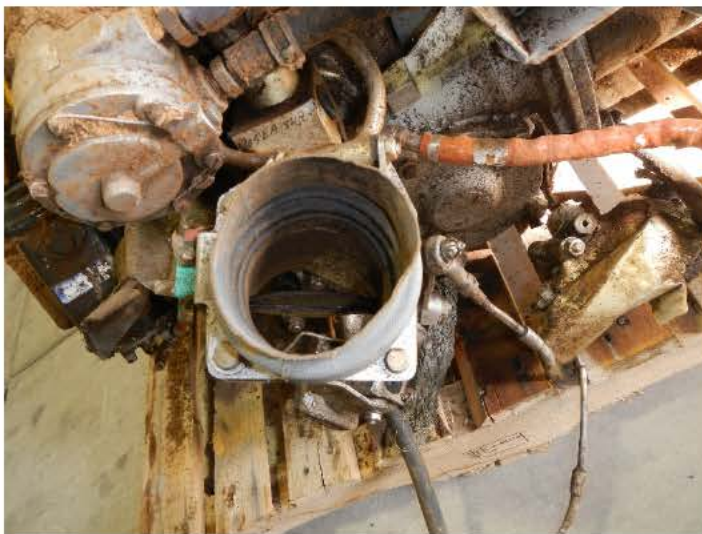
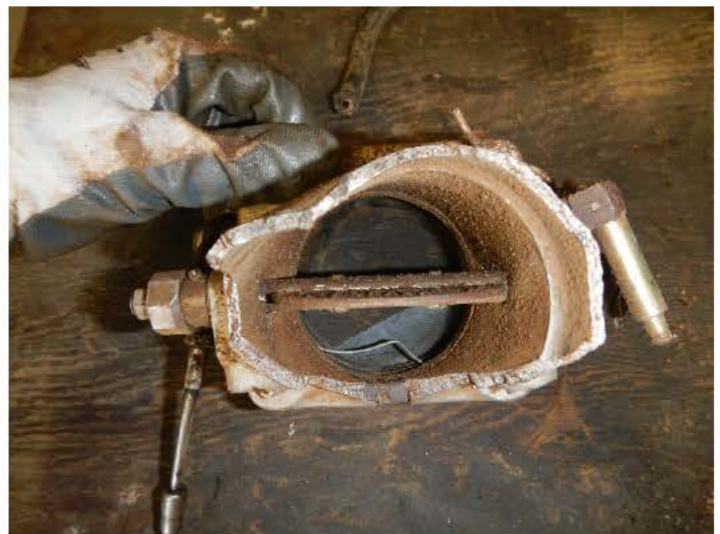
The exhaust system was separated from the engine. The induction system was fragmented. Only one intake riser remained attached to its cylinder. Two other risers were separated from their cylinders but remained attached to the engine by the balance tube. The throttle body was deformed and the throttle valve was in the full open position.

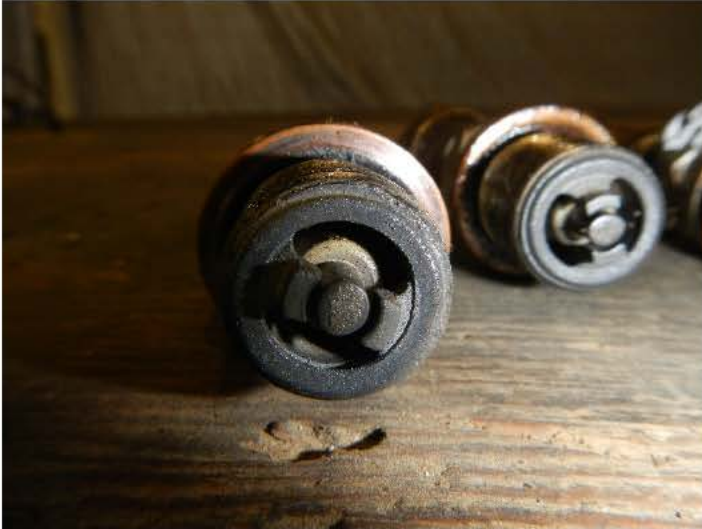
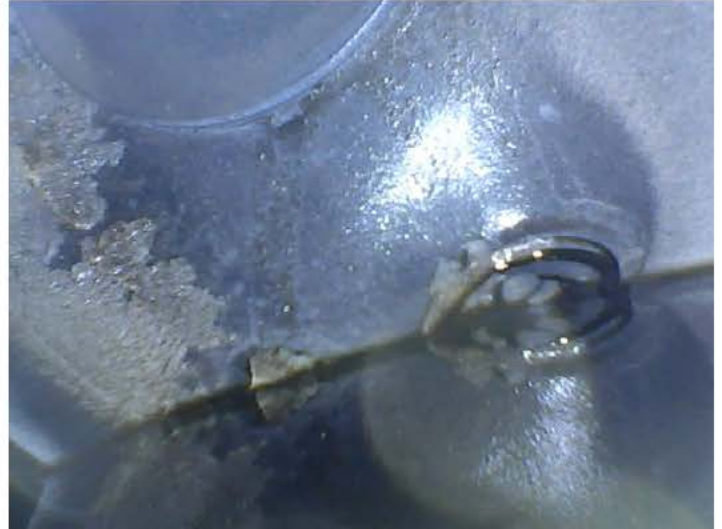
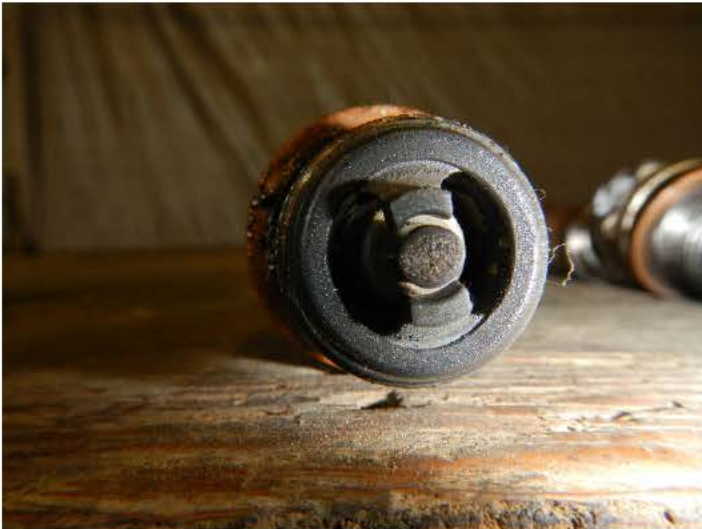
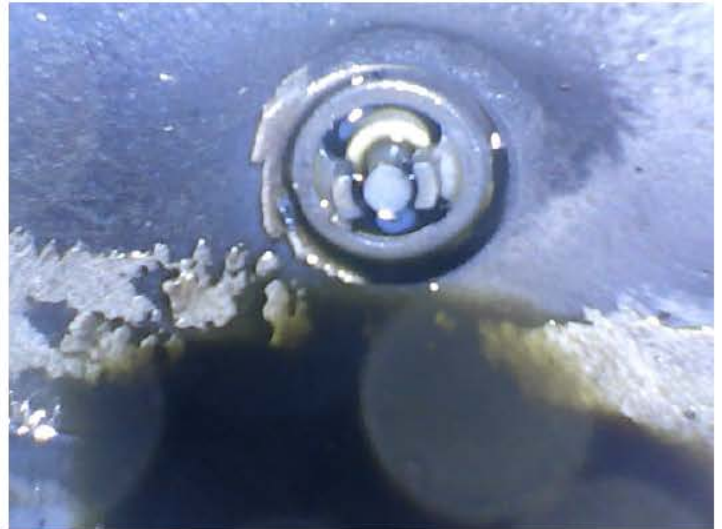
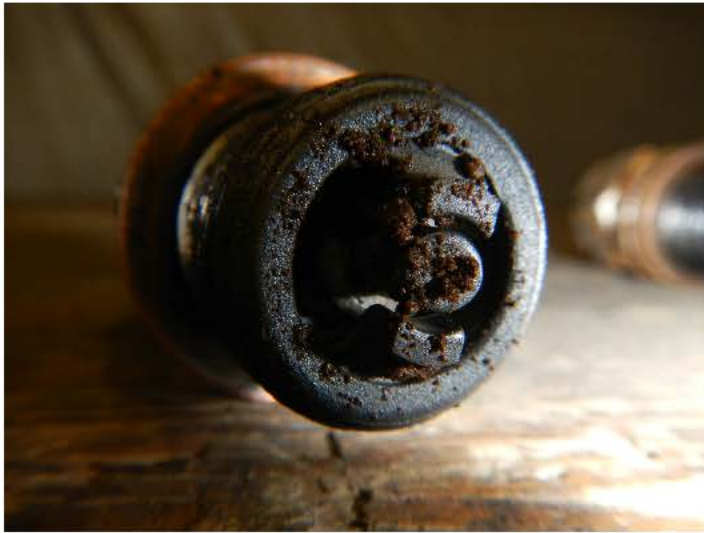
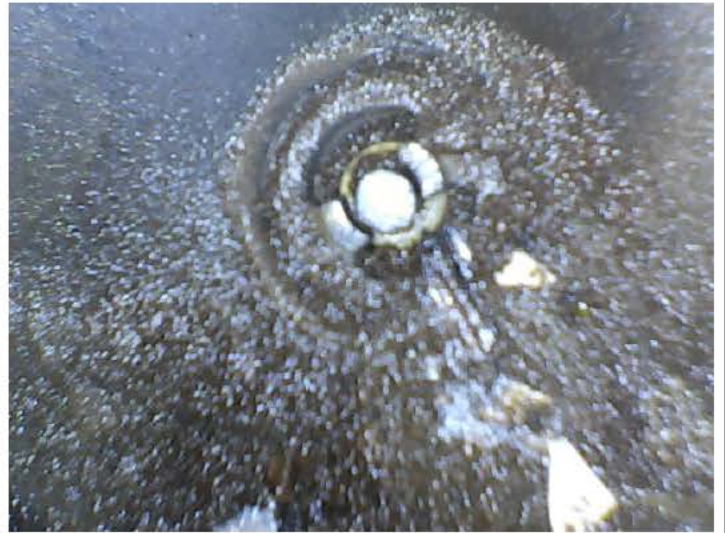
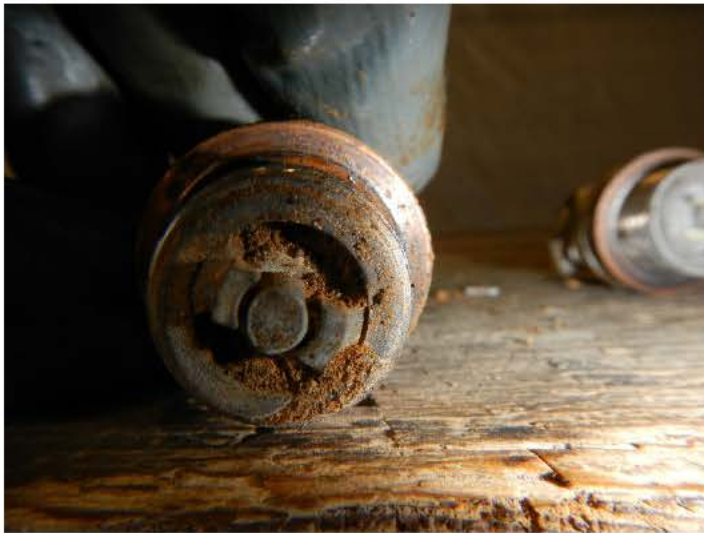
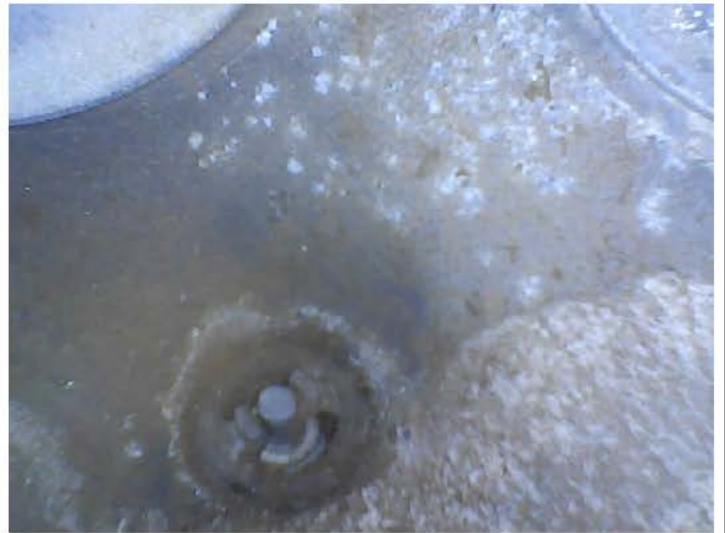
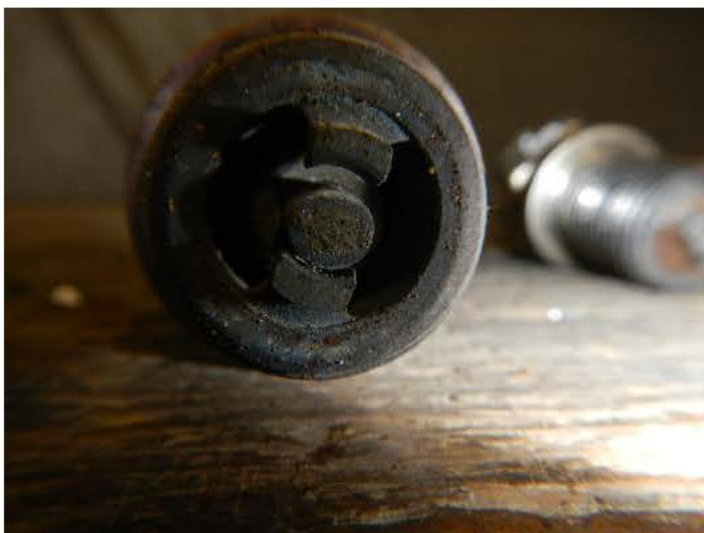
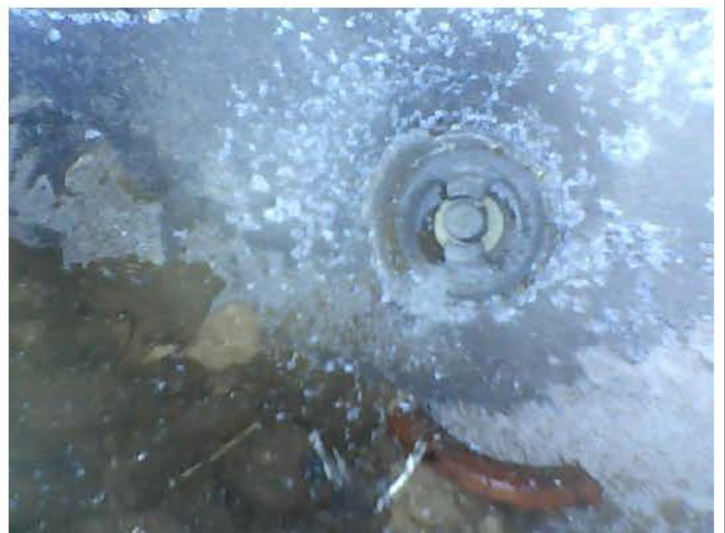
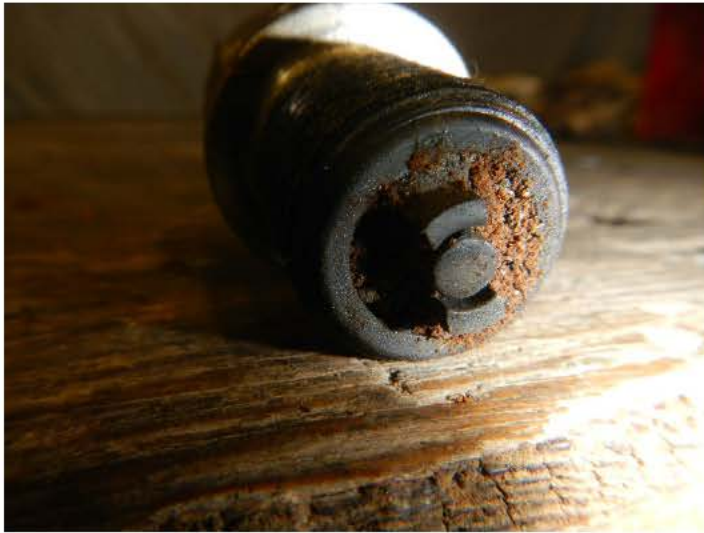
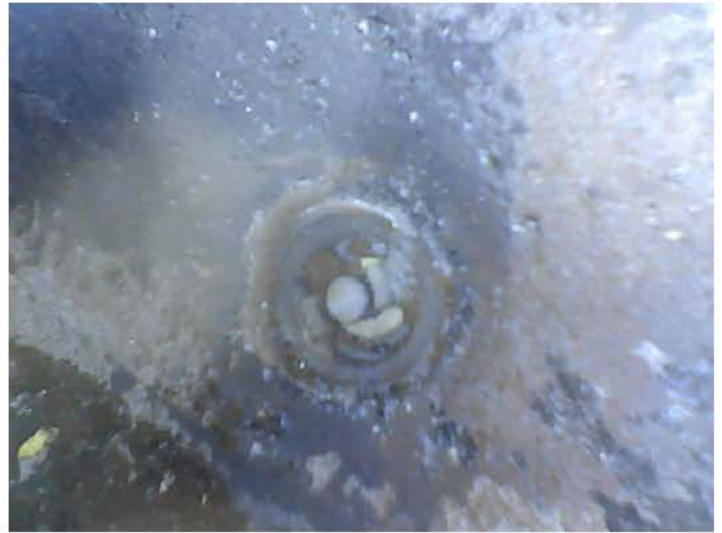
The top sparkplugs were removed from their respective cylinders and the bottom sparkplugs were documented utilizing a lighted borescope. Some of the sparkplugs were covered in dirt from the accident site and some were oil coated, but there was no sign of lead or carbon fouling on any of the electrodes.

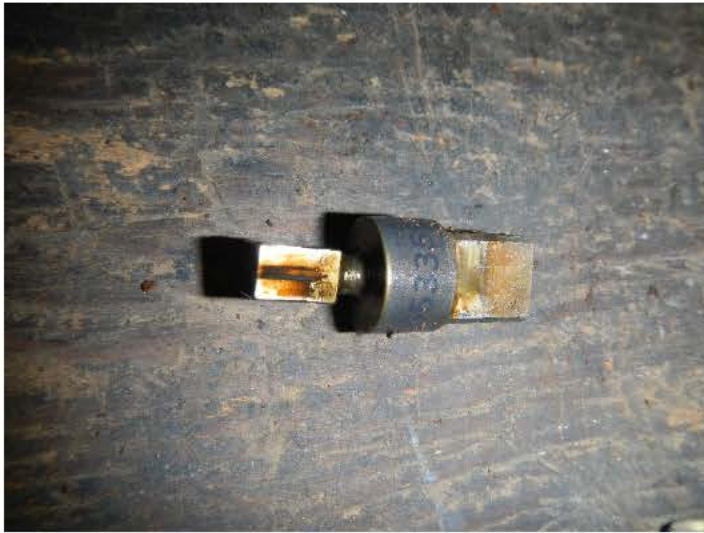
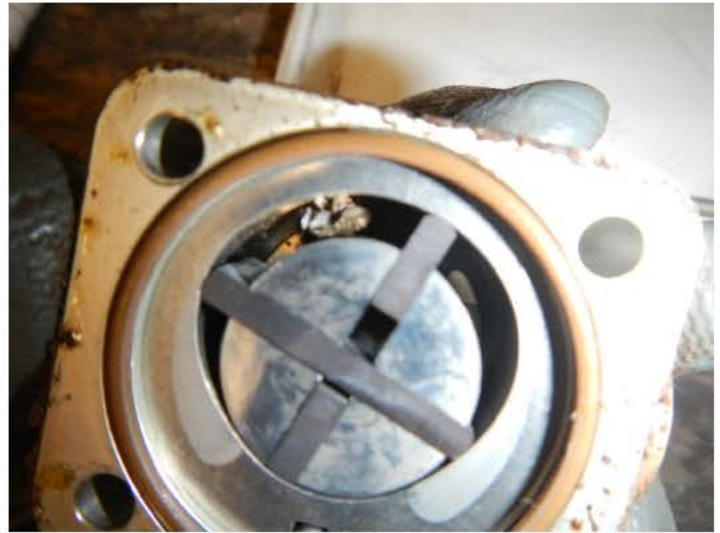
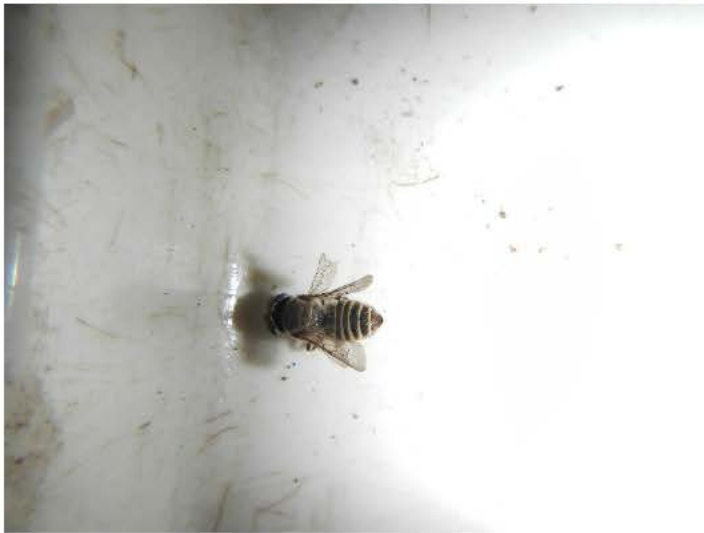
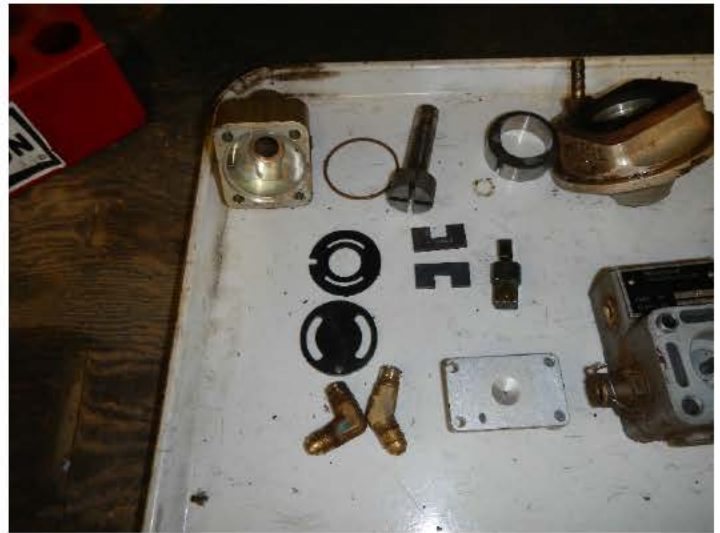
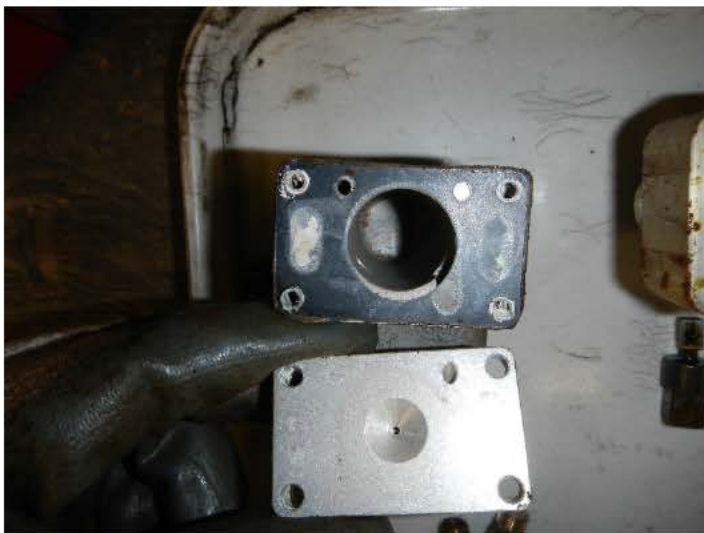
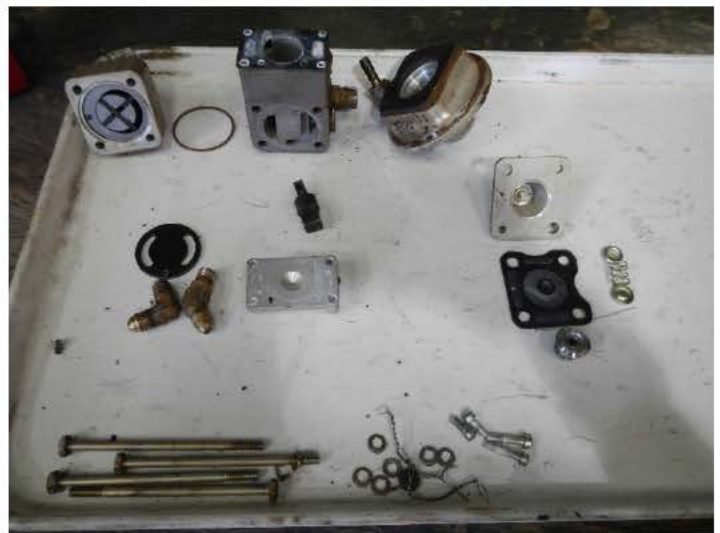
The engine-driven fuel pump remained secured to the backside of the engine. The vapor return fitting was fractured. The pump was removed and the drive coupling remained intact. The pump was disassembled and a bee was found between the pump vanes; however, since it was intact it is presumed that the bee entered the system following the wreckage recovery. No other pre-accident anomalies were noted with any of the internal components.

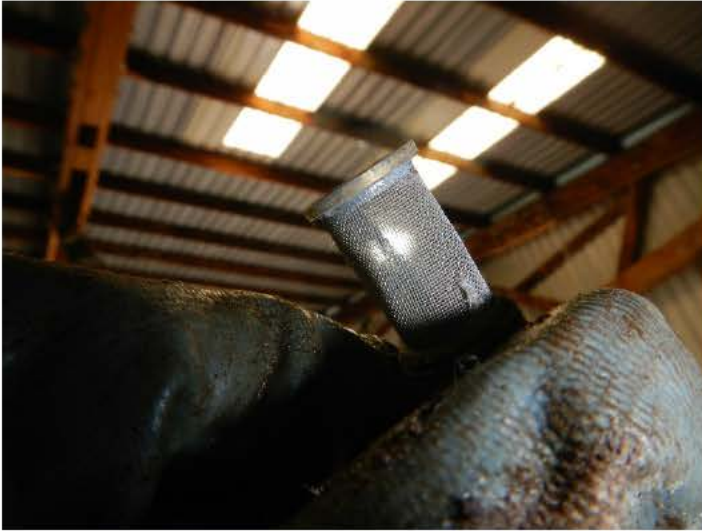
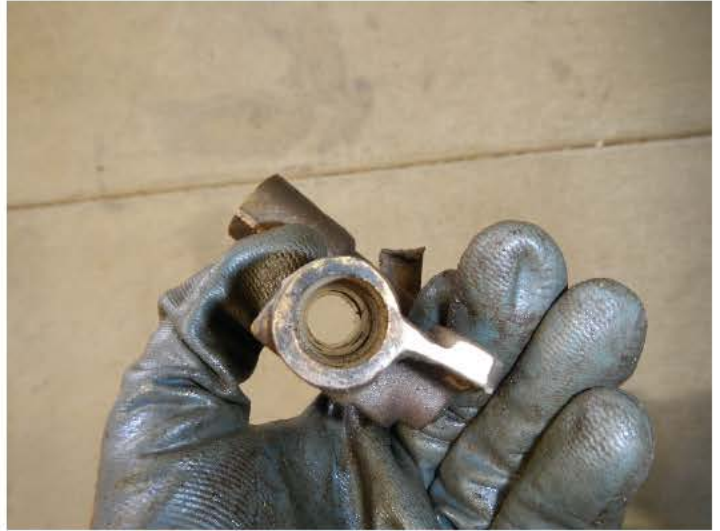
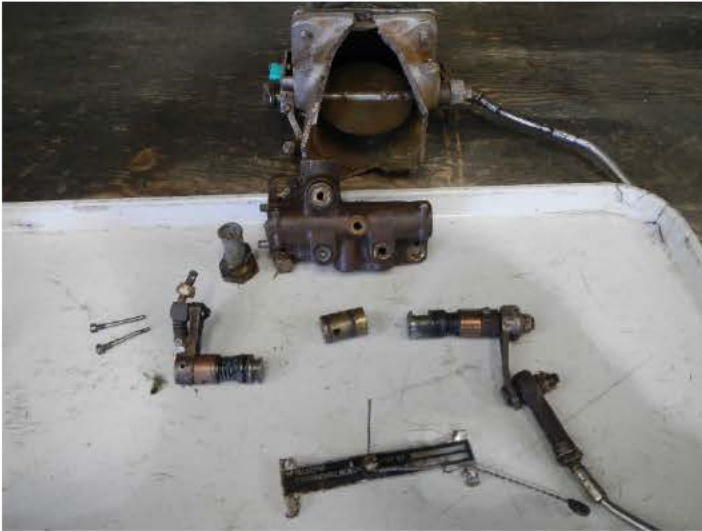
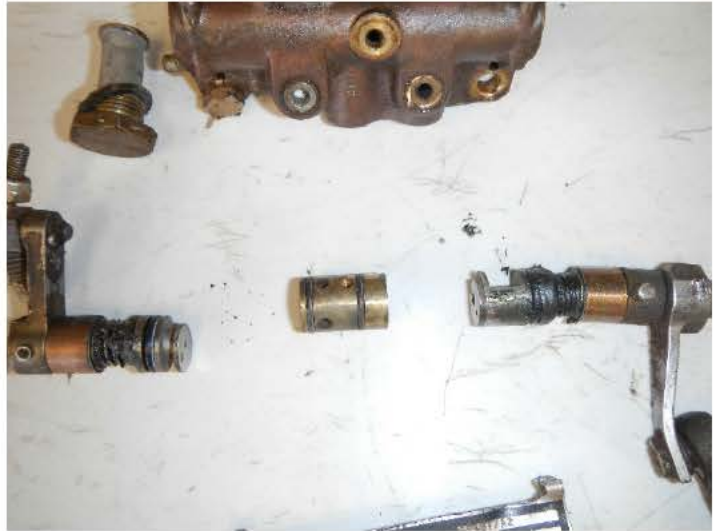
The throttle body and fuel metering unit remained attached to the backside of the engine, but they were separated from each other. The mixture and throttle control cables remained attached to their respective levers, but the levers were bent and deformed. The throttle lever and throttle valve were jammed in place and were found in the full open position. The throttle interconnect linkage was fractured. The fuel metering unit was disassembled. The inlet screen contained a small piece of lint near the base, but the screen was not blocked or obstructed. The mixture and throttle cams were removed as was the metering plug. No pre-accident anomalies were noted with any of the o-rings or metering orifices.

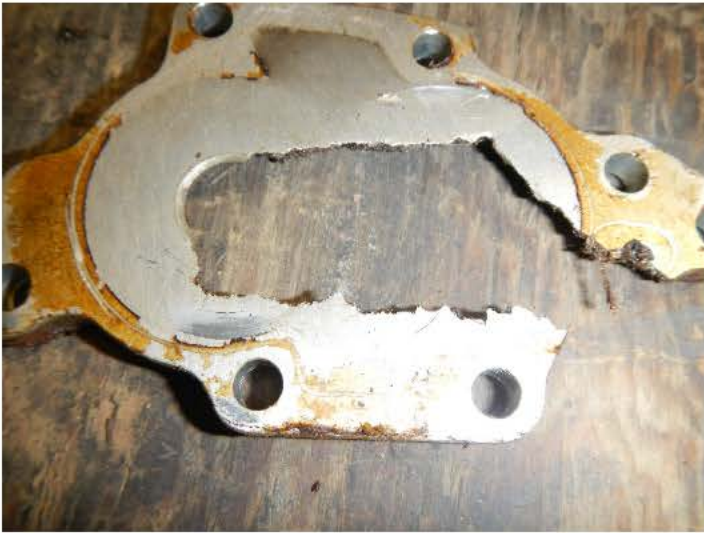
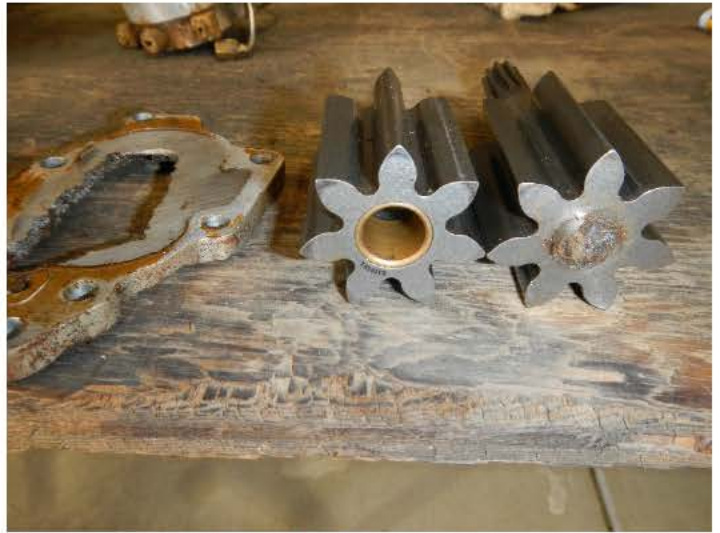
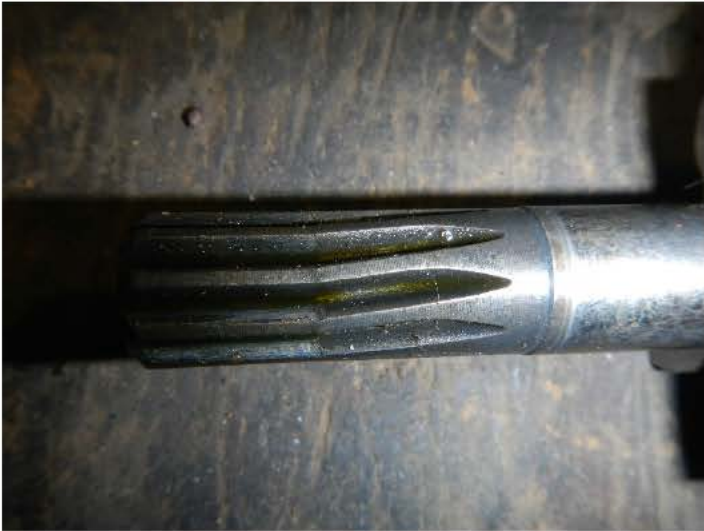
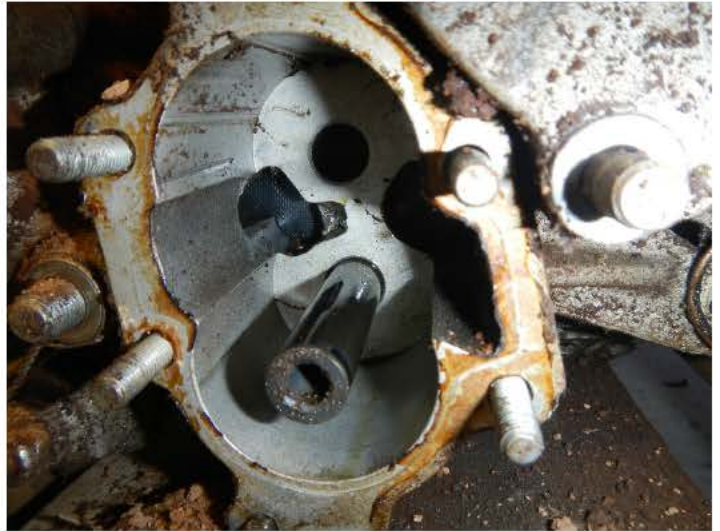
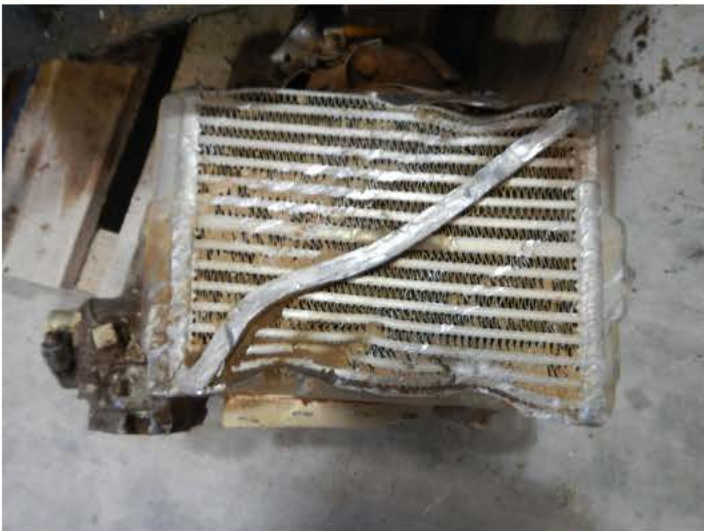
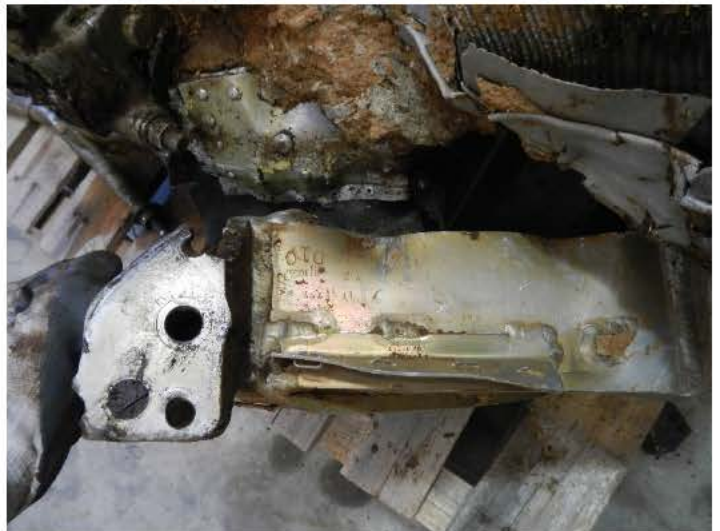
The oil sump was displaced up around the bottom of the engine and there were numerous punctures and tears. The camshaft gear was protruding from the aft end of the sump. The oil pump remained attached to the backside of the engine; however, the pump housing cap was fractured as was the tach drive. The remains of the cap were removed and the gears were examined. The drive gear splines displayed a torsional displacement. The gears were intact and did not display any pre-accident anomalies. The housing walls displayed short arcs of circumferential scoring that coincided with the apexes of the drive gear teeth and the cap remains displayed an arc of displaced and polished metal. The oil cooler was deformed and the mount was fractured. The oil filler neck and oil filter were separated from the engine. None of the observed components displayed signs of thermal discoloration or lubrication system distress.

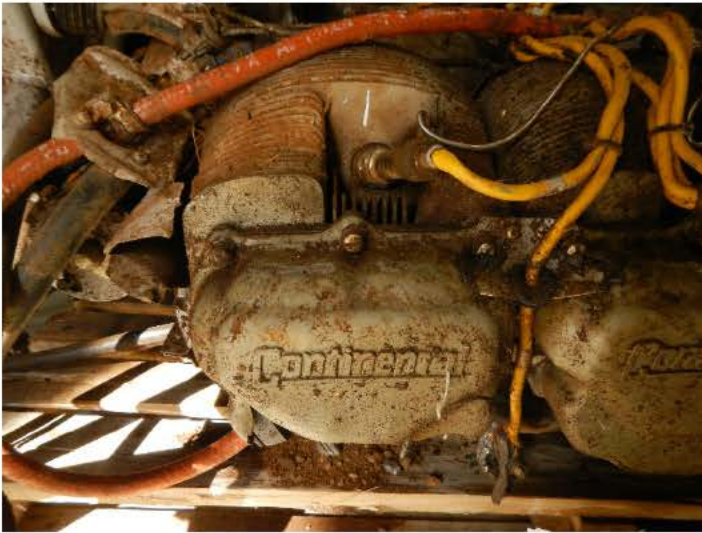
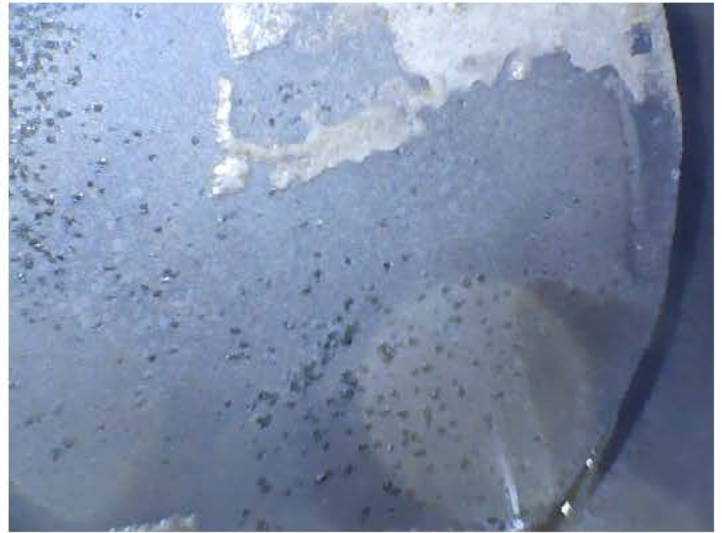
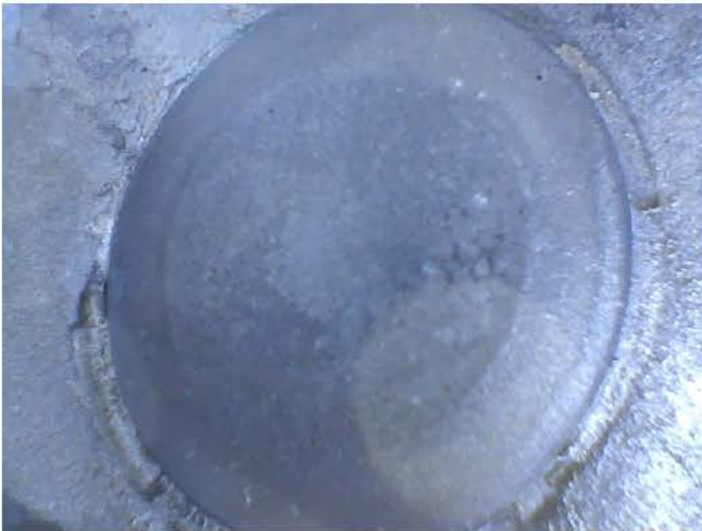
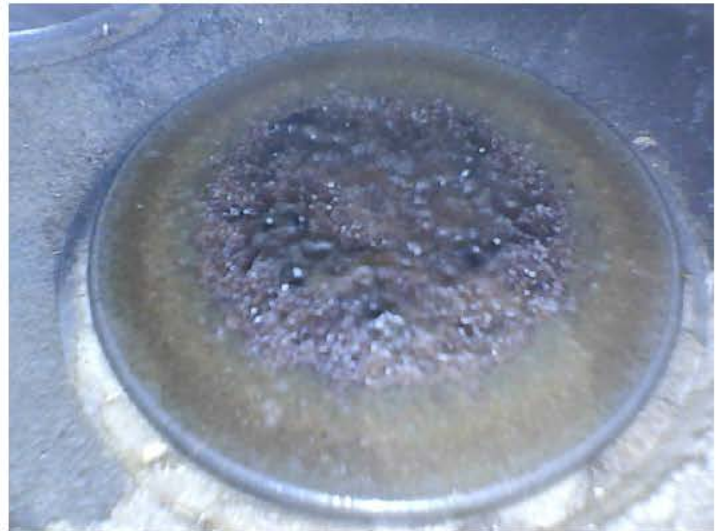
#### Cylinder 1

The cylinders remained attached to the crankcase and the original torque putty was observed on the attaching hardware. The cylinders sustained impact-related damage to the cooling fins and rocker area. The top sparkplugs were removed and the cylinders were examined internally utilizing a lighted borescope. Dirt from the accident site was present in some of the cylinders and oil was observed in cylinders #1 and #3; however, there were no pre-accident anomalies noted externally or internally on the barrels, pistons, valves or valve seats.

**NOTE:** The photographs that follow each cylinder number represent the rocker area, the piston, the intake valve and the exhaust valve in that order unless otherwise specified.

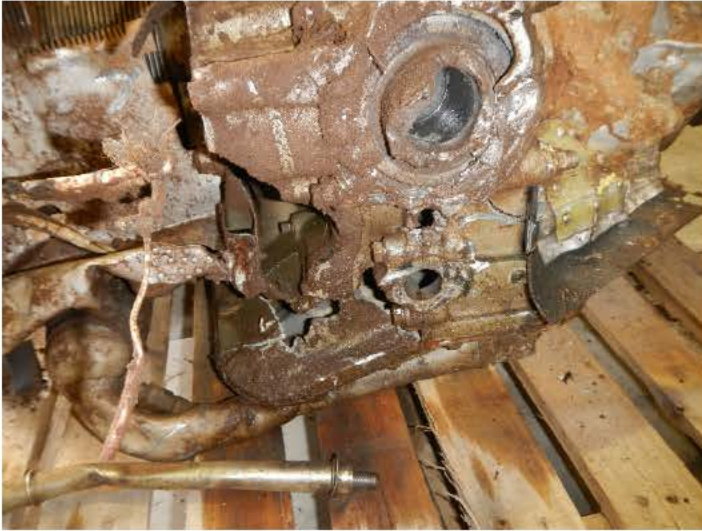
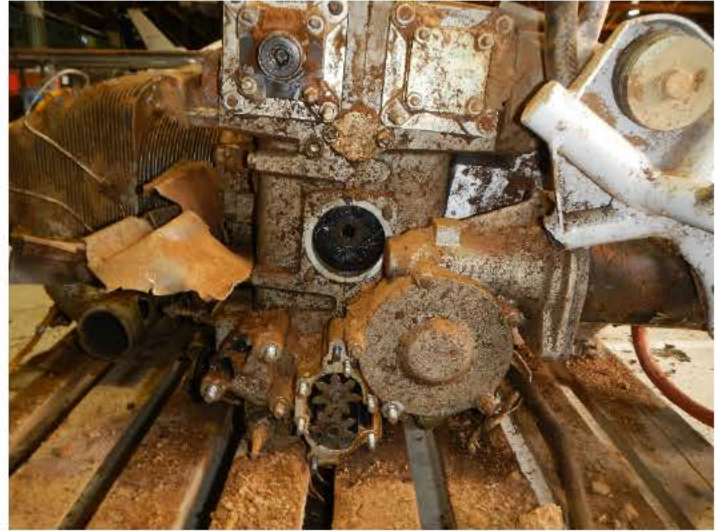
The crankcase sustained impact-related damage to the front end of the crankcase. The bottom portion of the case halves were damaged when the oil sump was displaced upward. Additionally, the area around the engine-driven alternator was also fractured. However, there were no signs of pre-accident operational anomalies with the crankcase.

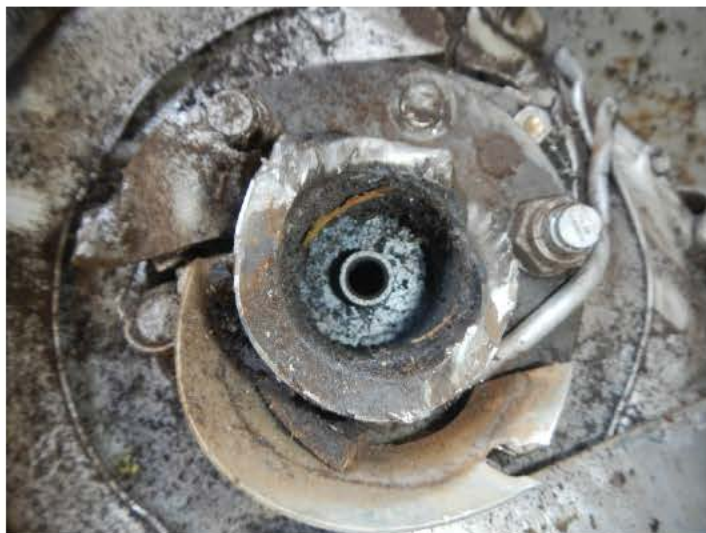
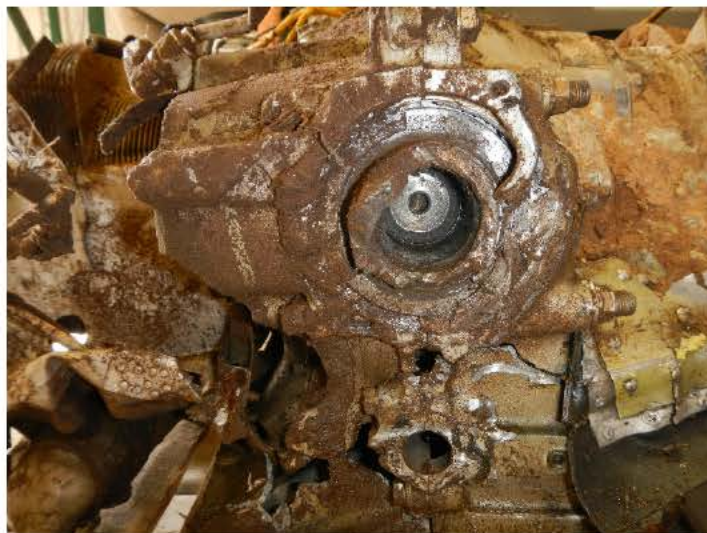
The crankshaft was fractured aft of the propeller flange. Though the crankshaft was not visible in its entirety, the portions that were did not display any signs of thermal discoloration or lubrication distress. The crankshaft gear remained secured in place. The connecting rods were not observed.

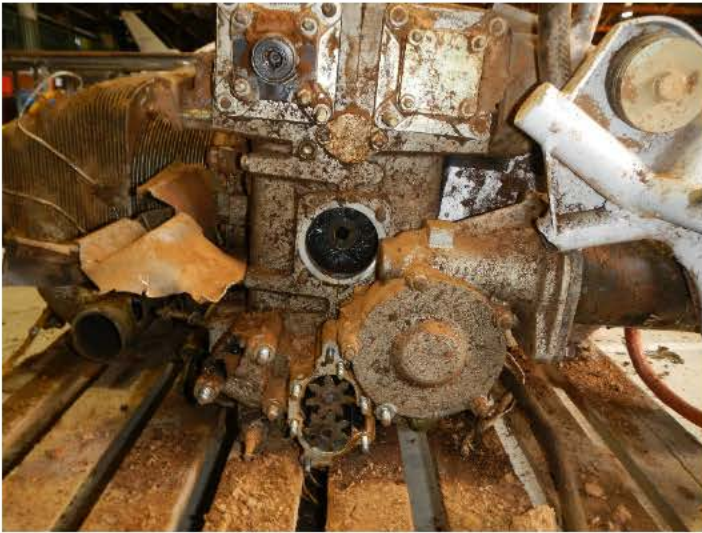
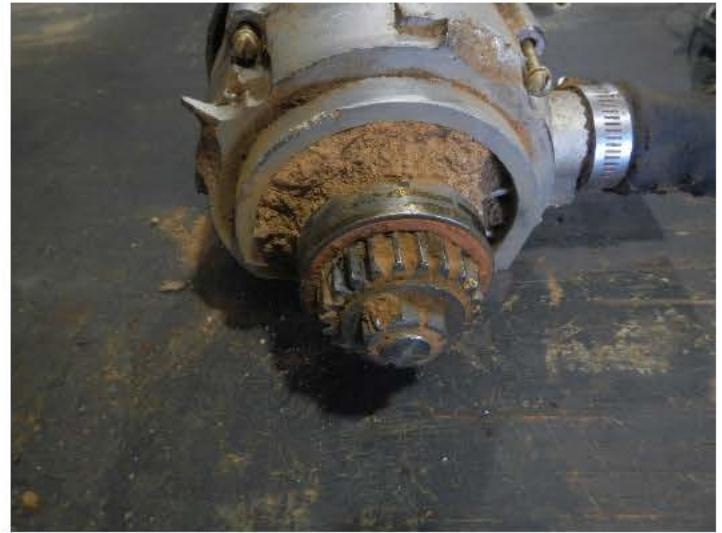
The vacuum pump remained partially attached to the backside of the engine. It was disassembled and the vanes remained intact with no pre-accident anomalies noted. The alternator was separated from the front right side of the engine. One alternator was found within the debris and it did not display any pre-accident anomalies. The starter and starter adapter remained attached to the backside of the engine.

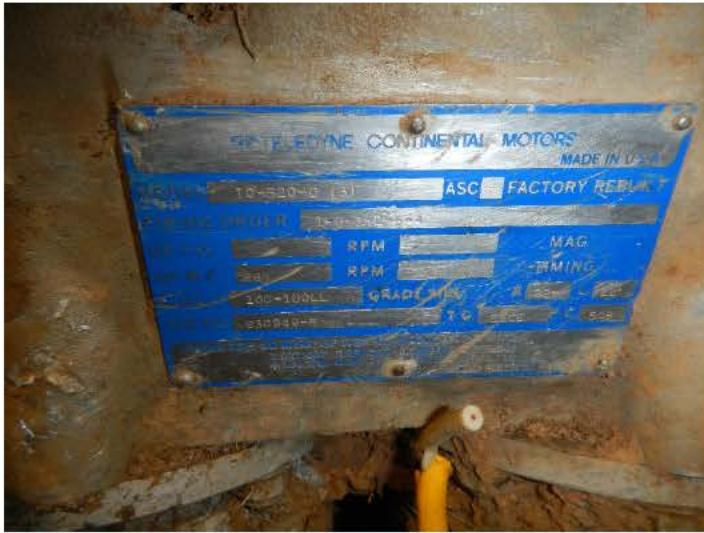
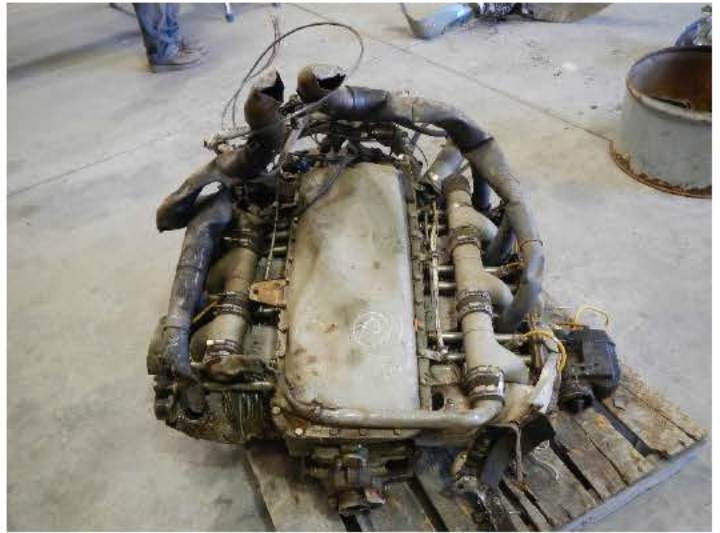
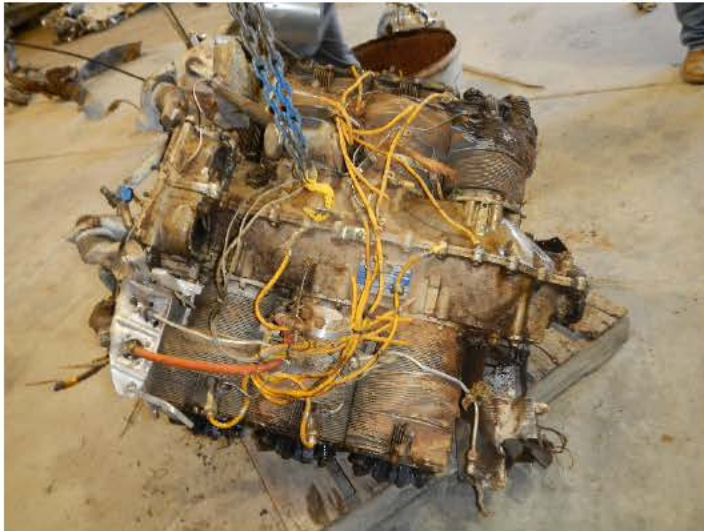
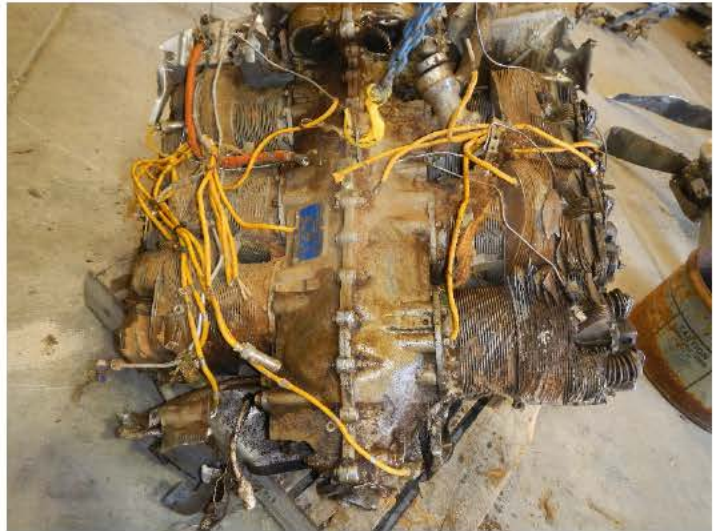
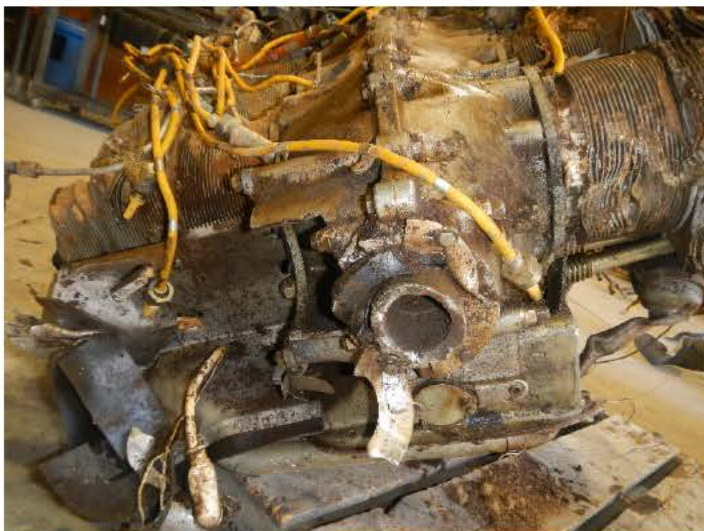
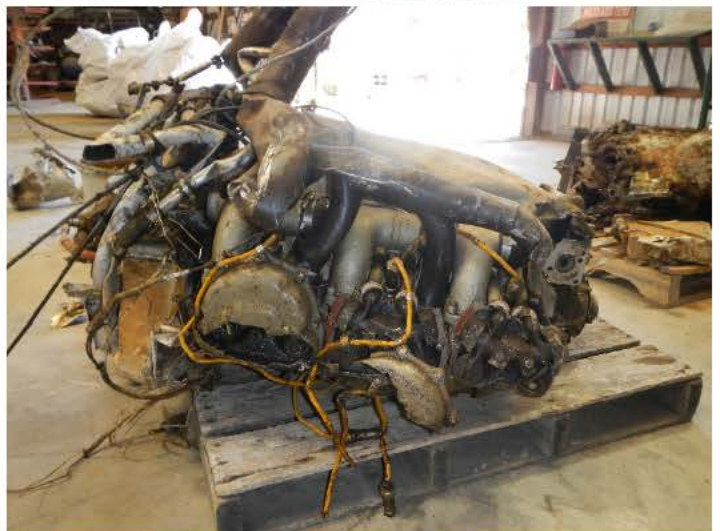
The propeller was separated from the engine and the engine was lying upside down on top of a wooden pallet. The crankshaft was fractured aft of the propeller flange and the crankcase around the nose seal sustained deformation damage. The exhaust system remained attached to the engine but sustained significant deformation damage. The magnetos were separated from the topside of the engine. All six cylinders sustained deformation or fracture damage to their cooling fins and/or rocker covers. The bottom front crankcase was fractured and the engine-driven alternator was separated from the engine. The alternator face gear and propeller governor drive and bevel gears were visible through the fractured case with no pre-accident anomalies noted. The crankshaft and oil transfer collar were intact and did not show any signs of lubrication distress.

The engine-driven fuel pump remained attached to the backside of the engine; all but one fuel line fittings were fractured. The throttle body remained attached to the engine, but the wye plenum was fractured. The throttle lever and throttle valve were found in the full open position. The fuel metering unit remained attached to the throttle body, though the mixture shaft was bent. The throttle and mixture control cables remained secured to their control levers, but the levers were bent and deformed. The fuel manifold valve was separated from its mount and all injector lines were separated from the housing, except one. The fuel inlet line remained attached to the manifold valve.

The oil pump housing was fractured but the pump remained attached to the backside of the engine. The oil filter remained attached to the oil filter adapter. The oil cooler remained in place, but its mounting system was fractured and the cooler was deformed. The oil sump sustained deformation damage but remained attached to the bottom side of the engine.

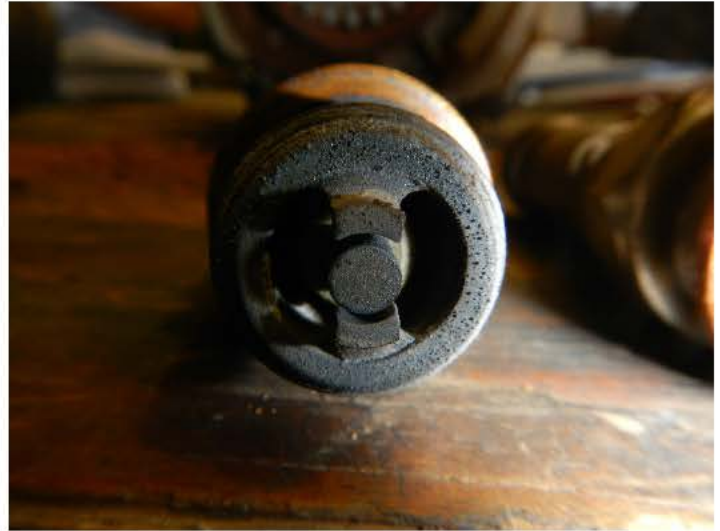
1T

The bottom sparkplugs were removed from their respective cylinders and the top sparkplugs were documented utilizing a lighted borescope. Some of the sparkplugs were covered in dirt from the accident site and some were coated in oil. The #4 and #6 top sparkplugs were missing their center electrodes, as the topside of those cylinders and top sparkplugs sustained significant impact damage. However, there was no sign of lead or carbon fouling on any of the electrodes.
