# Continental Motors

## ENGINE EXAMINATION REPORT

| ENGINE MODEL | IO-520-C3 |
| FILE NUMBER | 16-656 |

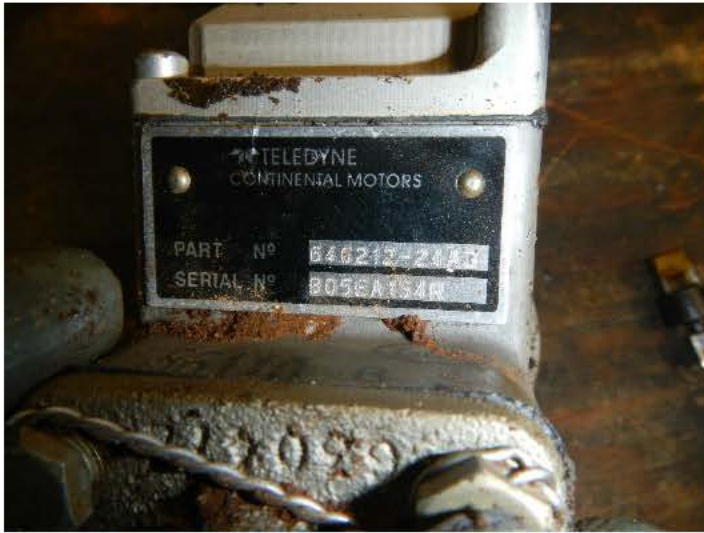
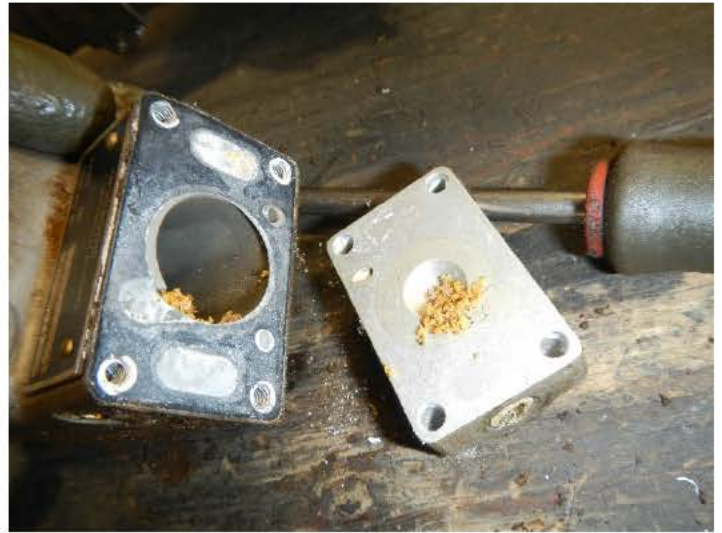
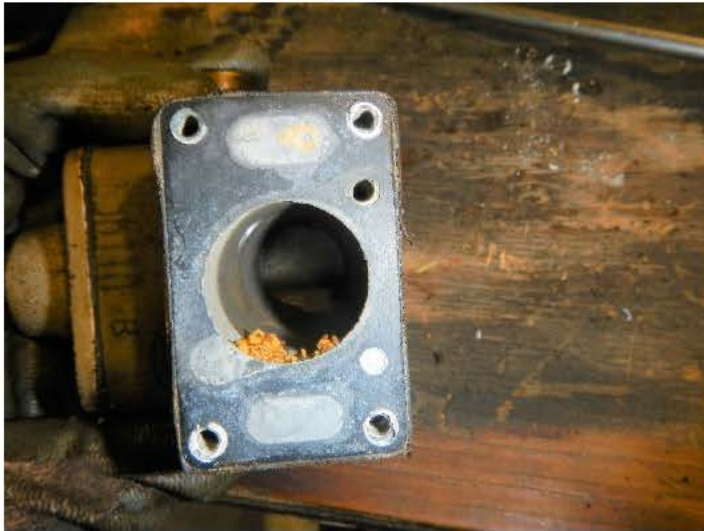
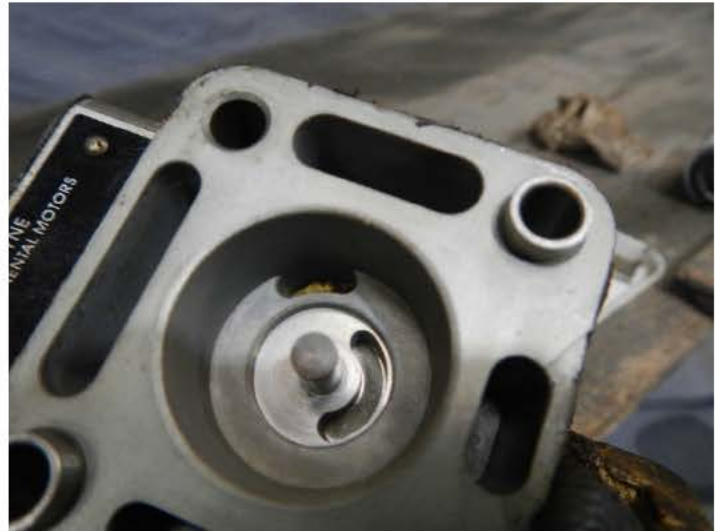
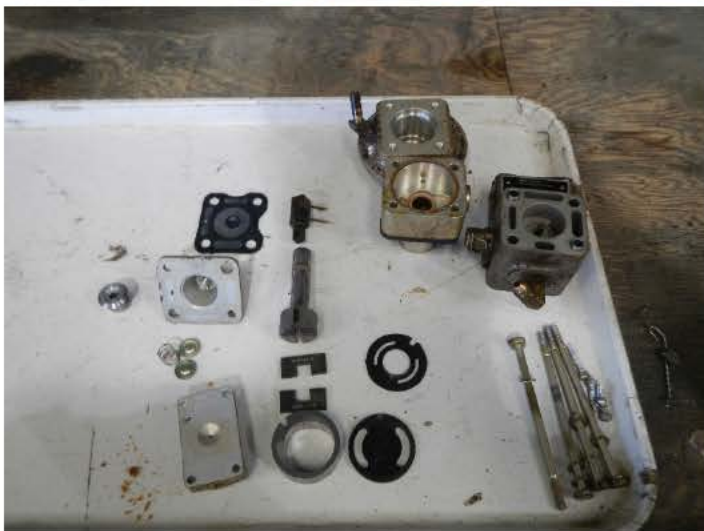
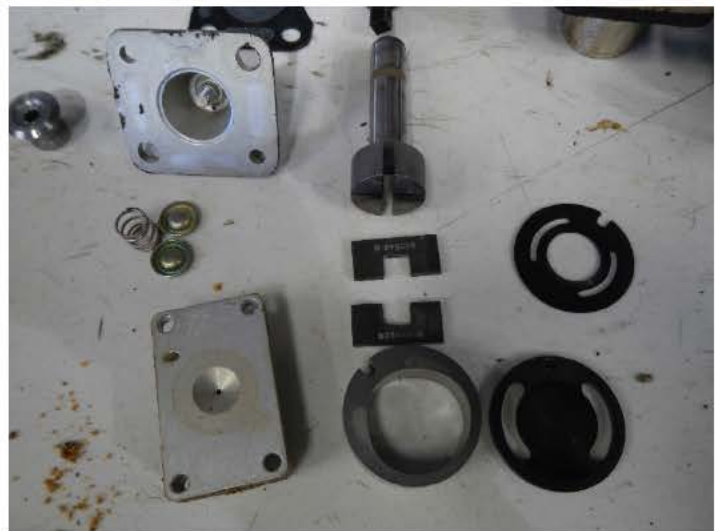
The engine-driven fuel pump remained secured to the backside of the engine. All but one of the fuel line fittings were fractured. The pump was removed and the drive coupling remained intact. The pump was disassembled and organic debris from insects was noted at the top of the swirl chamber near the vapor return jet; however, it is presumed that the debris entered the system following the wreckage recovery. No other pre-accident anomalies were noted with any of the internal components.

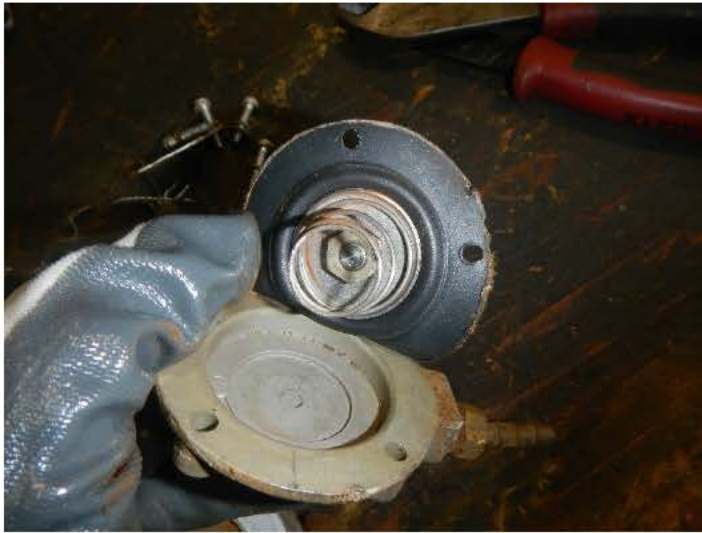
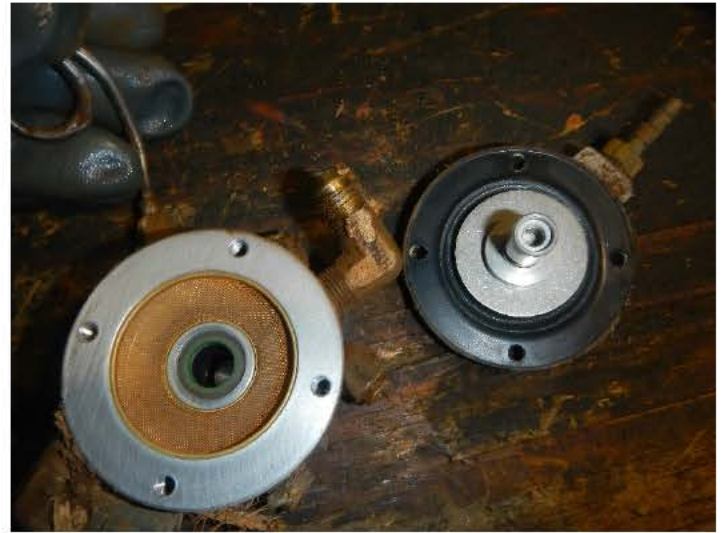
The fuel manifold valve remained attached to the topside of the engine via one injector line and the fuel inlet fitting. The cap was removed and the diaphragm was intact. The screen was clean and free from obstructions or debris. No pre-accident anomalies were noted with the unit.

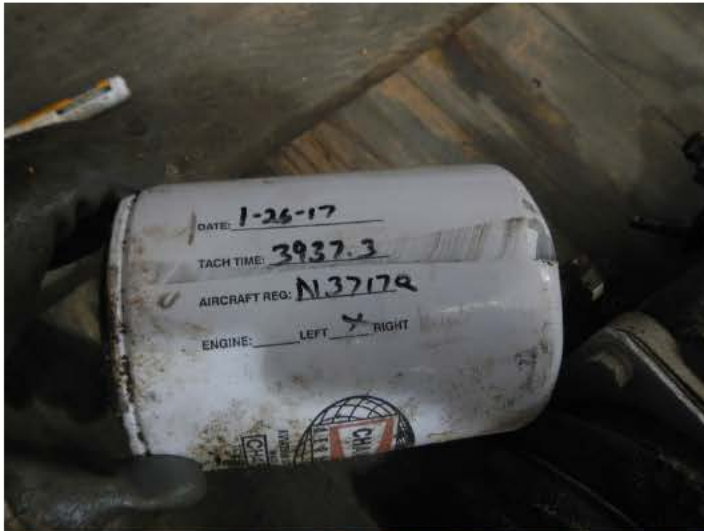
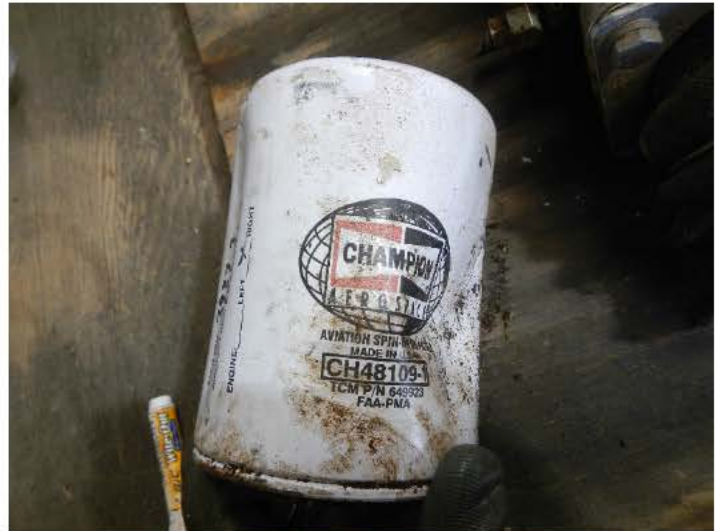
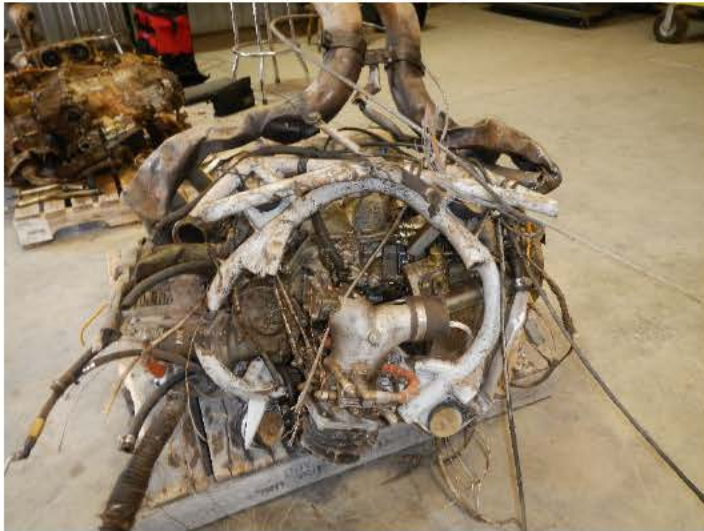
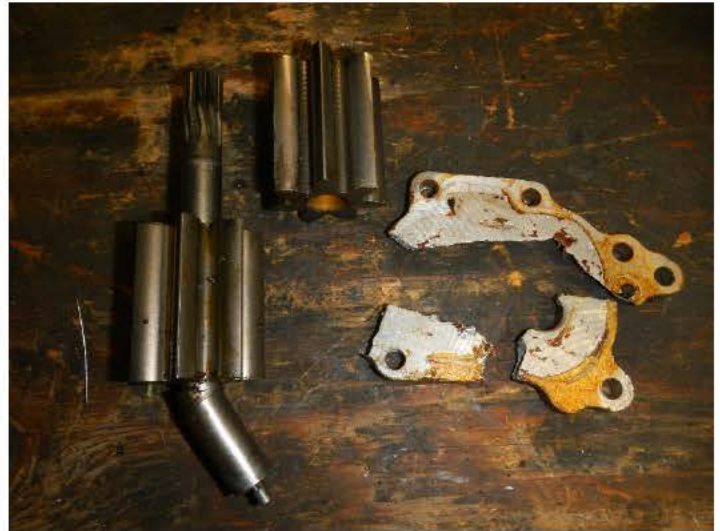
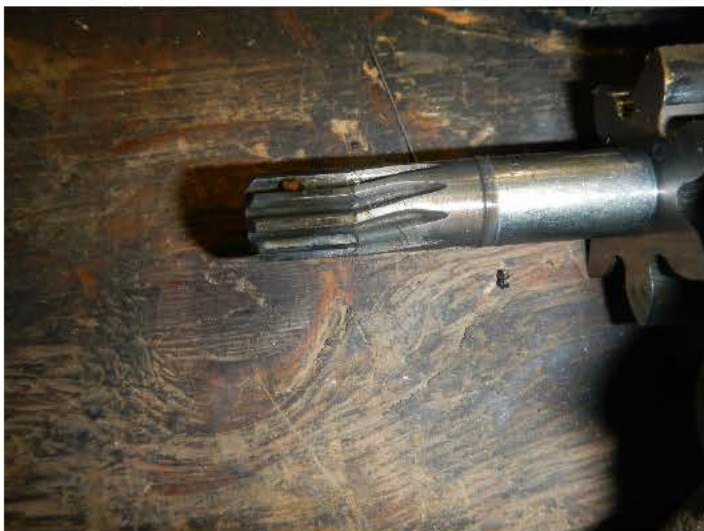
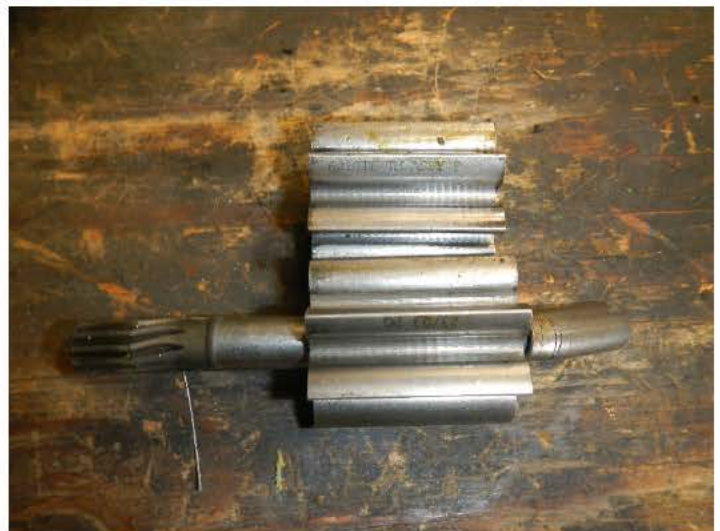
The oil sump remained intact on the bottom of the engine and there were no signs of pre-impact oil leaks. The oil pump remained attached to the backside of the engine; however, the pump housing cap was fractured as was the tach drive. The remains of the cap were removed and the gears were examined. The drive gear splines displayed a torsional displacement. The gears were intact and did not display any pre-accident anomalies. The housing walls displayed short arcs of circumferential scoring that coincided with the apexes of the drive gear teeth. The oil filter remained attached to the adapter and it had the following information hand written on the side for date and tach time, respectively: 1-26-17 and 3937.3. The oil cooler was deformed and the mount was fractured. The oil filler neck was partially separated from the engine. None of the observed components displayed signs of thermal discoloration or lubrication system distress.

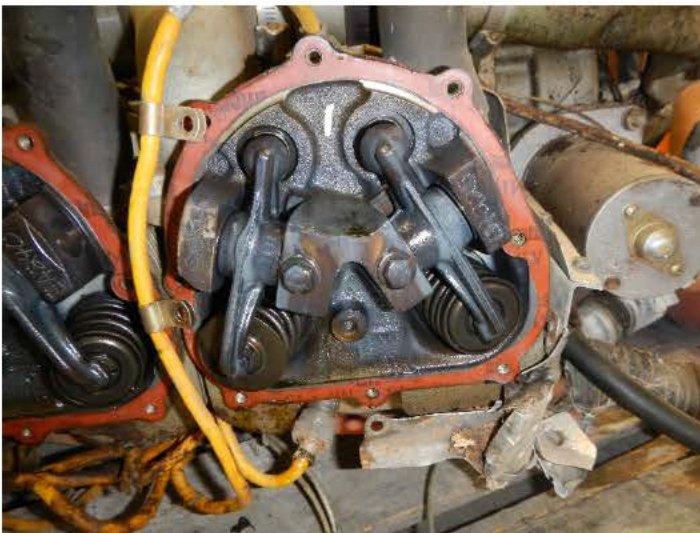
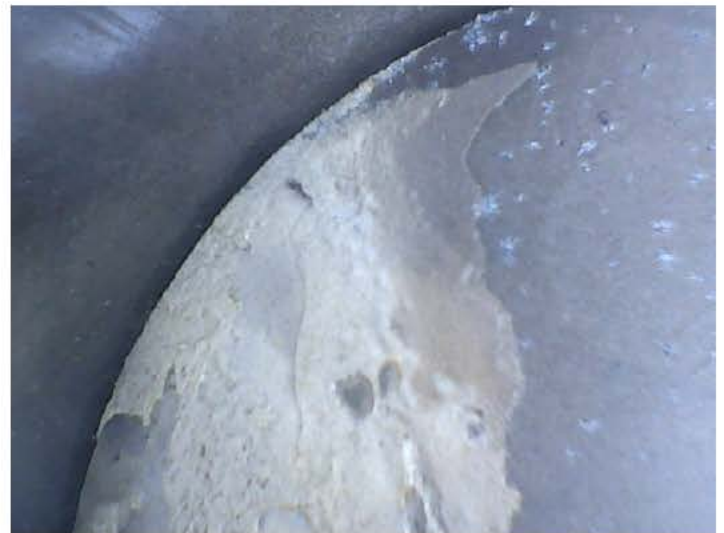
#### Cylinder 1

The cylinders remained attached to the crankcase and the original torque putty was observed on the attaching hardware. The cylinders sustained impact-related damage to the cooling fins and rocker area, with the #4 and #6 cylinder heads sustaining fracture and deformation damage to the rocker areas. The bottom sparkplugs were removed and the cylinders were examined internally utilizing a lighted borescope. Dirt from the accident site was present in some of the cylinders as was oil; however, there were no pre-accident anomalies noted externally or internally on the barrels, pistons, valves or valve seats.

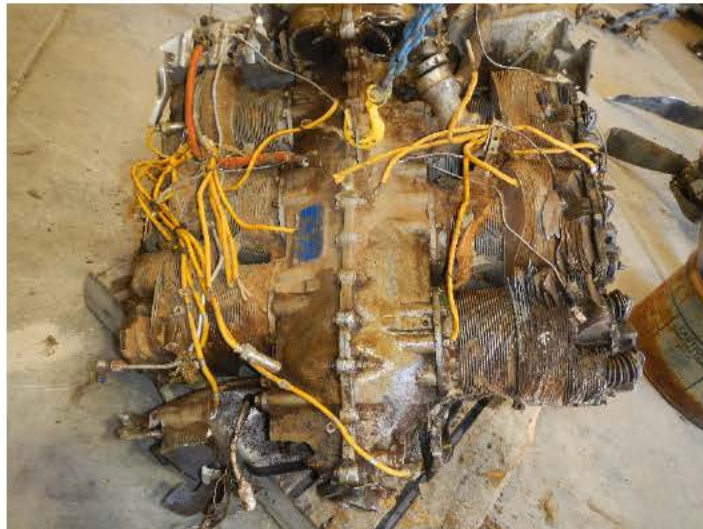
The crankcase sustained impact-related damage to the front end of the crankcase. Additionally, the area around the engine-driven alternator was also fractured. However, there were no signs of pre-accident operational anomalies with the crankcase.

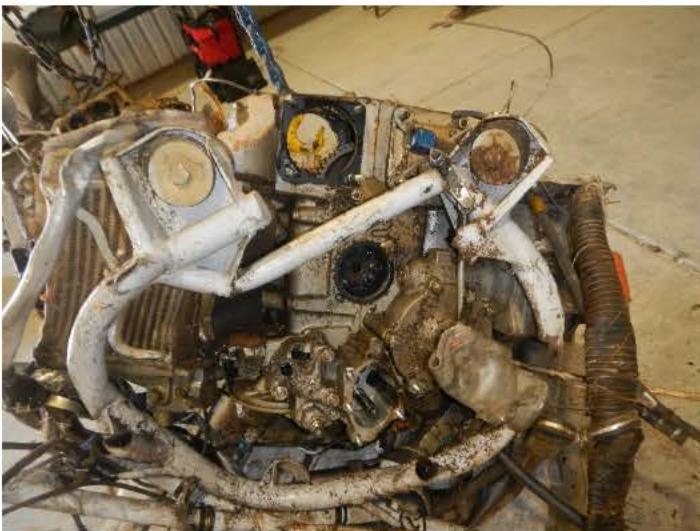
The vacuum pump remained partially attached to the backside of the engine. It was disassembled and the vanes remained intact with no pre-accident anomalies noted. The alternator was separated from the front right side of the engine. One alternator was found within the debris and it did not display any pre-accident anomalies. The starter and starter adapter remained attached to the backside of the engine.

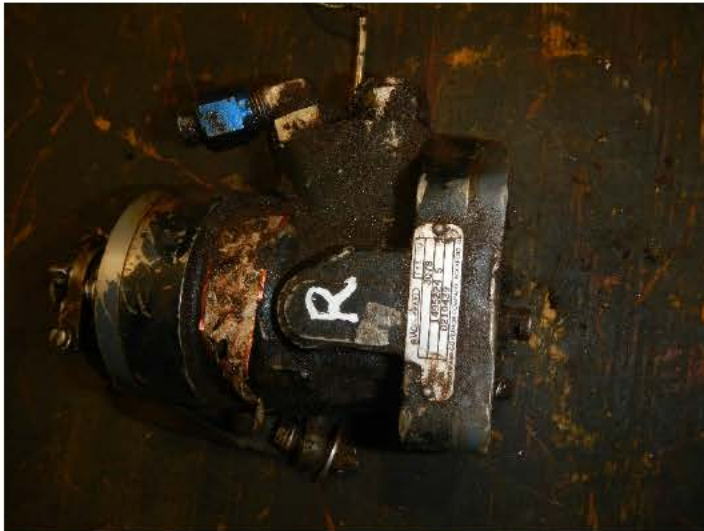
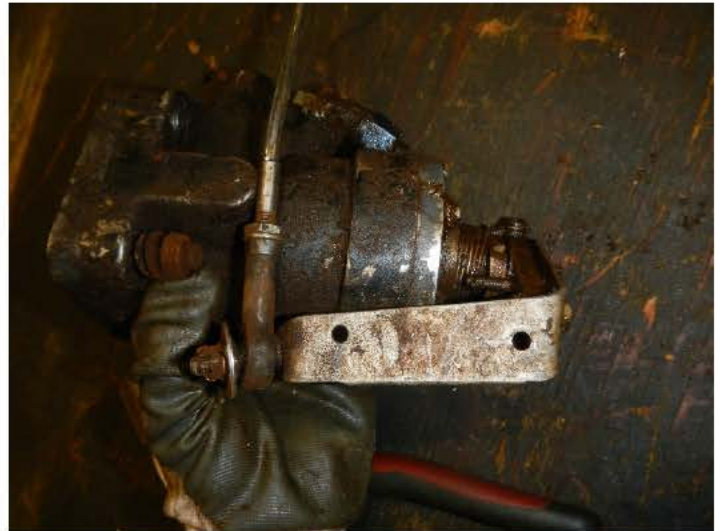
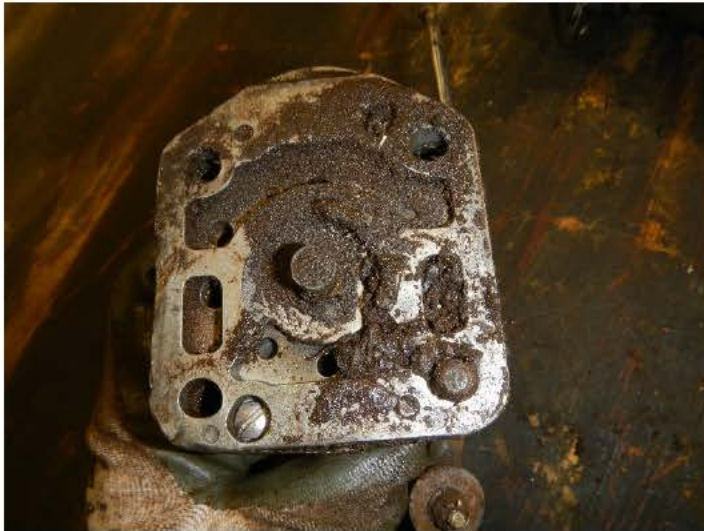
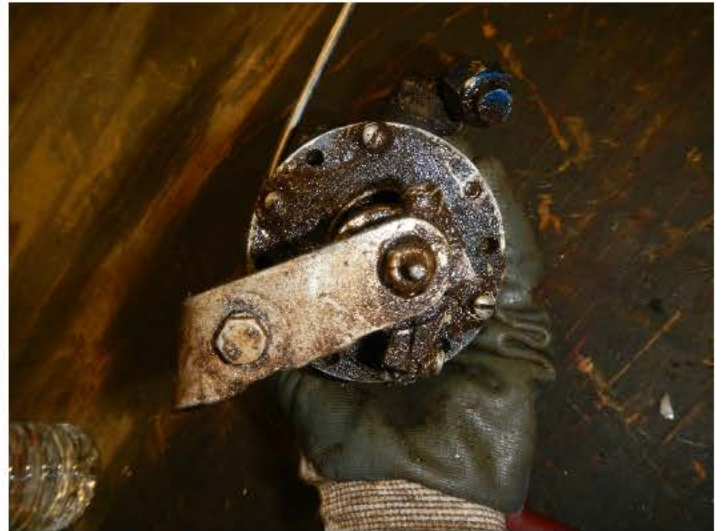
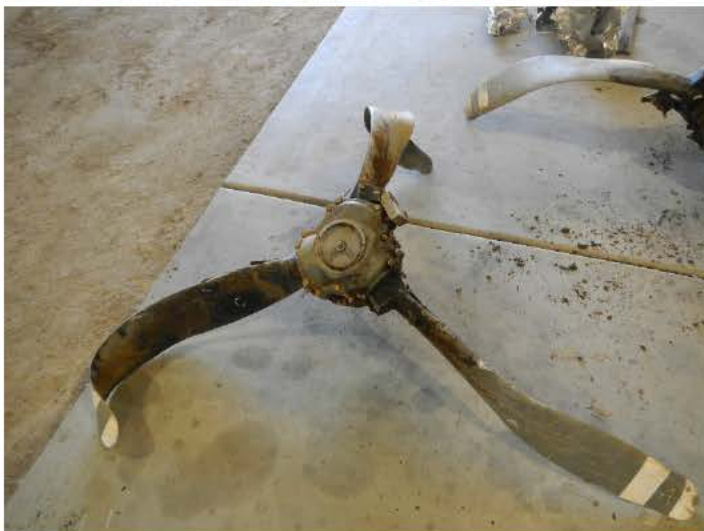
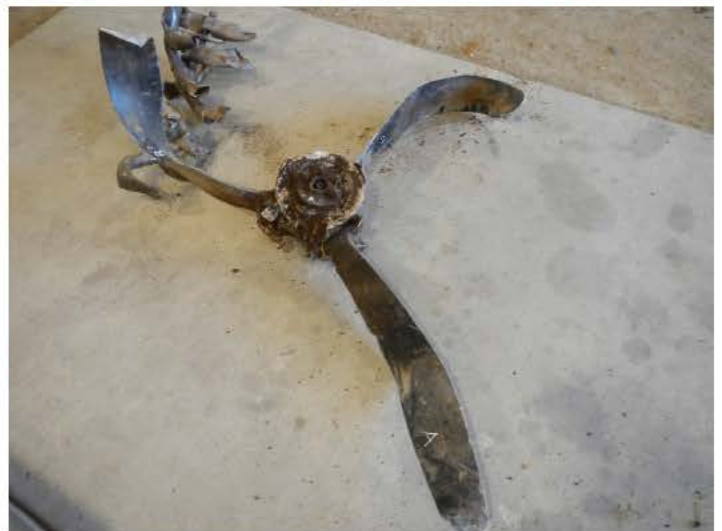
The propeller governor was separated from the engine. The control lever and cable remained attached to the governor. No anomalies were noted with propeller governor drive or the bevel gear.

The propeller was separated from the engine. The hub remained intact and all three blades remained attached. The blades were rotated in the hub, indicative of pitch change linkage fracture. The piston housing was separated. The blades were arbitrarily labeled A, B, and C. Blades B and C retained their counterweights; Blade A's counterweight was separated and the fracture surface appeared to be jagged and irregular. Blade A was twisted toward low pitch with two substantial leading edge gouges. Blade B displayed a 180-degree twist toward low pitch along with leading edge gouges. Blade C displayed a twist toward low pitch.
