## **NATIONAL TRANSPORTATION SAFETY BOARD**

# **AIRFRAME AND ENGINE EXAMINATION**

**WPR17FA146**

Location: Pt Mugu, CA  
Date: July 8, 2017  
Aircraft: Quicksilver Sport MX II, N2812, Serial # 1763  
NTSB IIC: Michael Huhn

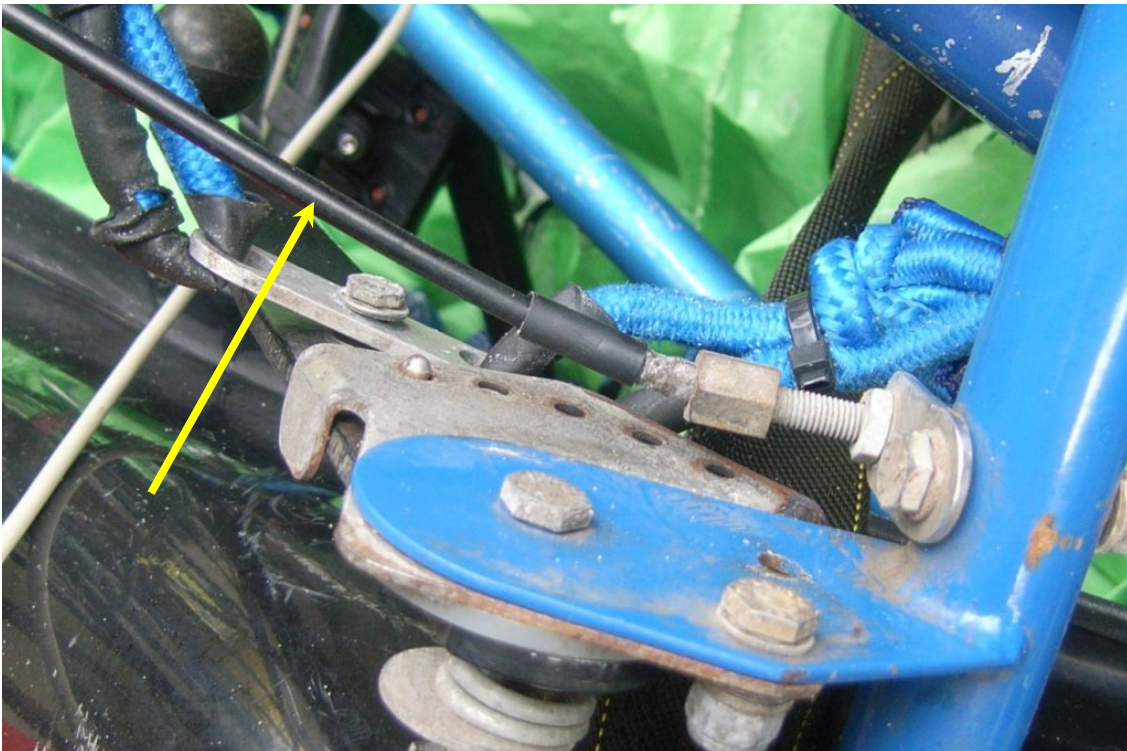
**Figure 9 - Throttle Cable Shroud**

Each pilot station was provided a separate throttle lever. The two levers were attached to each end of a transversely-mounted rod, outboard of each seat. The rod attached to the fuselage, and was free to rotate about the rod's central axis. A single throttle push-pull control cable attached to a fitting at the approximate lateral center of the throttle control rod. The throttle rod was partially fracture-separated from its fuselage pivot mount. Both throttles remained securely affixed to their respective ends of that rod. The throttle cable had been pulled from its rod connection, but its swaged end remained captive in the connector on the rod. The adjustable fitting for the throttle cable end adjacent to the throttle control rod remained securely attached to the fuselage tubing. The throttle mechanical stop arms remained securely attached to the rod. Their functionality/range could not be determined due to the damage to the aircraft.

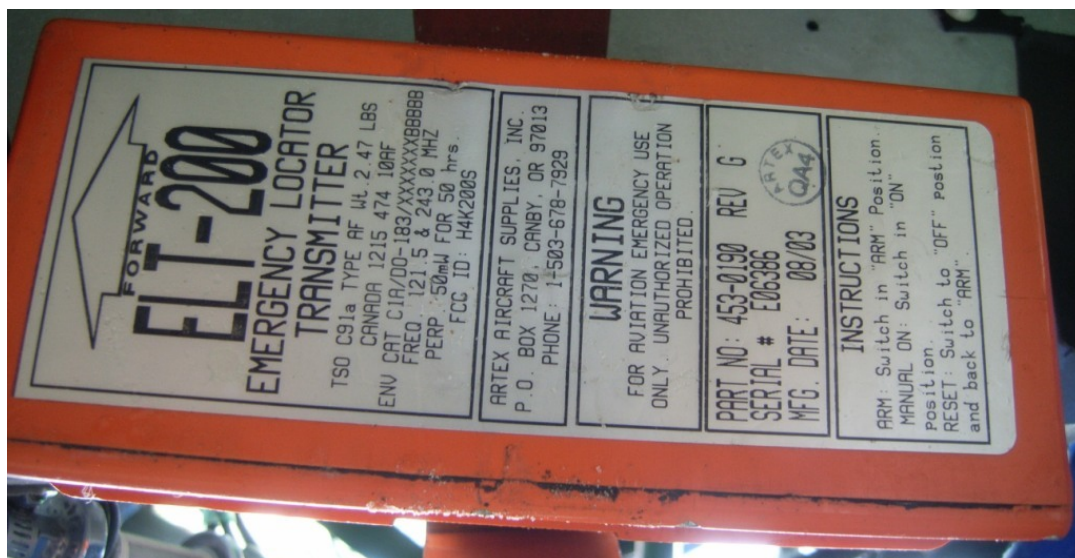
Figure 15 - ELT

- Hobbs brand engine hour meter. Attached, intact, registered 3184.6 hours
- ELT Artex ELT-200 TSOC91a 121.5 MHz
- Facet brand electric fuel pump (see engine section for details)
- Ignition switch set to "R", key absent
- "Light Switch" found in aft (off) position
- "Fuel Pump" switch, found in forward (on) position
- "Master Switch" position indeterminate

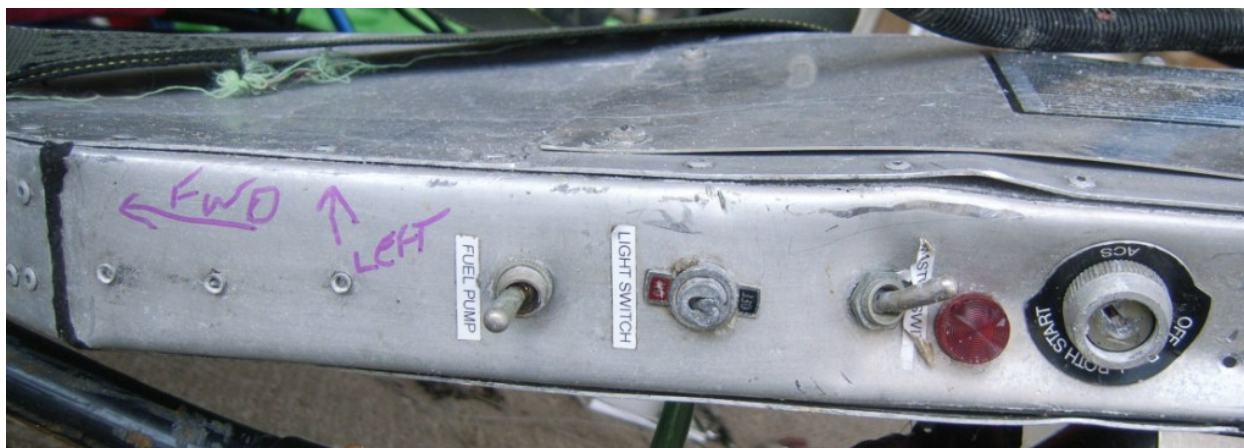
Figure 16 - Center Overhead Console

A center-mounted overhead console unit, which housed several components, remained attached to the structural tubing, but it and some of its components exhibited impact damage. Externally, this unit included:

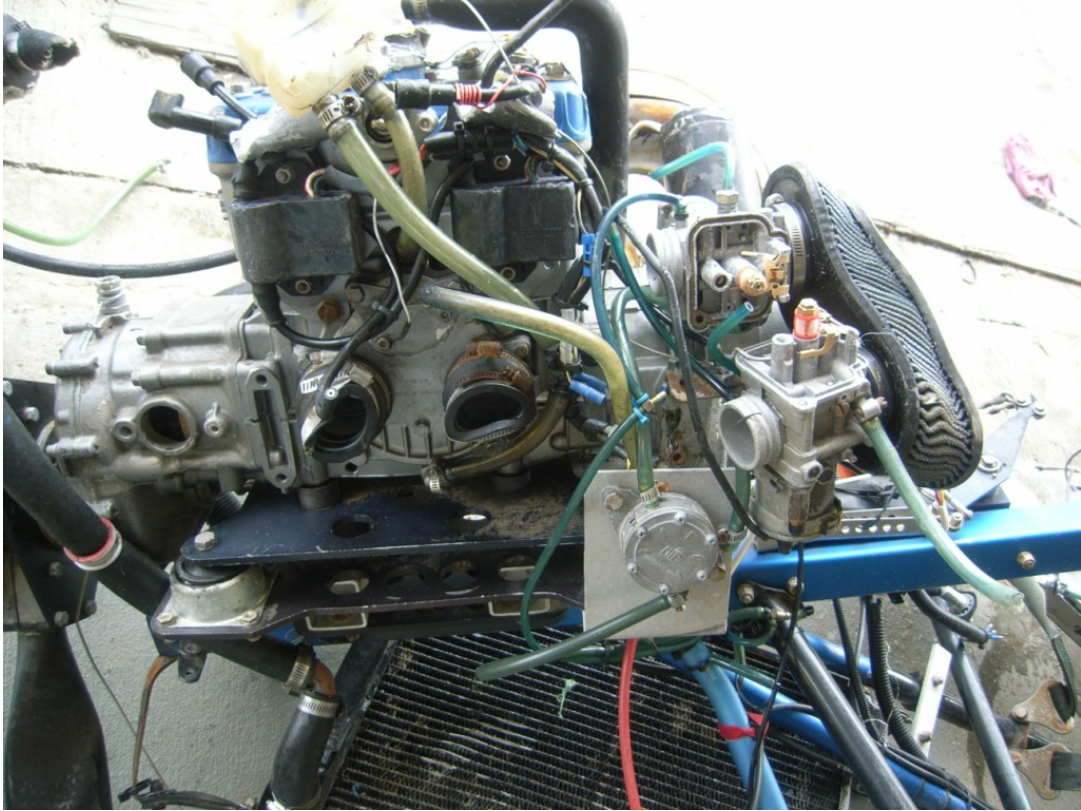
**Figure 19 - Engine Right Side**

The engine remained attached to its mounting pad, which remained attached to the fuselage structure. The propeller hub remained attached to the engine gearbox flange, but all three composite blades were fracture-separated from the propeller hub. The engine exhibited significant impact damage, corrosion, and sand infiltration. The engine was unable to be rotated manually. There was no external evidence of any catastrophic failure of any engine components.

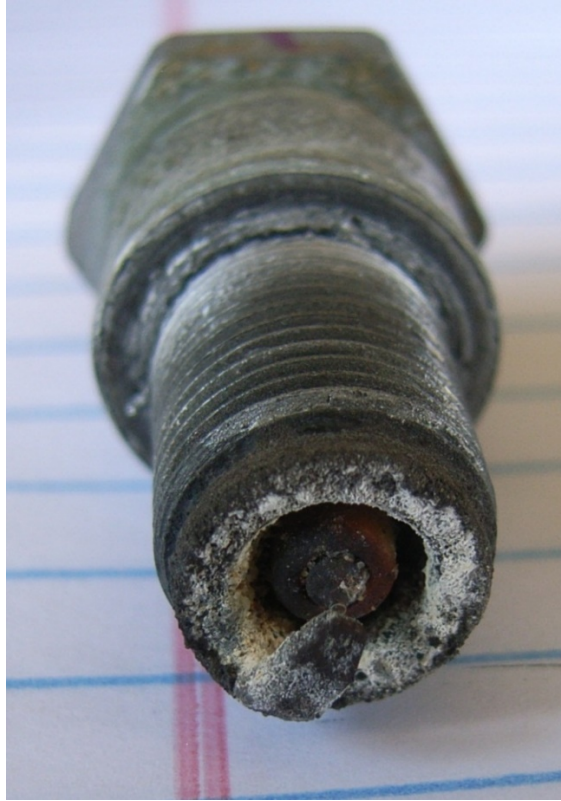
**Figure 24 - SP I**

- SP I (PTO end, aft) 0.022"
- SP II (PTO end, forward) 0.024"
- SP III (MAG end, aft) undetermined due to corrosion
- SP IIII (MAG end, forward) 0.024"

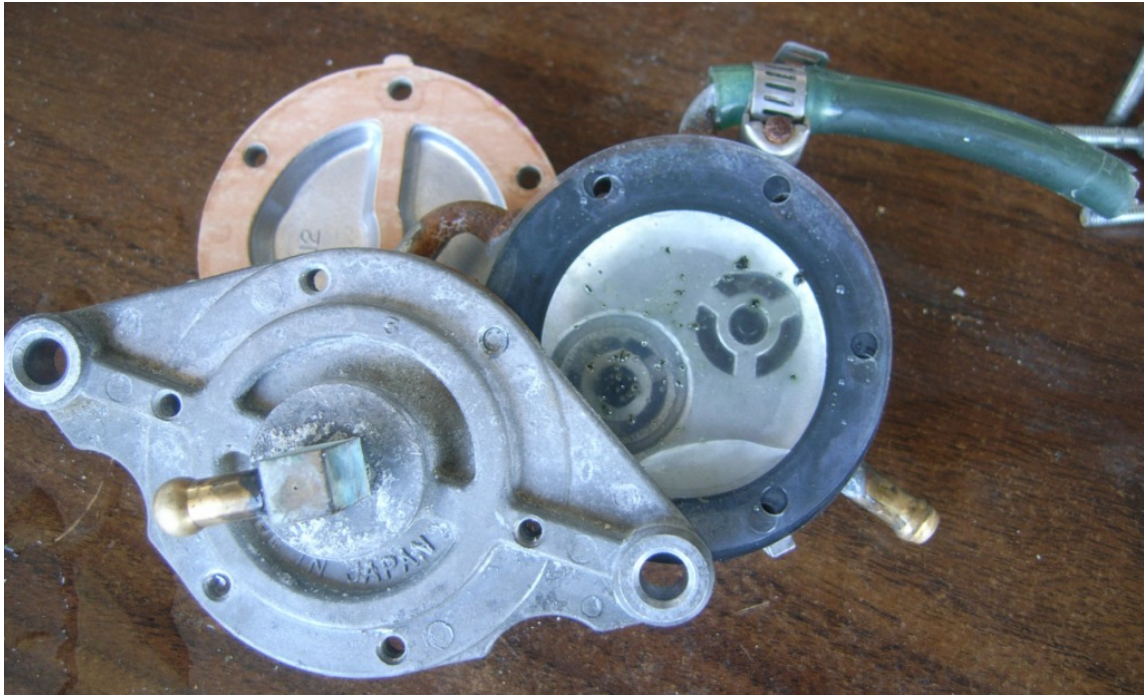
**Figure 32 - Engine Drive Fuel Pump (interior)**

Regarding the installation location of the EDP, the Rotax installation manual stated that "if possible, the pump should be located below the fuel tank level." The EDP location was near the bottom of the engine, which was above the top of the fuel tank.

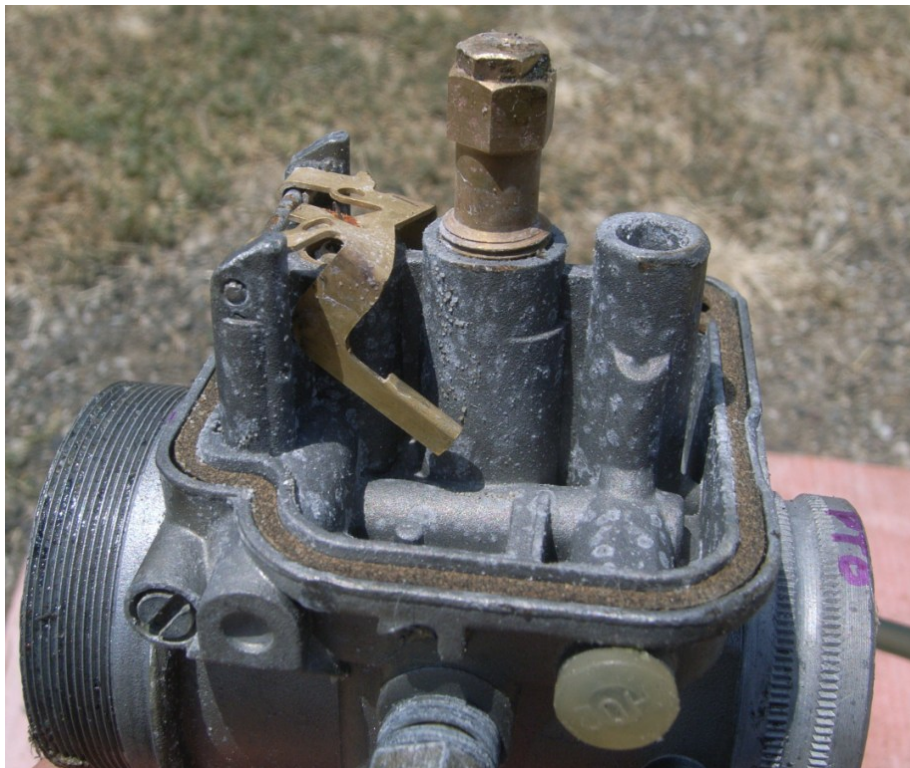
**Figure 36 - PTO End Carburetor**

The two sockets remained installed on the engine, and retained all four attaching worm clamps. The sockets were removed and examined; both were flexible, and no through-cracks were observed. Examination of the maintenance records indicated that the carburetor socket for the PTO carburetor was replaced on July 2, 2017 by the SKFC mechanic. That work was completed at a Hobbs meter reading of 3183.9 hours. The logbook entry did not contain any information regarding an operational check of the new installation. Discussions with the mechanic and another SKFC member revealed that no operational check was conducted, and that the installed socket was not brand new. According to the aircraft 'Flight Log', the next aircraft/engine run (unknown if actually flown) was on July 6, 2017, for 0.2 hours. The next entry on the Flight Log was for the accident flight.
