# Continental Motors

## ENGINE EXAMINATION REPORT

| ENGINE MODEL | TSIO-550-K1B |
| FILE NUMBER | 17-039 |

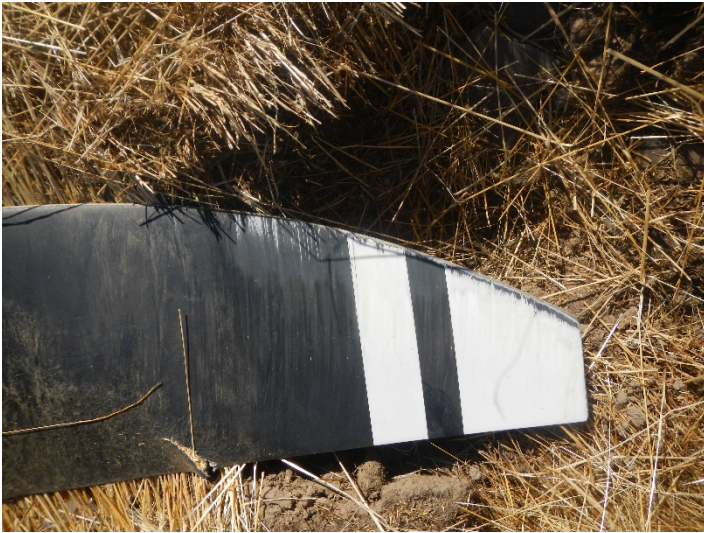
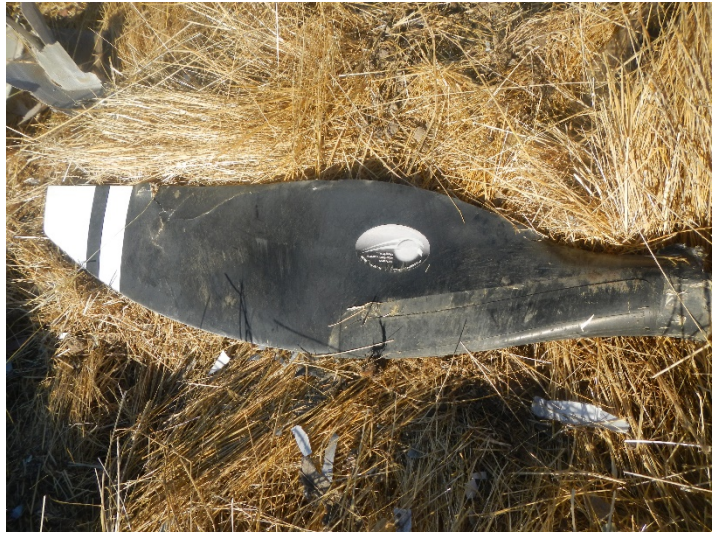
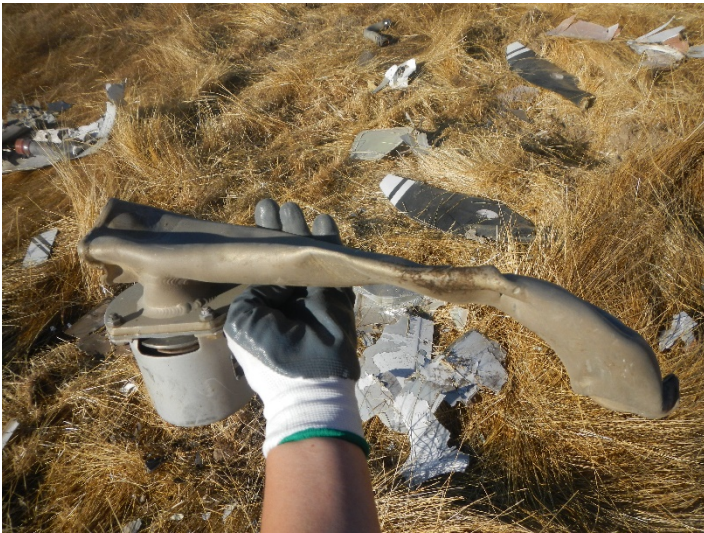
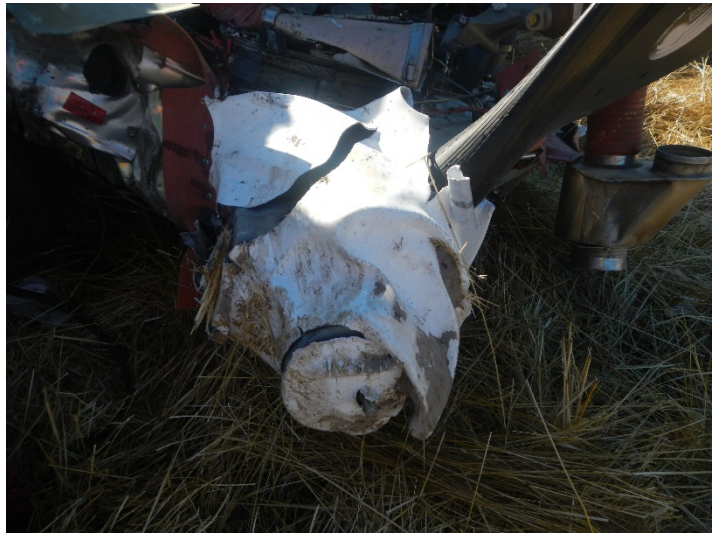
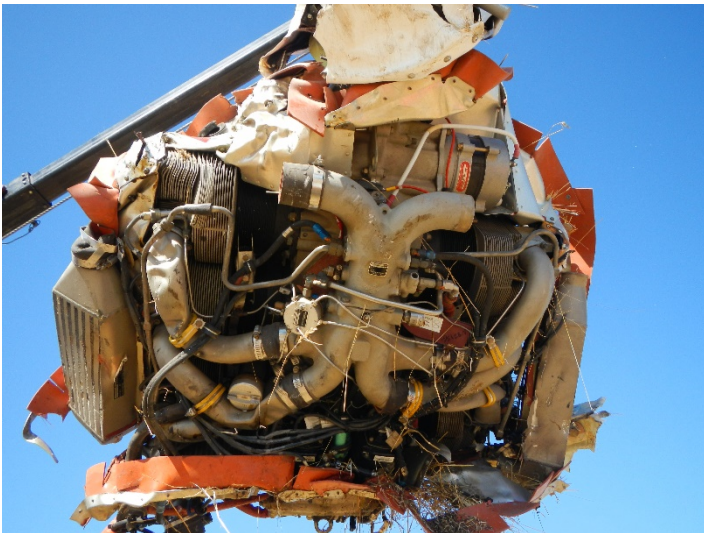
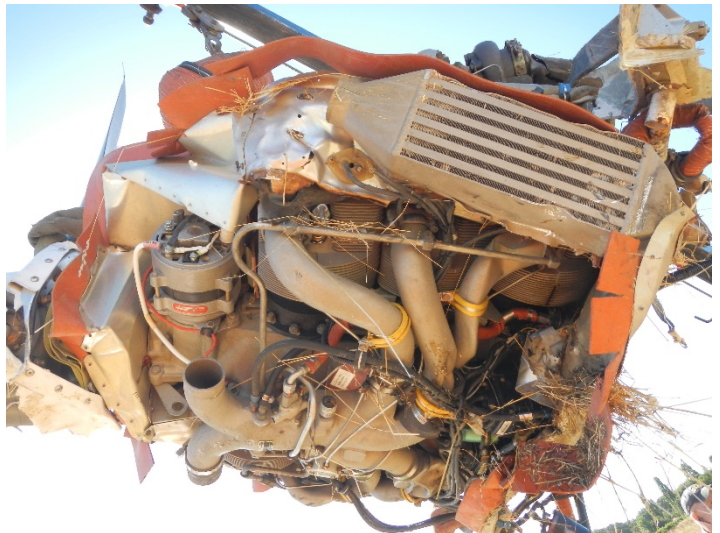
The engine came to rest in an inverted position adjacent to the cabin area, but askew from the firewall approximately 45 degrees to the right. The engine was separated from the mounts and remained attached to the aircraft via the throttle control cable, electrical wiring, and intertwined lubricating lines. The three-bladed composite propeller remained attached to the crankshaft and two of the blades were separated from the hub and were found near the initial impact area. One of the separated blades displayed leading edge and chord-wise paint erosion. The other separated blade remained relatively undamaged. The blade that remained attached to the hub was displaced forward at the tip and displayed light chord-wise paint erosion at the tip. The propeller spinner was crushed aft around the hub and was slightly displaced toward one side with the tip folded over the hub.

When the engine was righted, it was noted that the right magneto was separated from its mounting pad and its mounting flange was fractured in an area that coincided with the attaching hardware. The ignition harness remained attached to the magnetos, but the leads sustained impact-related pinching and tearing damage.

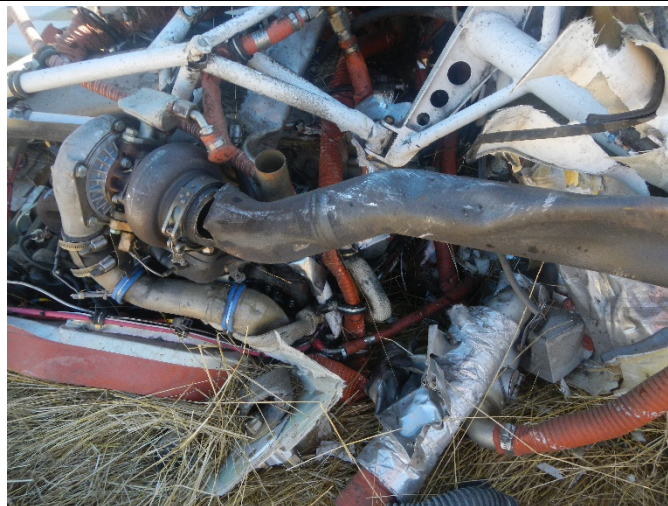
The exhaust tailpipes were flattened, and the right tailpipe was fractured at the flange weld. The left and right v-band couplings remained in place on the tailpipe and turbocharger exhaust flanges. The right side exhaust risers remained intact, though they all sustained deformation damage. The left side exhaust manifold was separated from the #2 cylinder exhaust riser and the left side exhaust risers were deformed. The wastegate remained attached to the exhaust system, but the exhaust manifold was deformed and the wastegate actuator mount was fractured. There were no pre-accident anomalies noted with the system.

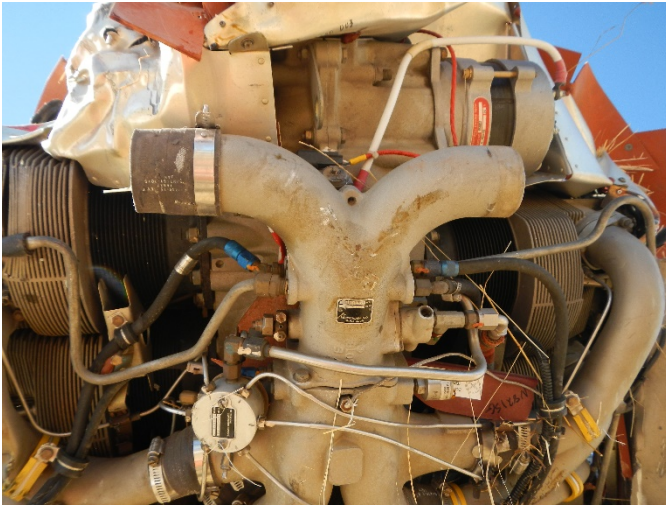
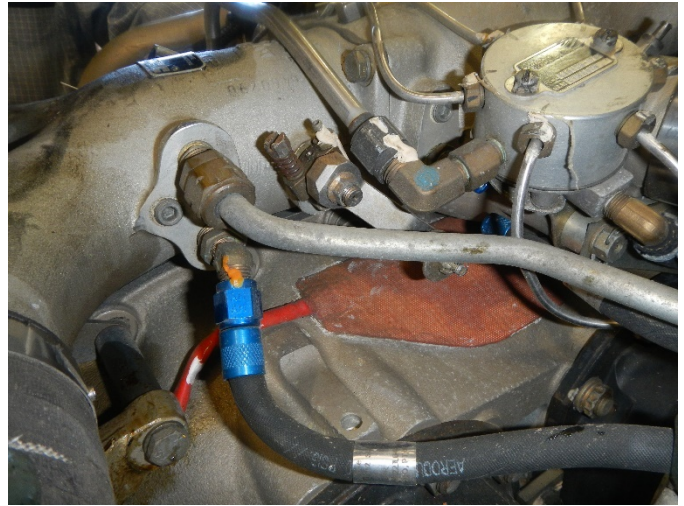
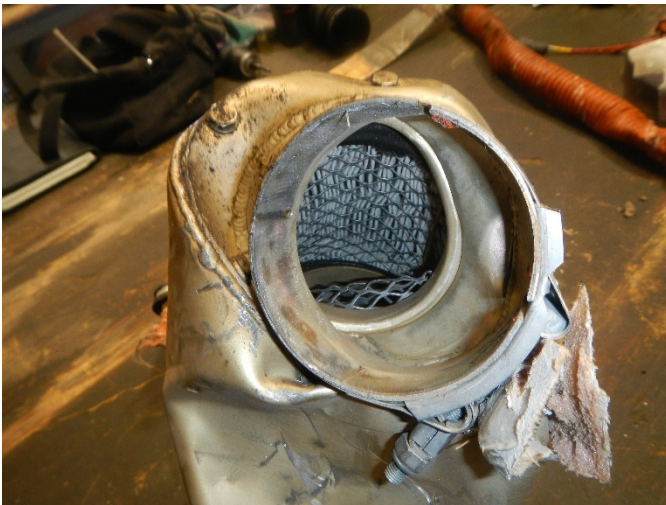
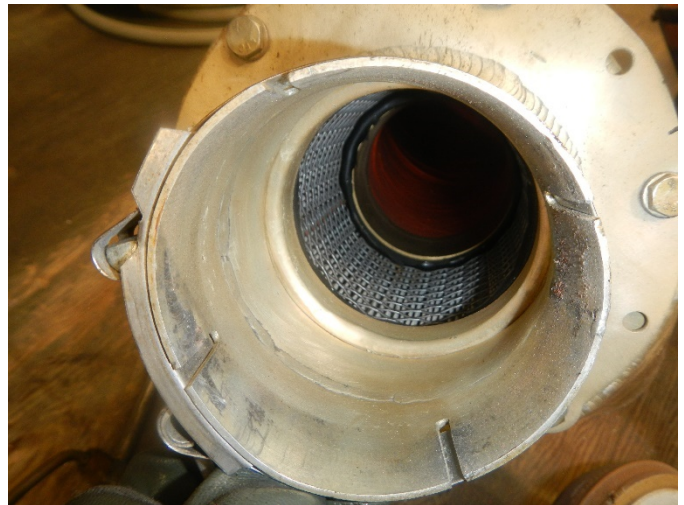
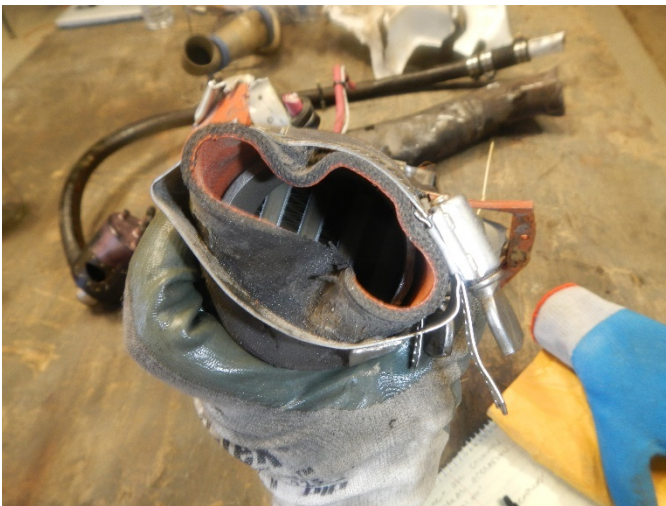
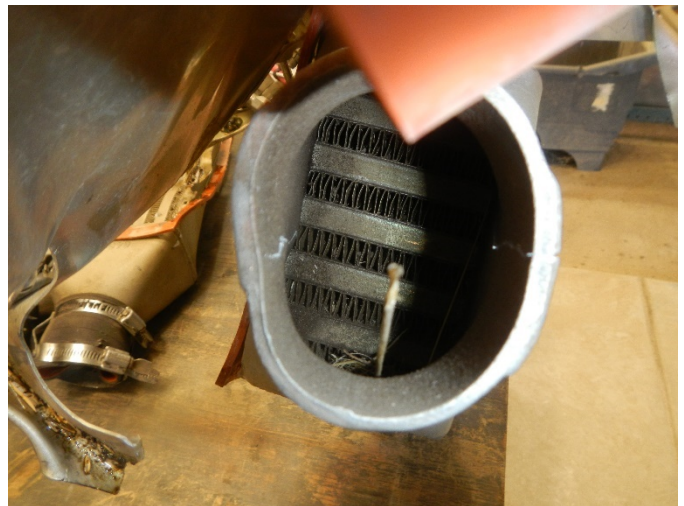
**Condition:** The right intake filter was separated from the turbocharger, but it remained attached to the engine via scat tubing. The filter housing was deformed, but there were no pre-accident anomalies or blockages noted. The left intake filter housing was crushed and remained in place around the left turbocharger compressor inlet. No pre-accident anomalies or blockages were noted when it was removed and inspected. The compressor outlets were separated from the tubing that led to the left and right intercoolers. There were no blockages noted in the intercoolers. The left and right intake elbows that led to the throttle body were separated from the engine. The elbow that contained the overboost valve was flattened and found near the initial impact area. There were no obstructions noted in the throttle body. The throttle lever/shaft functioned normally, with no pre-accident anomalies noted. There were no signs of induction leaks on any of the intake tubes and many sustained deformation damage. The upper deck and induction system reference lines remained in place, though some of the fittings sustained deformation or cracking damage during the accident. There were no pre-accident anomalies noted with the induction system.

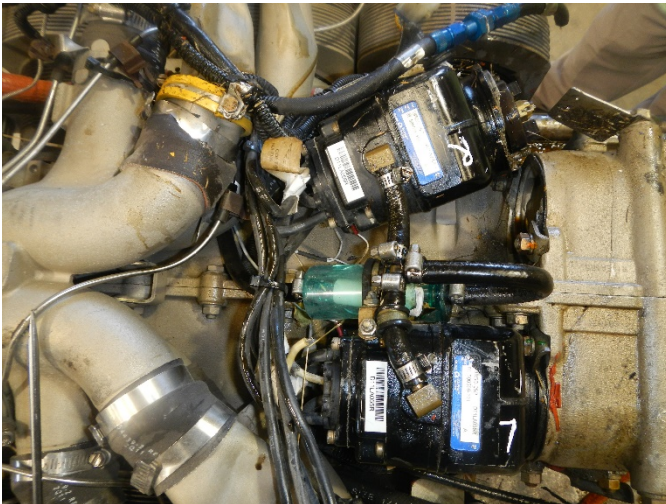
The ignition harness caps remained attached to their respective magnetos. Two leads were pulled away from the left magneto cap and one lead was pulled away from the right magneto cap. Many of the leads displayed pinching or tearing damage. The caps were removed from the magnetos and neither displayed any pre-accident anomalies or tracking.

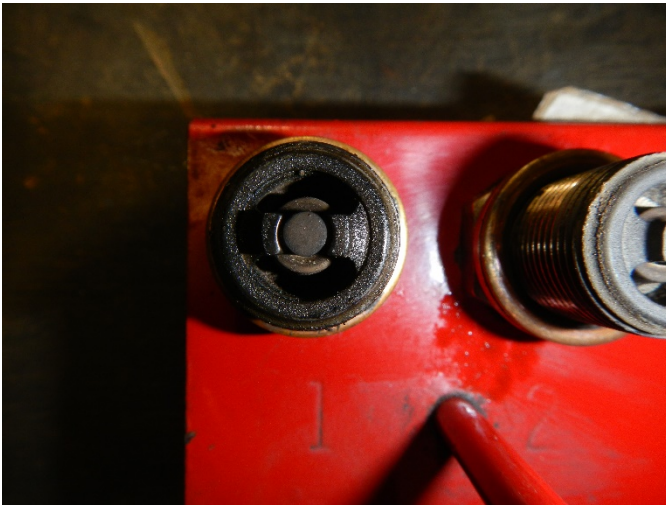
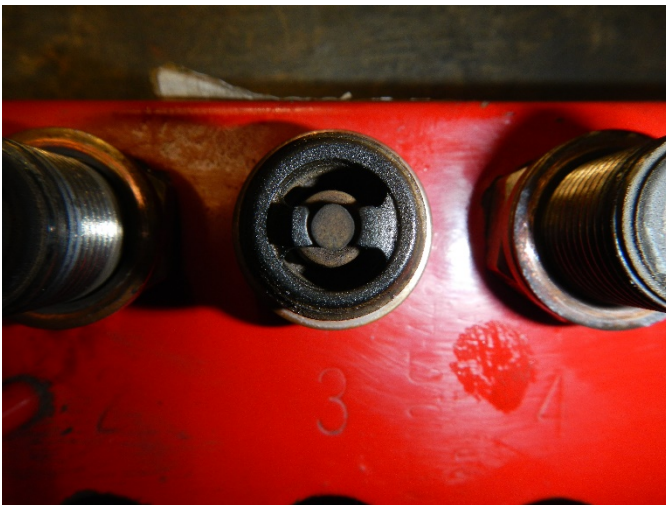
The sparkplugs remained secured to their respective cylinders and the ignition terminals remained attached to the sparkplugs. Removal of the top sparkplugs' ignition terminals revealed that 4 of the 6 sparkplug insulators were fractured. The top sparkplugs were removed and all displayed normal wear with no sign of carbon or lead fouling; however, the electrode insulators were dark, which was consistent with a slightly rich fuel/air mixture. The two sparkplugs that retained intact insulators were reattached to the left magneto's intact ignition leads. The crankshaft was manually rotated and a spark was observed from each sparkplug during the snap of the impulse coupling. The bottom sparkplugs were documented with lighted borescope and are depicted in the right photo column below. The #6 bottom sparkplug was surrounded by debris that was consistent in color and consistency as separated combustion deposits.

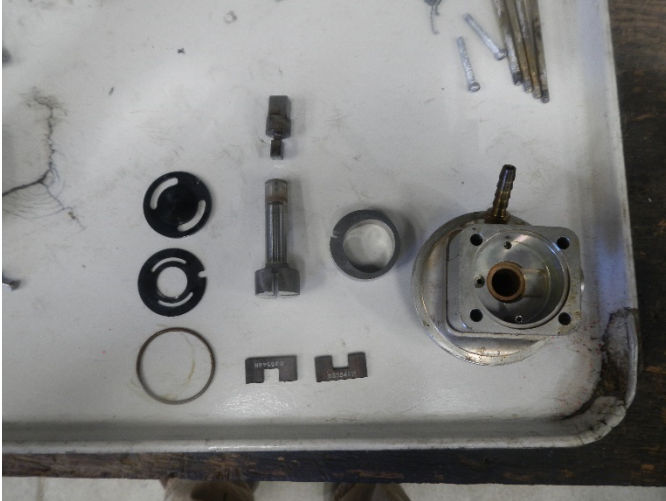
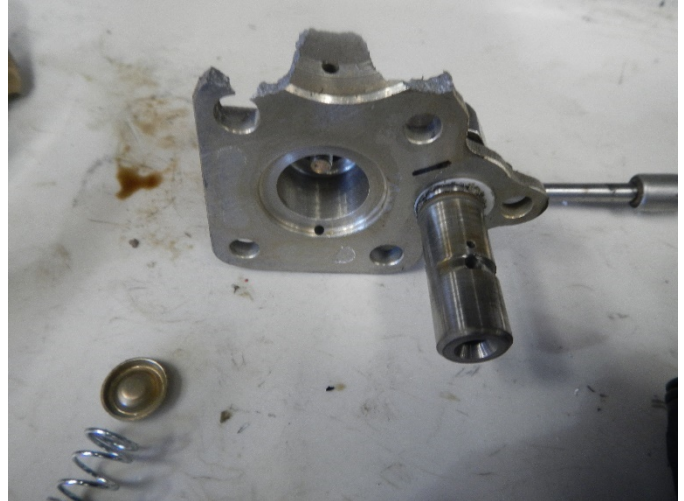
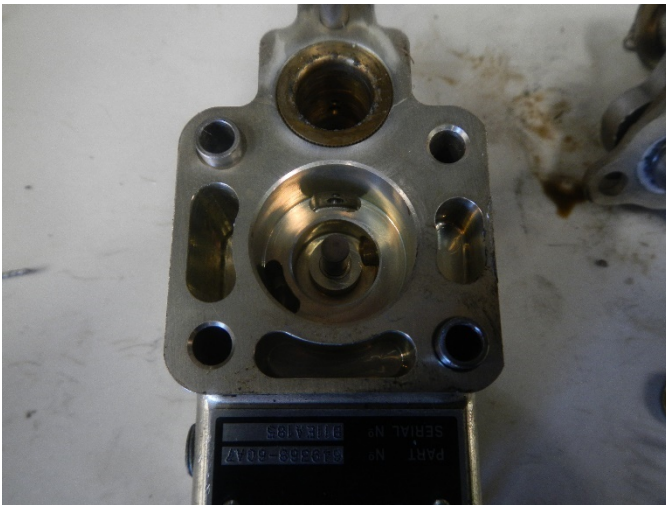
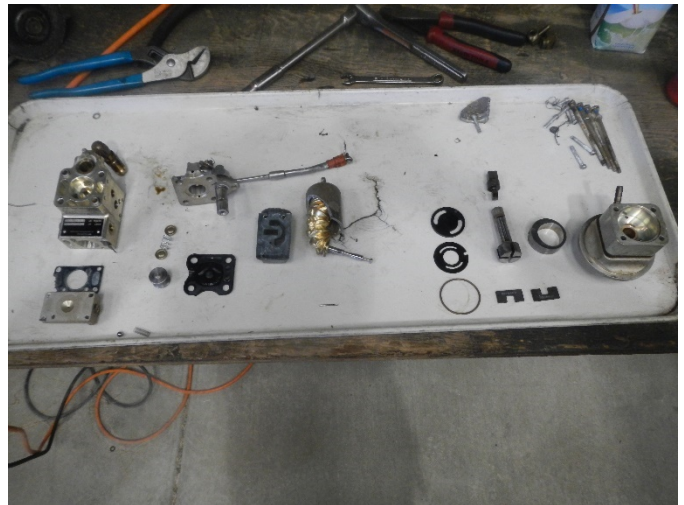
The fuel inlet and vapor return lines were separated from the engine-driven fuel pump and the mixture control cable rod end remained attached to the mixture control lever. The mixture control cable was separated from the rod end and the rod was bent and the lever was deformed. The aneroid bellows housing was fractured and the bellow was distorted and stretched to the side. The low pressure relief valve set screw was bent. The pump was removed from the backside of the engine and fuel consistent in color and odor as 100LL AVGAS poured from the fittings. The drive coupling was intact and manual manipulation of the coupling resulted in rotation of the drive shaft with a sucking sound emanating from the pump fittings. The pump was disassembled and the vanes were intact with no pre-accident anomalies noted. The pump was clean with no signs of contamination.

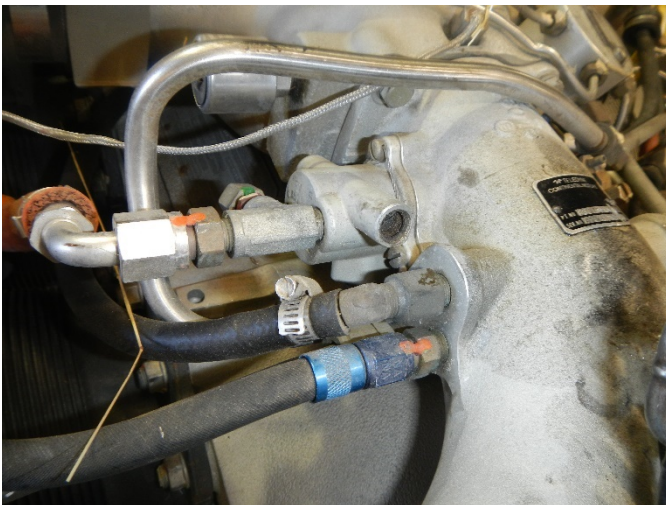
The throttle body remained attached to the topside of the engine with no pre-impact anomalies or signs of fuel leakage noted. The flange attaching the throttle body to the plenum was cracked on the left side and the throttle body mount was damaged. The throttle cable remained attached to the throttle lever. The throttle lever was manipulated after the cable was disconnected and the throttle shaft rotated with no signs of slipping noted. The throttle shaft was bent slightly. The reference lines to and from the throttle body remained secured as did the fuel lines; however, the upper deck reference fitting on the left side was cracked and the reference line was displaced down toward the cylinders. Fuel was present in the lines to and from the fuel metering unit. Disassembly of the fuel metering unit revealed no pre-accident anomalies and fuel was present in the metering unit.

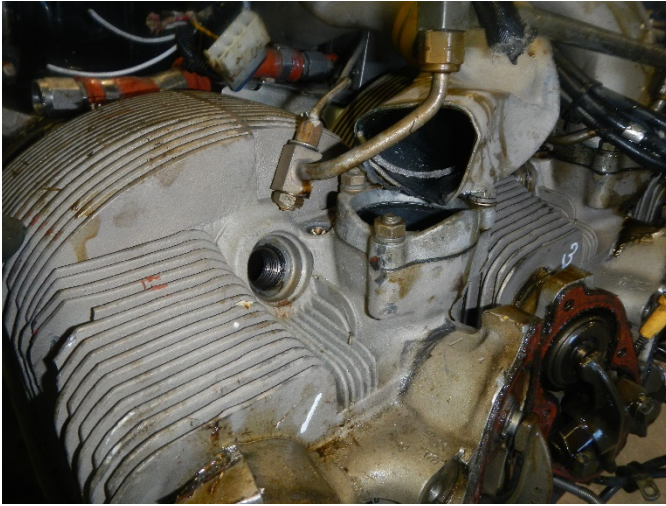
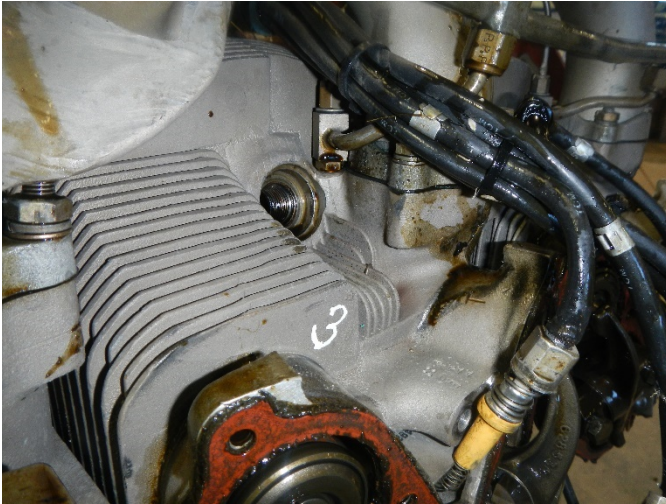
The fuel injection lines remained in place and intact though they received deformation damage. All of the fuel injector nozzles remained attached to the lines, though the #1 fuel injector nozzle was fractured where it threaded into the cylinder. The upper deck reference line remained secured to each nozzle, but it sustained deformation damage. No pre-accident anomalies were noted externally. The nozzles were removed from their respective cylinders and all were clear and free from any obstructions

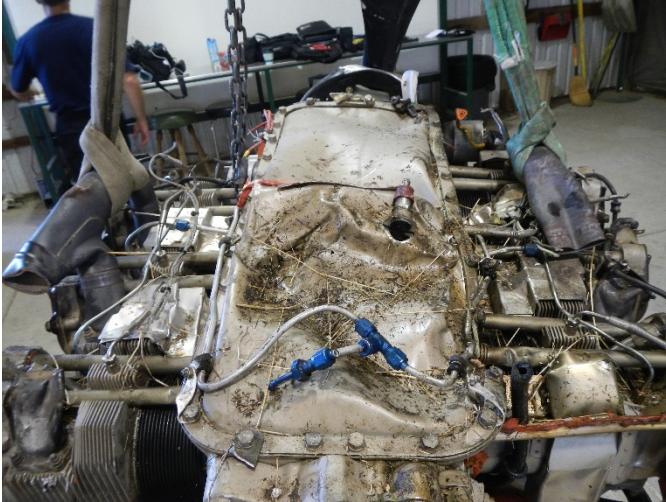
The oil sump drain plug was displaced and the oil sump was breached. The oil sump was displaced up toward the bottom of the engine.

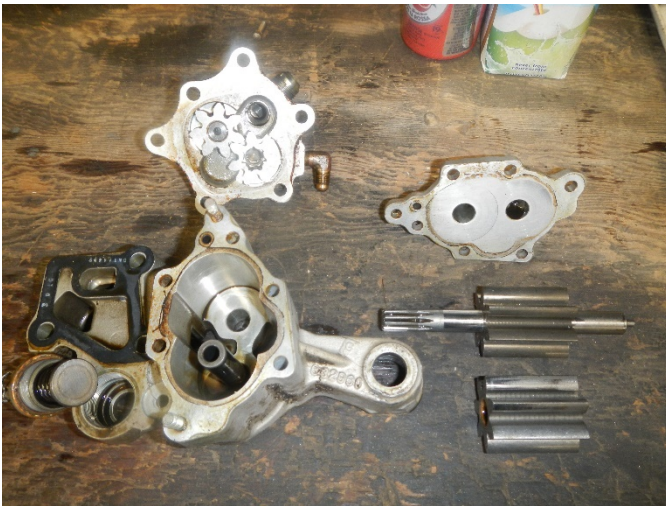
The engine oil supply pump remained attached to the backside of the engine with no signs of oil leaks noted. The oil pump housing cap was removed and residual oil coated the internal components with no signs of lubrication distress or pre-accident anomalies. The oil pressure relief valve did not display any evidence of unusual seating.

The oil scavenge pump was in place on the backside of the starter adapter with no signs of an oil leak noted. Removal of the housing cap revealed residual oil coating the internal components with no signs of lubrication distress or pre-accident anomalies.

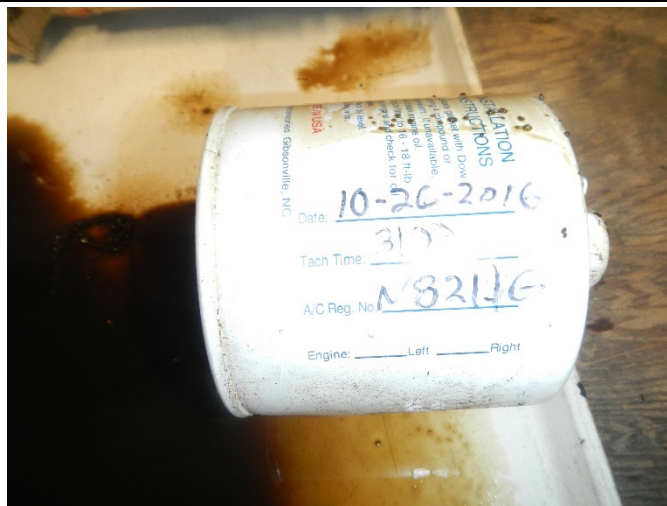
Condition: The oil filter remained in place on the adapter and the safety-wire was intact. Residual oil poured out from the filter with no pre-accident anomalies noted.

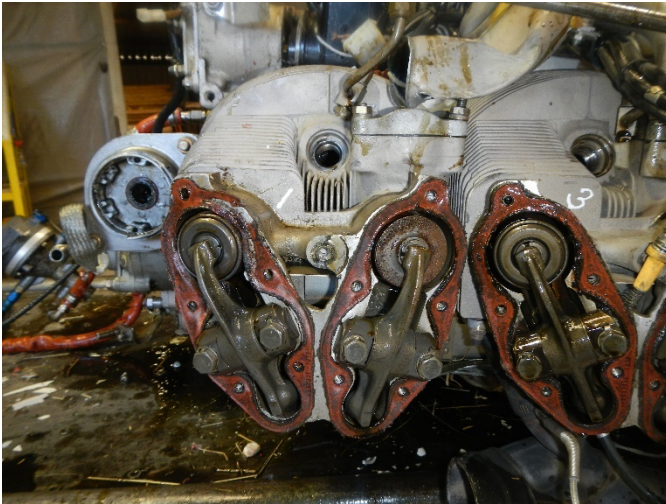
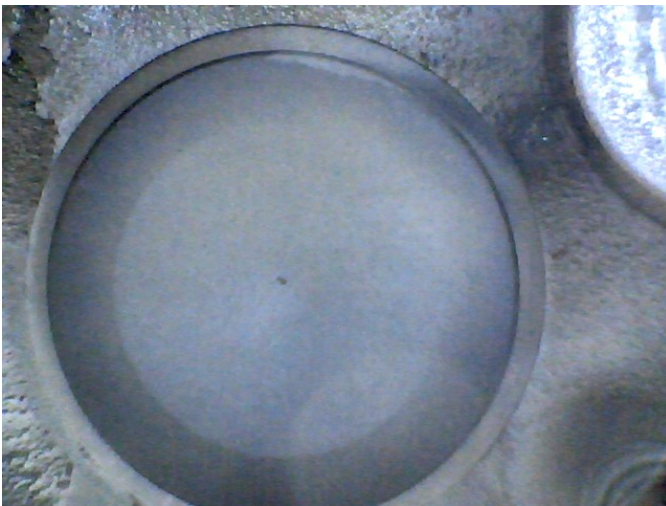
#### CYLINDER #1

Condition: The cylinder remained attached to the crankcase with no external signs of operational distress noted. The rocker covers were removed and no pre-accident anomalies were noted with the valve springs or rockers. Residual oil coated the overhead components. The top sparkplug was removed and a borescope inspection of the cylinders was conducted and documented. No pre-accident anomalies were noted with the piston, barrel, valves or valve seats. Thumb compression was obtained and valve train continuity was confirmed during rotation of the crankshaft.

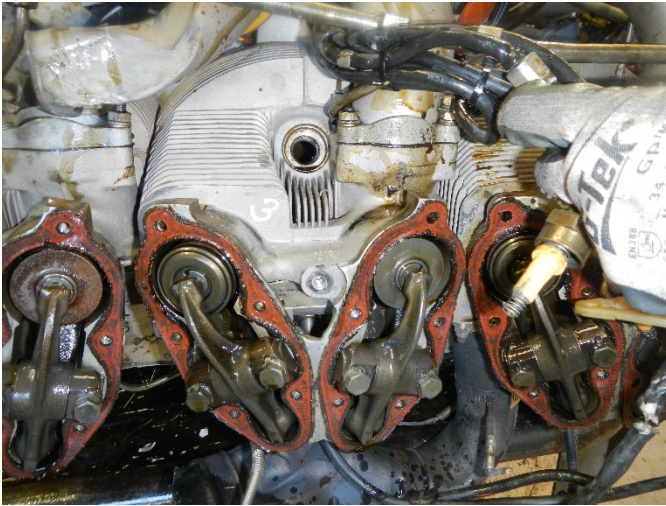
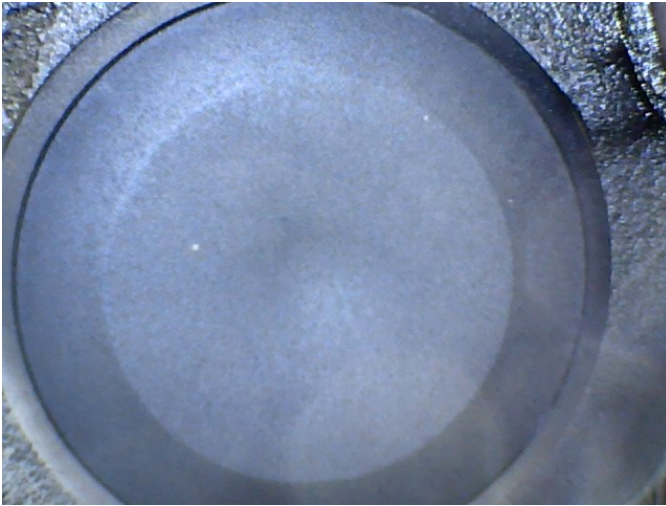
### CYLINDER #3

Condition: The cylinder remained attached to the crankcase with no external signs of operational distress noted. The rocker covers were removed and no pre-accident anomalies were noted with the valve springs or rockers. Residual oil coated the overhead components. The top sparkplug was removed and a borescope inspection of the cylinders was conducted and documented. No pre-accident anomalies were noted with the piston, barrel, valves or valve seats. Thumb compression was obtained and valve train continuity was confirmed during rotation of the crankshaft.

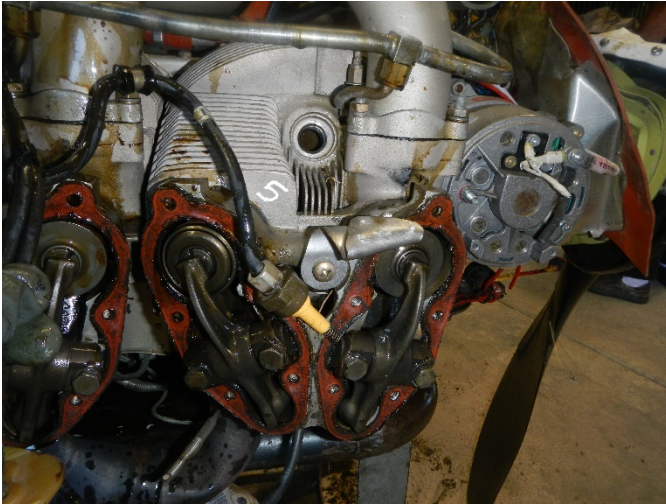
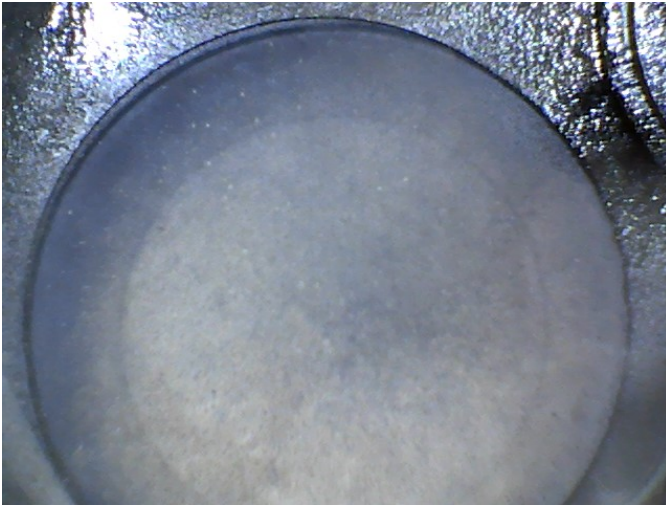
### CYLINDER #5

Condition: The cylinder remained attached to the crankcase with no external signs of operational distress noted. The rocker covers were removed and no pre-accident anomalies were noted with the valve springs or rockers. Residual oil coated the overhead components. The top sparkplug was removed and a borescope inspection of the cylinders was conducted and documented. No pre-accident anomalies were noted with the piston, barrel, valves or valve seats. Thumb compression was obtained and valve train continuity was confirmed during rotation of the crankshaft.

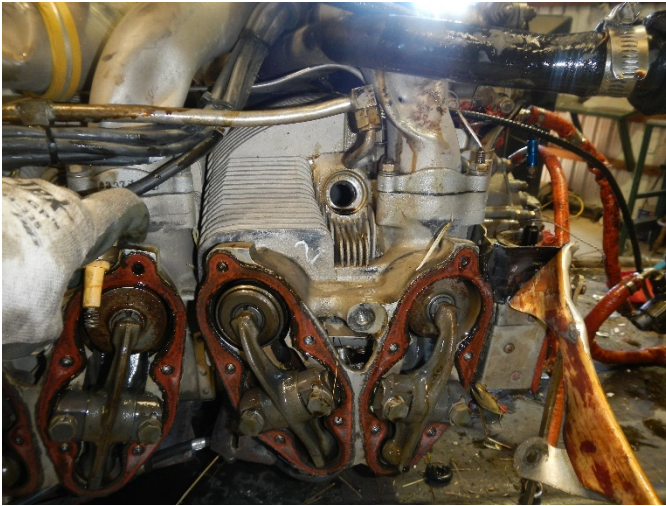
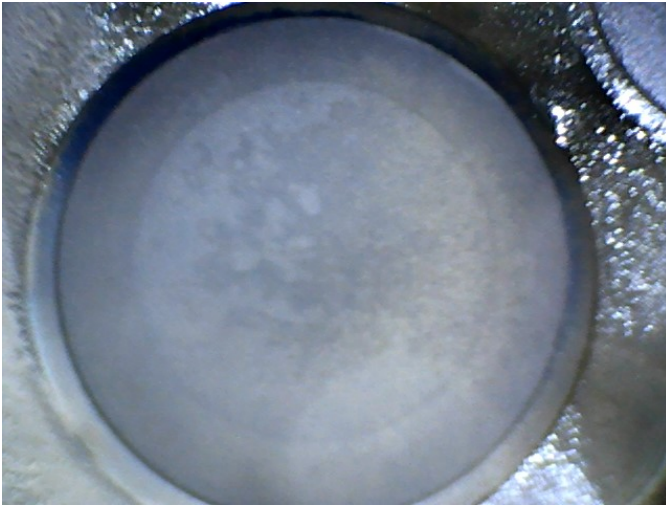
### CYLINDER #2

Condition: The cylinder remained attached to the crankcase with no external signs of operational distress noted. The rocker covers were removed and no pre-accident anomalies were noted with the valve springs or rockers. Residual oil coated the overhead components. The top sparkplug was removed and a borescope inspection of the cylinders was conducted and documented. No pre-accident anomalies were noted with the piston, barrel, valves or valve seats. Thumb compression was obtained and valve train continuity was confirmed during rotation of the crankshaft.

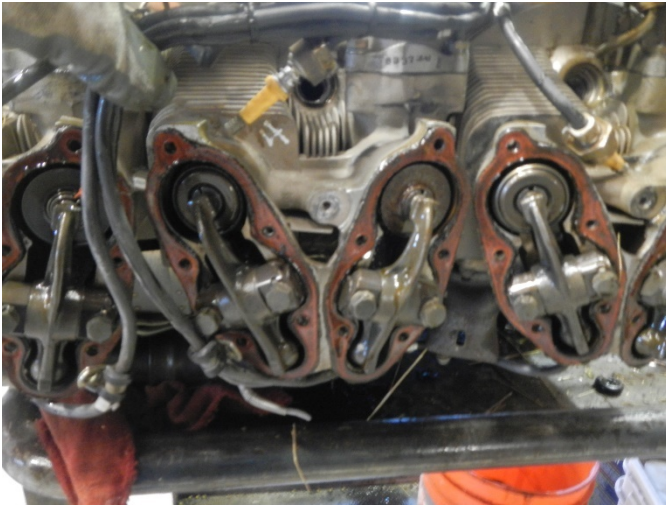
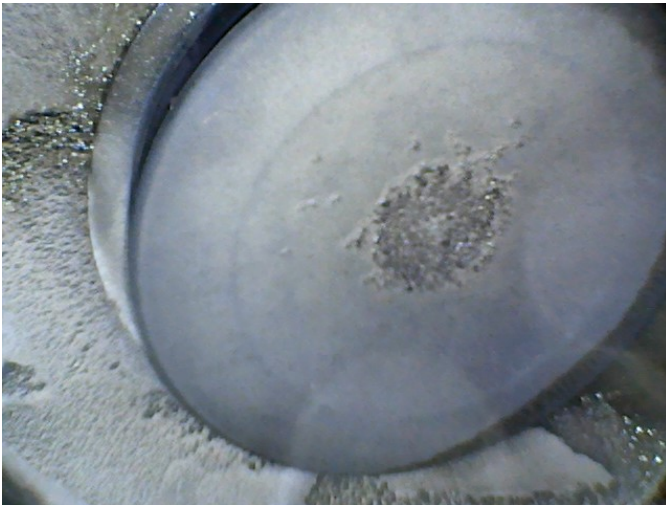
### CYLINDER #4

Condition: The cylinder remained attached to the crankcase with no external signs of operational distress noted. The rocker covers were removed and no pre-accident anomalies were noted with the valve springs or rockers. Residual oil coated the overhead components. The top sparkplug was removed and a borescope inspection of the cylinders was conducted and documented. No pre-accident anomalies were noted with the piston, barrel, valves or valve seats. Thumb compression was obtained and valve train continuity was confirmed during rotation of the crankshaft.

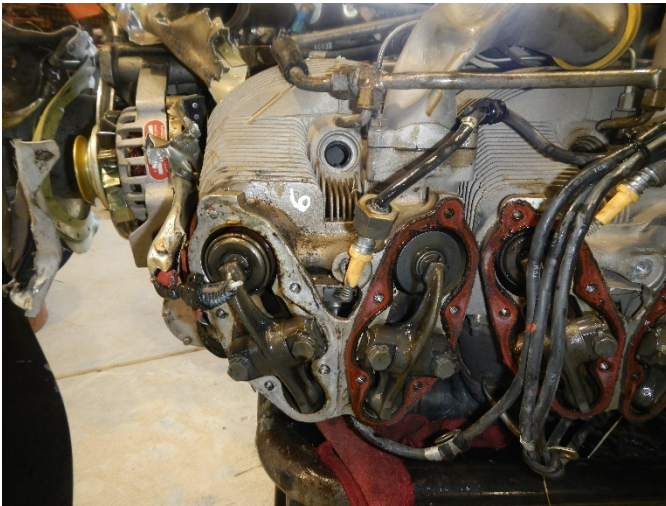
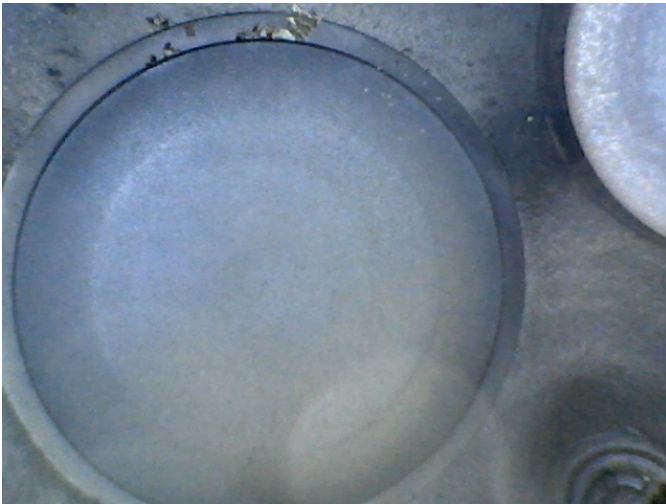
### CYLINDER #6

Condition: The cylinder remained attached to the crankcase with no external signs of operational distress noted. The cooling fins on the topside sustained cracking and displacement damage. The rocker covers were removed and no pre-accident anomalies were noted with the valve springs or rockers. Residual oil coated the overhead components. The top sparkplug was removed and a borescope inspection of the cylinders was conducted and documented. No pre-accident anomalies were noted with the piston, barrel, valves or valve seats. Debris consistent with loose combustion deposits were noted on the bottom of the cylinder and around the bottom sparkplug. Thumb compression was obtained and valve train continuity was confirmed during rotation of the crankshaft.

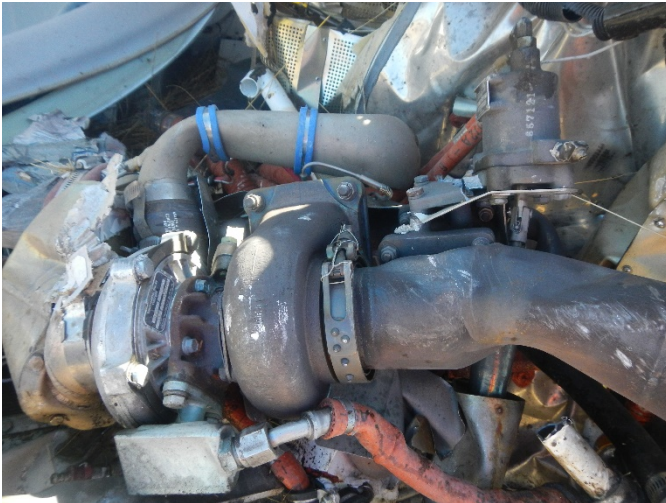
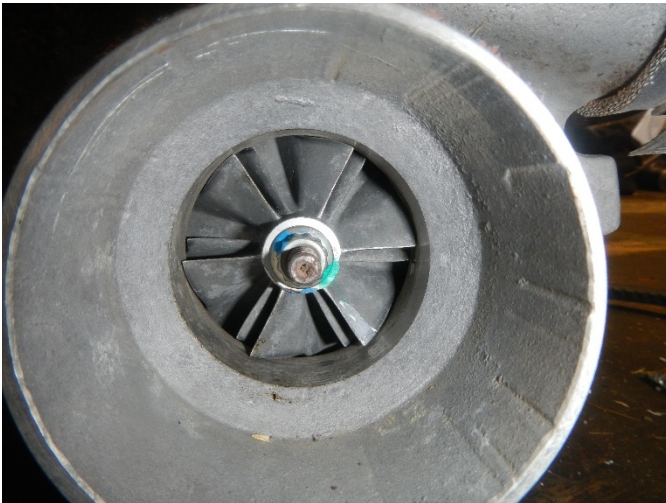
The turbocharger remained attached to the engine mount system and the inlet filter was deformed around the compressor inlet. The filter housing was removed and the compressor and shroud did not reveal any pre-accident anomalies. The oil supply and return lines for the turbocharger bearing remained in place with no signs of leaking. Burnt grass was observed on the v-band clamp area of the turbine shroud. The compressor was manually manipulated and the compressor rotated freely with no binding noted.

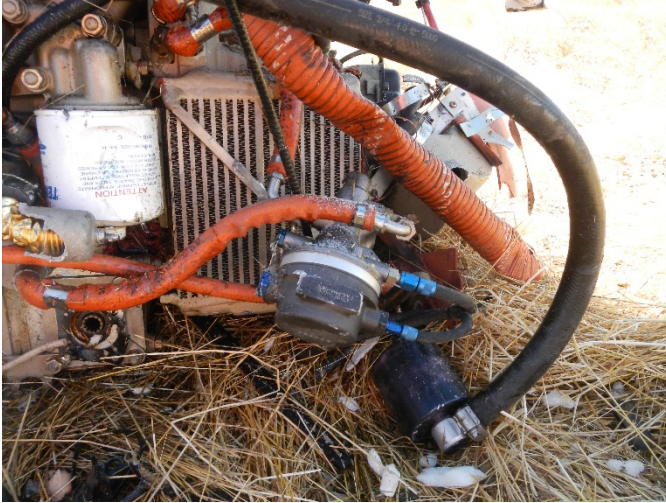
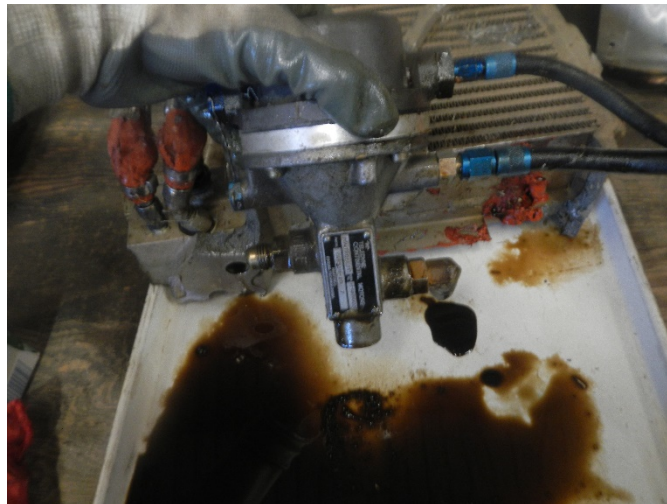
The pressure controller was separated from the firewall but the oil and reference lines to and from the controller remained intact and in place.

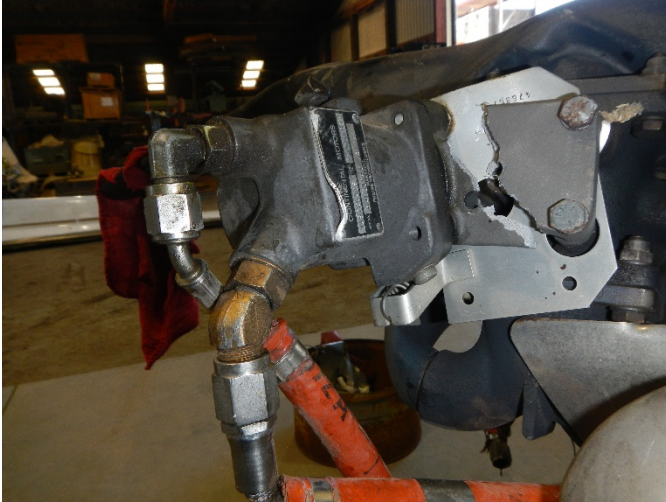
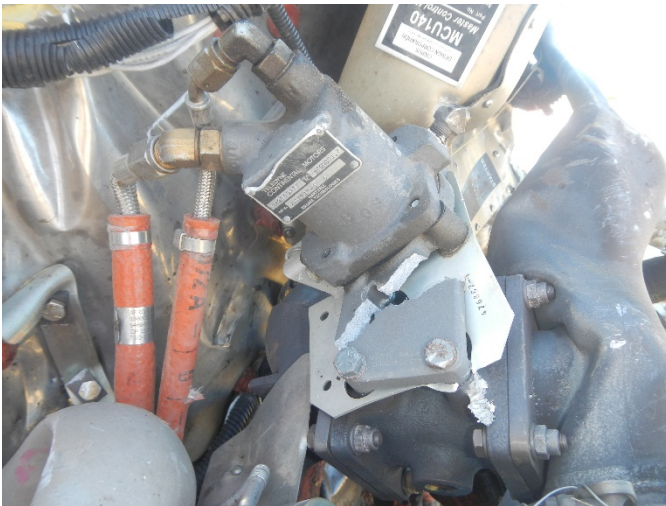
Condition: The wastegate actuator linkage remained intact and the oil lines to and from the actuator remained in place and intact. The mount for the wastegate actuator was fractured and the linkage was displaced slightly. Compressed air was applied to the actuator ports with actuation noted.

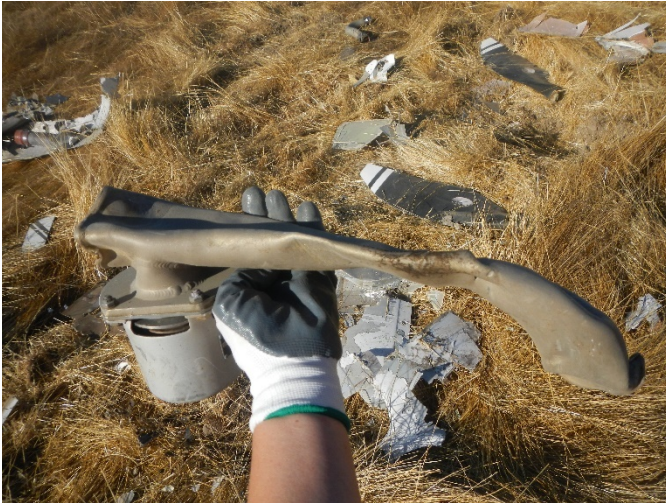
The intake tube and overboost valve were separated from the induction system. It was found near the initial impact area and the tube was flattened. No pre-accident anomalies were noted with the unit and the spring and poppet remained intact.

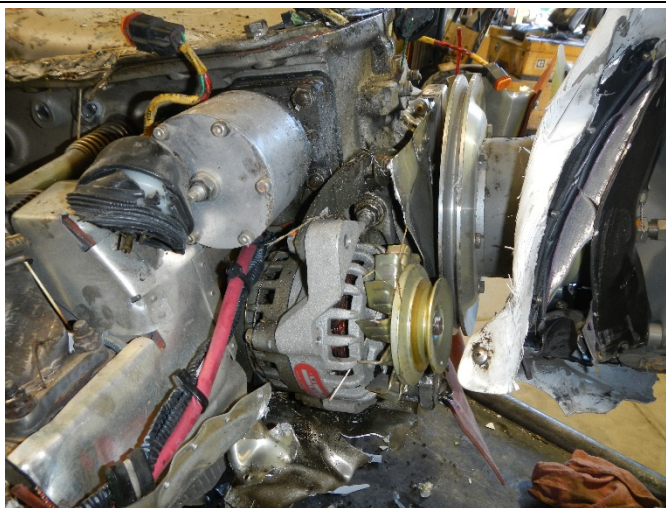
The cable-less governor remained attached to the engine with no pre-accident anomalies noted. However, the governor was not examined in any detail.

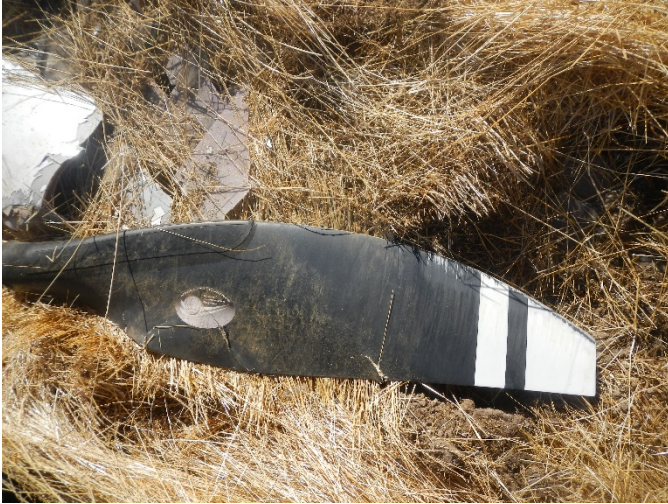
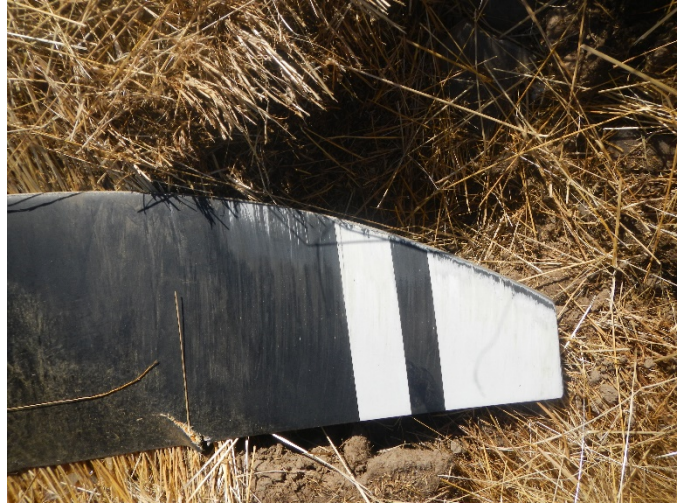
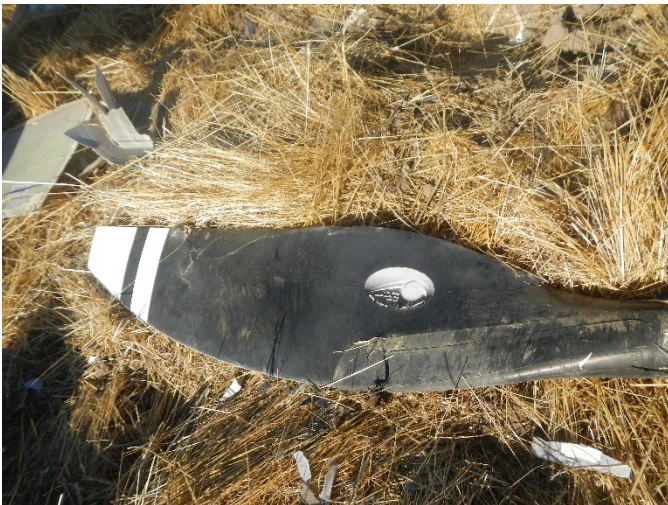
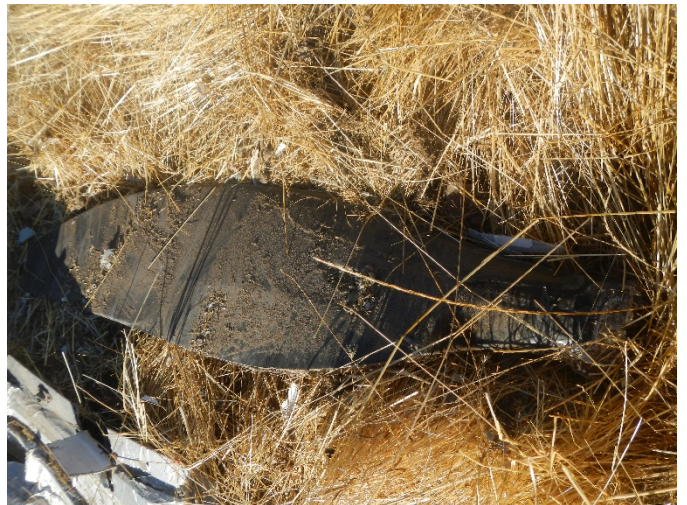
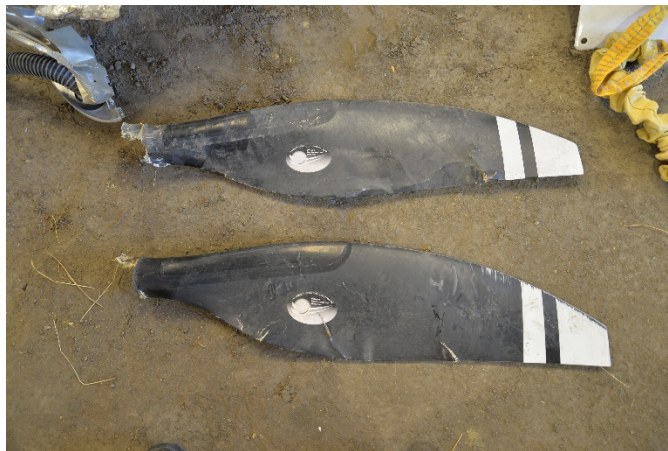
The three-bladed composite propeller remained attached to the crankshaft and two of the blades were separated from the hub and were found near the initial impact area. One of the separated blades displayed leading edge and chord-wise paint erosion. The other separated blade displayed a split along the leading edge near the blade root, but otherwise remained relatively undamaged. The blade that remained attached to the hub was displaced forward at the tip and displayed light chord-wise paint erosion at the tip. The propeller spinner was crushed aft around the hub and was slightly displaced toward one side with the tip folded over the hub
