**Date of Accident:** July 13, 2017

**NTSB File No.:** WPR17FA151

**Aircraft:** Piper PA-44-180 Seminole

**Written by:** Les Doud – Hartzell Propeller Air Safety Investigator

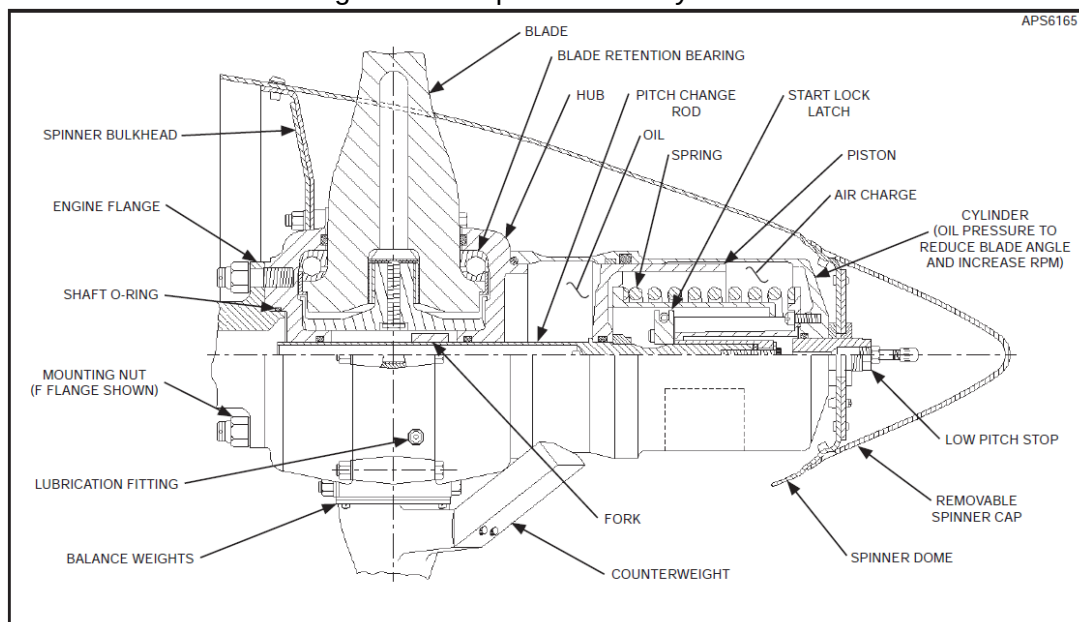
Figure 1 – Propeller Cutaway Sketch

**General Comments:** The Piper Seminole propellers examined are 74" diameter, 2-blade single-acting, hydraulically operated, constant speed models with feathering capability. Oil pressure from the propeller governor is used to move the blades to the low pitch (blade angle) direction. A spring, counterweights, and an air charge move the blades to the high pitch/feather direction in the absence of governor oil pressure. The propeller incorporates start locks to keep propeller blade angle low to minimize the starting torque. The blades and hub are of aluminum construction. The Piper Seminole uses counter-rotating propellers; rotation is clockwise on the left engine and counterclockwise on the right engine as viewed from the rear. A cutaway sketch of the propeller is shown in Figure 1.
