## FIELD NOTES

### HISTORY OF FLIGHT

On August 19, 2017, about 1352 Pacific daylight time, a Rich Wheeler Express CT, N246TM, impacted the wall of a canyon while on approach to land at the Madras Municipal Airport, Madras, Oregon. The pilot/owner was operating the airplane under the provisions of 14 Code of Federal Regulations Part 91. The private pilot, the sole occupant, sustained fatal injuries; the airplane was destroyed. The cross-country personal flight originated from San Carlos, California with a final destination of Madras. Visual meteorological conditions prevailed and no flight plan had been filed.

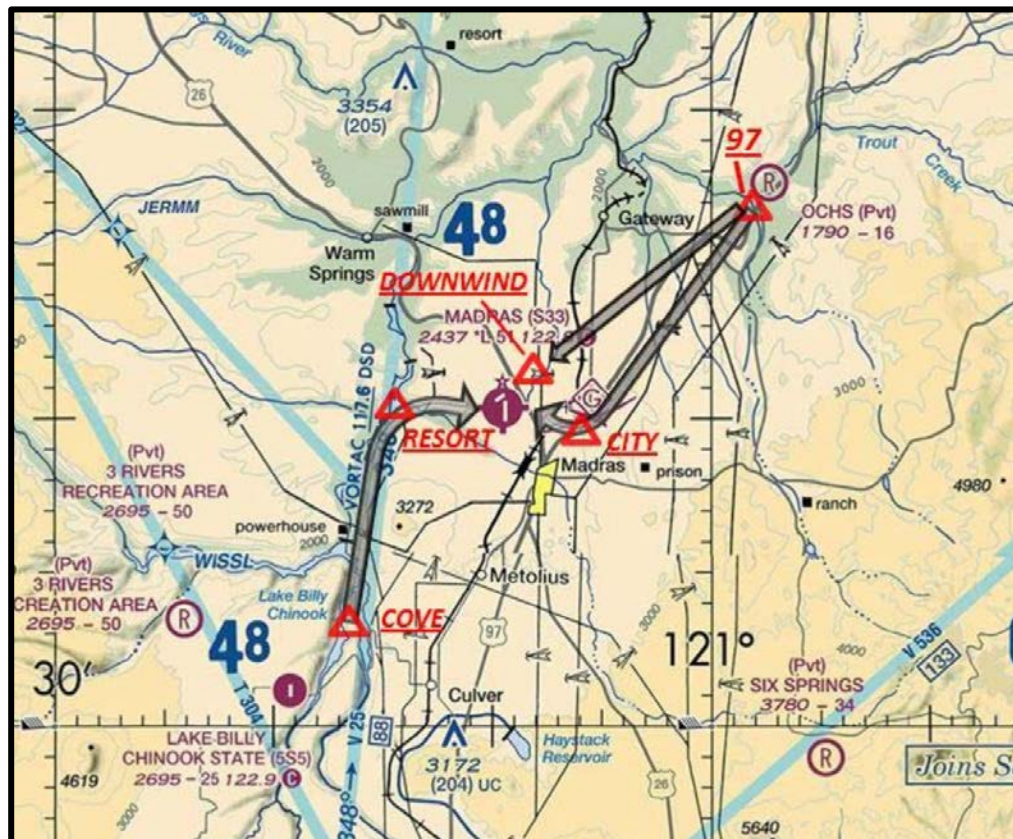
Figure 02: NOTAM Directions

VFR sequencing inbound to Madras Airport begins over The Cove Palisades State Park, 8.5 NM SW of Madras Airport and the intersection of HWY 97 and Old HWY 97, 10.4 NM NW of the Madras Airport.

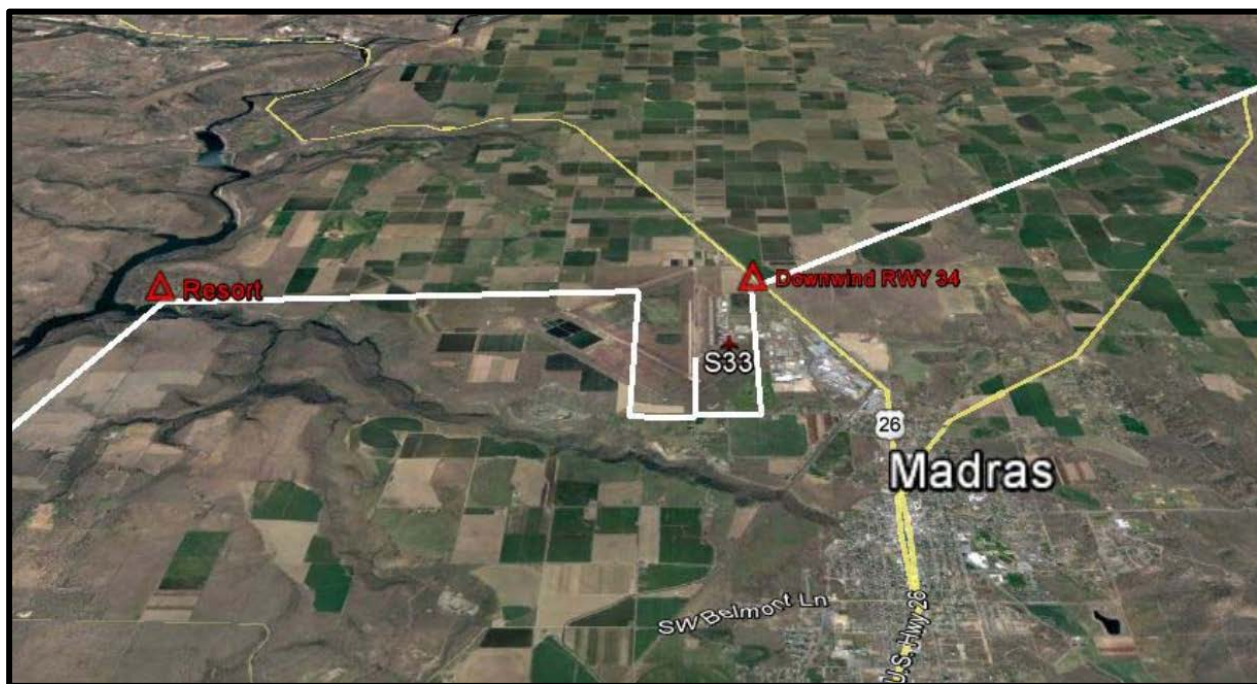
Figure 03: NOTAM Map

Reporting Points: Watch for and sequence your aircraft with other observed traffic. Maintain single file. Aircraft maintain 90 KTS and 3700 MSL over reporting points COVE and 97. If unable, maintain 130 KTS and 4200 MSL over reporting points COVE and 97. Descent from these altitudes to pattern altitude may begin after being told to proceed to the next reporting point.

Airport pattern altitude for aircraft at 90 KTS is 3200. Airport pattern altitude for aircraft at 130 KTS is 3700. Monitor Madras NFCT as you approach COVE or 97 to obtain runway direction and inbound clearance. Announce yourself to Madras NFCT at COVE or 97. Inbound report RESORT, CITY or entering downwind RWY 16 or 34. All Aircraft
