## **NATIONAL TRANSPORTATION SAFETY BOARD**

### **AIRFRAME and ENGINE EXAMINATION**

**NTSB Accident: WPR17FA215  
Accident Date: September 29, 2017**

Location: Brinnon, Washington  
Date: September 29, 2017  
Aircraft: Piper PA28-140, N9549W, Serial # 28-22981  
NTSB IIC: Michael Huhn

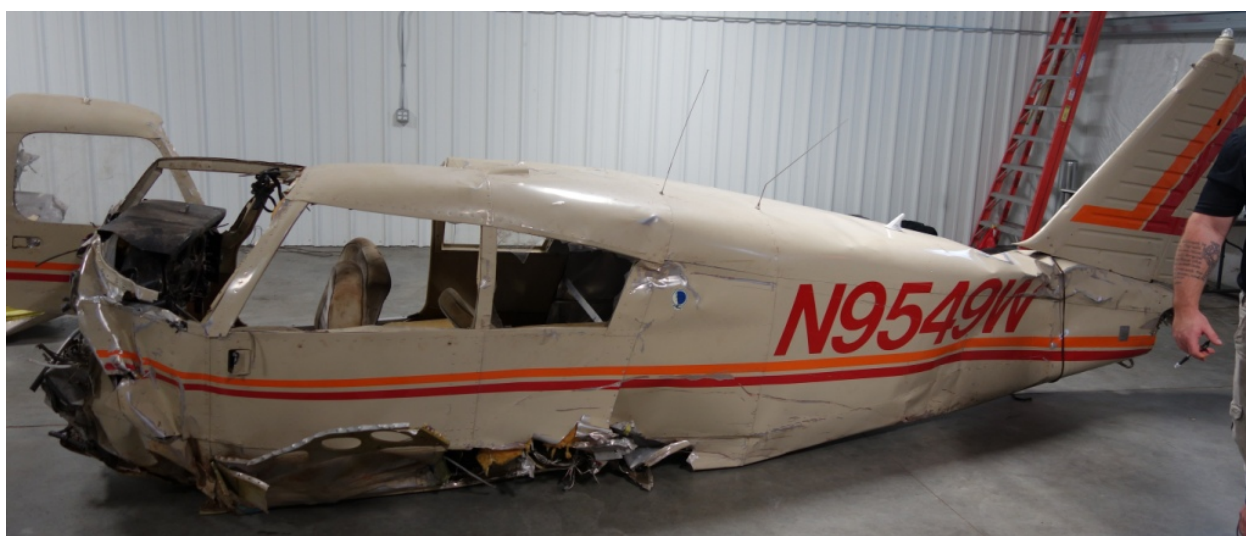
**Figure 4 - Fuselage**

The fuselage sustained impact damage but remained mostly intact. The upper cabin top skin around the door frame was crushed downward. The center and right windshield post were bent in a downward direction.

The lower left side of the fuselage in the area of the wing root going forward to the firewall sustained impact damage. The firewall sustained impact damage along its left side and bottom. The upper nose landing gear strut remained attached to the engine mount. The lower strut (with the nose wheel) separated from upper strut. The engine mount assembly had been cut off the firewall by recovery personnel.

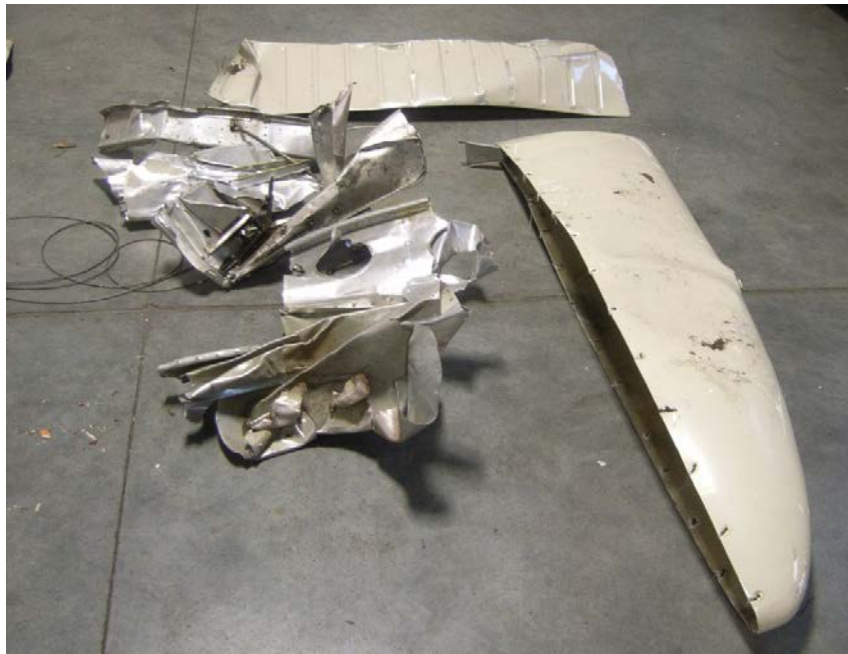
**Figure 8 - Left Wingtip**

The left wing sustained significant tree and ground impact damage. The wing had separated from the fuselage and was fragmented into several sections. The inboard section outboard of the fuel tank exhibited aft crushing signatures consistent with tree impact. The outboard wing section was highly fragmented. Most of the leading edge skins had separated from the wing. The landing gear remained attached to the wing. The wing tip assembly separated from the wing and was recovered at the accident site.
