# Continental Motors

## Component Examination Report

| Engine Model: | TSIO550C (9B) | | Engine S/N: | 914445 | |
| Component P/N: | 642087- Starter Adapter Assembly | | Component P/N: | AL-00028-Pulley- Kelly Aerospace (part of Kelly Aerospace STC) | |

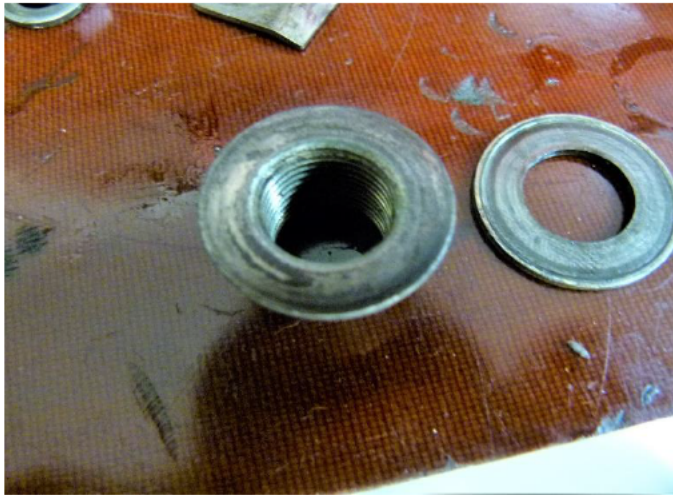
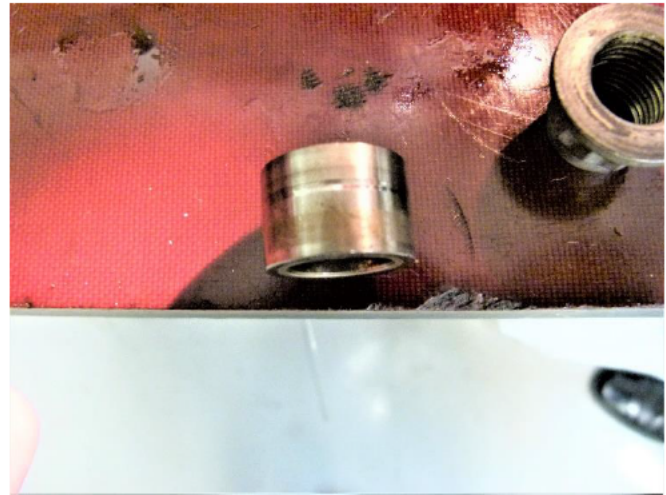
| Comments: | <p>The airplane was equipped with an optional third alternator. A pulley was installed on the starter adapter shaft to provide a power source for a third airframe alternator. The pulley assembly hardware (nut and washer) were tight but the pulley was found to be loose on the starter shaft allowing the pulley to wobble. The pulley was removed and found to be damaged. The ball bearing, shaft seal, spacer and shaft were also damaged. The condition of the pulley is consistent with damage caused by over-tensioning the accessory belt causing excessive side-load on the bearing, seal and shaft. The starter adapter assembly, including aftermarket pulley and belt as installed were located directly above the rear exhaust cross-over pipe which exhibited baked on engine oil.</p> | | | | |

View looking up from beneath the engine near the firewall. The red arrow points to the starter adapter and aftermarket pulley used to power the optional third alternator. NOTE the baked-on oil on the outer surface of the exhaust cross-over tube located directly under the starter adapter pulley (yellow arrow).
