# **ENGINE EXAMINATION REPORT**

**WPR17LA012**

Location: Lovelock, NV  
Date: 10/20/16  
Aircraft: Lancair 4P, N4YB  
NTSB IIC: Shaver

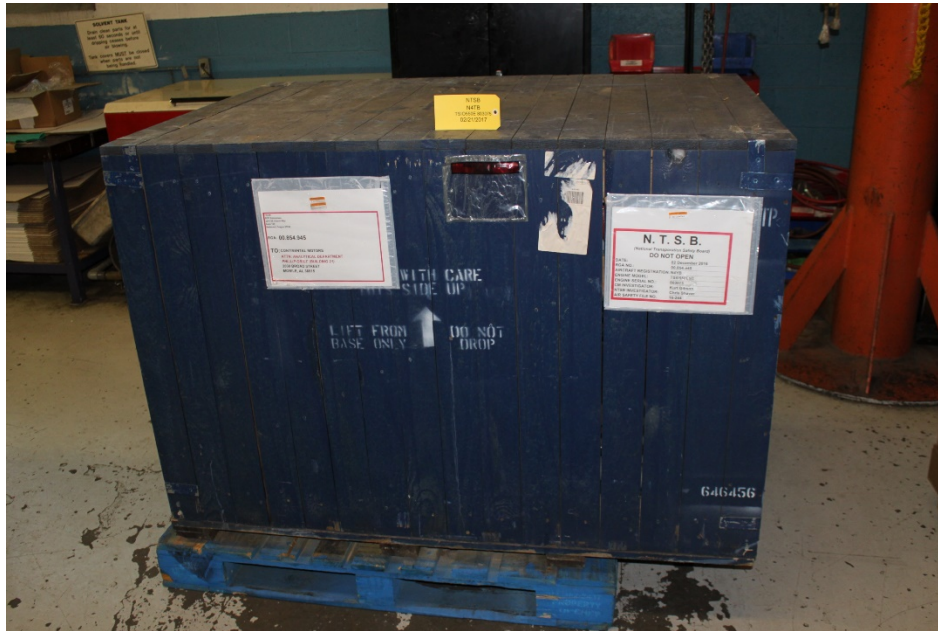
Figure - 1 Engine As Received In Shipping Container

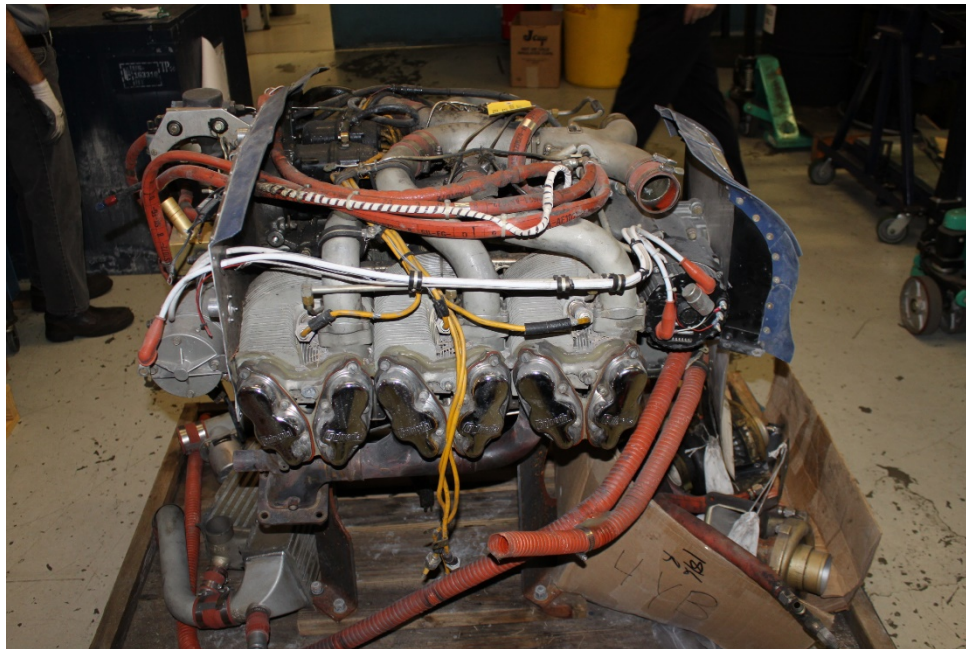
The engine had a hole upper portion of the crank case, above the #3 and #4 connecting rods. A portion of the cam shaft was protruding from the oil sump pan.

Figure 2 – Uncrated Engine
