# Continental Motors

## ENGINE INSPECTION REPORT

| AIRCRAFT MAKE & MODEL | Cessna-182A |

## ENGINE FIELD INSPECTION REPORT

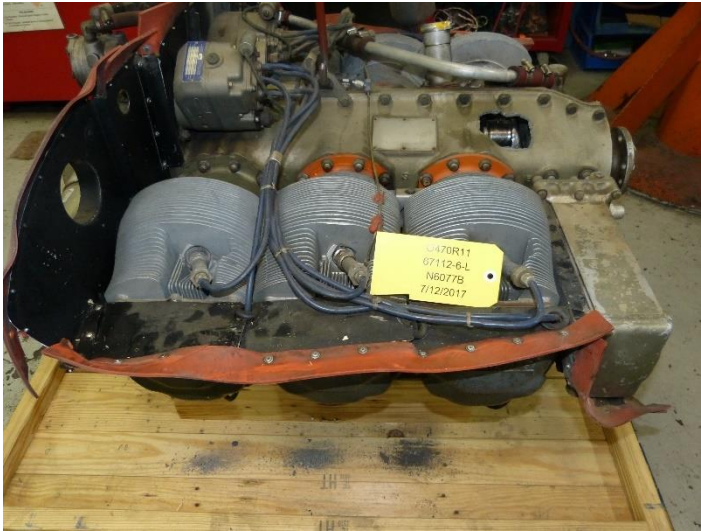
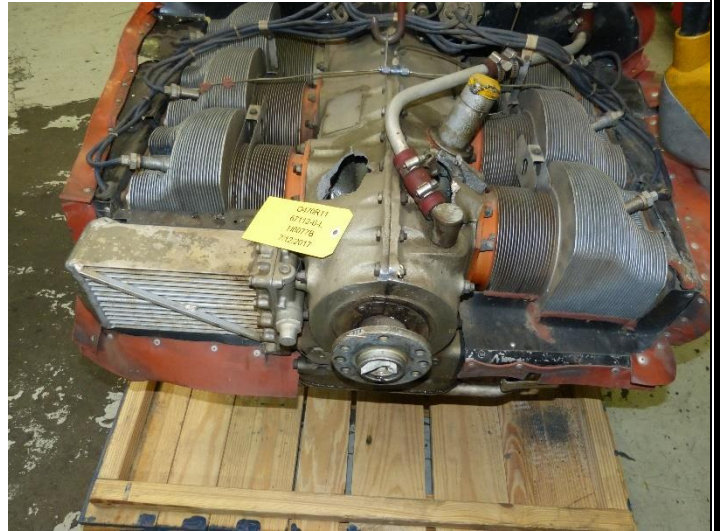
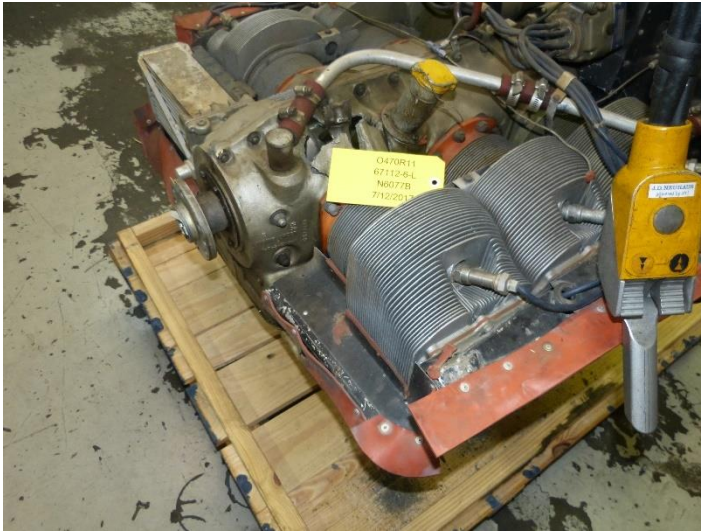
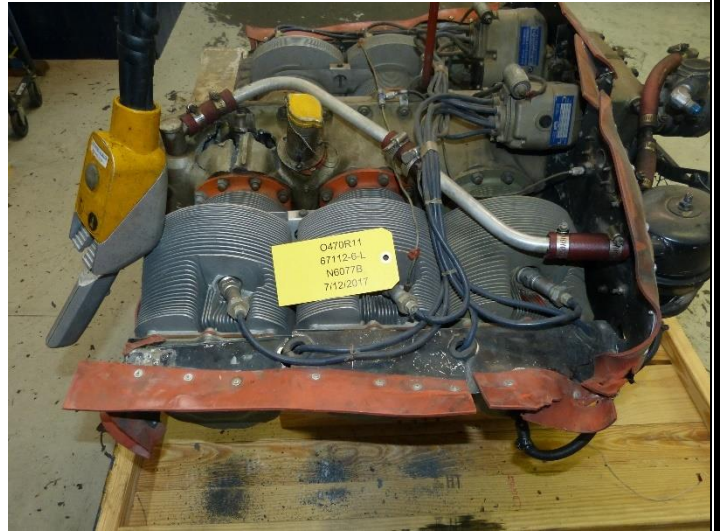
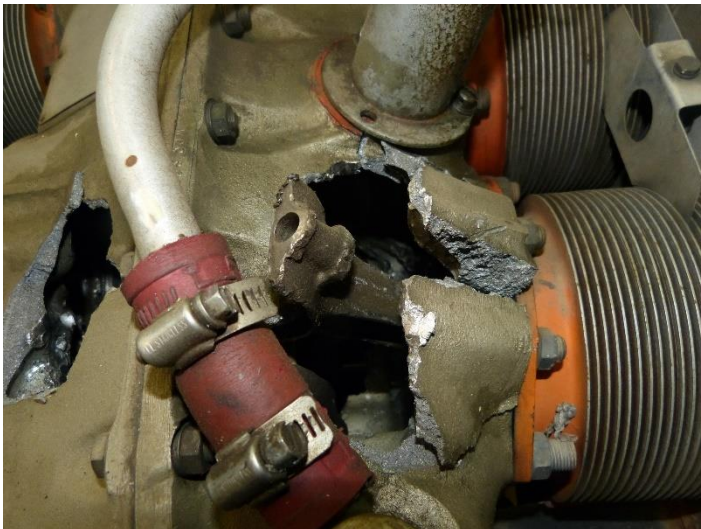
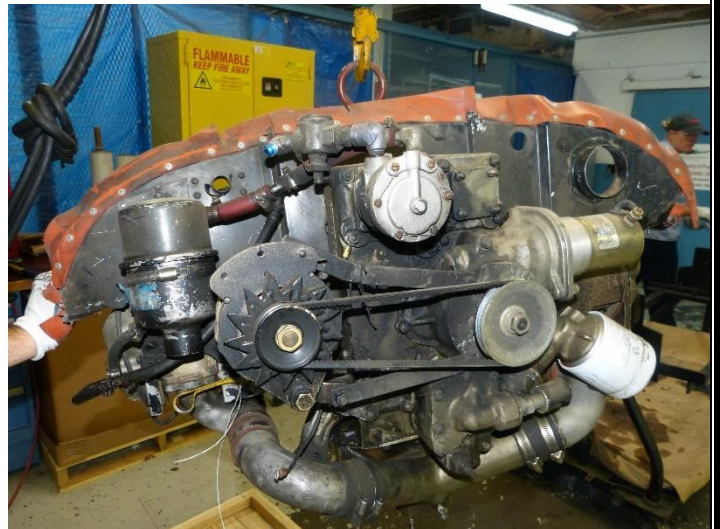
The engine was intact except for holes in the right and left crankcase halves over the number 5 and 6 cylinders. The number 6 connecting rod was extended through the hole over the number 6 cylinder attachment point. The number 5 connecting rod was missing except for the rod cap and bolts which were found in the oil sump. All of the accessories were attached except for the Carburetor which was missing. The exhaust system was also missing. The engine was equipped with an oil recovery system which was attached to the number 2 rocker cover. All of the cylinders had chrome markings.

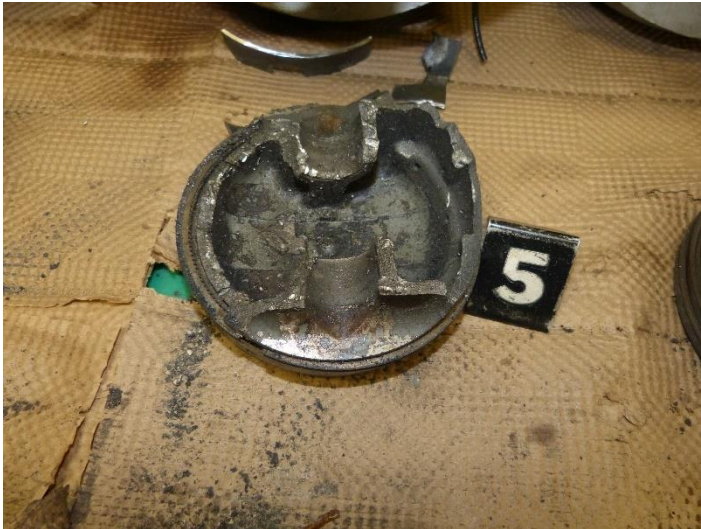
Crankcase Halves: Casting Numbers Left, 539488, Right, 539489, Work Orders Left, WDC56237, Right, WDC56237

The crankcase halves were intact except for holes over the number five and six cylinder attachment points on the case halves. The remainder of the crankcase halves were not damaged.

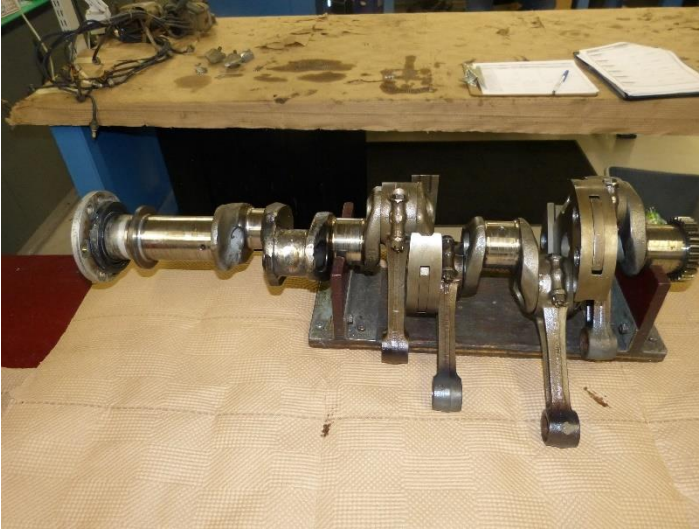
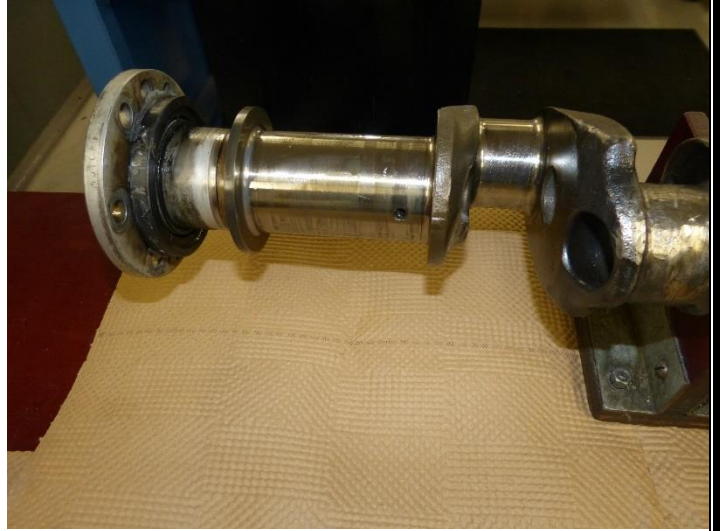
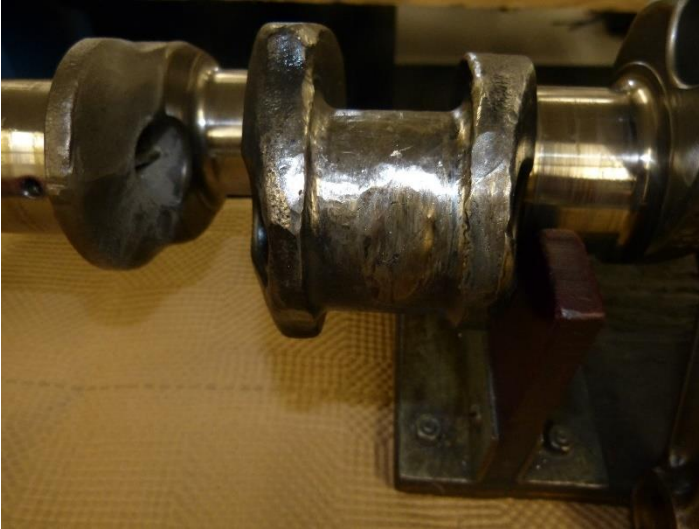
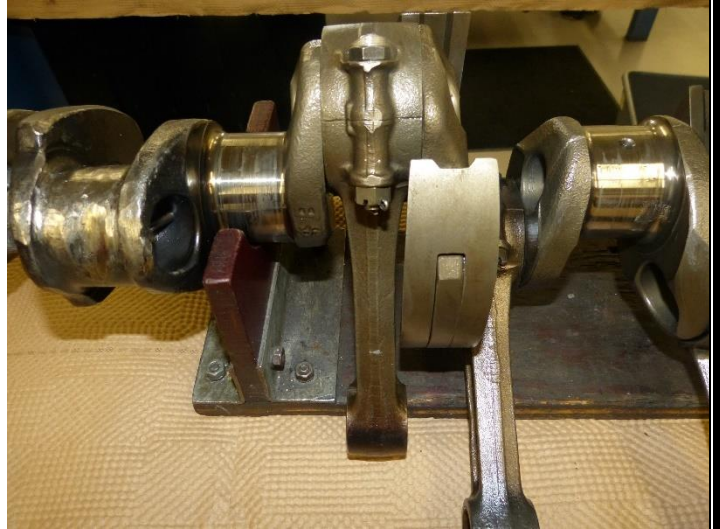
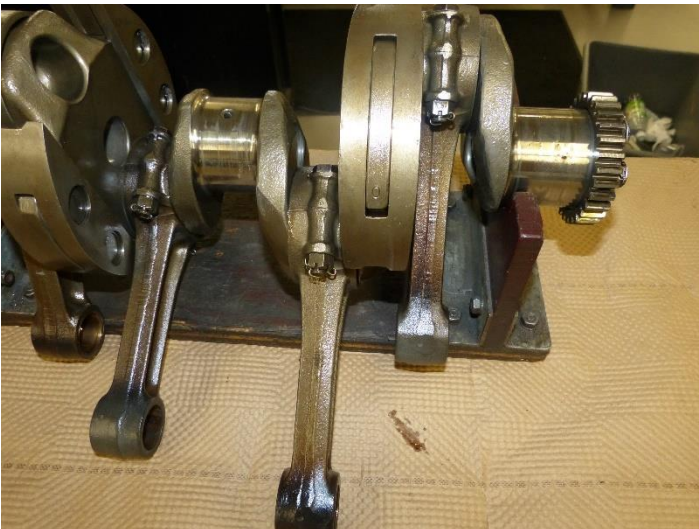
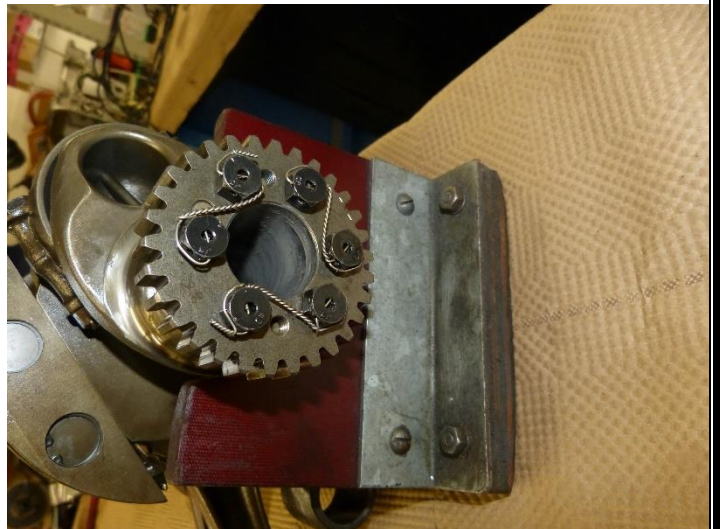
The crankshaft was intact and not damaged except for the number five connecting rod journal which had heat damage and heavy gouging. The number six connecting rod journal had rotational damage and was slightly discolored. All of the main journals were not damaged and were coated with oil.

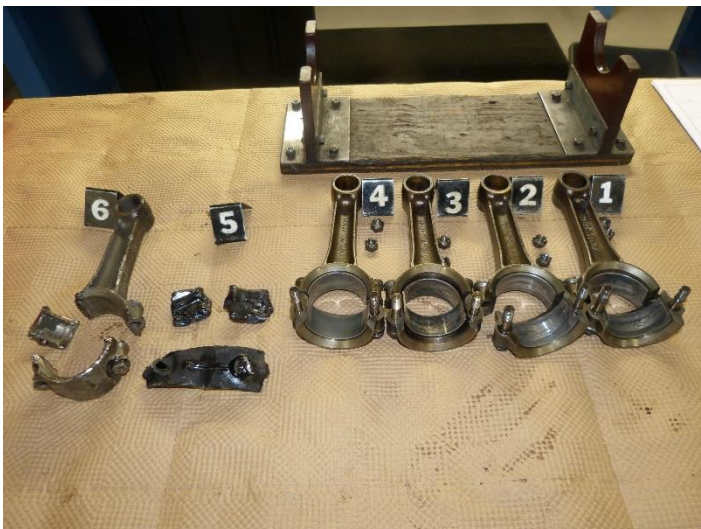
Connecting Rods: Atlas 40742, Rod Cap Bearings-SA530383-010, 8/5

Connecting rod number five was missing except for the rod cap which was found in the oil sump. Rod cap six was also found in the oil sump with the number five piston pin. The rod cap bearings from connecting rods five and six were also found in the oil sump and they had heavy impact damage. Connecting rods one, two, three and four were not damaged, and the rod bearings were in place and not damaged.

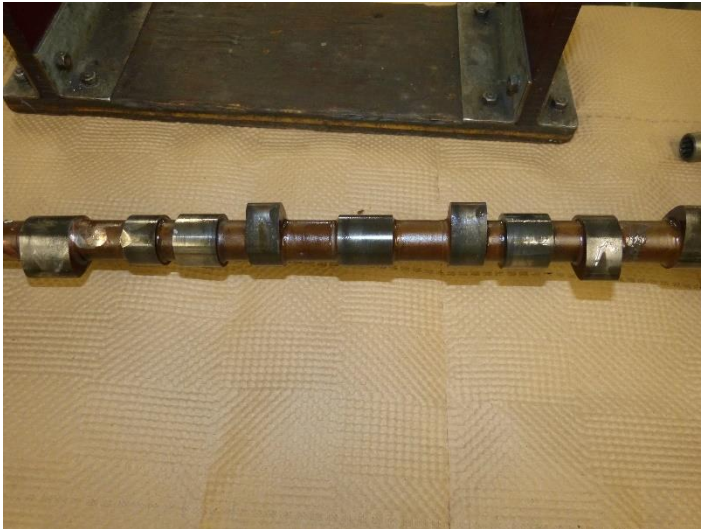
Valve Lifters: Intake SA628488, Exhaust SA646277

The lifters were in place and were not damaged. They were coated with oil.

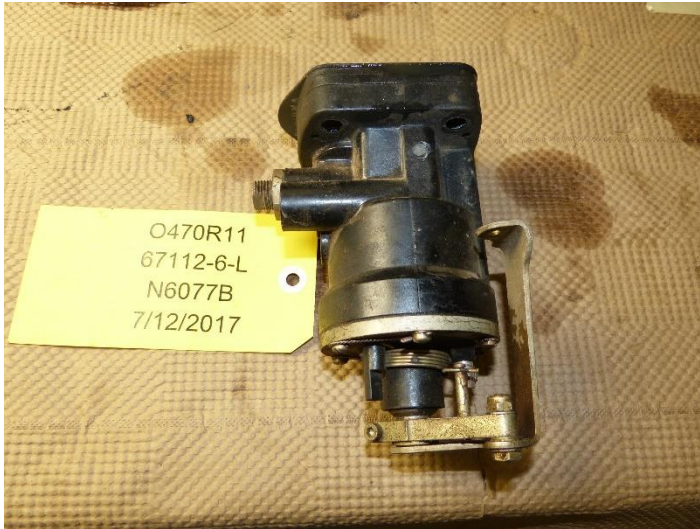
Propeller Governor: McCauley, C290D3K1T1, SN-735551

The propeller governor was not damaged. The drive shaft was free to rotate, and a very small amount of metal was noted on the oil screen.
