# **ENGINE EXAMINATION REPORT**

**NATIONAL TRANSPORTATION SAFETY BOARD**

**January 11, 2018**

**WPR17LA042**  
**Willows, California**  
**December 27, 2016**  
**1553 PST**  
**Air Tractor AT-602; N602L**

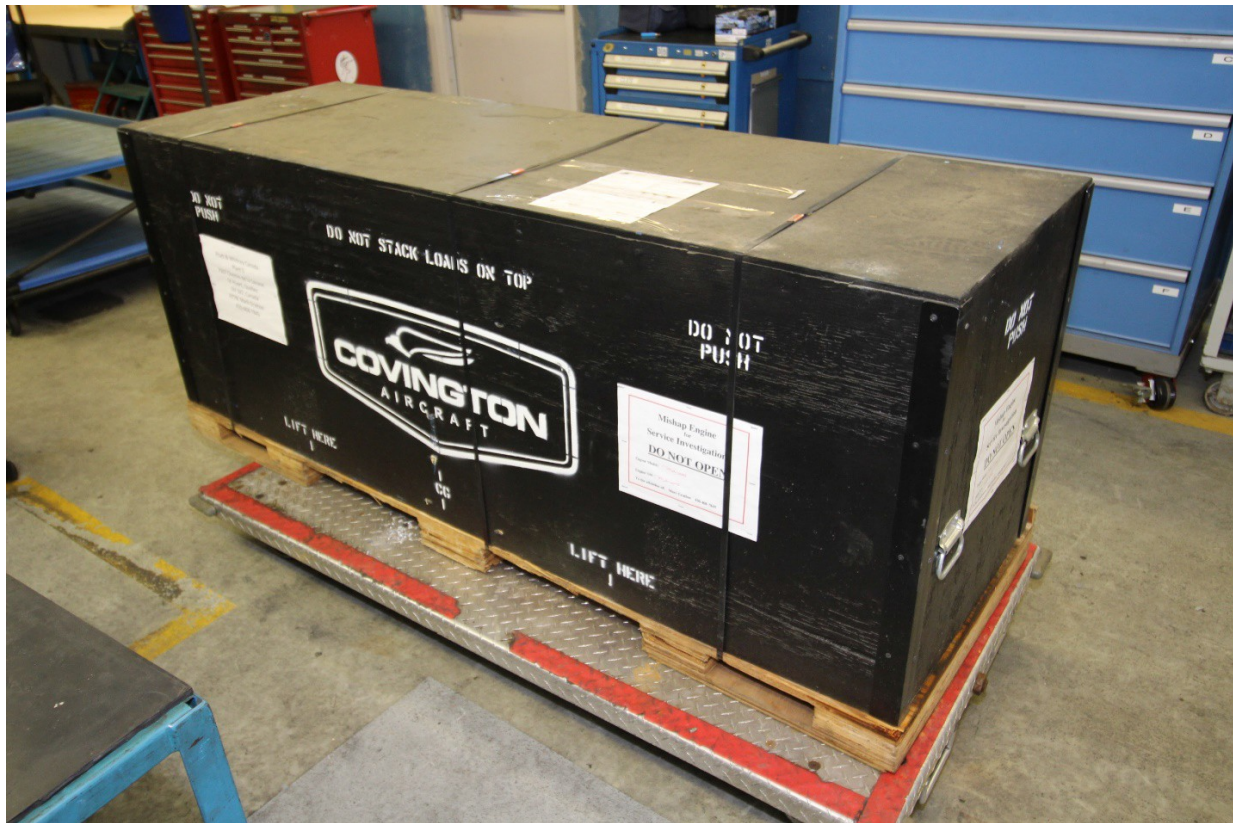
The engine was shipped from the recovery facility in Sacramento, California to Pratt and Whitney, Canada in Longueuil (Quebec), Canada via crate and bonded shipment. Upon receipt the engine was immediately logged and placed in bonded/secure storage and was not opened. The crate was viewed by the IIC as unopened and subsequently photographed and opened for examination. No external damage to the engine components were noted.

Photo 2: Engine as Received

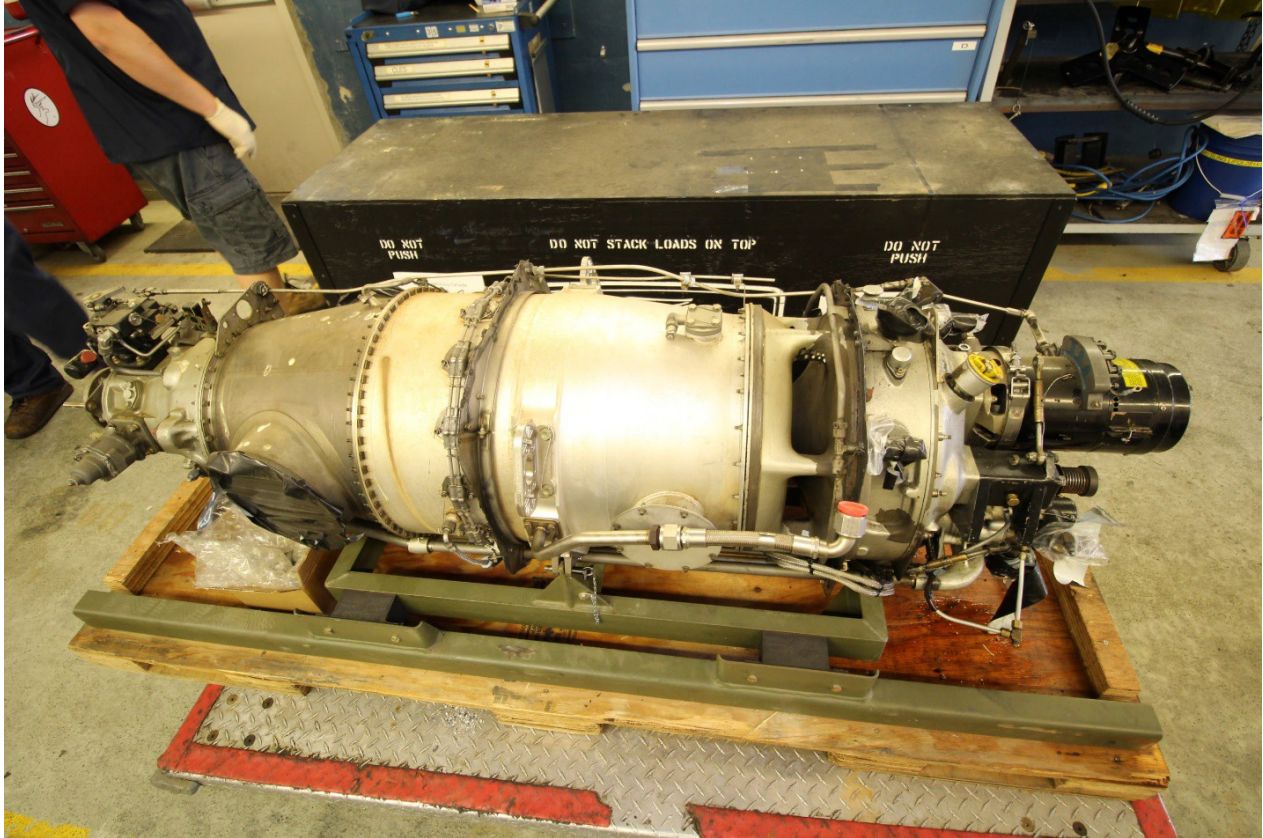
Photo 3: Engine After Secure Crate Removed
