## TESTS AND RESEARCH

## FUEL SERVO

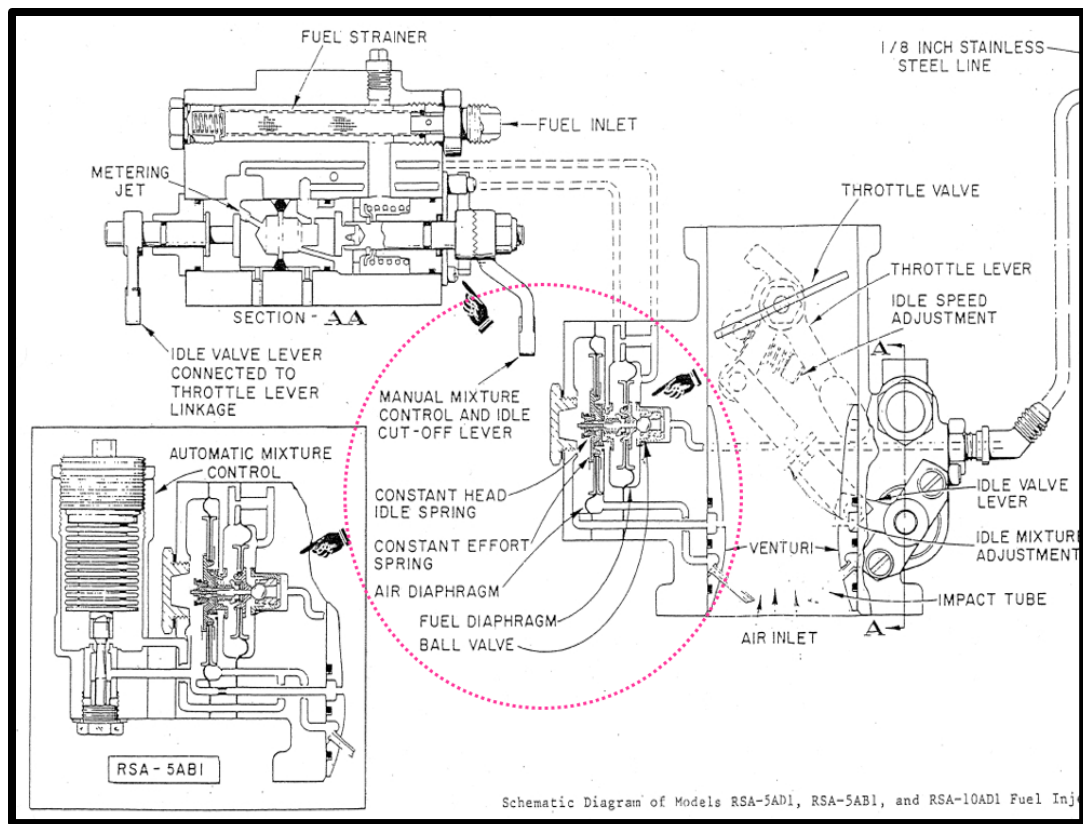
Picture 05: Fuel Servo (engineering drawing)

The regulator assembly contains an air diaphragm, a fuel diaphragm, and regulator stem that has a regulator ball affixed at the end. The air diaphragm senses impact air and compares it to venturi suction. The fuel diaphragm compares metered and unmetered fuel pressure. The diaphragms are connected by the regulator stem, which passes through the center body section of the regulator. The four chambers in the regulator section of the servo act in unison to cause the diaphragms to equalize and regulate the appropriate amount of fuel to the engine when the airflow is altered. When the engine is operating at a constant throttle setting, opposing forces of the fuel and air diaphragms cause the regulator valve stem to unseat to a specific position and an appropriate quantity of fuel is provided to the engine. As the throttle setting is increased, velocity of air through the venturi increases and pressure decreases within the suction side of the air chamber relative to the impact side. This creates a pressure differential across the air diaphragm and causes the regulator valve (ball at the end of the regulator stem) to move towards a

more open position. As the regulator valve opens (ball moves off the seat), more fuel is provided to the engine. Once the pressure differential across the fuel diaphragm stabilizes and reaches a force in equilibrium with the air diaphragm, fuel flow is again stabilized.

Fuel servo was completely disassembled. The safety wire on the regulator housing had a crimp with a stamp that read "AKB."

Upon disassembly of the regulator, investigators noted that the valve stem was separated from the regulator valve (ball). The accident servo was reassembled and investigators affixed the exemplar servo's regulator section. A fuel source was connected and the servo flowed fuel normally. The accident regulator section was installed on the exemplar servo and tested; the fuel would not flow.
