**FLUID SYSTEMS DIVISION  
PARKER HANNIFIN CORPORATION  
711 TAYLOR STREET  
ELYRIA, OHIO 44035**

**5 DECEMBER 2017**

**2C27-1 CENTRIFUGAL FUEL PUMP CARTRIDGE  
EXAMINATION**

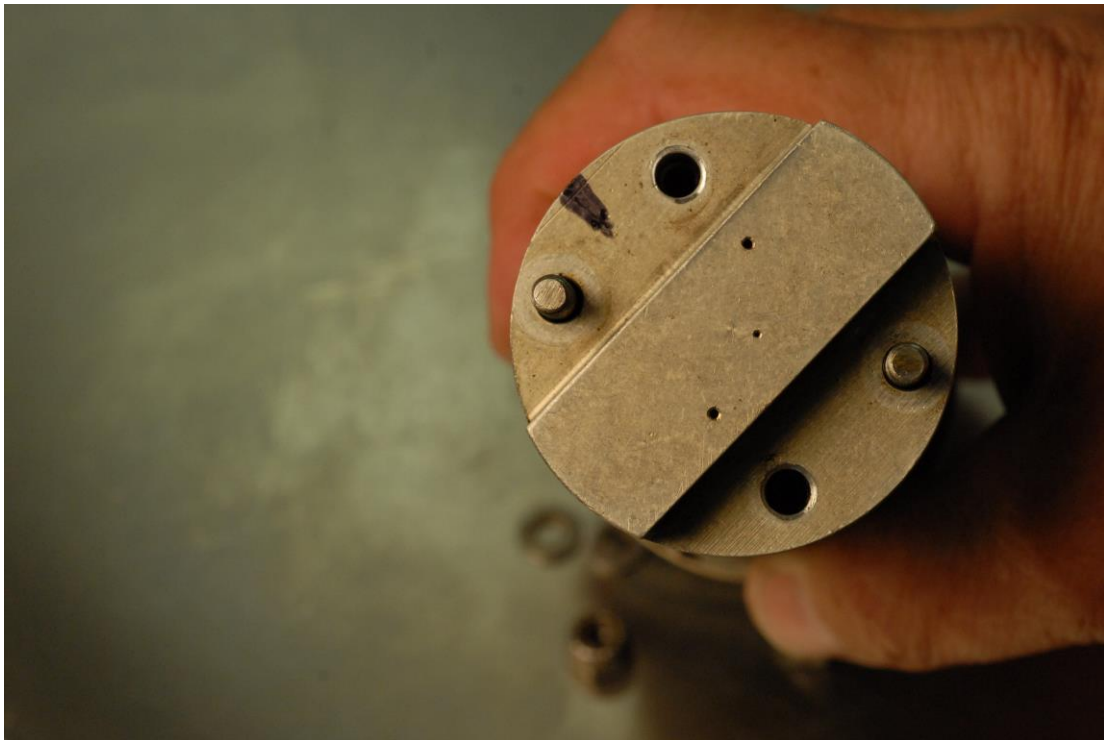
2C27-1 4H234 31Aug17\_026 | Removal of Motor Stud Nuts

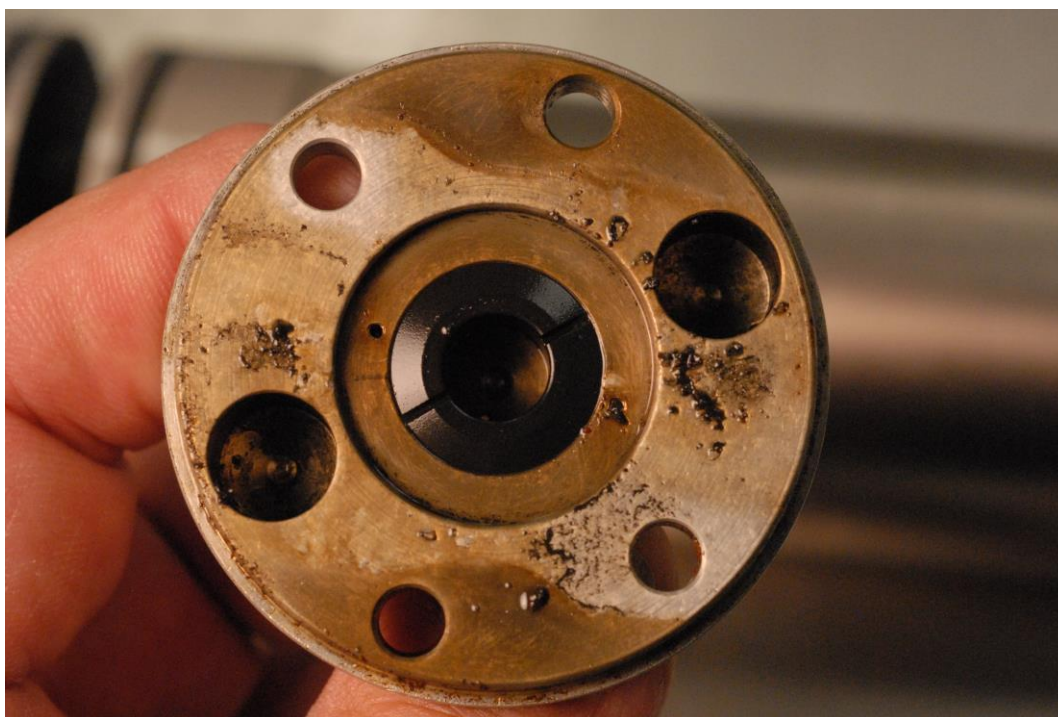
2C27-1 4H234 31Aug17\_028 – Inside of Motor Cover

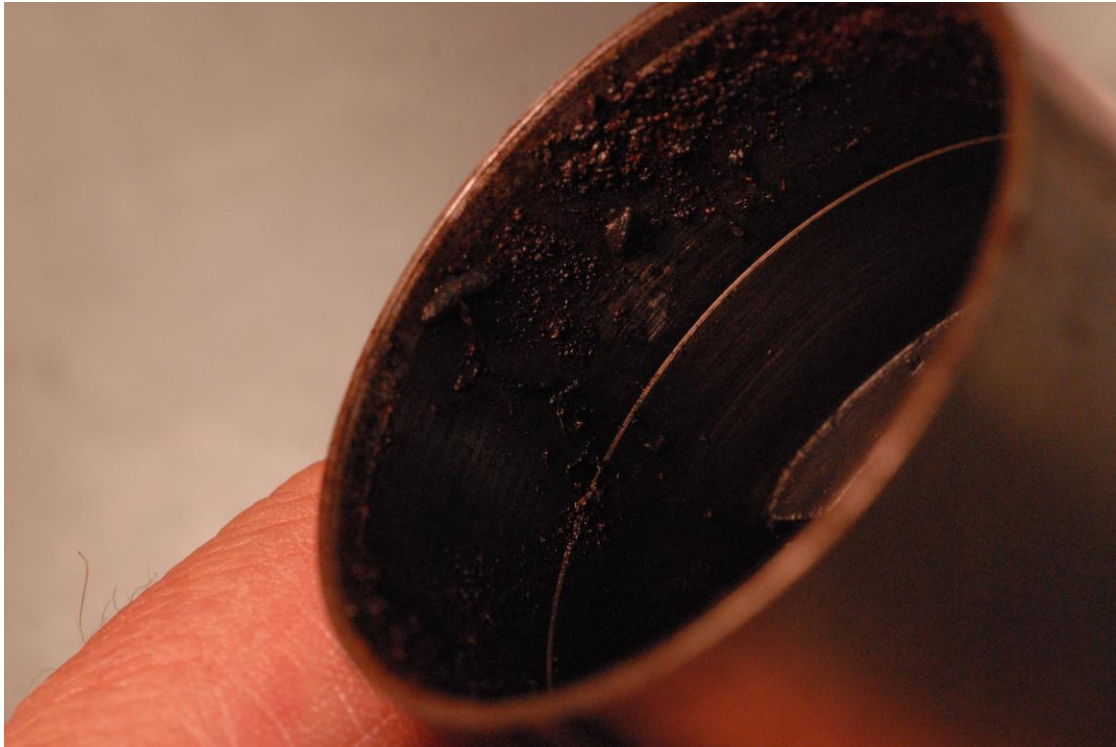
2C27-1 4H234 31Aug17\_047 – Field Tube Heavy Corrosion

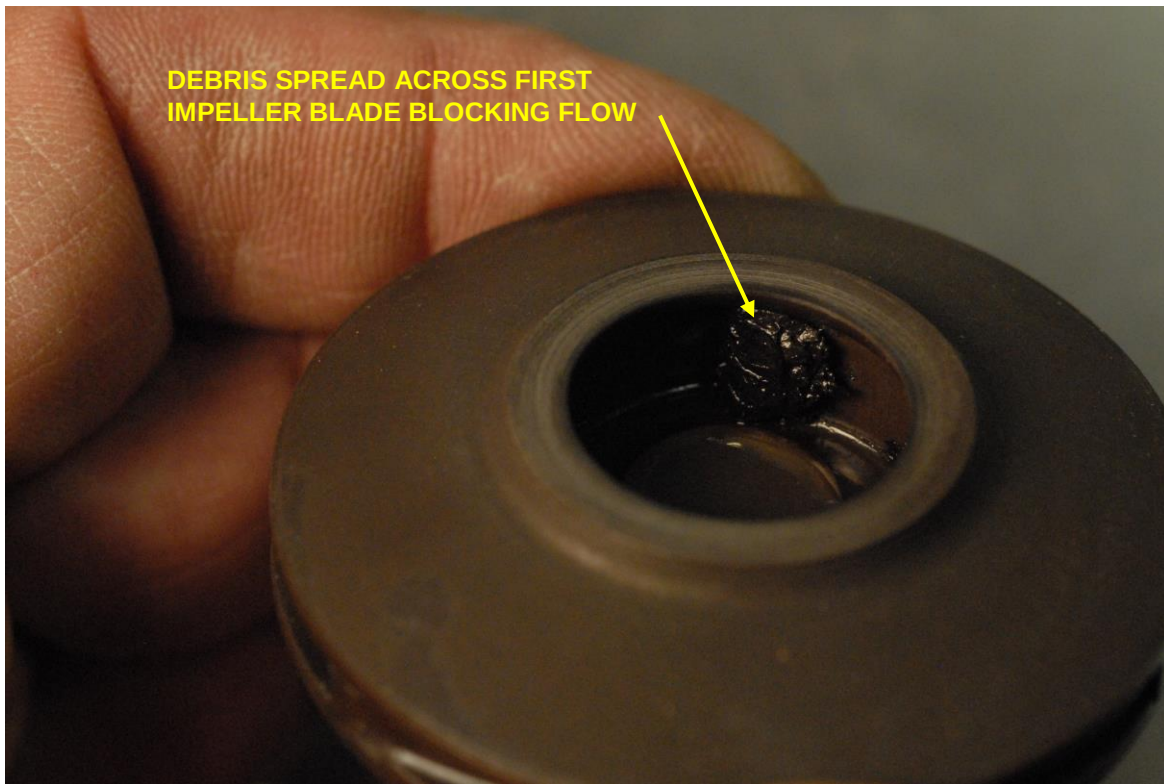
2C27-1 4H234 31Aug17\_071 – Debris across 1<sup>st</sup> Impeller Blade Inlet
