## **NATIONAL TRANSPORTATION SAFETY BOARD**

# **ENGINE EXAMINATION AND RUN**

**WPR17FA035**

Location: Carson City, NV  
Date: December 12, 2016  
Aircraft: Bellanca 17-30A, Registration #39894, Serial #73-30544  
NTSB IIC: Samantha Link

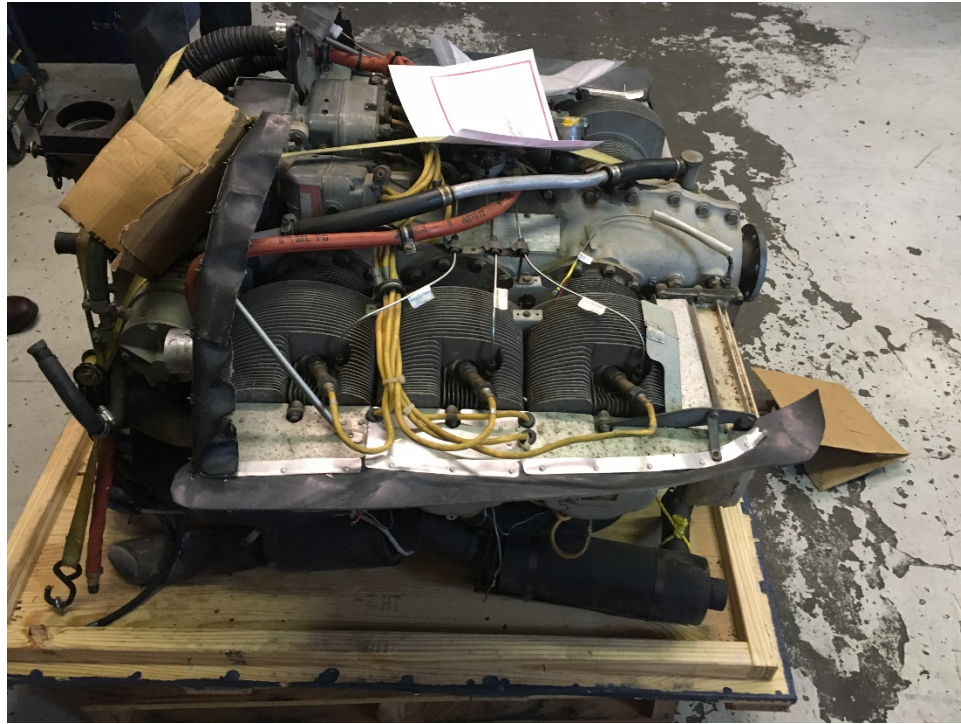
Figure 1: Engine After Unboxing

- The engine was removed from the crate and three new engine mounts were added (The fourth mount was still intact)
