## **NATIONAL TRANSPORTATION SAFETY BOARD**

# **AIRFRAME AND ENGINE EXAMINATION**

**WPR17LA075**

Location: Pacific Ocean, Near Guam  
Date: February 22, 2017  
Aircraft: Hughes -369A, N805LA, S/N 101355  
NTSB IIC: Michael Huhn

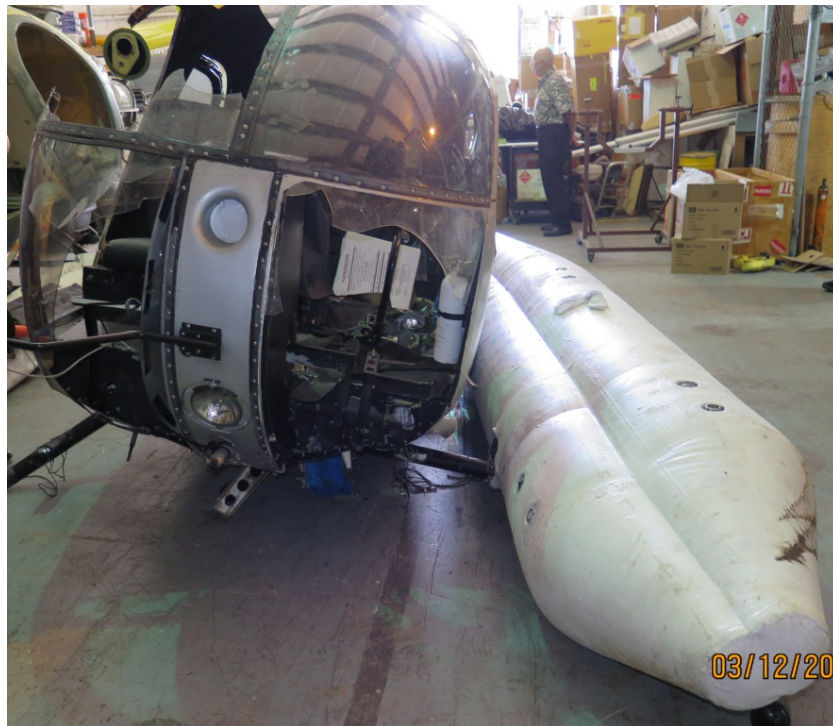
Figure 1 - Front View

The helicopter fuselage experienced extensive impact damage to the forward fuselage, pilot/copilot seat structure, and aft fuselage. Visual inspection revealed significant damage to the lower fuselage at the landing gear attach structure locations. The four landing gear struts, dampers, and braces all had impact damage and fractures, with the worst damage on the left side. The aft landing gear center beam fitting was fractured. The utility float attachment to the skid tube and landing gear foot showed little visible damage.

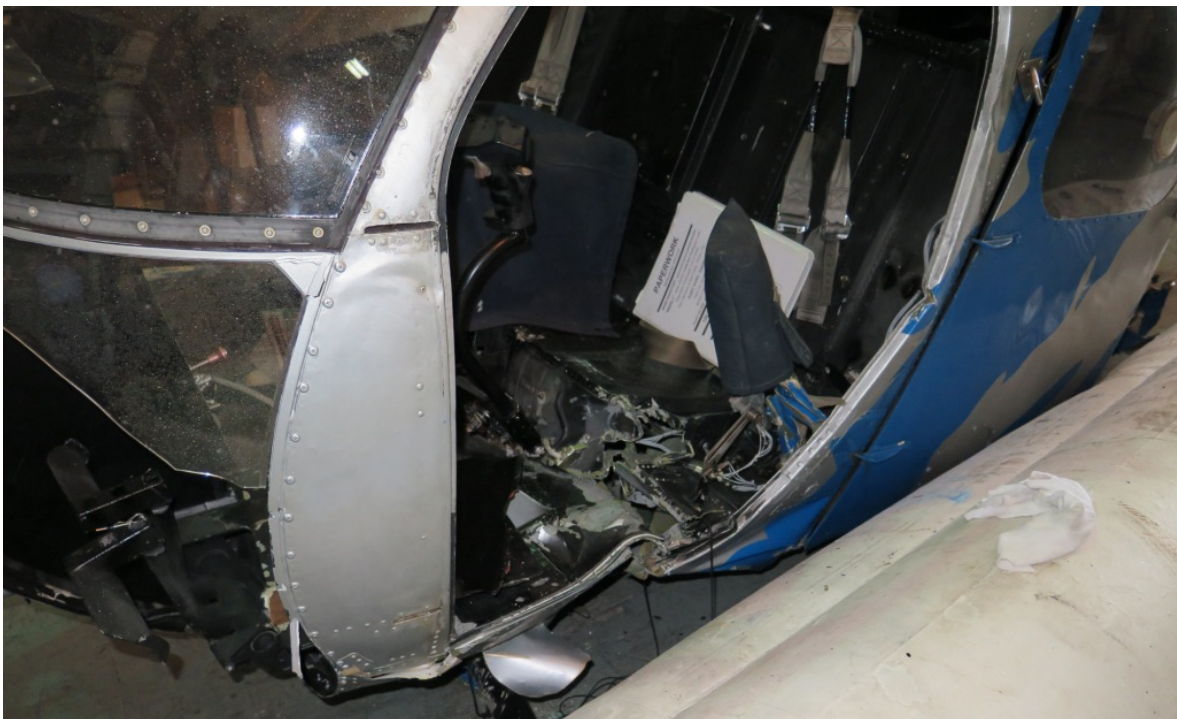
Figure 2 - Pilot's Compartment

The seat box structure was extensively damaged, with both left and right cockpit seat pans significantly deformed downward and their box structures crushed. The seat restraint systems were intact and functional.

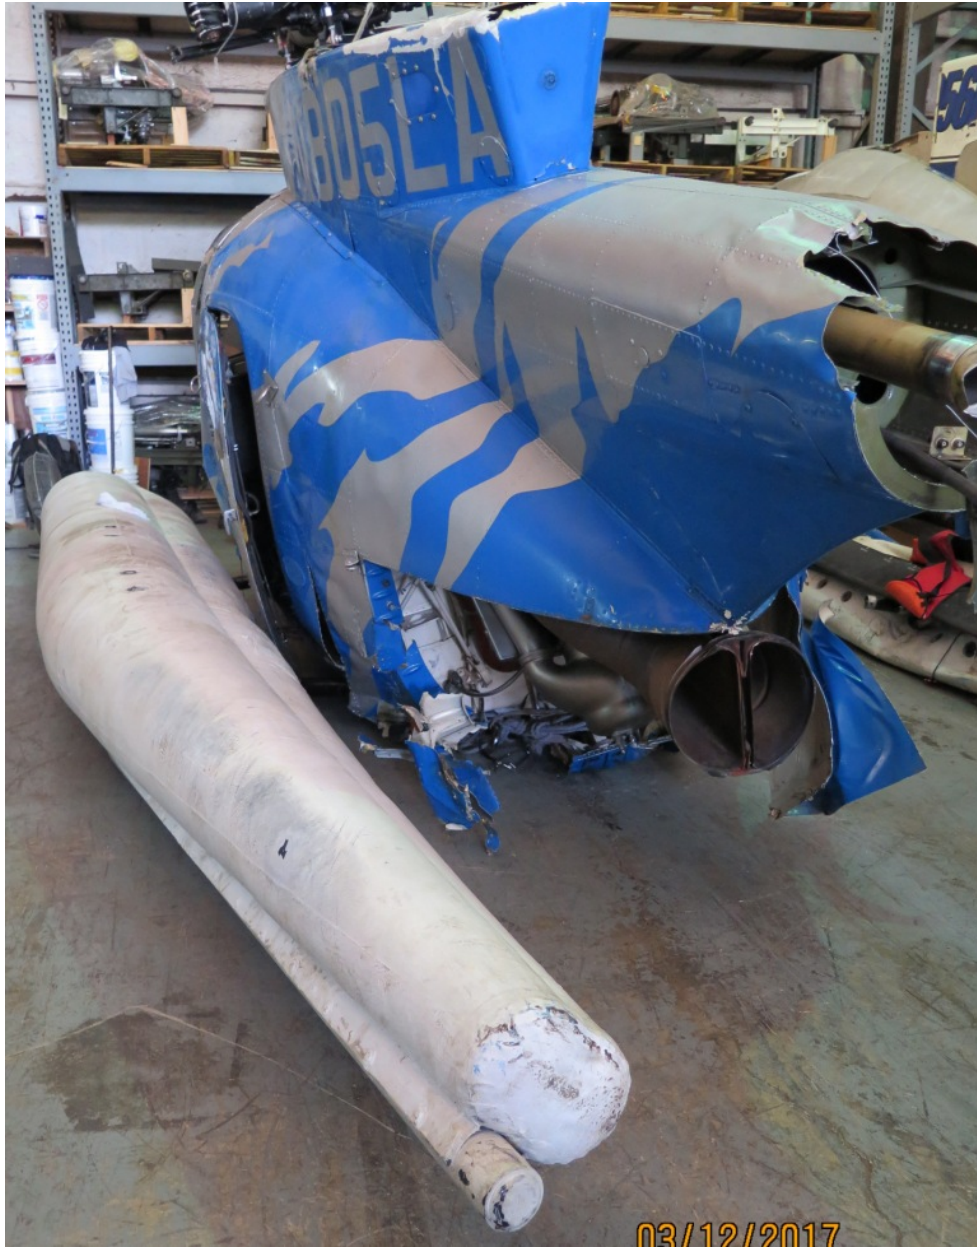
Figure 3 - Aft View

The composite "doghouse" assembly, located aft of the engine inlet, was broken and torn, consistent with main rotor blade contact. A section of the upper aft fuselage was separated at the tailboom attach point, fuselage station (FS) 197.78, with torn and ripped skin, and a fractured tailboom attach frame.

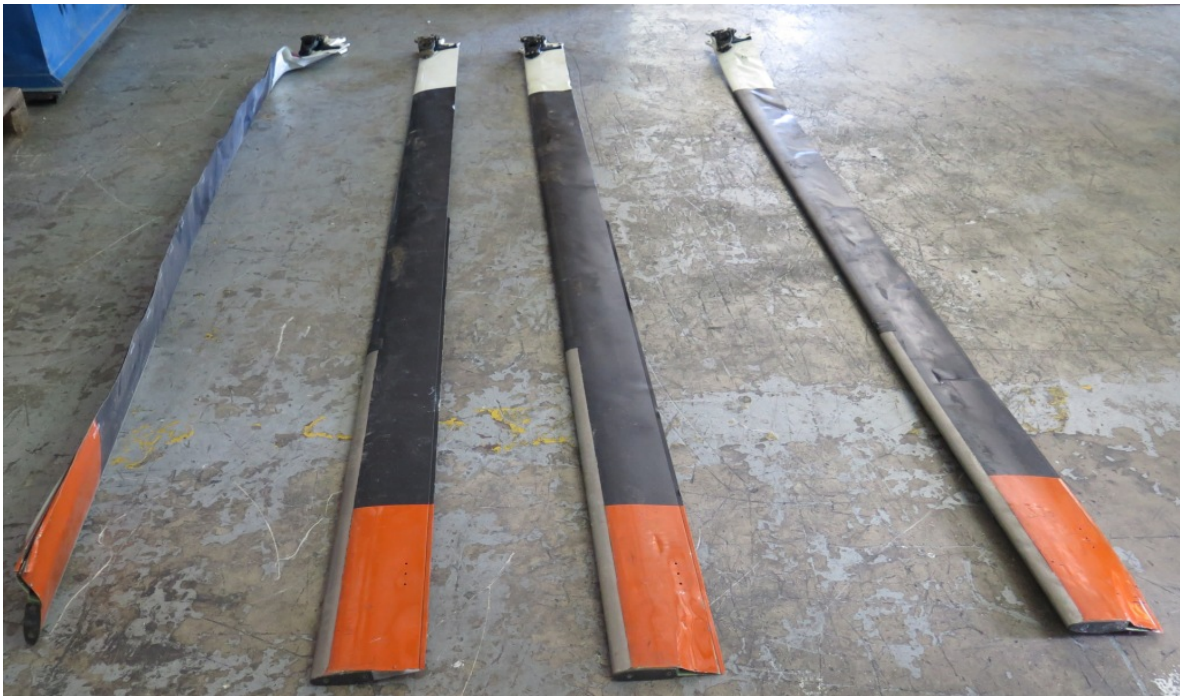
**Figure 13 - Main Rotor Blades**

The main rotor system hub assembly and components, strap assemblies, pitch housings, feather bearings, and pitch change links were relatively undamaged. The main rotor head showed damage to one damper arm, but overall was intact with chips and scrapes. The rotor system did exhibit visible hub damage due to excessive lead/lag excursions and high flapping angles. All four main rotor blades (Helicopter Technology Company PN: 500P2100-303, SNs: 0864B, 0865B, 0866B and 0867B) were unbroken, with varying degrees of bends and skin damage. The damage to the main rotor system components was consistent with low rotor RPM, power-off, main rotor blade strikes.
