N610TT Engine inspection accomplished 9 May 2017 at the owner's hangar located at Columbia Gorge Airport, Dallesport, Washington. Inspection conducted by the owner and builder, Louis Ott with FAA airworthiness inspector Thomas Borland observing.

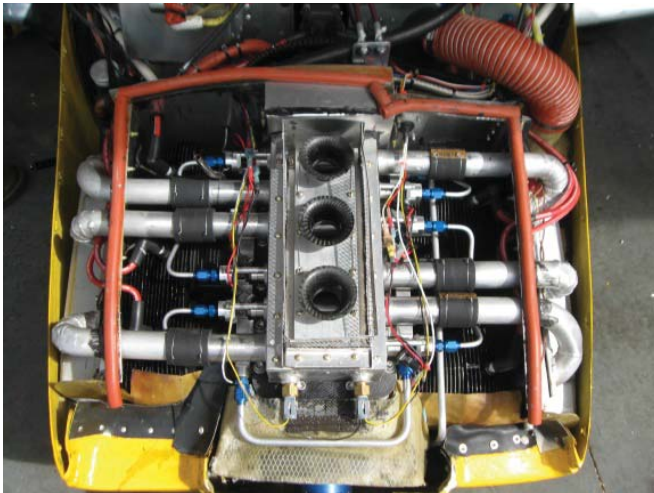
The engine is an air cooled, six cylinder automobile engine modified with dual Ford electronic ignition units and electronic fuel management. Engine output to the three bladed, composite propeller incorporates a specially designed thrust/support bearing assembly mated with the engine output shaft and drive hub. This arraignment is somewhat unique to this aircraft adaptation. A multi-toothed steel plate is mounted on the shaft aft of the propeller to provide crankshaft position indication to the electronic ignition through two electronic ignition pick-ups mounted to the front of the crank case. The two separate ignition units share the coil and spark plug leads that feed 1 spark plug per cylinder.

Six fuel injectors provide metered fuel into the common induction manifold. Fuel scheduling is accomplished by the electronic system in part by using inputs from sensors mounted in the forward end of the manifold. The custom sliding plate throttle system integral to the top of the manifold provides filtered air into the manifold through three air intakes. The fuel/air mixture is then introduced to the cylinders through conventional tubing.
