## **NATIONAL TRANSPORTATION SAFETY BOARD**

### **Field Notes**

**WPR17LA087**

Aircraft: Titan Tornado I, Registration Number: N5131H, Serial #: T9XXXCPJLO177

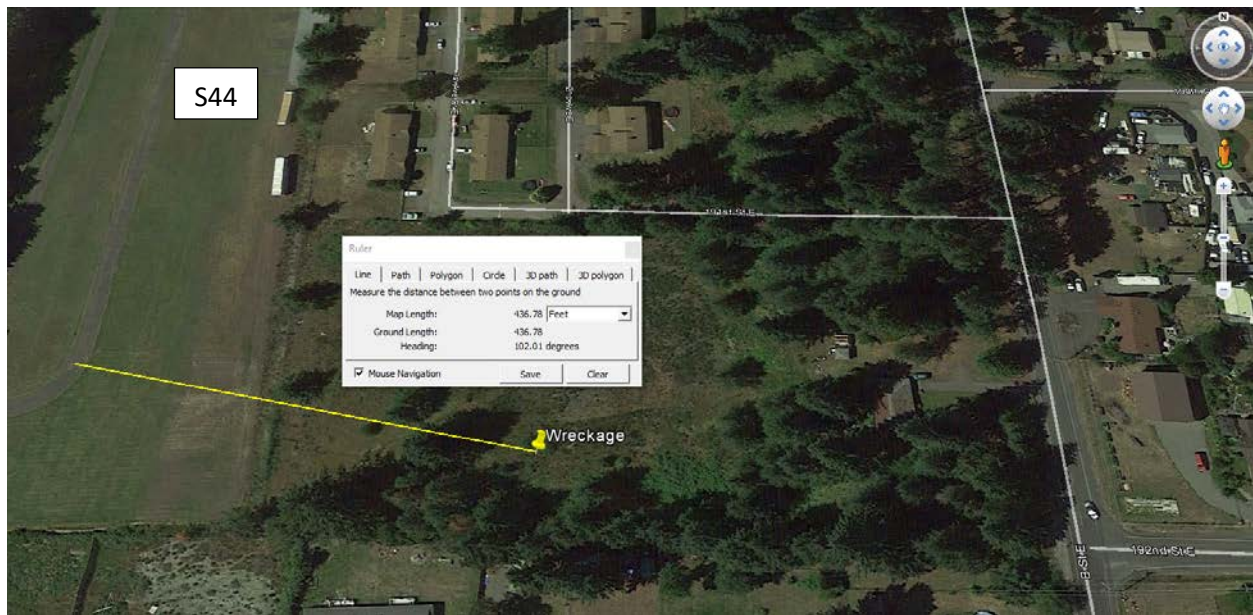
Main Wreckage: N41.082866, W-122.429901– Elevation: 385 feet

Accident site was about 436 feet on a heading 102 degrees from the departure runway

Figure 1: Main Wreckage location and distance from Spanaway Airport (S44)
