# NATIONAL TRANSPORTATION SAFETY BOARD

MATERIALS LABORATORY FACTUAL REPORT

Report No. 17-085

Place : Santa Barbara, California  
Date : May 5, 2017  
Vehicle : Robinson R44  
NTSB No. : WPR17LA097  
Investigator : Elliott Simpson, AS-WPR

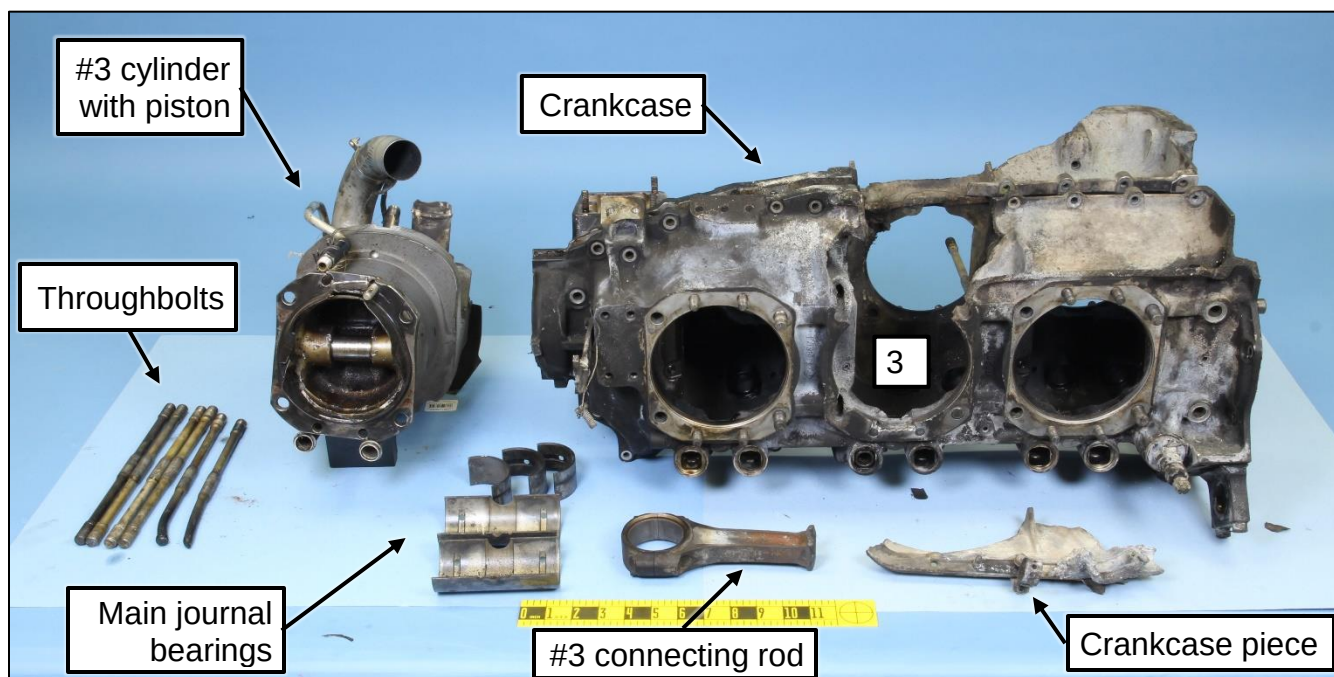
An overall view of the components initially submitted for examination at the NTSB Materials Laboratory are shown in figure 1. After an initial examination of the components and a review of photographs of the engine, additional components were submitted for examination as shown in figures 2 through 4. The exterior surfaces of the submitted components were oxidized and sooted consistent with exposure to a fire. The number 3 cylinder had separated from the engine and had been found approximately  $\frac{1}{4}$  mile from the main wreckage site. The number 4 connecting rod had been cut to facilitate disassembly of the engine. The lower side of the crankcase below the number 3 cylinder port was fractured, and pieces were missing. The number 3 connecting rod was fractured at the outboard (piston) end of the rod, and the bushing and outboard end of the connecting rod was missing. According to maintenance records at the time of the last entry on April 6, 2017, the engine had 1,473 hours time in service since overhaul in 2011 at Lycoming Engines.

Figure 1. Overall view of the submitted components initially examined by the NTSB Materials Laboratory. The components are oriented to show the lower right side of the crankcase and the inboard end of the number 3 cylinder assembly. The location of the number 3 cylinder port is indicated on the crankcase.

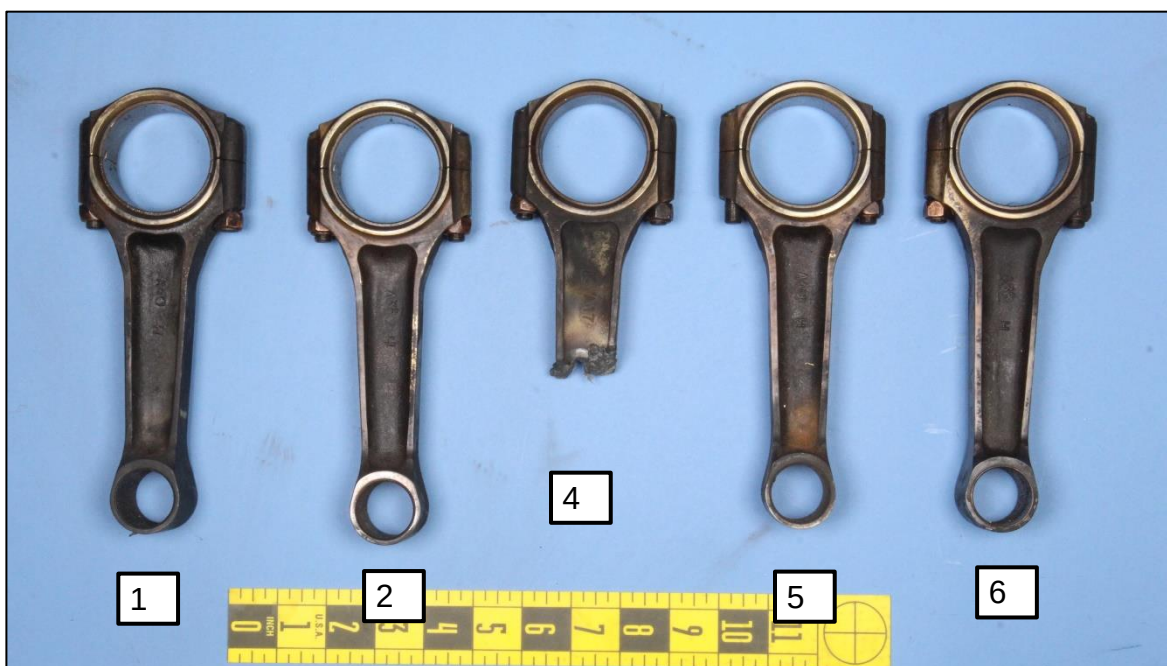
Oily deposits were present on much of the surfaces of the remaining 5 connecting rods. Many of the deposits were removed using a soft bristle brush with a solution of Alconox detergent and warm water. After cleaning, the outboard ends of the number 2, 4, and 6 connecting rods had a bright blue color. The outboard end of the cleaned number 6 connecting rod noting the blue tint is shown in figure 20. A slight blue tint was also noted at the outboard ends of connecting rods 1 and 5.

Figure 3. Overall view of the numbers 1, 2, 4, 5, and 6 connecting rods.

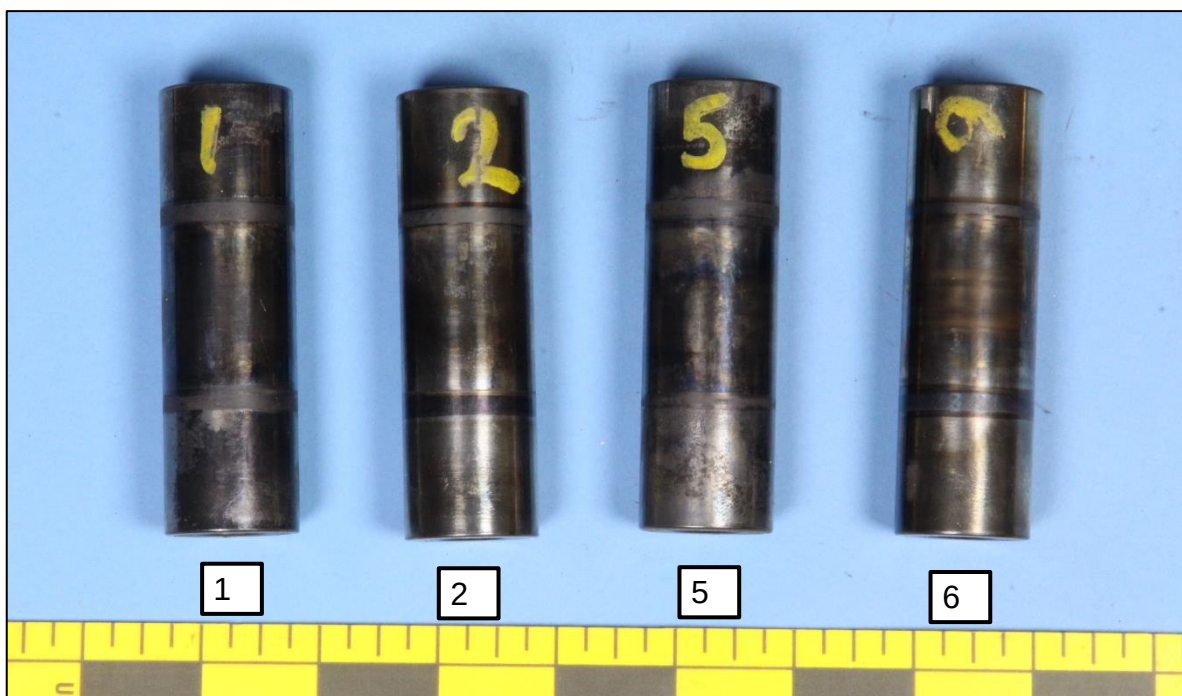
Figure 4. Wrist pins from the numbers 1, 2, 5, and 6 cylinders.
