# Continental Motors

## ENGINE FIELD INSPECTION REPORT

| ENGINE MODEL | O-470-S(1B) |
| FILE NUMBER | 16-604 |

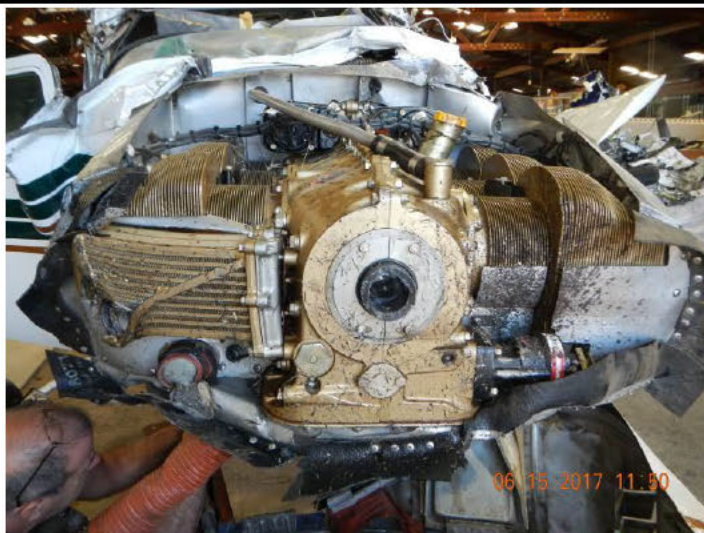
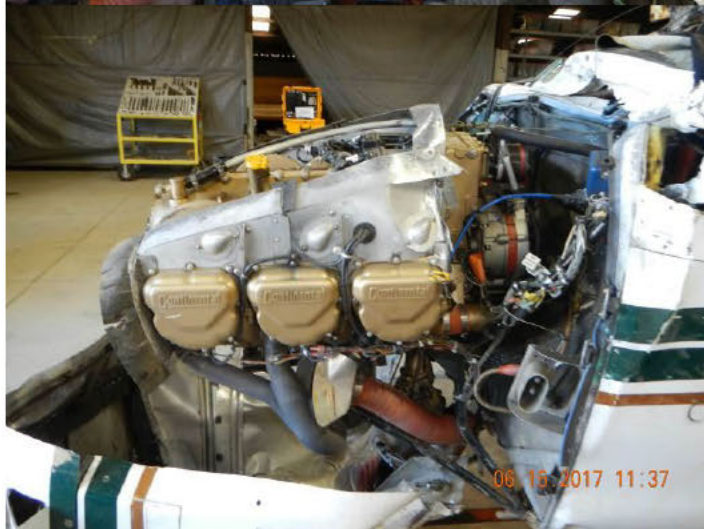
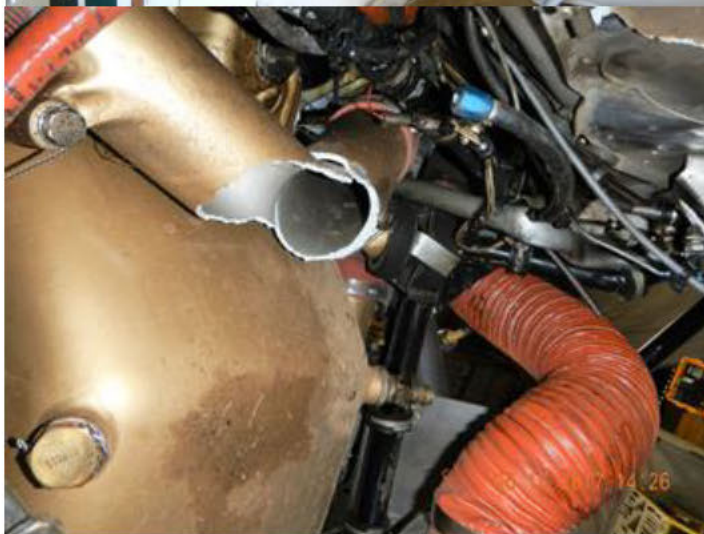
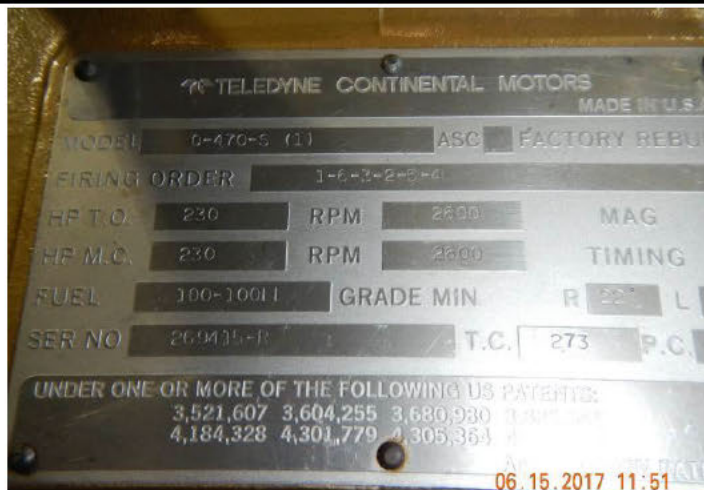
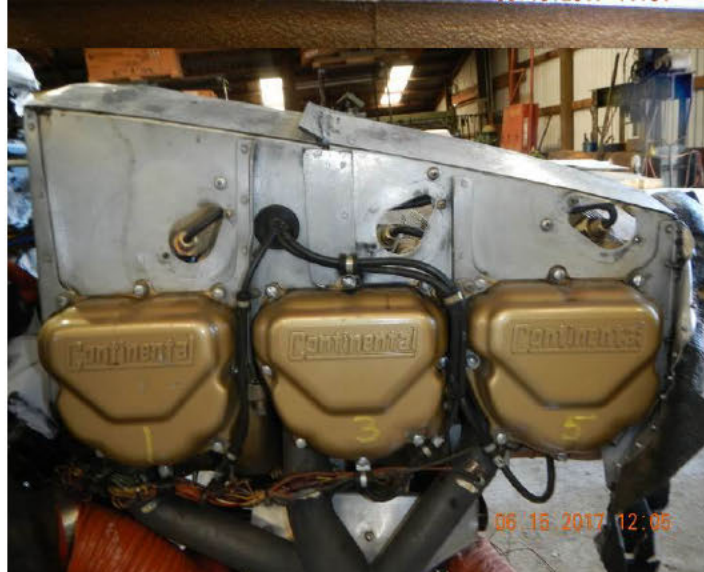
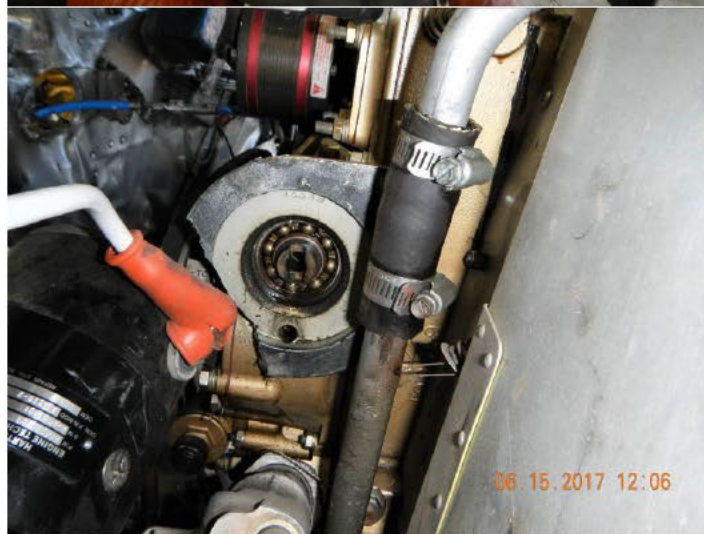
The right and left exhaust collectors were impact damaged. The right exhaust collector was semi-separated at the muffler attachment clamp. The muffler heat outer heat shield exhibited minor impact damage.

The induction forward balance tube assembly exhibited minor impact damage. The carburetor separated due to impact forces at the rear manifold riser assembly (wye induction pipe). The carburetor remained attached to the carburetor attachment flange and control cables. The carburetor assembly exhibited only minor impact damage.

The outboard lower corner of the engine oil cooler exhibited impact damage. The oil filler cap remained attached but received impact damage. The spin on type oil filter exhibited impact damage.

The engine starting motor separated from the starter adapter. The starter adapter was impact damage at the starter attachment flange.
