## **Engine Investigation Report**

**Rolls-Royce Corporation  
Model 250-C20B**

**Pauley's Helicopter Services, Inc.  
Jordan Valley, Oregon**

**Accident date: 26 May 2017  
Investigation date: 29 June 2017  
Engine exam date: 4 October 2017  
Report date: 16 February 2018**

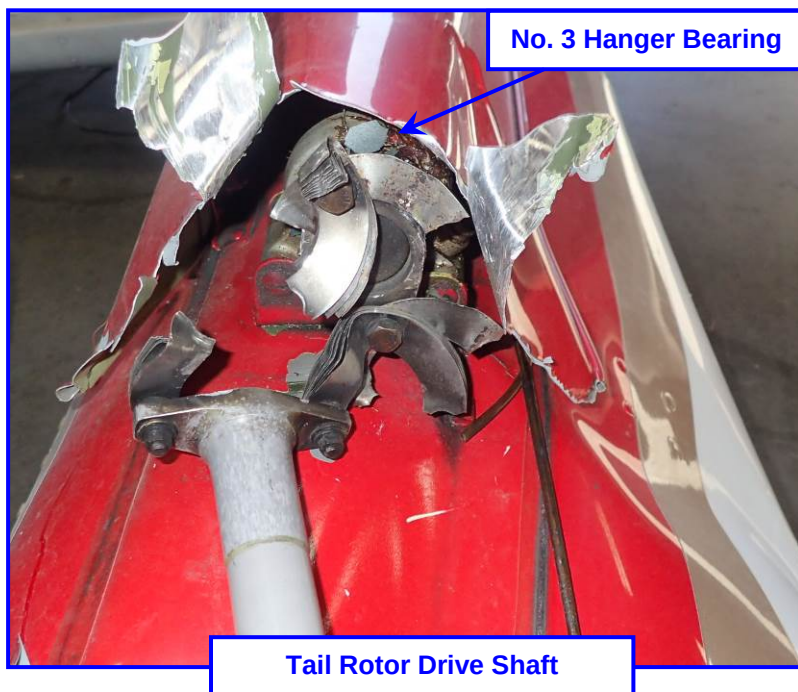
The tail rotor drive shaft sustained a total of 3 fractures along its length with evidence of torsional breakage and rotational scoring.

A mid-span section of drive shaft had liberated from its hanger bearing allowing leading to significant rotational whipping damage to the tail boom and drive shaft sheet metal cover adjacent to the horizontal stabilizer.

The KAflex® coupling frame forward of the 3<sup>rd</sup> hanger bearing contained numerous fractures within its disc stack. The surrounding sheet metal structure was also heavily damaged drive shaft whipping.

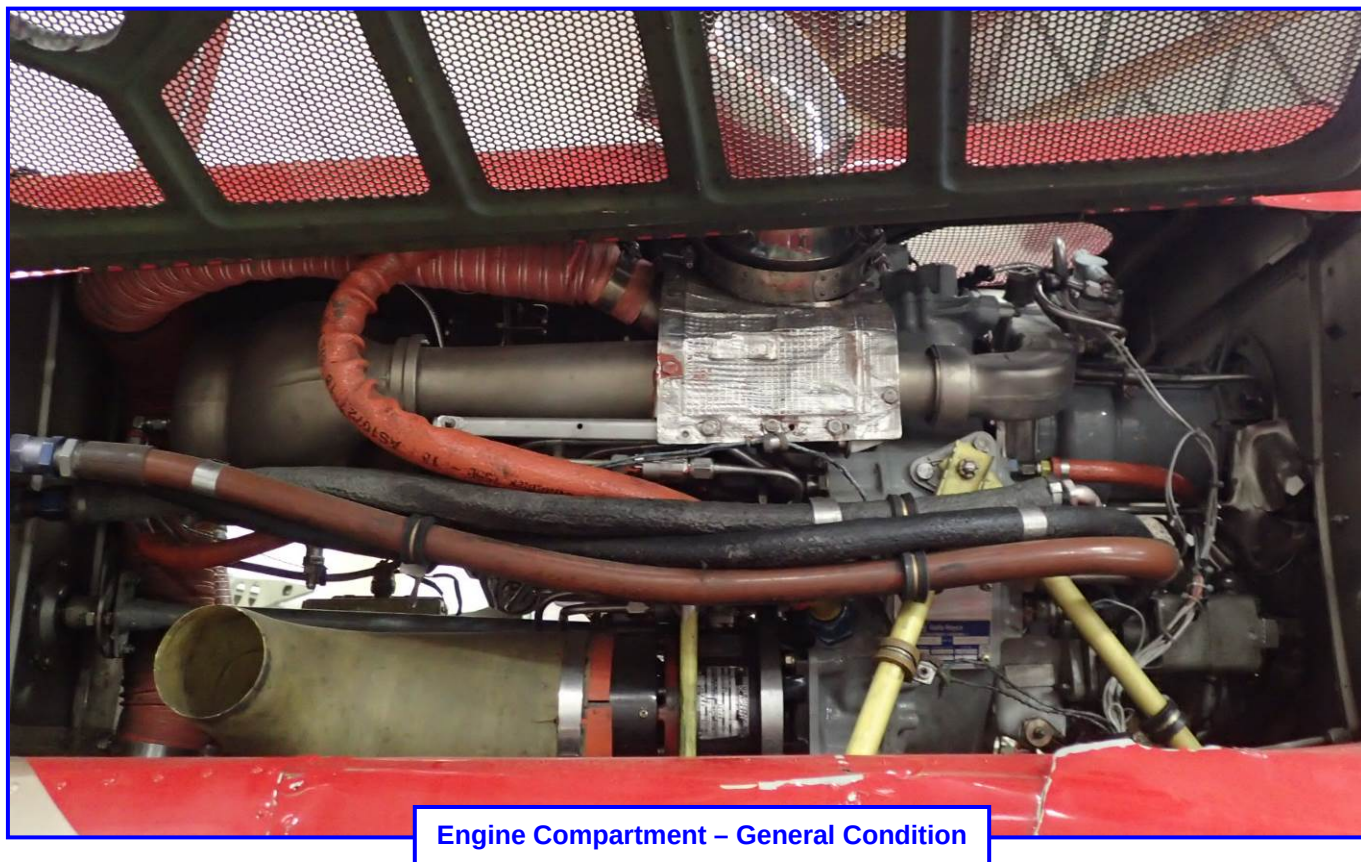
The engine to transmission drive shaft (short shaft) had separated by fracture at the KAflex® coupling frames forward of the freewheeling unit and at the main rotor transmission connection.

The NTSB-IIC directed the KAflex® coupling, drive shaft, isolation mount, and related components to the NTSB lab in Washington, D.C. for further analysis.

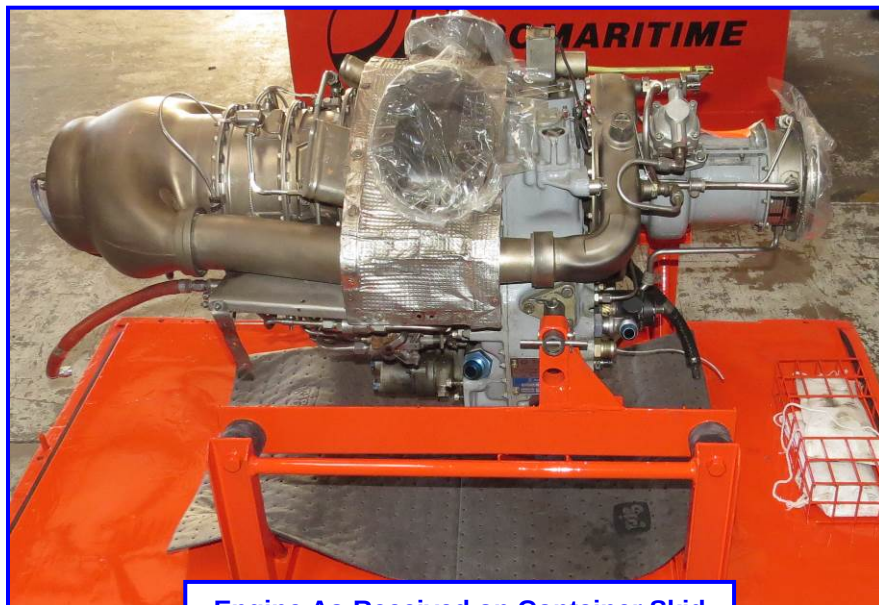
Engine As-Received on Container Skid

The shipping container was opened and the engine appeared in the same general condition as when it was examined in Boise, ID. The compressor and exhaust collector ducts were covered clear plastic wrap.

No evidence of damage or abnormal conditions was noted during the uncrating process.

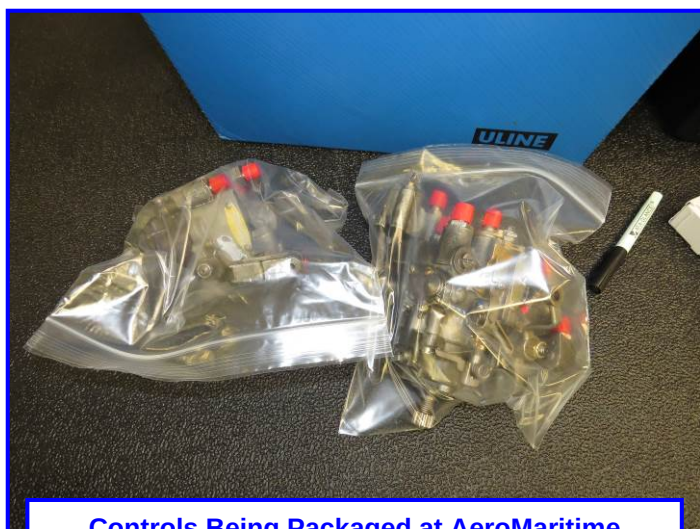
Controls Being Packaged at AeroMaritime

Given the metal debris and N2 turbine rotor scraping sound a collective decision was made to discontinue further preparation for compressor swap and engine test. The NTSB-IIC issued the direction to remove the power turbine governor & fuel control unit for further testing at Honeywell in South Bend, IN.

An update from the NTSB-IIC on 26-Jan-2018 indicated that fatigue cracks had been found on the KAflex® coupling and that further analysis is ongoing. The direction was then given by the IIC to forego the controls testing at Honeywell suggesting that they were not contributory to the event. Both the power turbine governor & fuel control unit were shipped back to SP Aircraft at the request of the NTSB.
