# Service Instruction Number SIN2348 Revision K

Installation, Maintenance, and Repair of the KAflex®  
Driveshaft for the Bell 206A and 206B Helicopter.

**KAMATICS CORPORATION SERVICE INSTRUCTION NUMBER 2348**

Subject: KAflex Main Driveshaft Retrofit in accordance with Supplemental Type Certification Number SH7767SW.

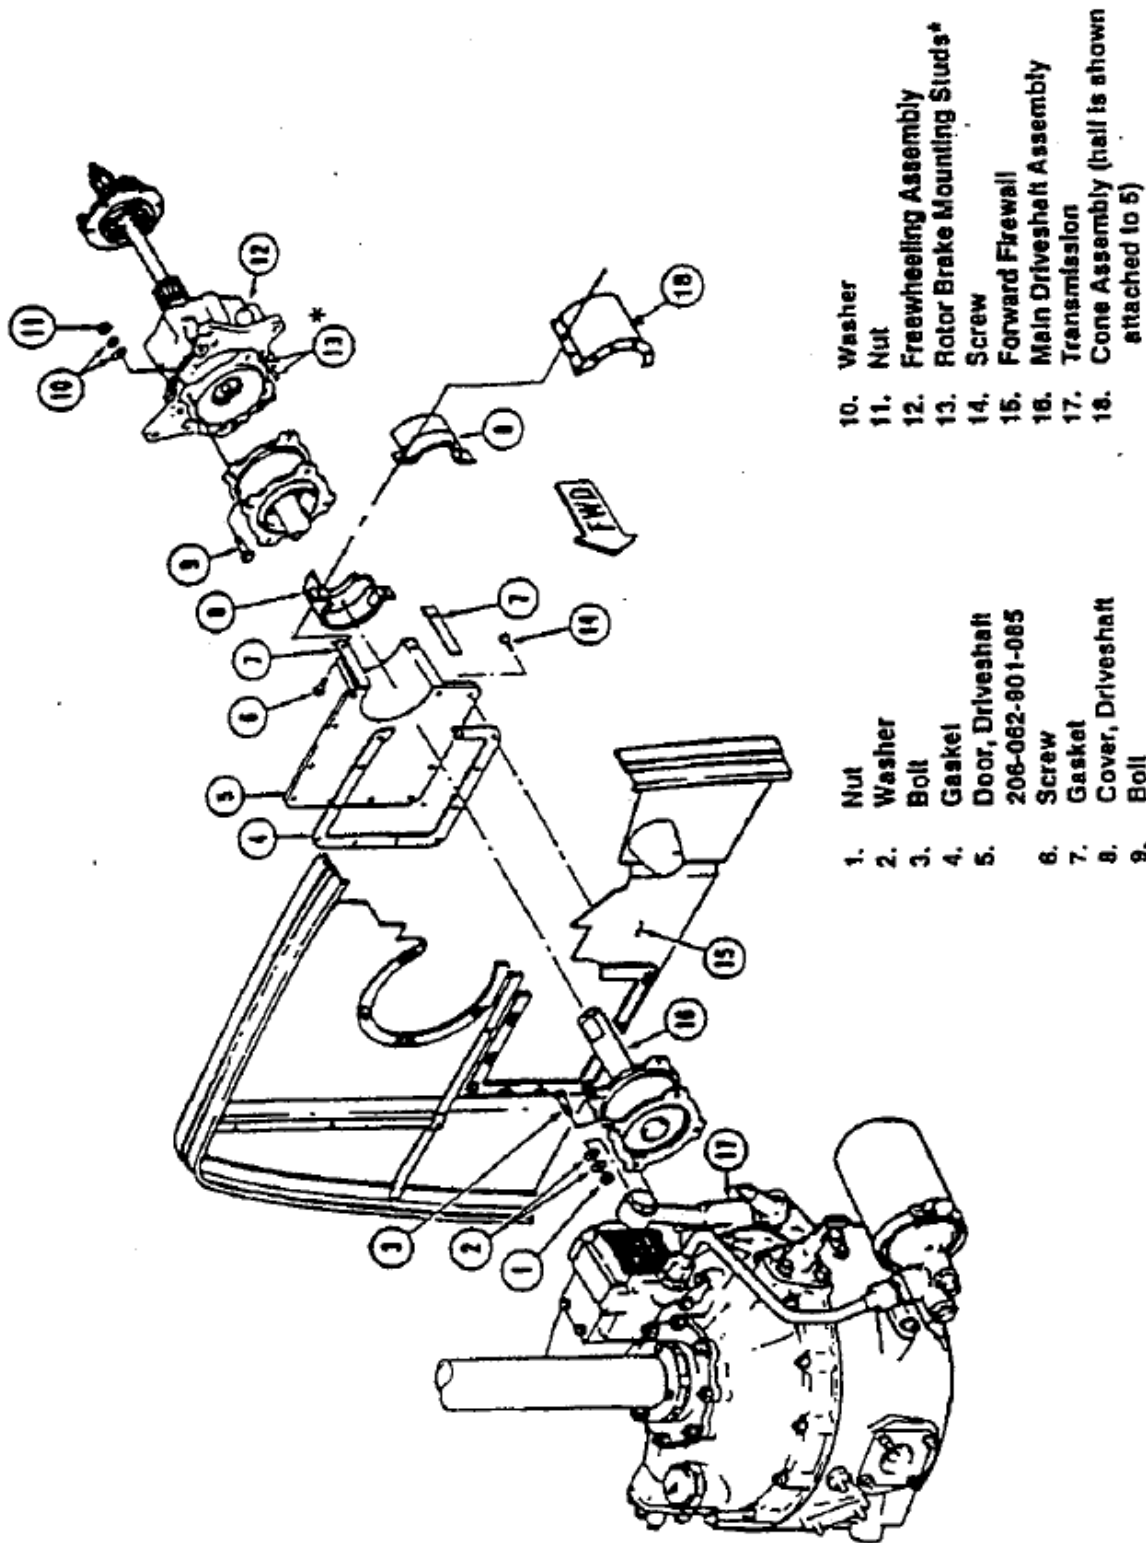
FIGURE 1: Existing Installation Main Driveshaft P/N 206-040-100-13

**Inspect driveshaft door for cracks, damage and corrosion (Figure 1, Item 5). If these conditions exist, replace driveshaft door before proceeding.**
