## ENGINE EXAMINATION REPORT

| ENGINE MODEL | IO-520-M1B |
| AIRCRAFT MAKE & MODEL | Cessna 310R |
| FILE NUMBER | 16-697 |

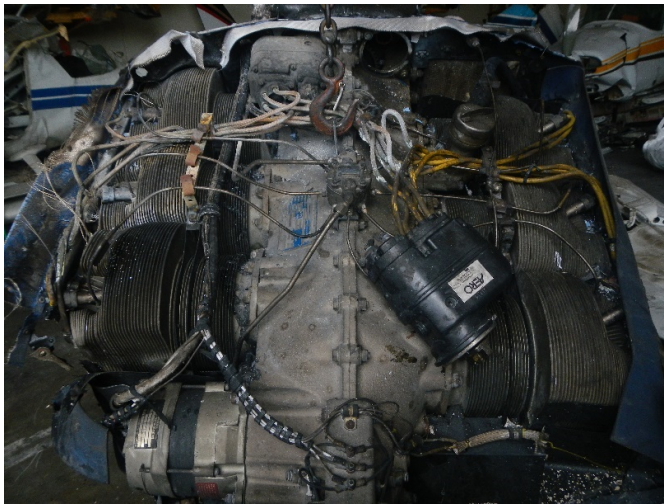
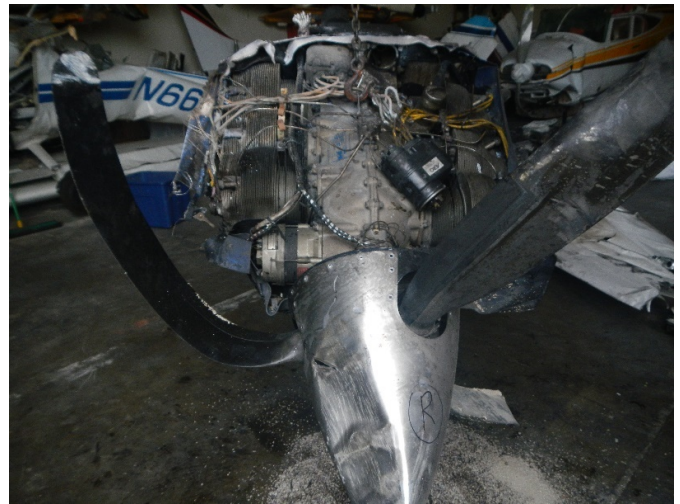
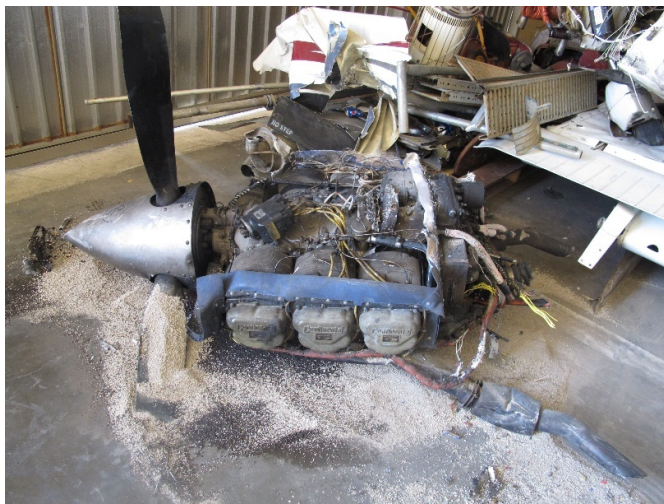
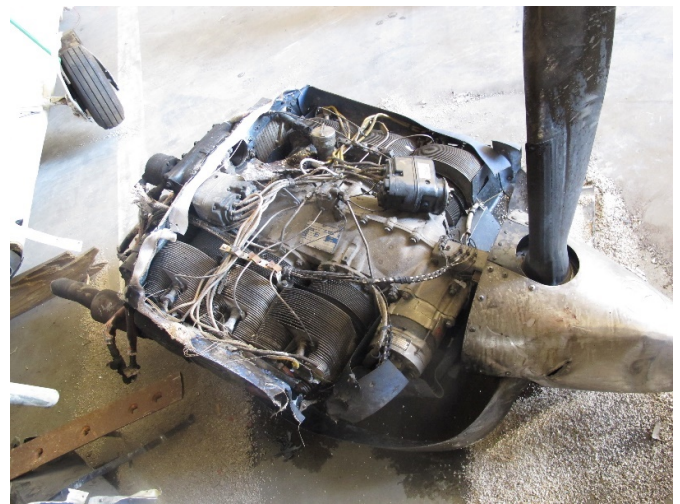
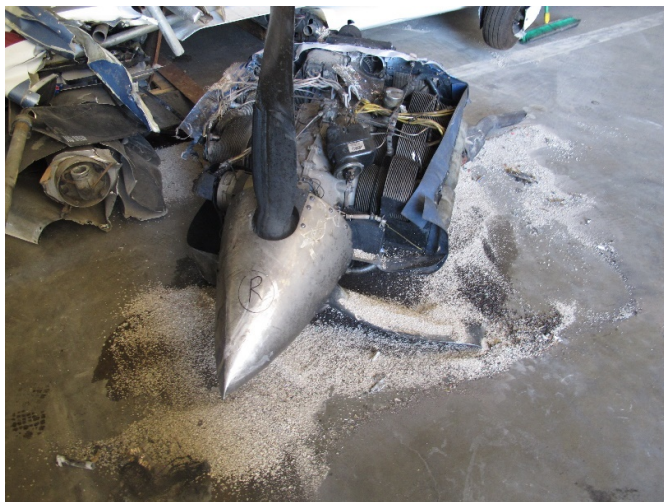
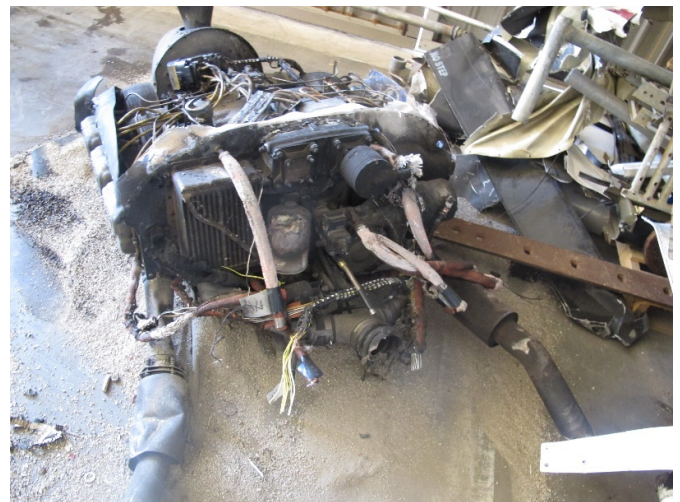
The #5 cylinder sustained impact damage that fractured the cylinder head resulting the separation of the rocker assemblies and pushrod tubes/pushrods. The left magneto was separated from the topside of the engine and its mounting flange was fractured under the attaching hardware. The magneto remained attached to the engine via the ignition harness. The backside of the engine sustained thermal damage that compromised the fuel system. The low pressure relief valve screw on the engine-driven fuel pump was bent and the fuel inlet fitting was fractured.

There were no external pre-accident anomalies noted with the engine.

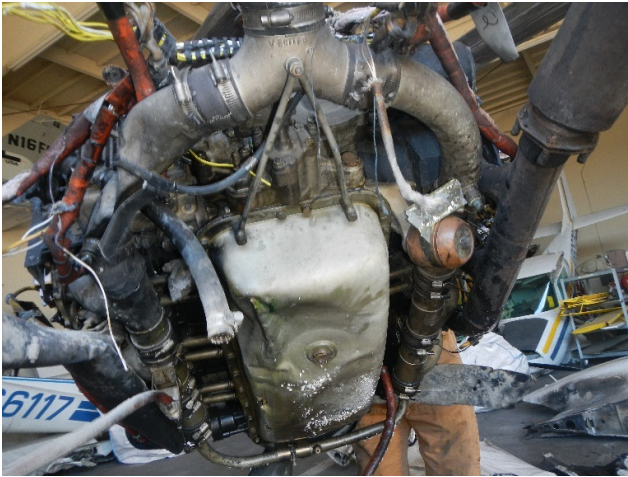
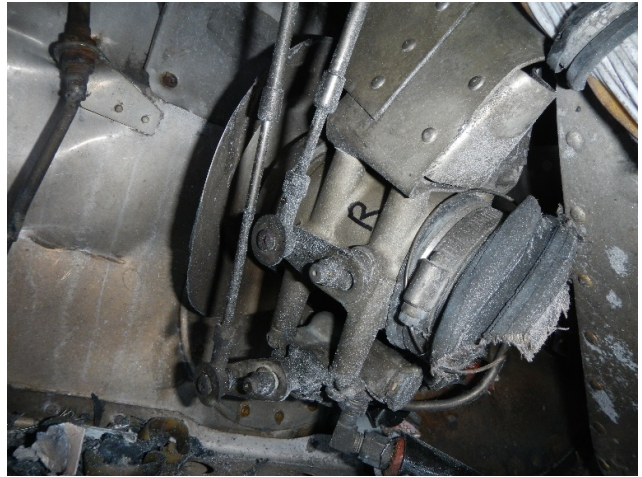
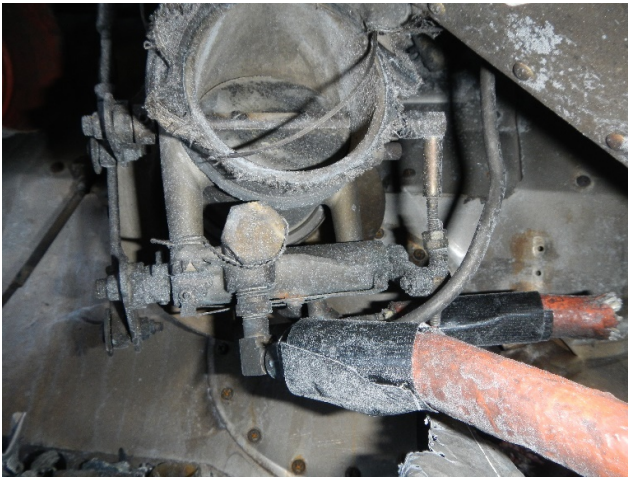
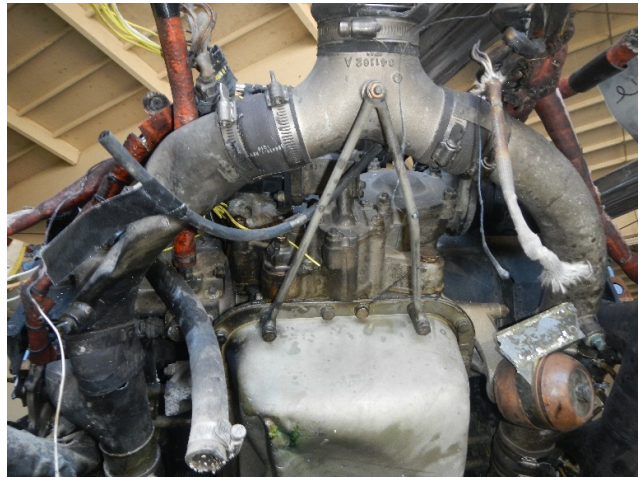
| Condition: | The left magneto was separated from its mounting pad and its mounting flange was fractured in the area of the attaching hardware. The magneto remained attached to the engine via the ignition harness. The vent cover was removed from the housing and the distributor gear was intact and rotated during drive shaft rotation. No pre-accident anomalies were noted and the magneto was retained for further testing (see Appendix A of this report for more details). | | |

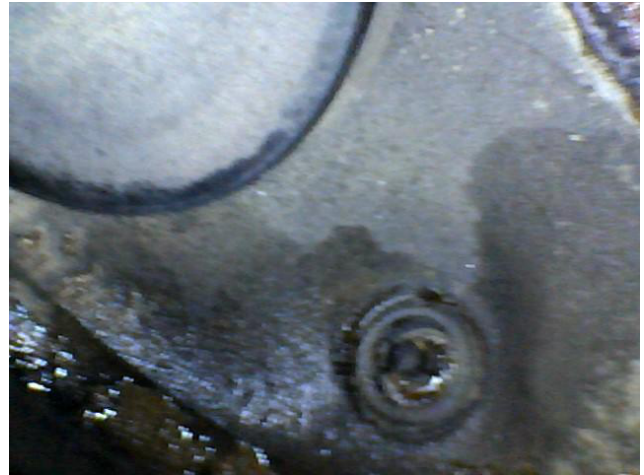
1B

Condition: The sparkplugs remained secured to their respective cylinders and each ignition terminal remained attached to its sparkplug. The top sparkplugs were removed from the cylinders and each displayed a normal worn condition with no evidence of carbon or lead fouling. The bottom sparkplugs were examined/photographed via lighted borescope.

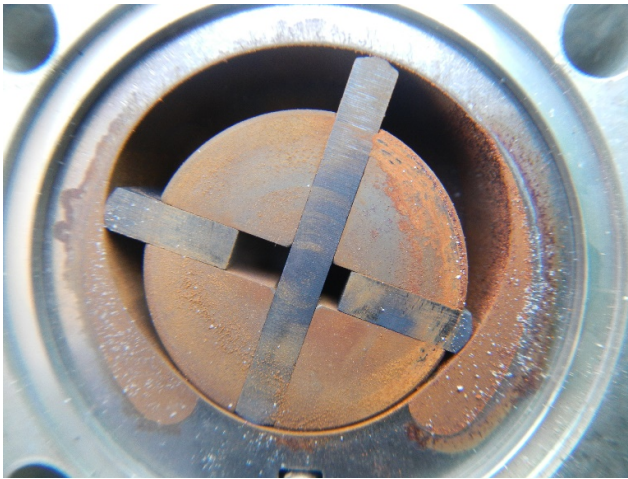
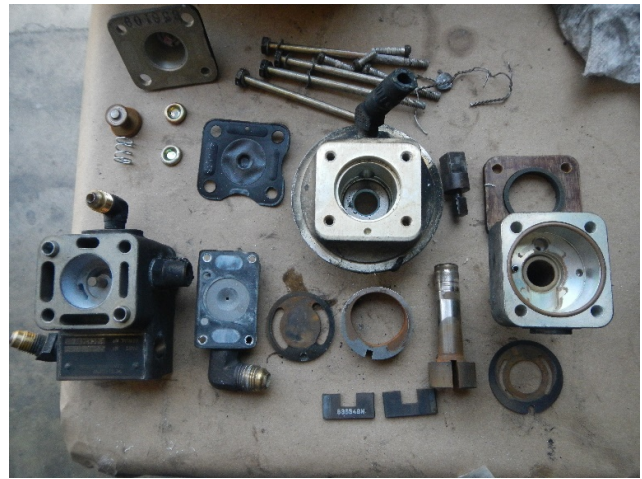
**Condition:** The engine-driven fuel pump remained secured to the backside of the engine and all of the fuel lines remained secured to their respective fittings, though the fuel inlet fitting was fractured. The pump was removed and the drive coupling was intact. The pump could not be functionally tested due to the thermal damage, but disassembly revealed that the pump vanes were intact and no pre-accident anomalies were observed with the pump's internal components.

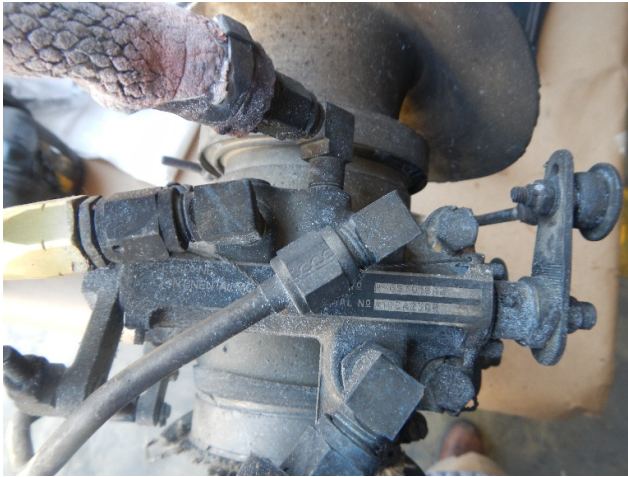
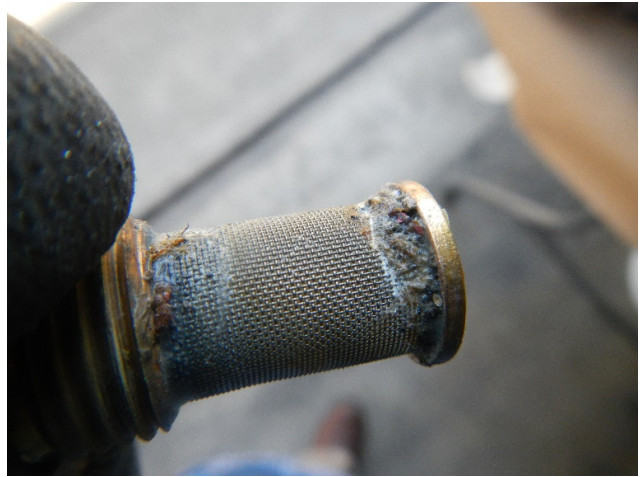
Condition: The throttle body/fuel metering unit was separated from the wye plenum and remained secured to the engine nacelle via the throttle and mixture control cables. The fuel lines leading to and from the fuel metering unit remained secured to their respective fittings, though the lines were cut by recovery personnel. Manual manipulation of the mixture and throttle control levers resulted in a coinciding movement in their control cams. The interconnect between the throttle valve shaft and the throttle metering cam was distorted. The fuel inlet screen was removed and no obstructions were observed; however, there was some debris noted on the edges of the screen.

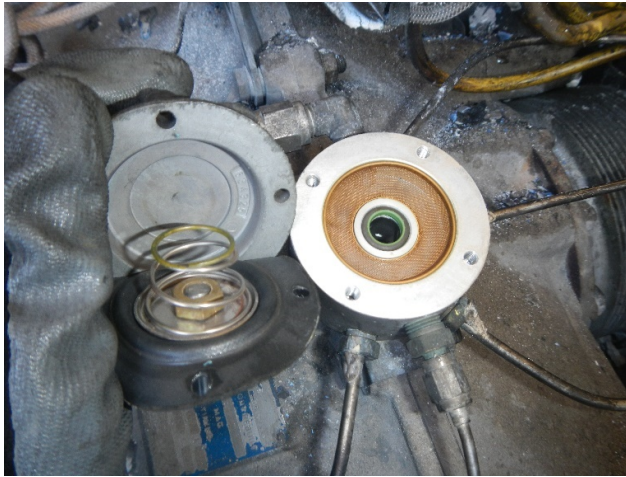
Condition: The fuel manifold valve remained secured to the topside of the engine and all lines to and from the manifold valve remained secured in place. The cap was removed and the diaphragm was intact and the plunger was in place. The screen was clear.

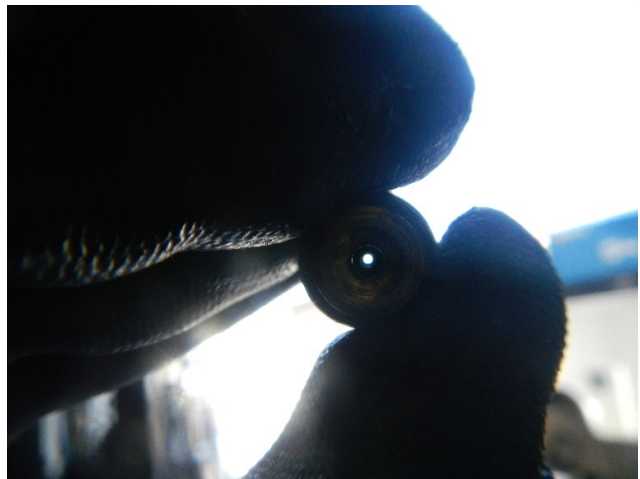
3

Condition: The fuel injector nozzles remained secured to their respective cylinders and the fuel injection lines remained intact. The nozzles were removed and there were no obstructions or blockages noted in any of the nozzles.

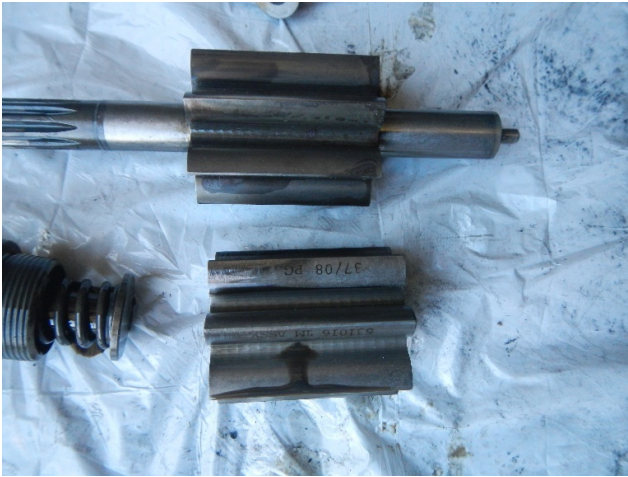
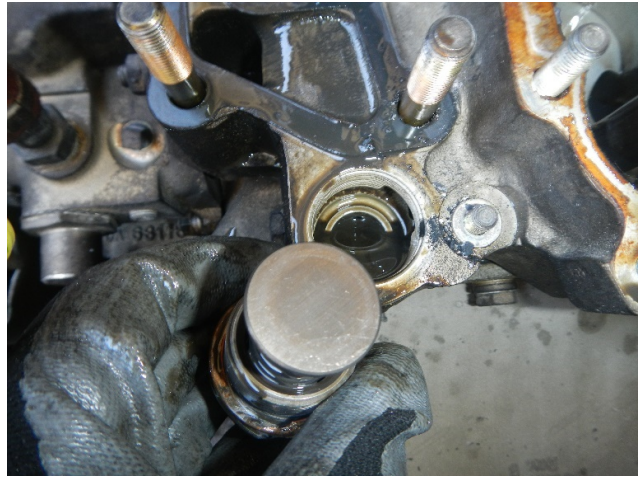
Condition: The oil pump remained attached to the backside of the engine with no evidence of oil leaks or pre-accident anomalies noted. Disassembly of the oil pump revealed residual oil in the housing. The gears were intact with light surface corrosion and wear noted in areas. The oil pressure relief valve and valve seat did not display and sign of abnormal seating.

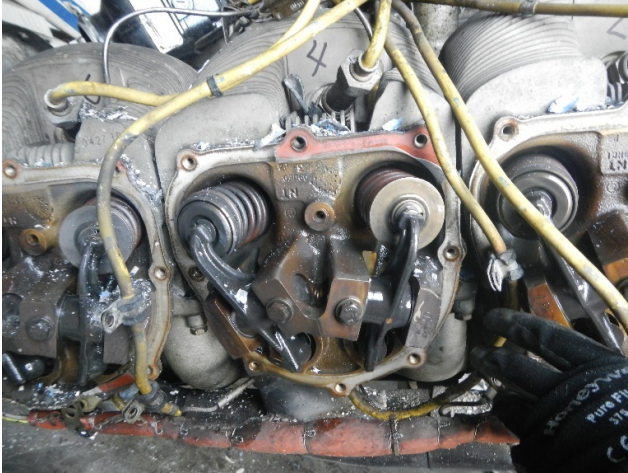
Condition: The cylinder remained attached to the engine and the original torque putty appeared to be intact on the attaching hardware (the serial number matched that on the build record). The rocker cover was removed and no pre-accident anomalies were observed with the rockers or valve springs. A borescope inspection of the cylinder's internal components did not reveal any pre-accident anomalies with the barrel, piston, valves or valve seats. A thumb compression test resulted in compression and confirmed connecting rod, piston, and rocker arm movement.

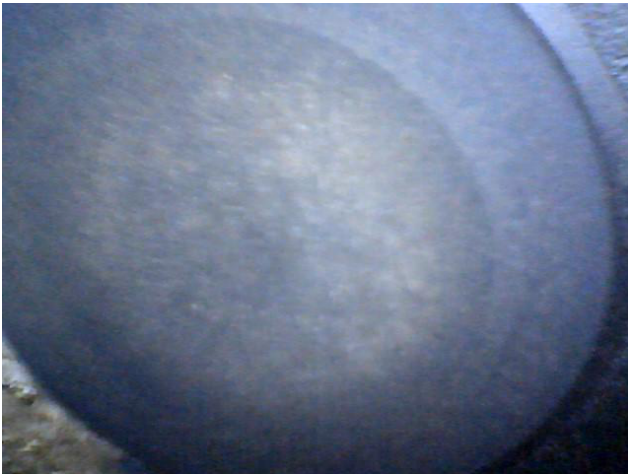
Condition: The cylinder remained attached to the engine and the original torque putty appeared to be intact on the attaching hardware (the serial number matched that on the build record). The rocker cover was removed and no pre-accident anomalies were observed with the rockers or valve springs. A borescope inspection of the cylinder's internal components did not reveal any pre-accident anomalies with the barrel, piston, valves or valve seats. A thumb compression test resulted in compression and confirmed connecting rod, piston, and rocker arm movement.
